S1/MPG/02/CSB/LM/1.0/104/R2

## PARKFIELD HOUSE BOUNDARY WALL, MANCHESTER OLD ROAD

Muller Property Group have requested a structural appraisal of the stone boundary wall to the footpath of Manchester Old Road in particular near to tree reference 9T.

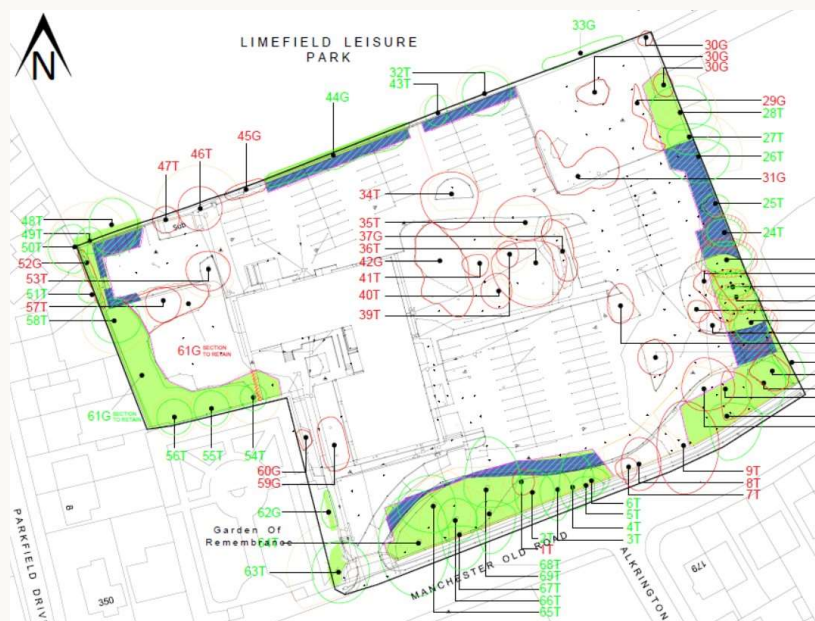
The boundary wall is approximately 1.8m high and retains soil for its full height on the north side. The width of the wall cannot be confirmed however the coping stone at the top of the wall is approximately 450mm wide. We would expect the wall to increase in thickness with depth on the retained soil side. No weep holes were noted in the wall therefore water pressure will also be applied to the wall.

For much of the length of the wall the wall face is vertical, however in the vicinity of tree 9T the wall starts to lean towards the footpath/road. The wall is out-of-plumb by approximately 115mm in 1000mm (210mm in the full wall height).

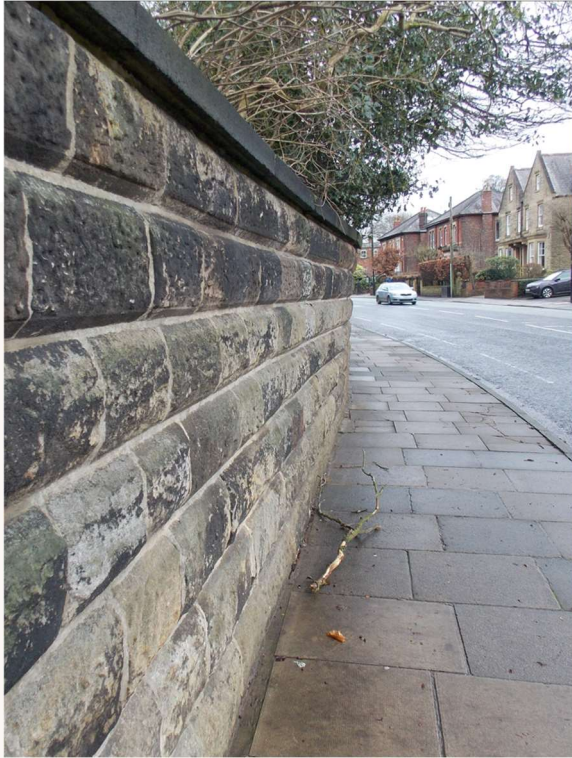
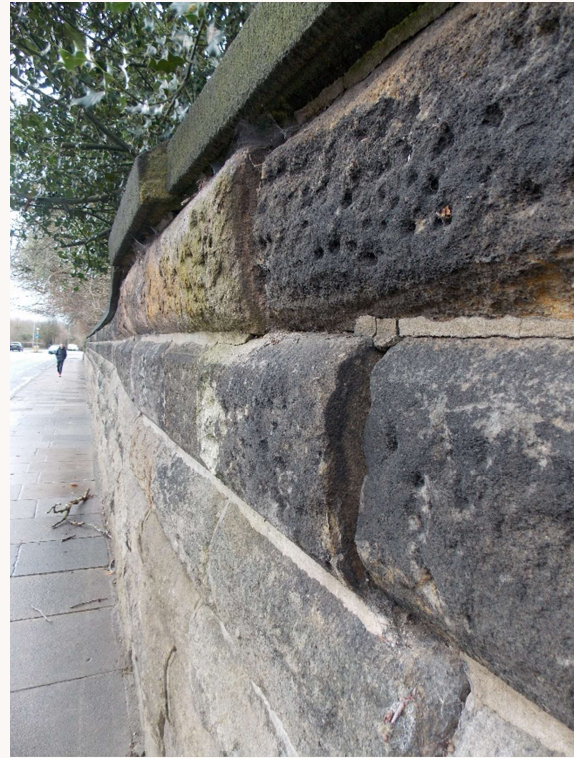
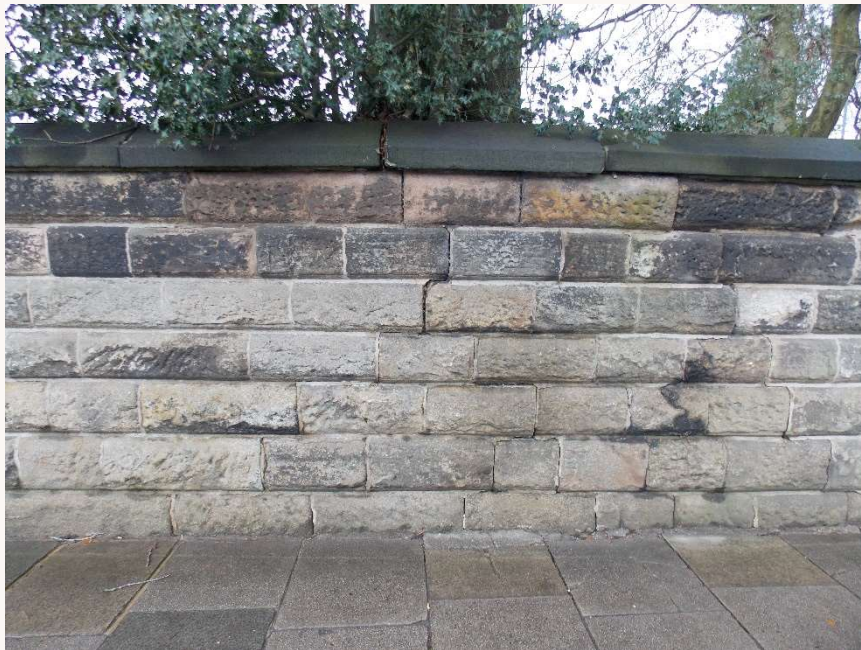
Tree 9T is a mature Beech tree in excess of 20m tall with an approximate diameter of 900mm. Due to close proximity of the main trunk to the wall the root growth is applying horizontal force against the wall and displacing the stone work.

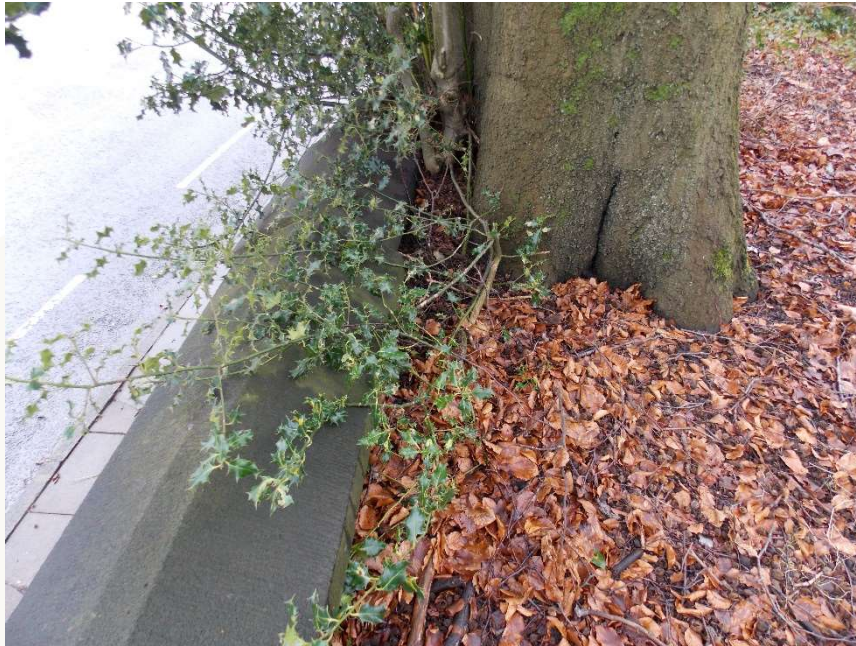
Whilst the wall is currently retaining the soil and tree there is likely to be further growth to the 9T Beech tree imposing increased load onto the boundary wall and causing further damage. In addition, if the wall were to be rebuilt locally there is a possibility that future growth will impose further pressure on the wall.
