23261

FALINGE PARK – ROCHDALE

AUGUST 2023

# REPORT ON STRUCTURE

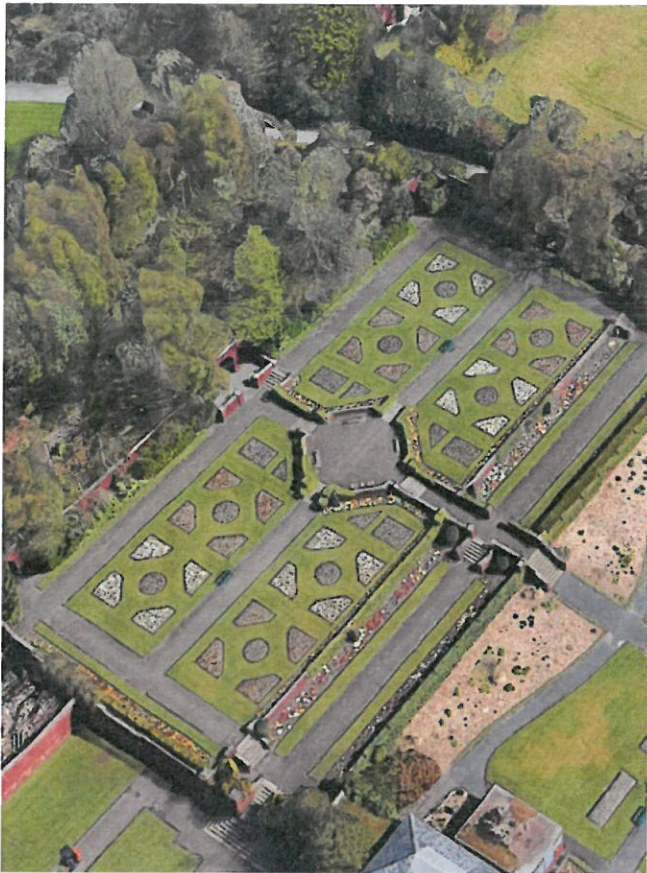
Photograph 1

- 1.01** Further to a request from Chris Hilton of ABM (Lancashire) Ltd, we visited the above public park to inspect and comment upon the structural condition of a brickwork retaining wall that forms the rear boundary to the ornamental gardens of the former hall. Photograph 1.

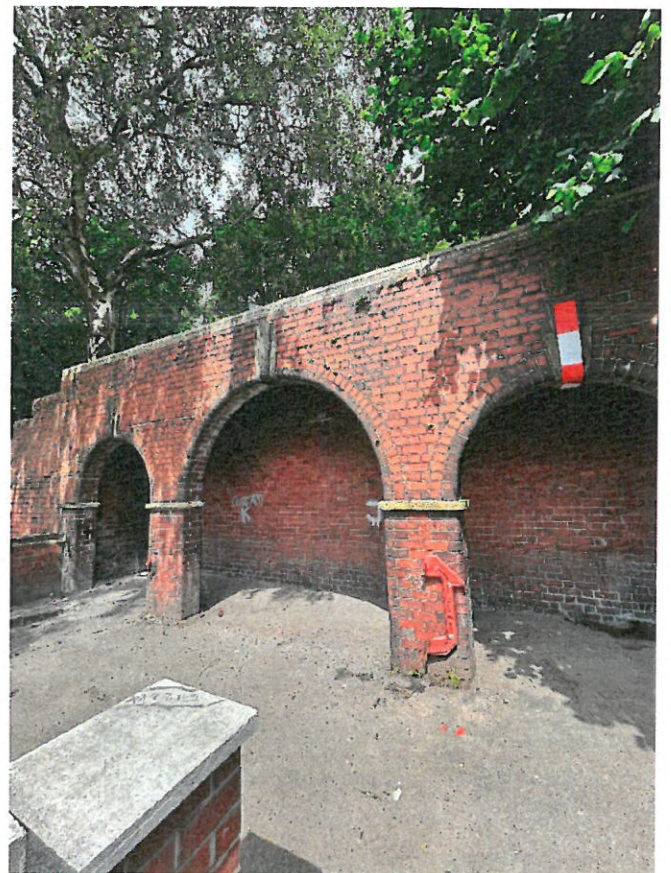
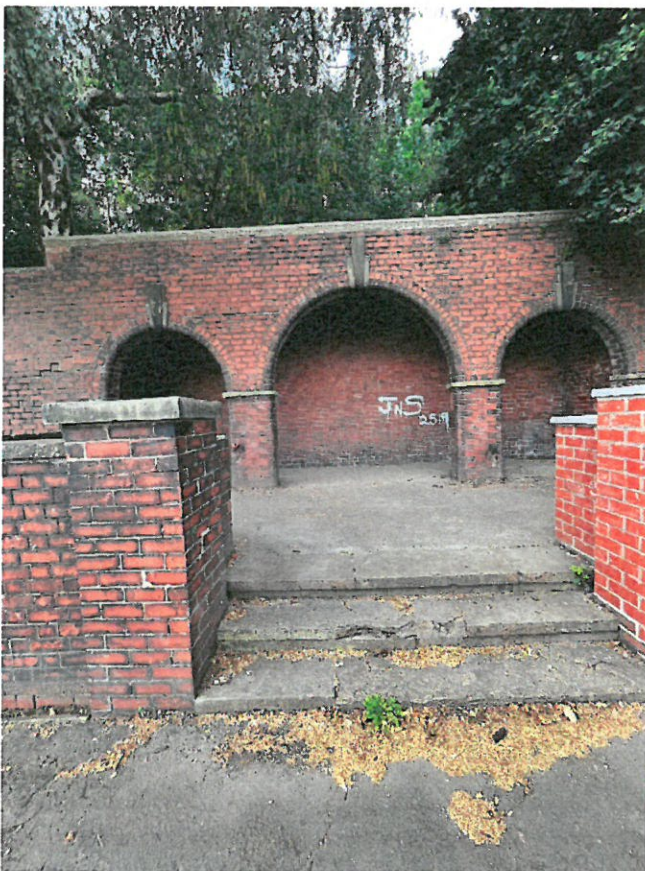
- 2.02** In appearance the wall, when viewed from the ornamental garden, consists of a central recessed area, in which there are three archways. These comprise of a large central arch with smaller archways other side, photographs 2 & 3.

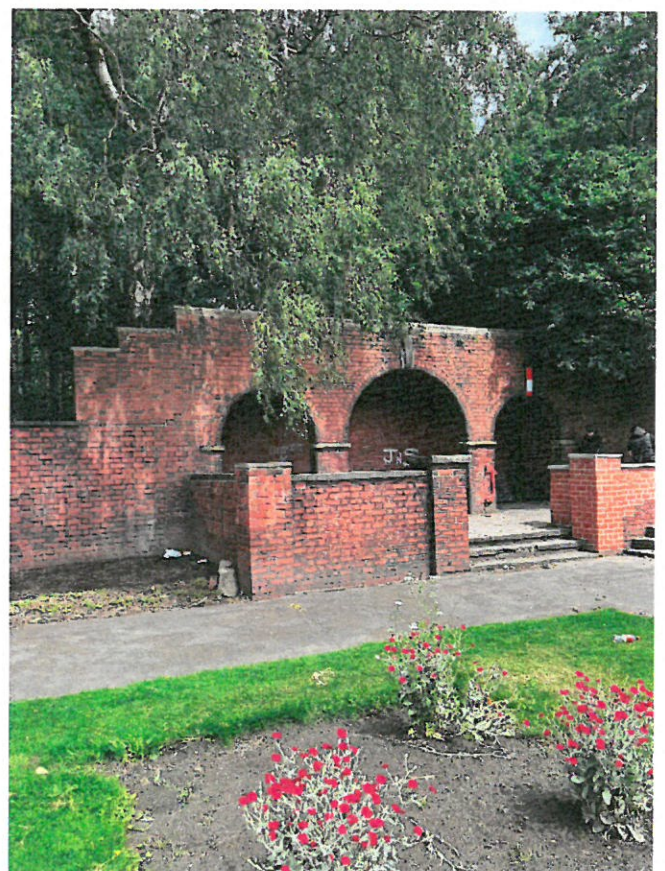
Photograph 4

- 2.03** There is a small courtyard surrounded by brickwork immediately in front of the wall, photograph 4.
- 2.04** The wall extends both to the left and to the right. At each end is a single recessed area, each accessed via a single brick arch, photographs 5 & 6, are of the left and right respectively.

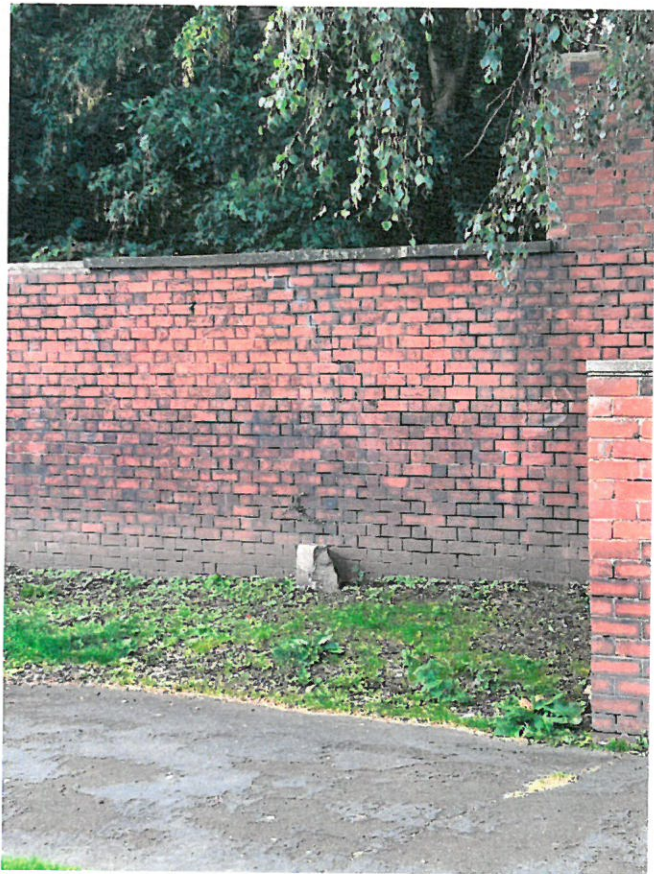
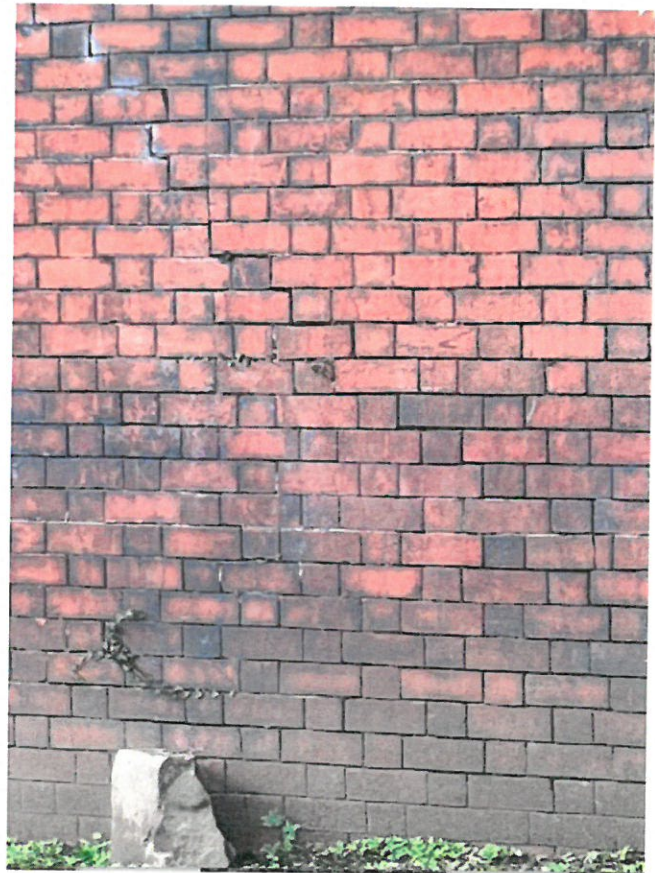
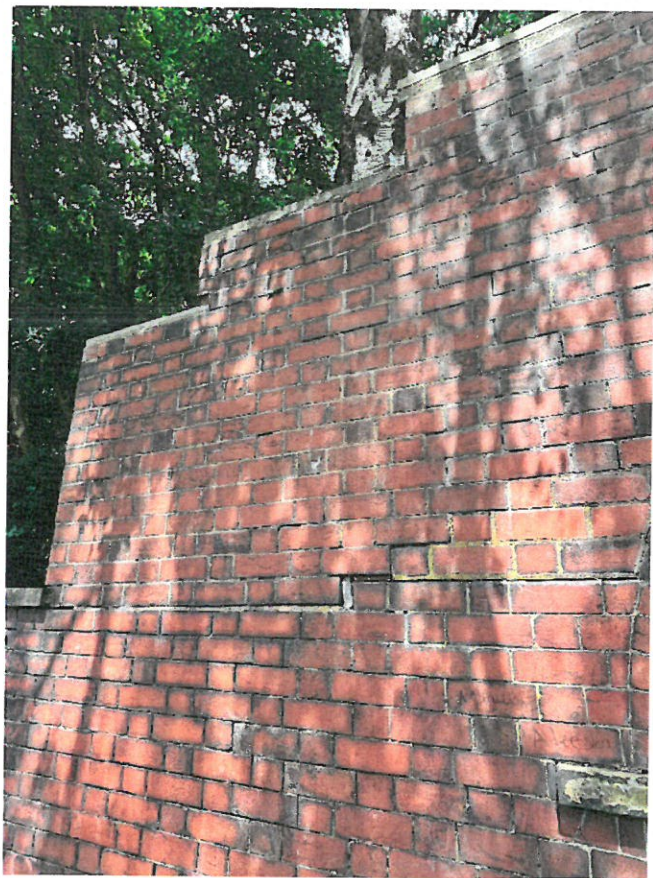
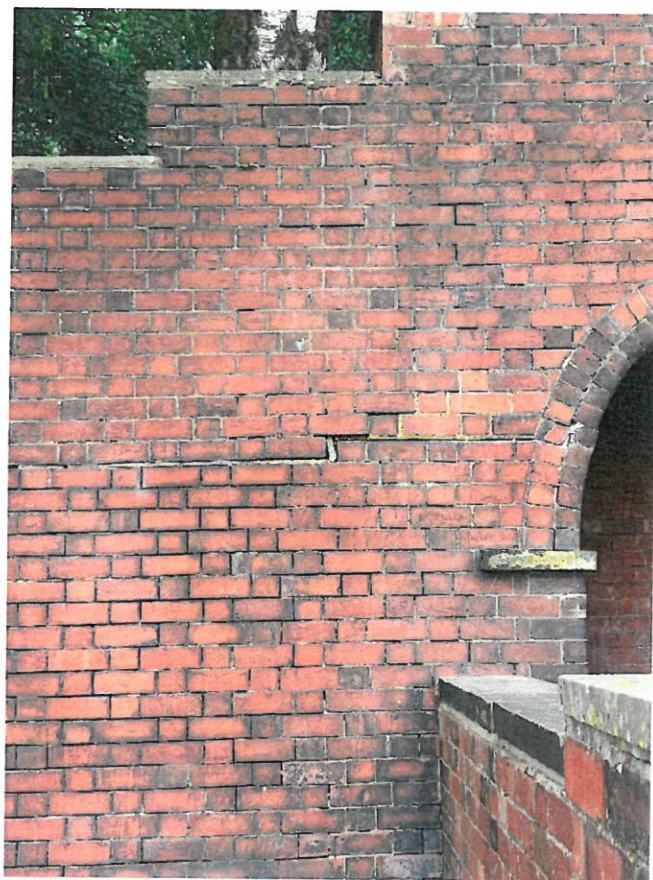
- 3.02** On the left of first of the three arches, there is stepped cracking in the boundary wall. Photographs 7, 8, 9 & 10.
- 3.03** Where the wall steps up to cover the arch, there is further stepped cracking and horizontal displacement of the bed joints which extend beyond the arch key stone. Photographs 11, 12, 13 & 14.

Stepped cracking to the left of the arch which will need to be stitched with helical bar and the area repointed. See elevation drawing.

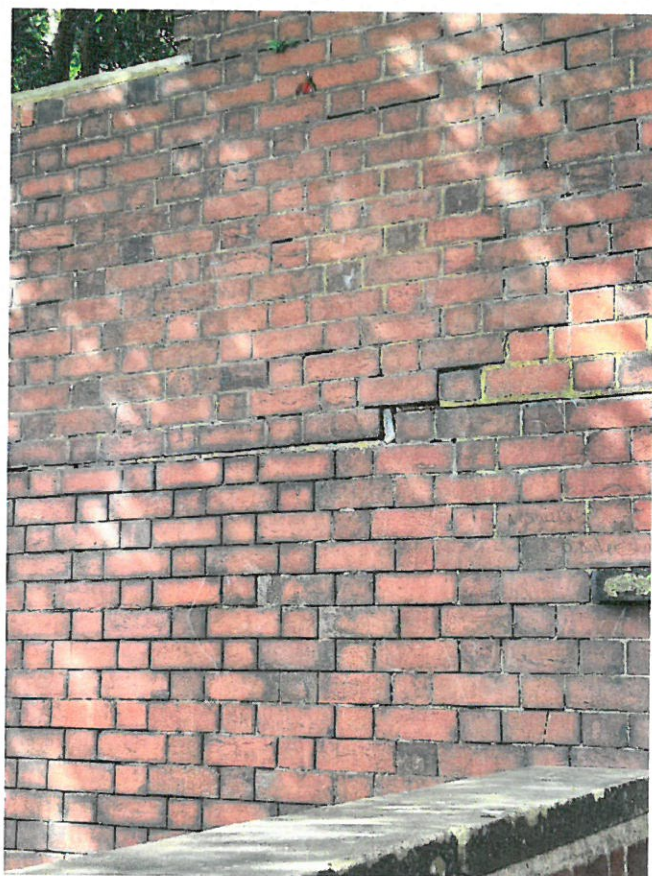
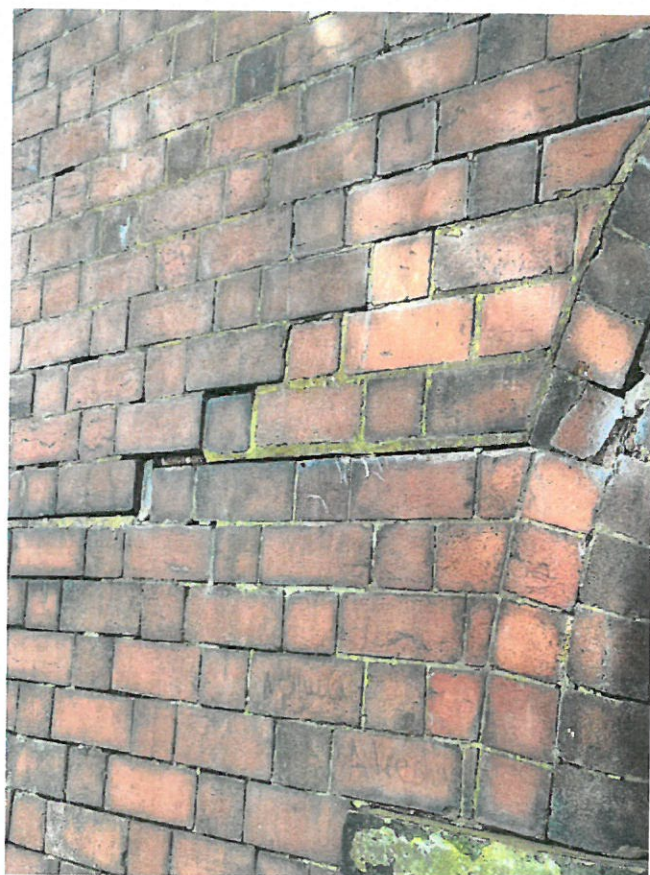
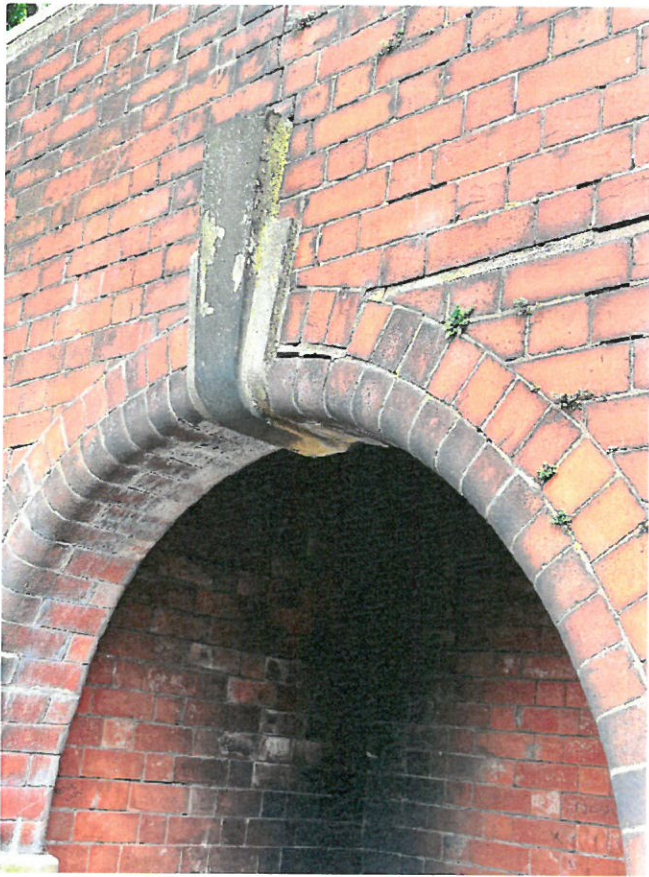
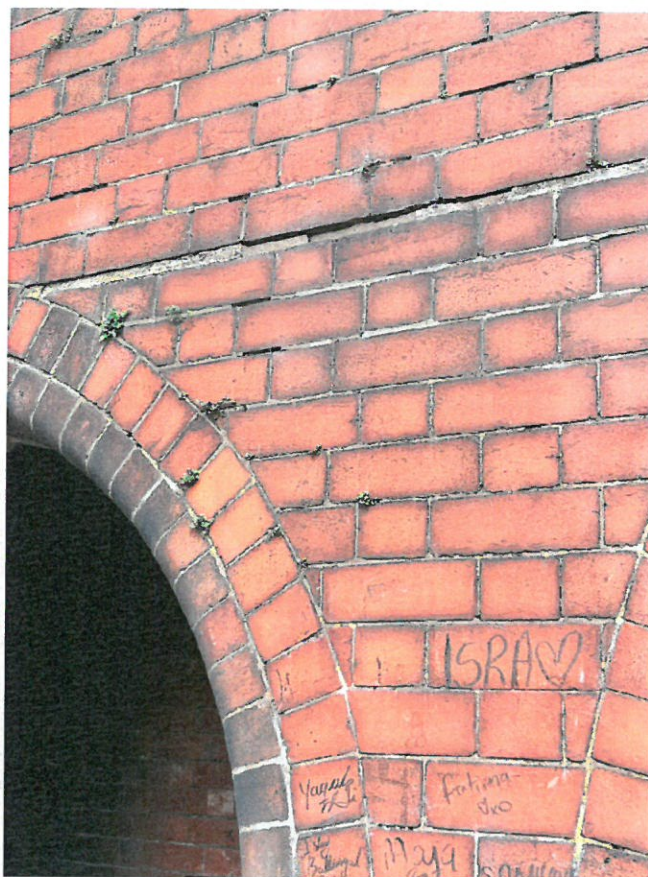
- 4.03** There is vertical displacement of the bed joints either side of the first arch. This, along with the damage to the rear has been caused by the silver birch tree.

The horizontal joint can only be repointed/ the brickwork to the rear of the wall will need to be locally rebuilt and stitched. See sketch.

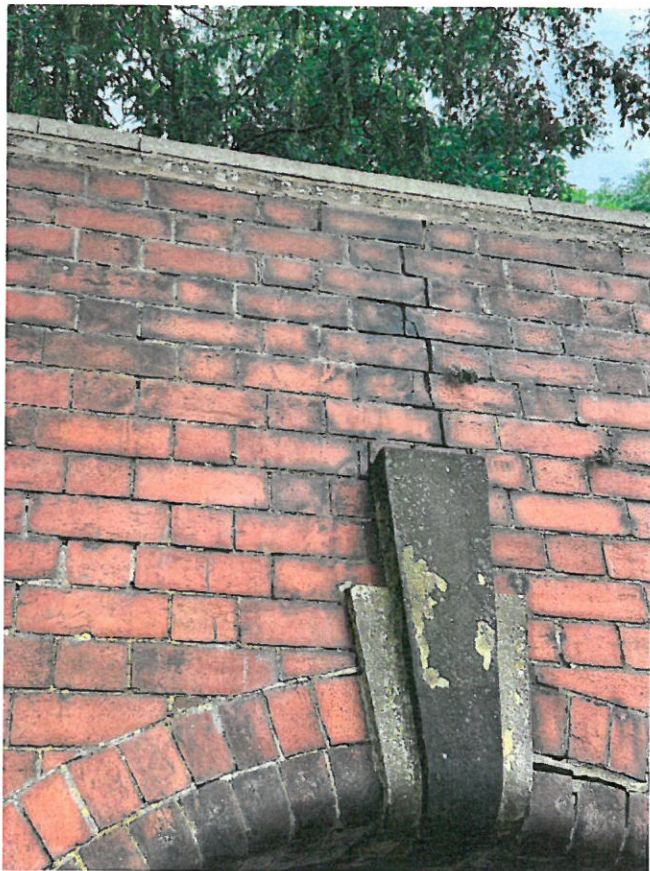
Photograph 15

- 3.04** Above the keystone of the first arch there is a vertical crack in the brickwork, photograph 15.
- 3.05** The arch brickwork has lost compression and areas of the arch masonry are loose, photographs 16, 17 & 18.

- 4.04** The vertical crack above the arch should be stitched with helical bar.
- 4.05** The loose arch masonry needs to be made good and pinned. See sketch.
- 4.06** The shrubbery behind the wall should be managed to prevent further damage to the wall.
- 4.07** Any loose copings should be re-bedded.

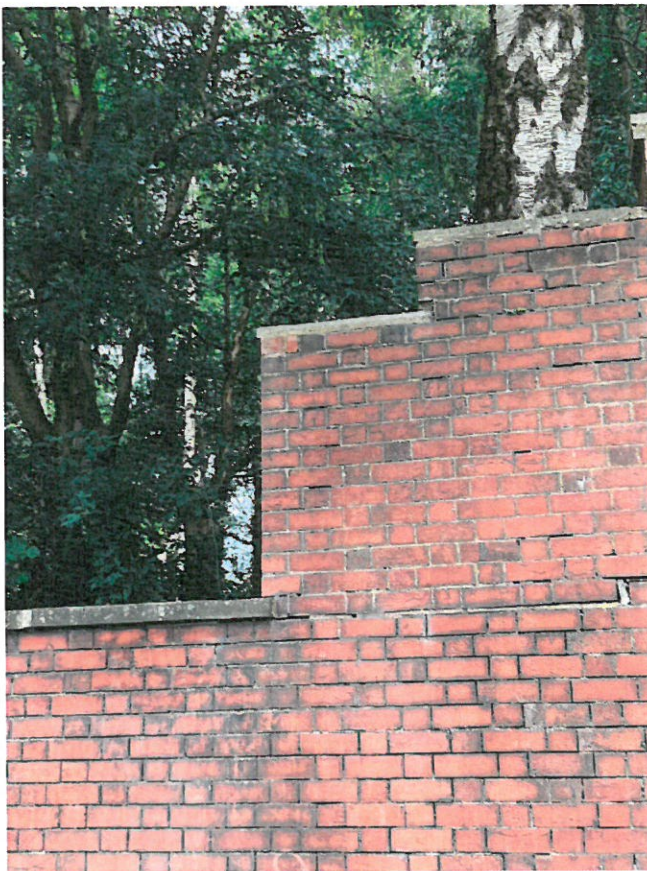
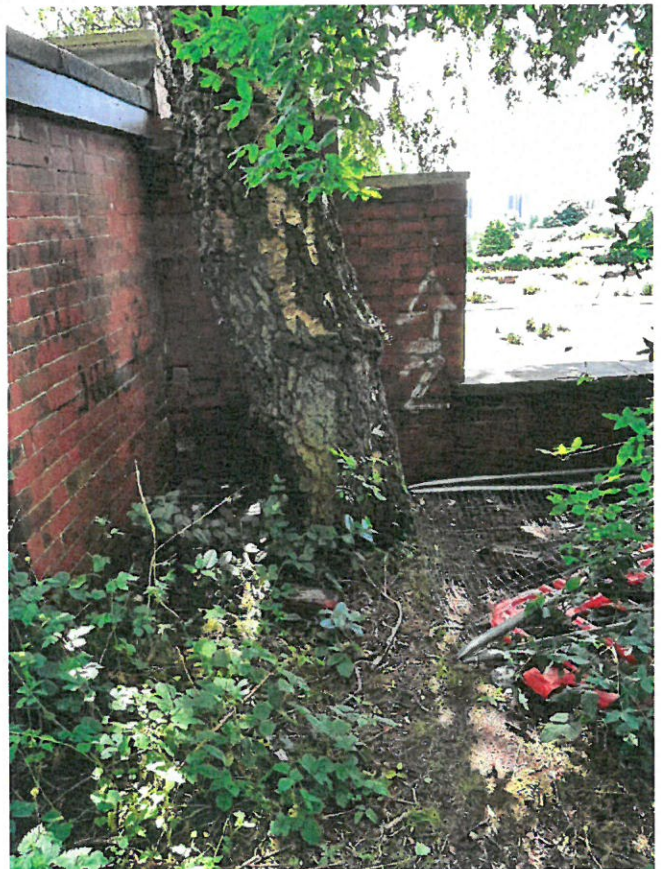
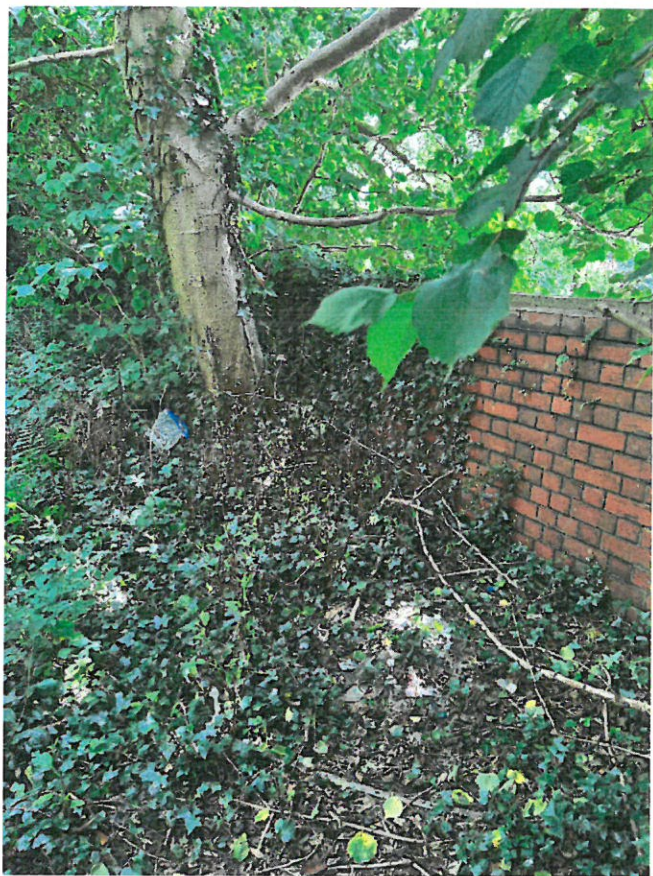
- 3.06** At the rear of the wall there is a large silver birch tree, photographs 19, 20 & 21. The roots to this tree are clearly affecting the wall and have damaged the rear of the shelter, photographs 22, 23 & 24. This damage is not reflected internally within the shelter, photographs 25 & 26.

- 4.02** The central arch arrangement has been affected by tree growth. There is a particularly large silver birch tree to the left of the arch which has caused damage to both the front and rear of the wall.

This tree needs to be removed and the roots killed.

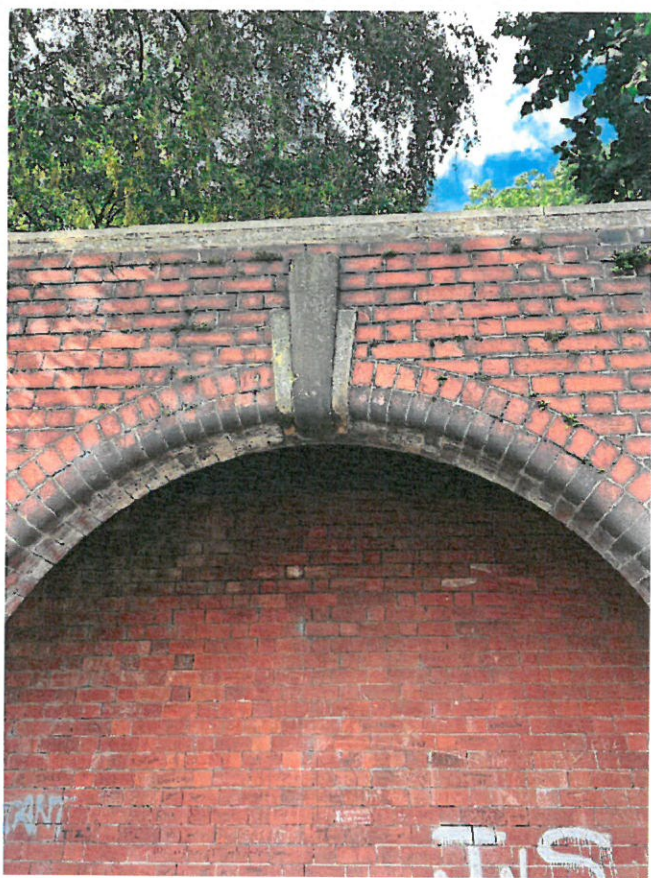
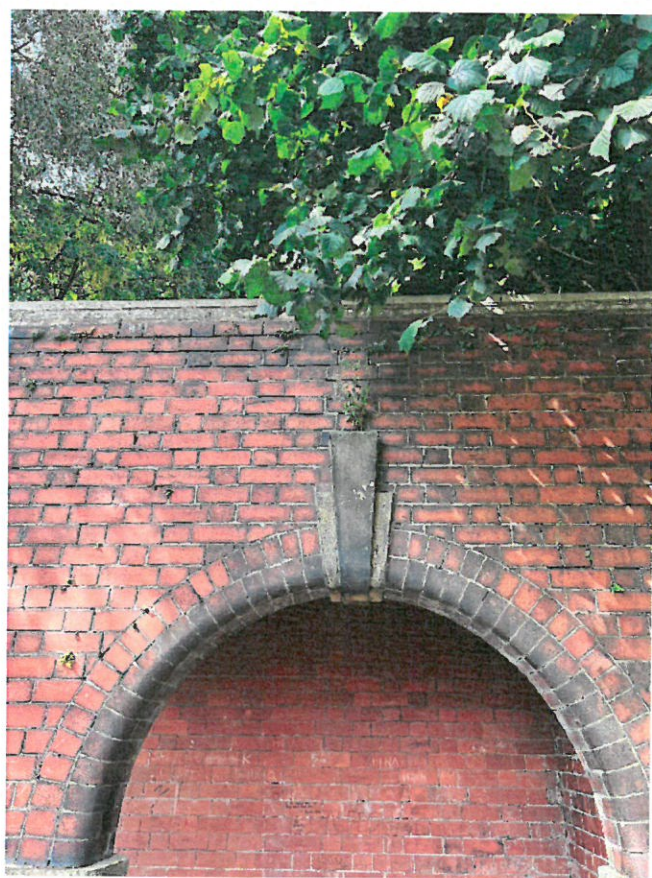
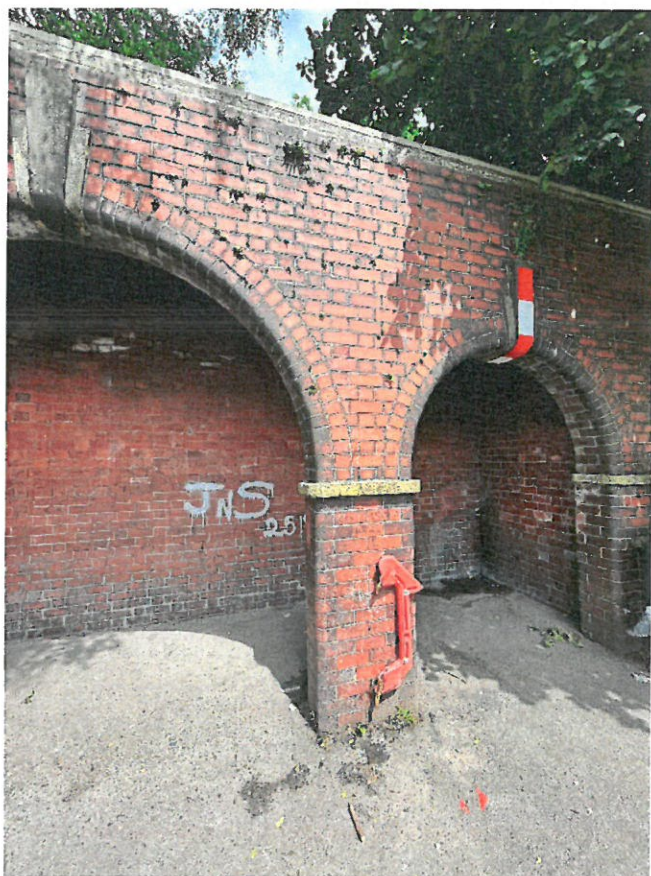
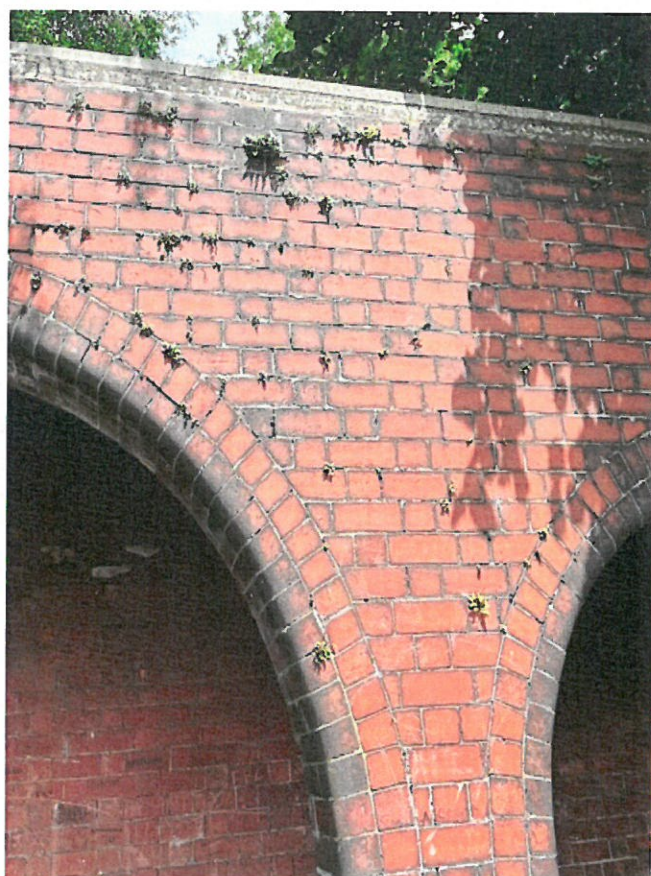
- 3.07** The remaining arches are in need of repointing. There are areas of plant growth which will need to be removed and treated prior to repointing. Photographs 27, 28, 29 & 30.

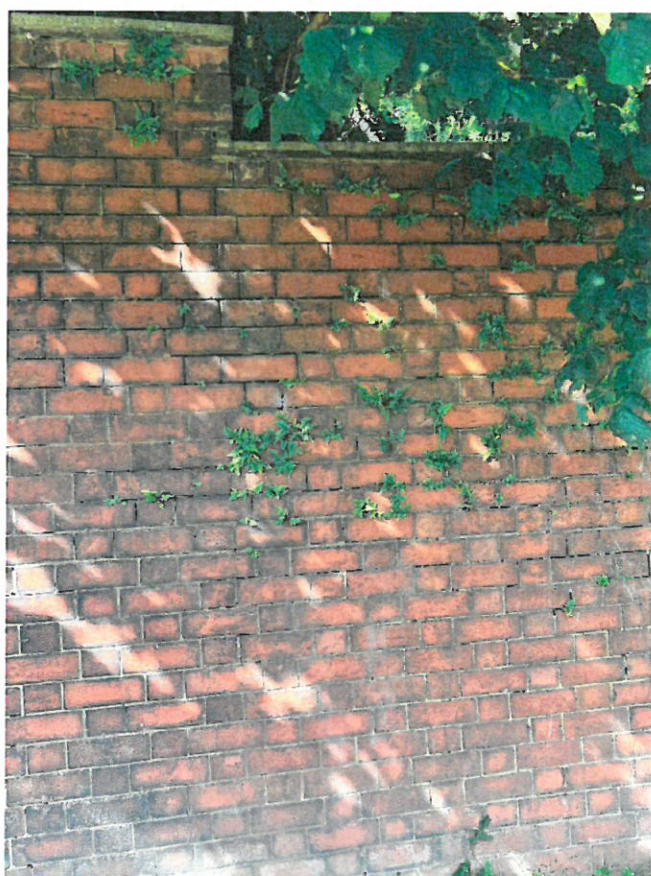
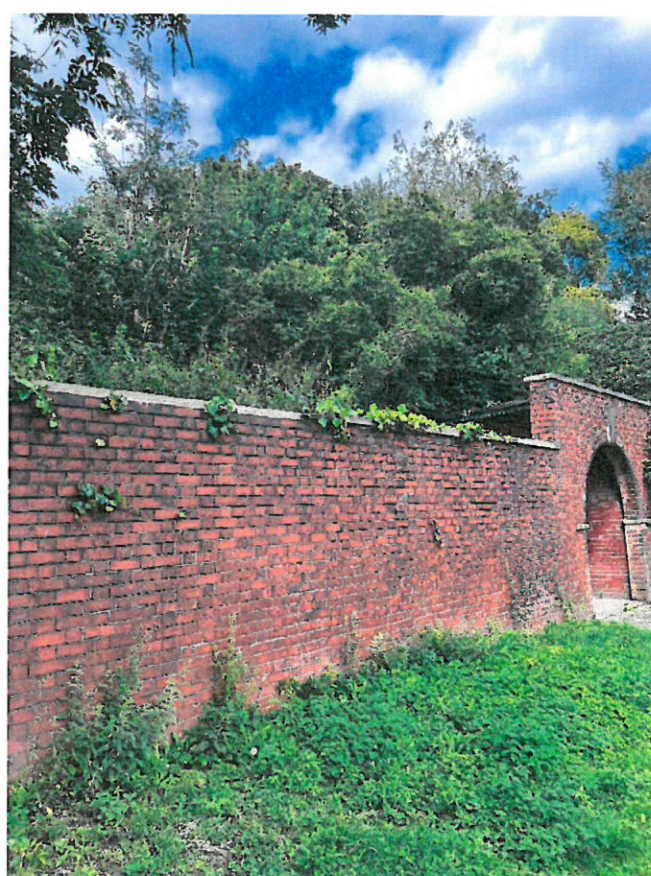
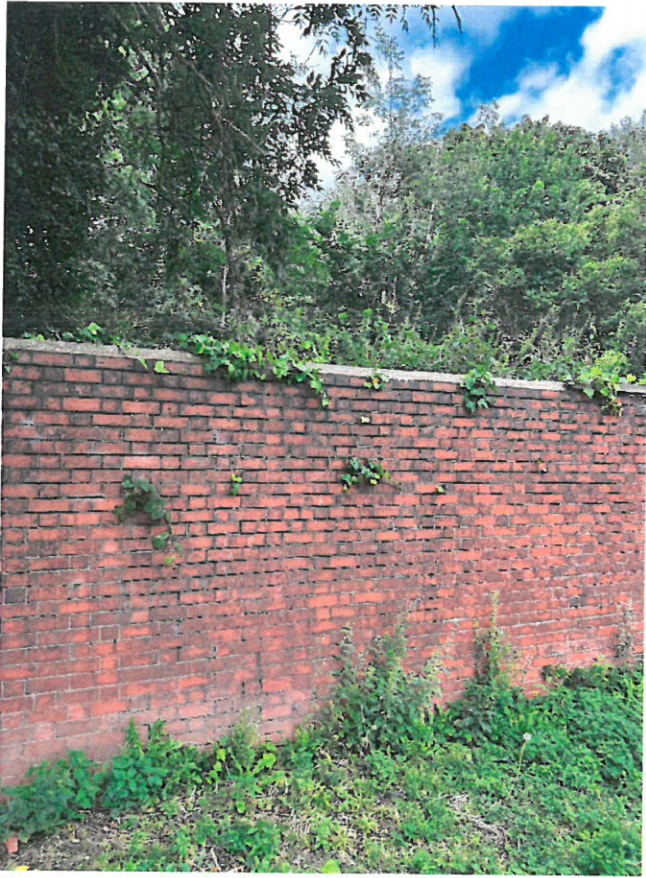
- 3.08** The long length of wall between the central arches and the end shelters are generally considered to be within acceptable tolerances for plumb. These sections are in need of patch pointing, photographs 31, 32 & 33.

- 4.01** The two long lengths of wall between the central arch and the end arches are generally in a reasonable structural condition.

There is plant growth in some of the mortar joints. This should be removed, and the areas patch pointed.

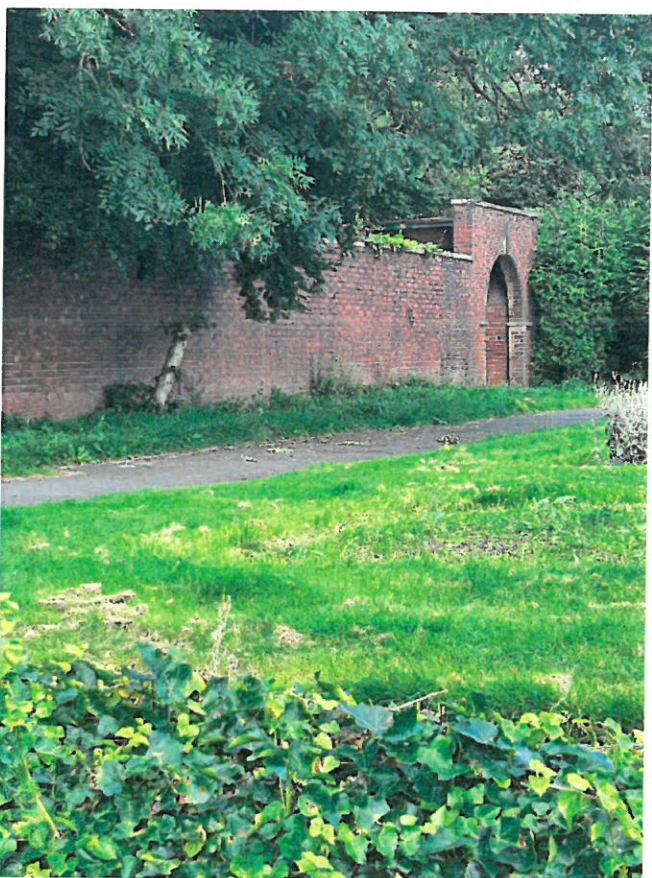
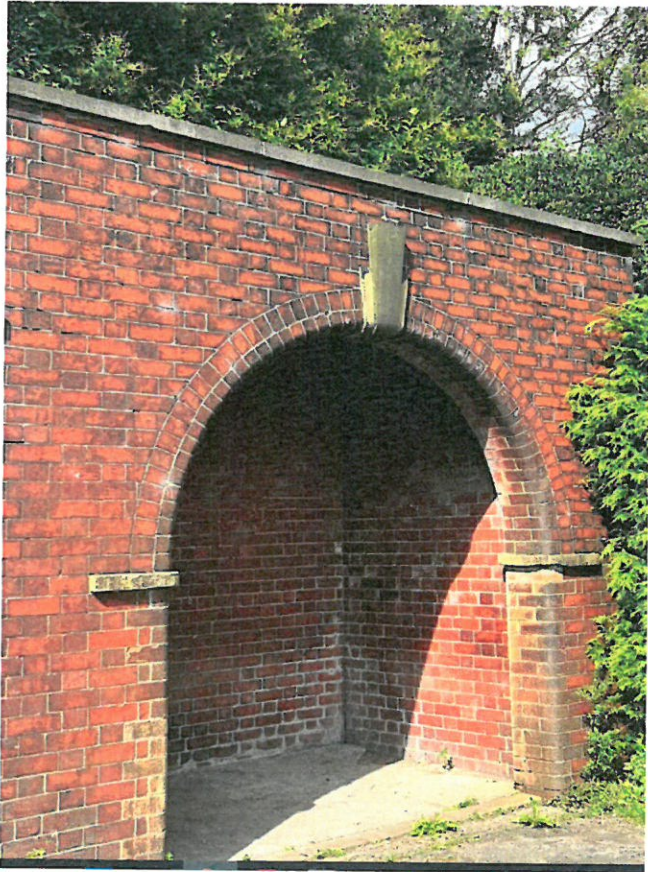
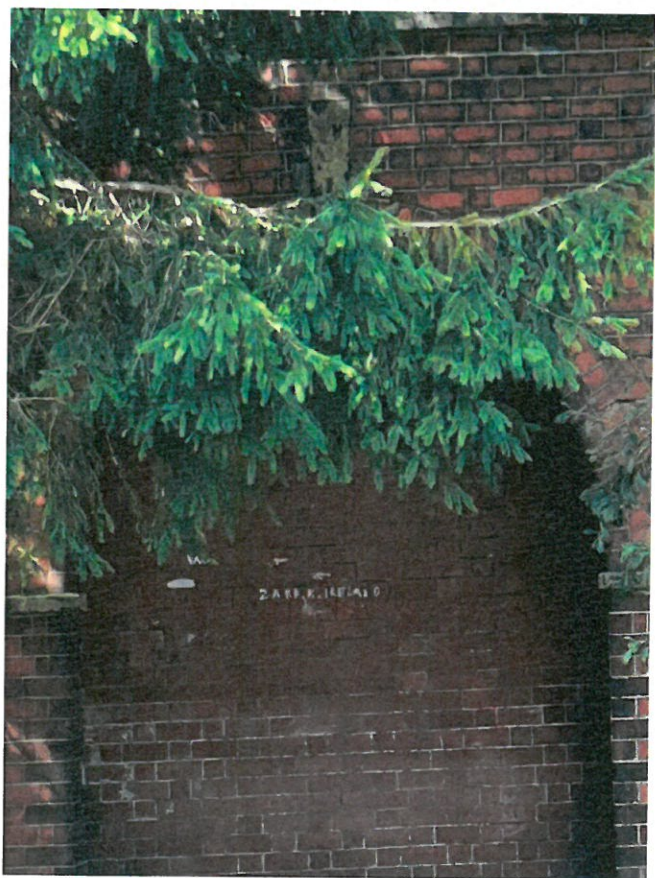
- 3.09** The two end shelters are deemed to be in a reasonable condition., these simply need to be maintained, photographs 34, 35 & 36.
- 3.10** The low-level wall bounding the small courtyard in front of the 3 arch shelter has been repaired in the recent past, photographs 37, 38 & 39.

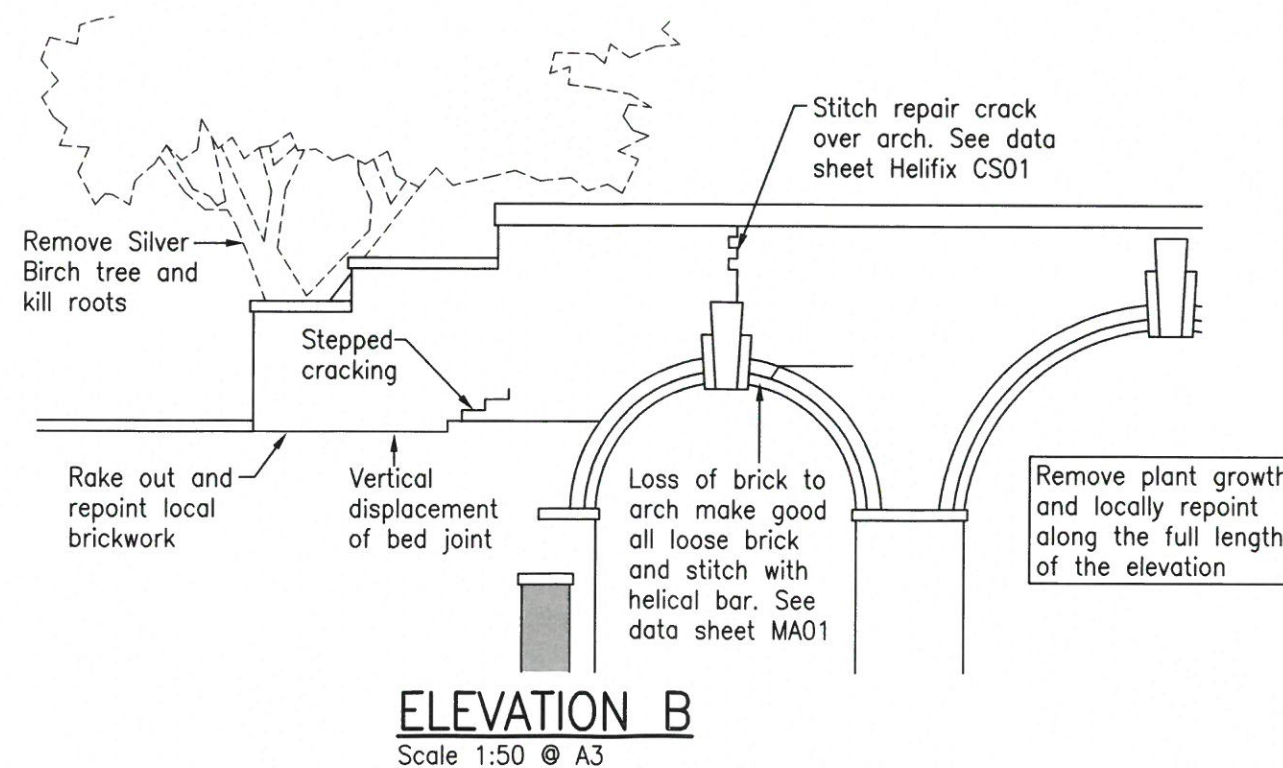
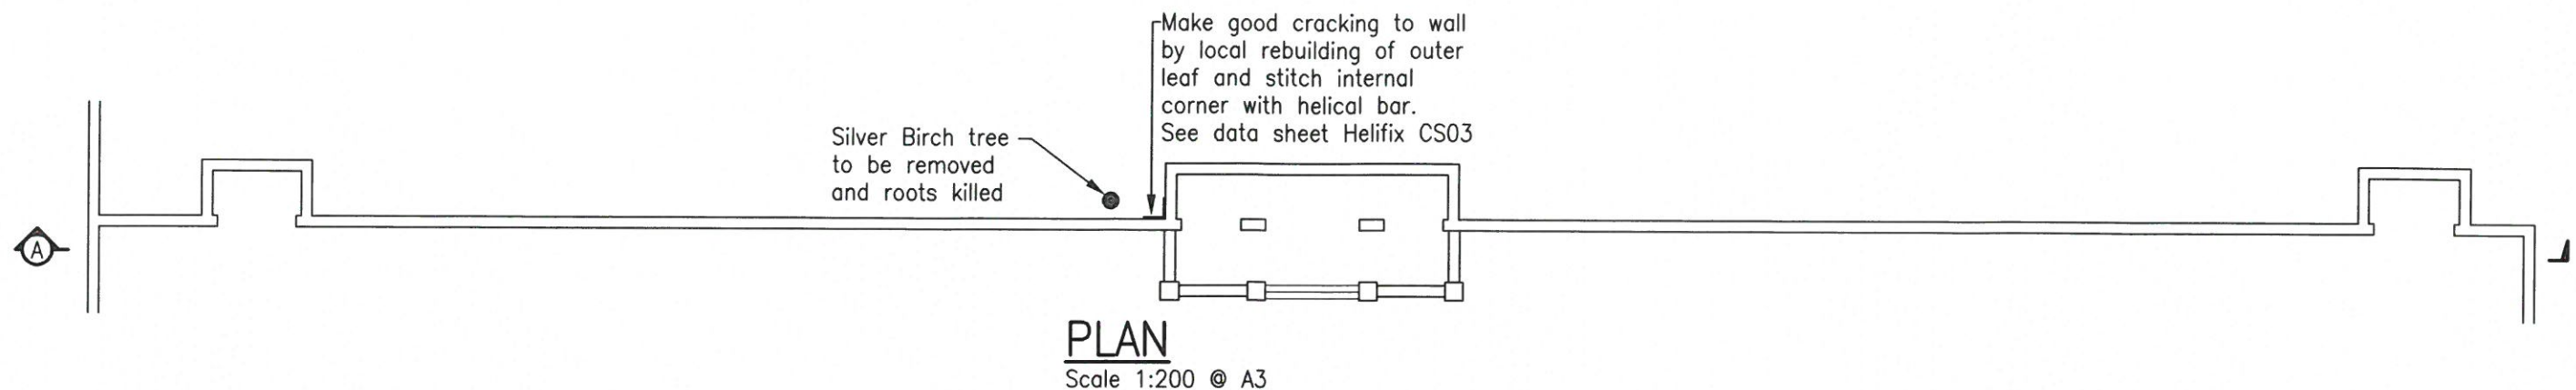
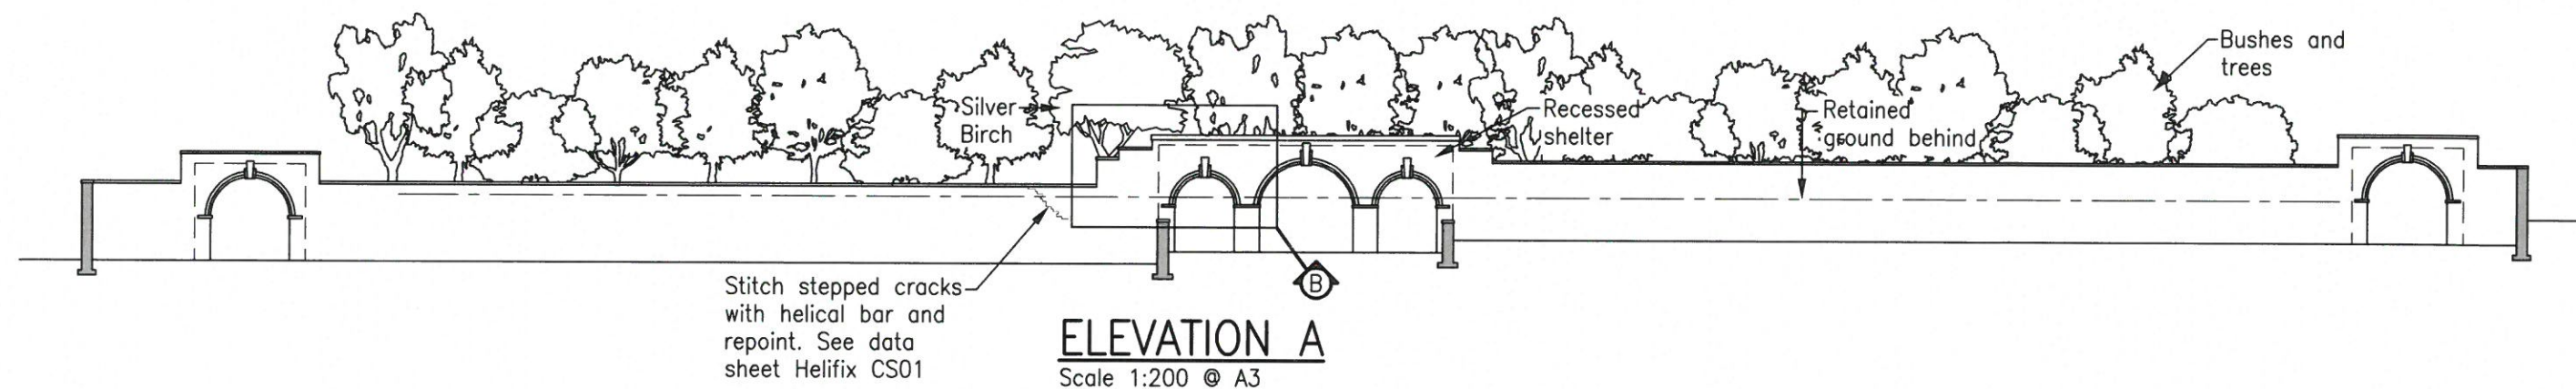
| PLAN & ELEVATION | | | JTB |

- 3.11** We have attached a sketch detail of the above defects in Appendix C.
