**Report for the Man Entry Chamber Inspection of**  
**SW MH S14.**

**Site : Former Akzo Nobel Site, Hollingworth Road,**  
**Littleborough, Rochdale.**

**Client : Woodford Group / Countryside**  
**Properties.**

Document Ref : GL1382/MAB

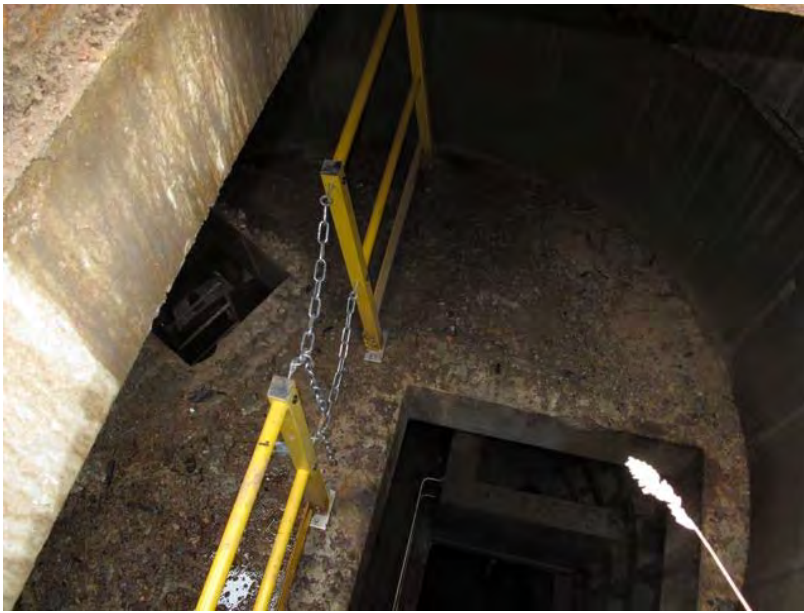
Views from Surface Level  
to Level 1 and Chamber  
Base

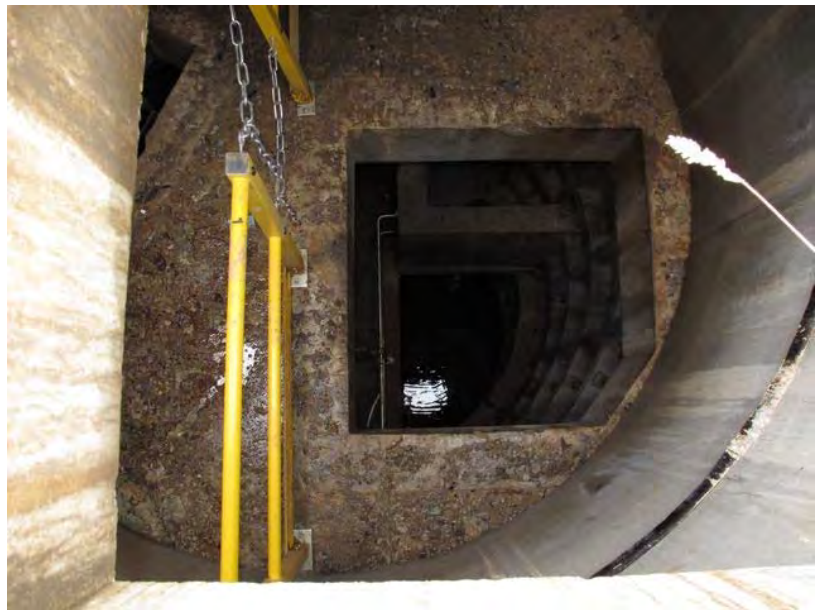
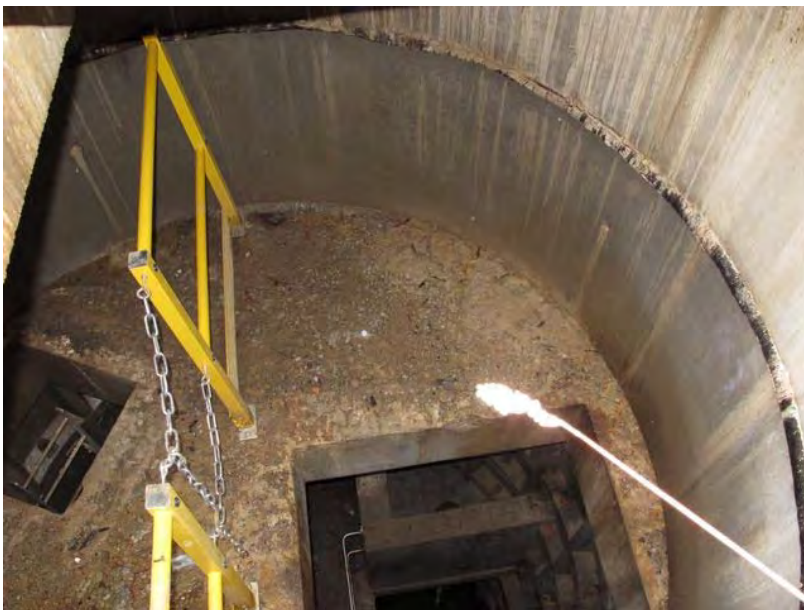
Views From Surface Level to Level 1  
Landing

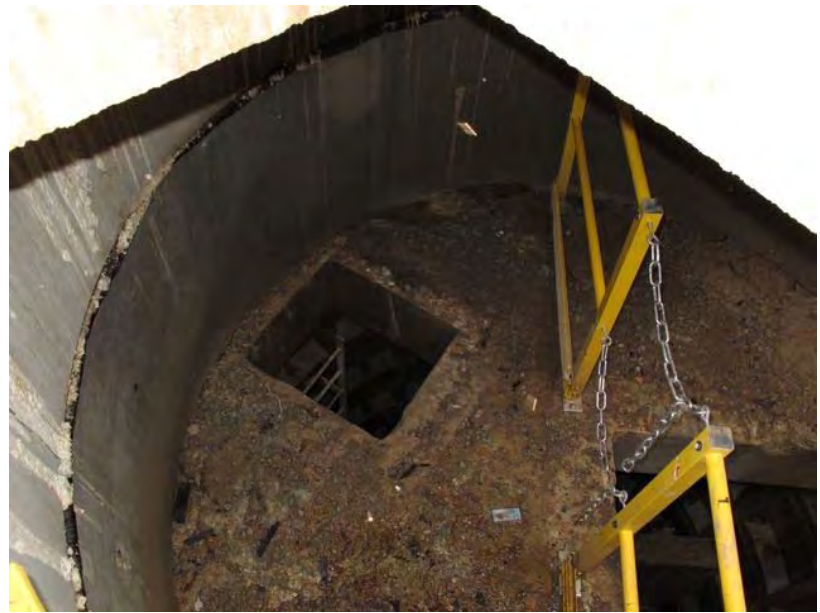
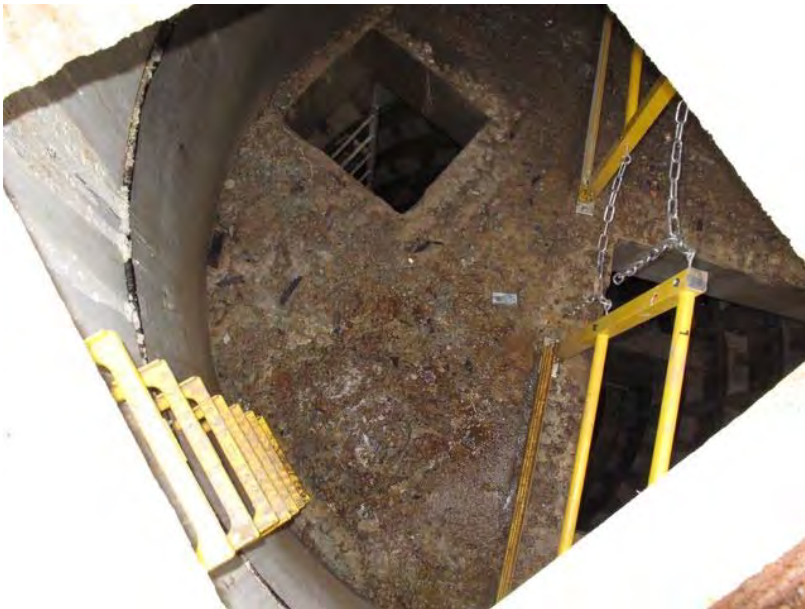
View from Level 1 to underside of MH cover.

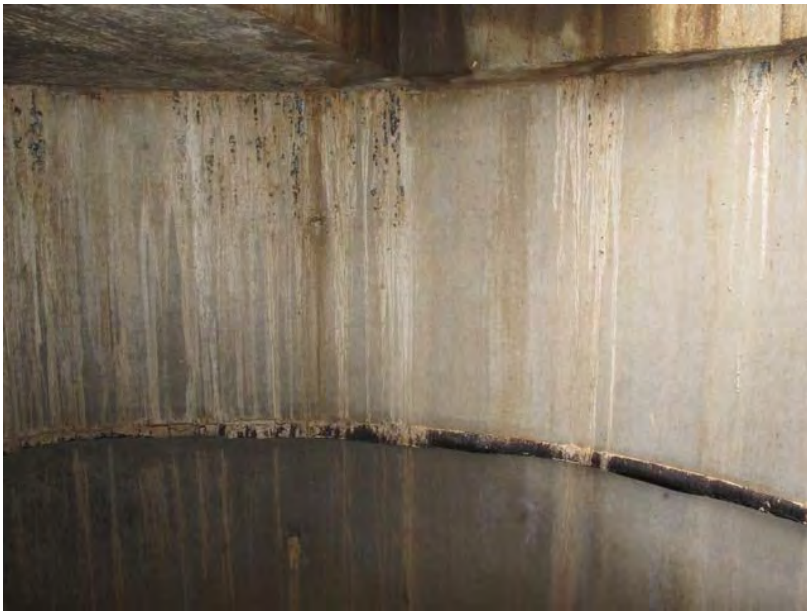
Water infiltration and associated scaling has occurred at Level 1 of the chamber. Water appears to be ingressing at the joint between at the top most MH ring and the reducing slab. Some of the grouted up lifting holes in the MH rings are weeping slightly.

View from Level 1 of MH rings showing infiltration.

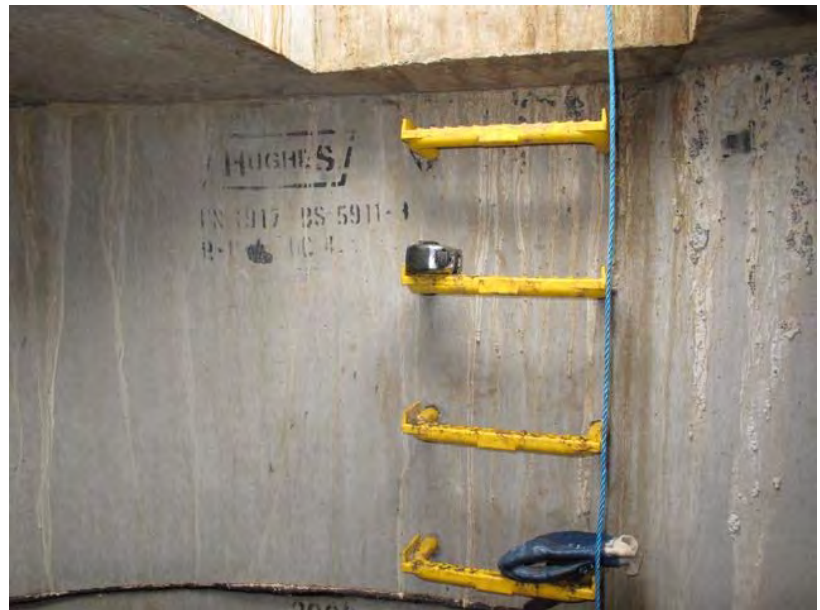
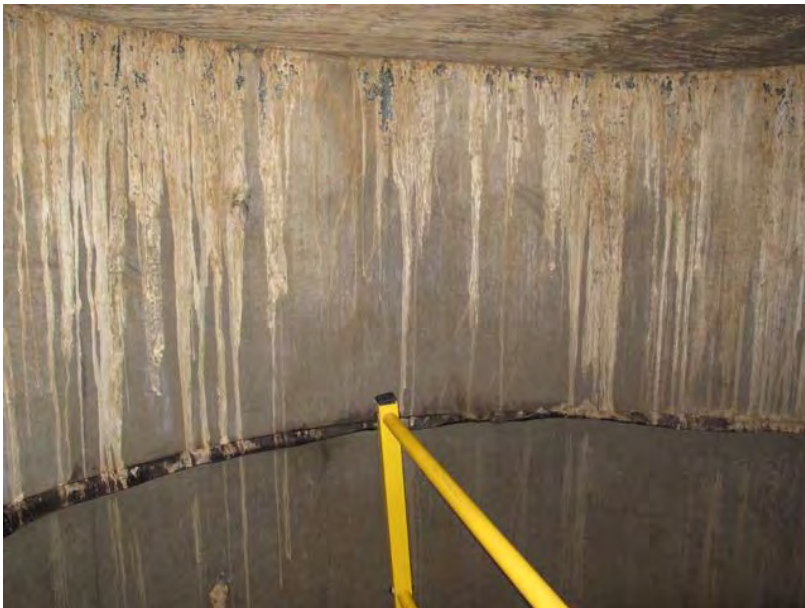
Views of Infiltration from Cover Slab at Level 1

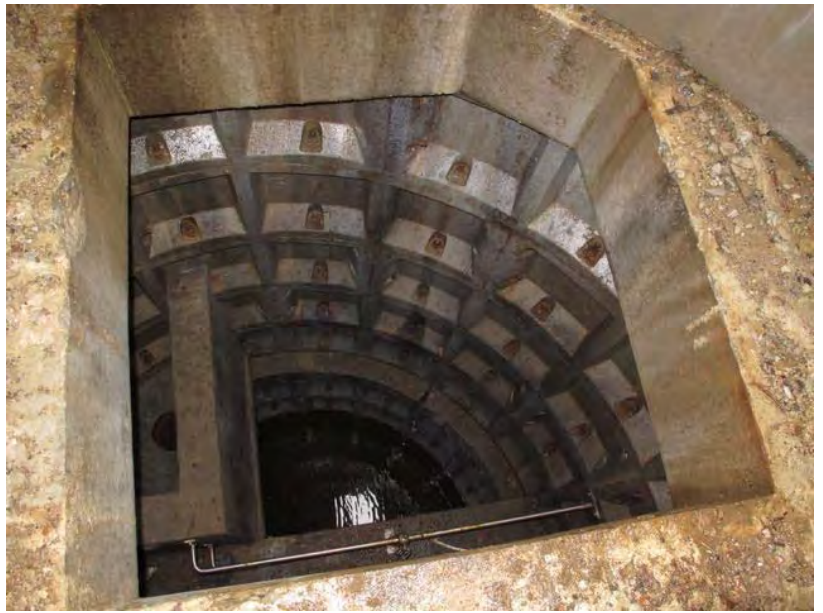
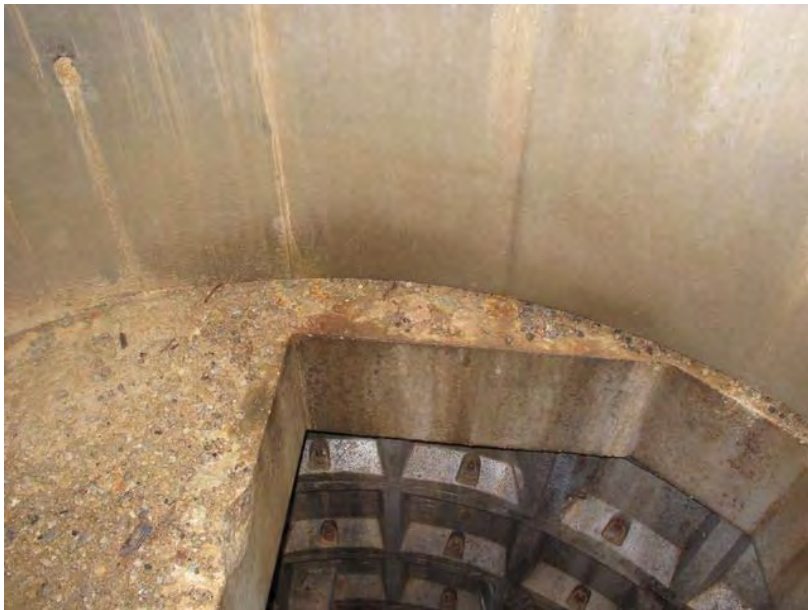
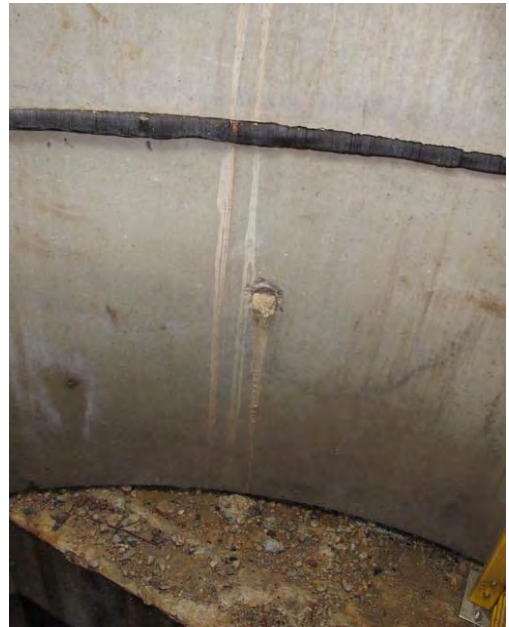
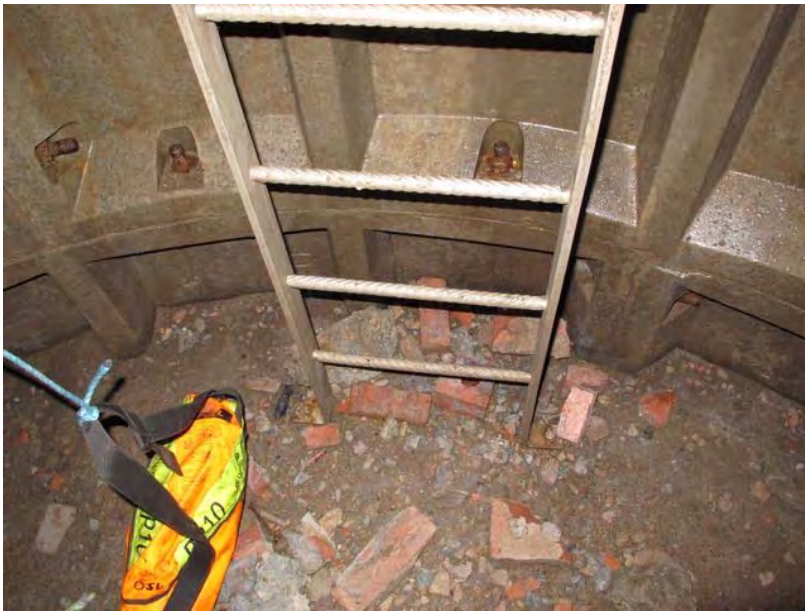
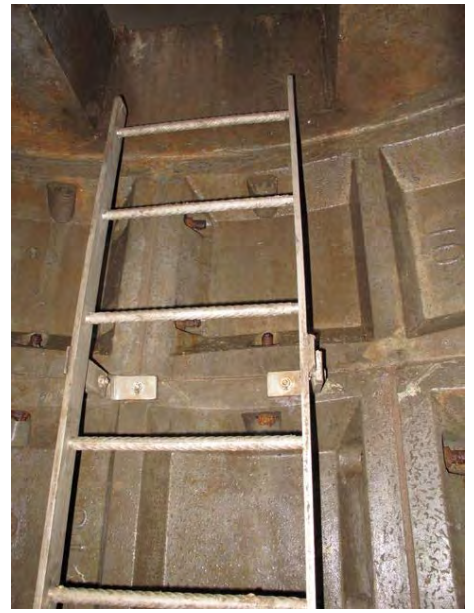
The stainless ladder from Level 1 to Level 2 is in good condition and is secure. The landing at Level 2 has some debris (stones and broken masonry) which does not appear to have been part of the original chamber structure. The reducing slab structure appears to be in good condition.

Views from Level 2 Landing  
Showing Debris, Ladders and  
Cover Slab above.

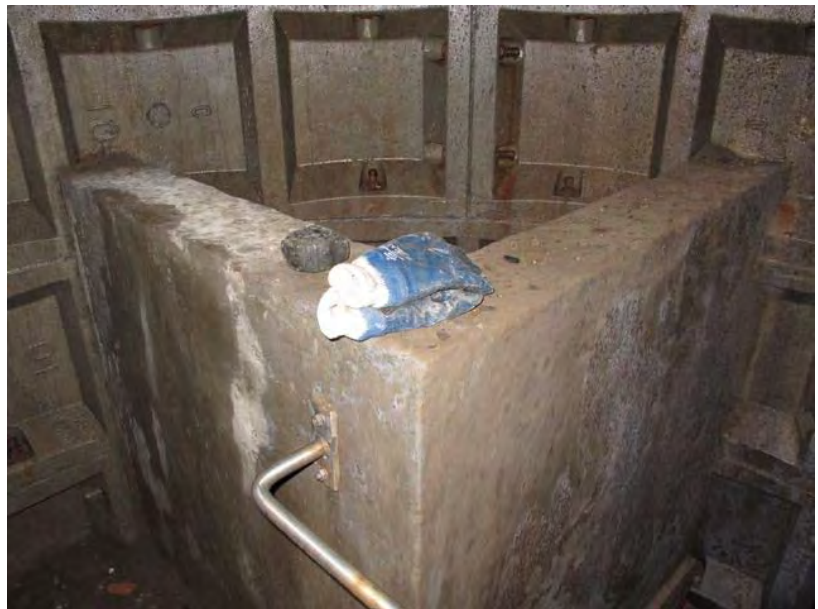
There is infiltration through some of the PCC bolted sections and minor rusting of the bolts and fasteners. None appeared to be missing or broken at the time of our inspection.

Typical Detail of PCC Bolted Sections and Fasteners.

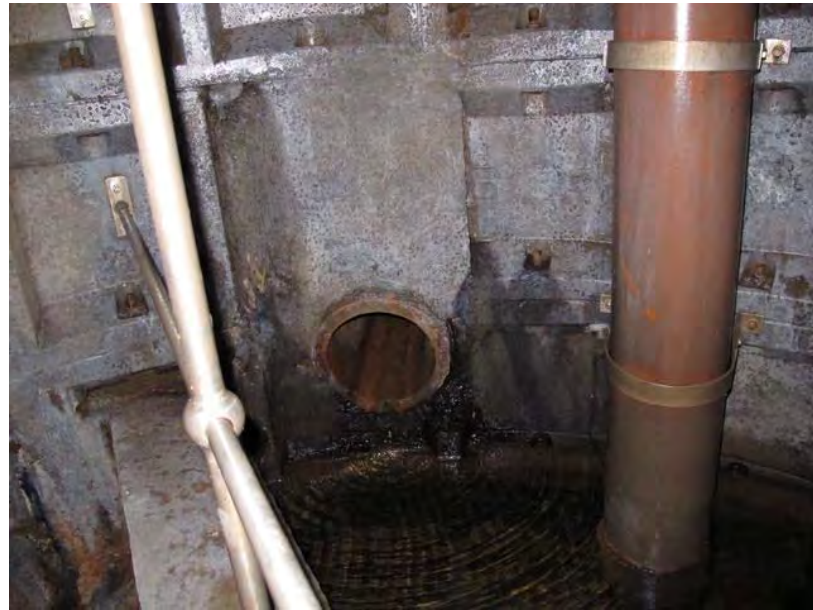
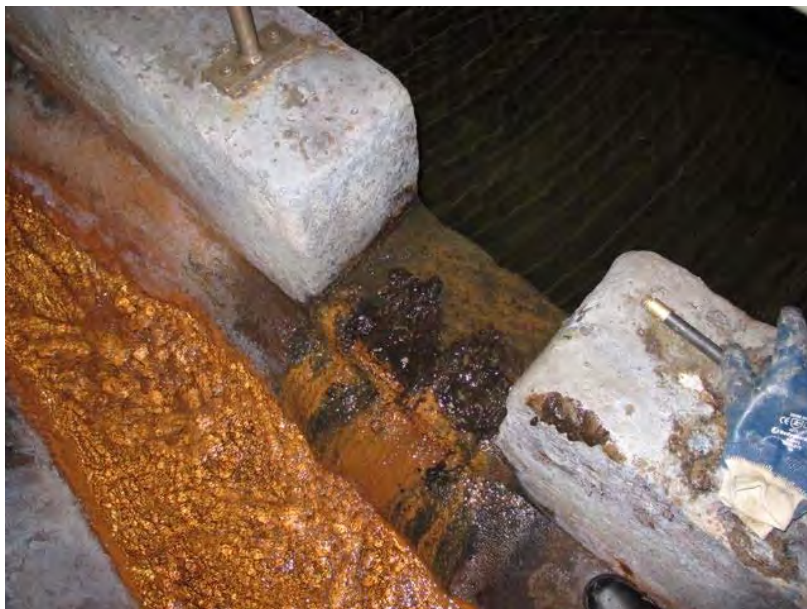
Notch in Dividing Wall

The separating wall appears to be in good condition and the notch is sharply defined.

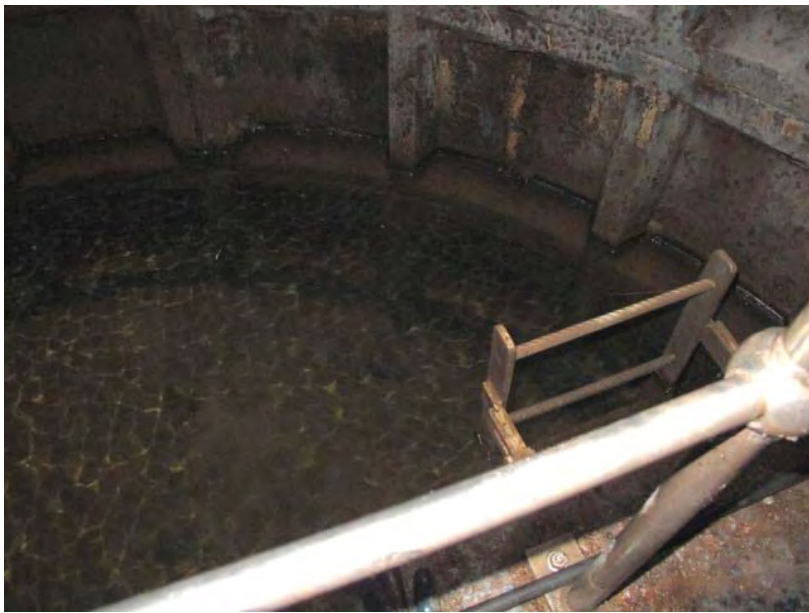
View into Sump

The Sump was not easily inspected due to the water level, however the chamber base appears to be benched as shown on the drawing. The level of silt in the chamber was not easily determined but appears to be 300mm – 400mm deep at the base of the chamber.
