**385 Bury & Rochdale Old Rd, Rochdale**

**BAT SURVEY REPORT**

**October 2024**

**Report Ref:** KSE\_M+P\_02\_02

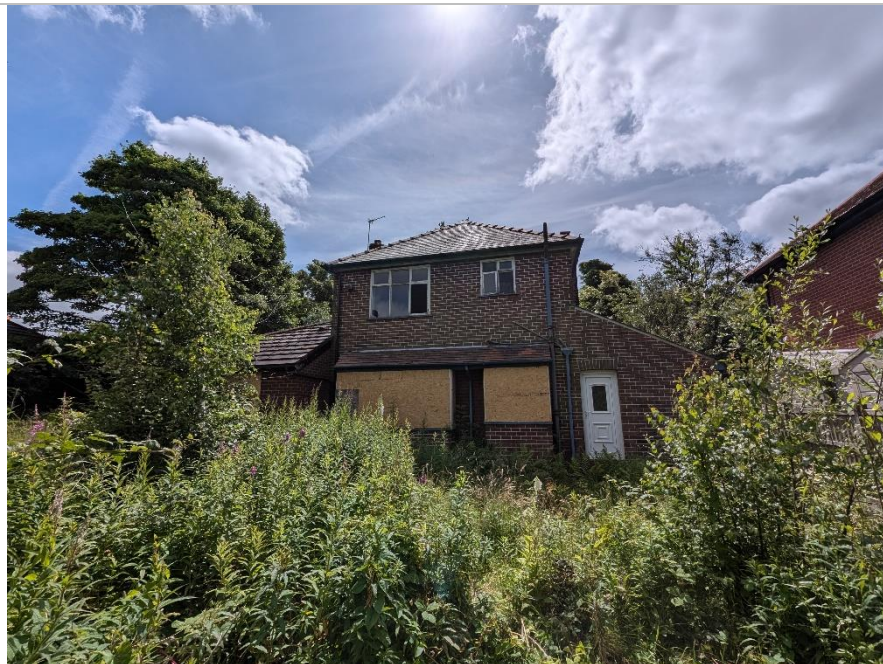
**Photo 1.**  
Rear (north)  
elevation

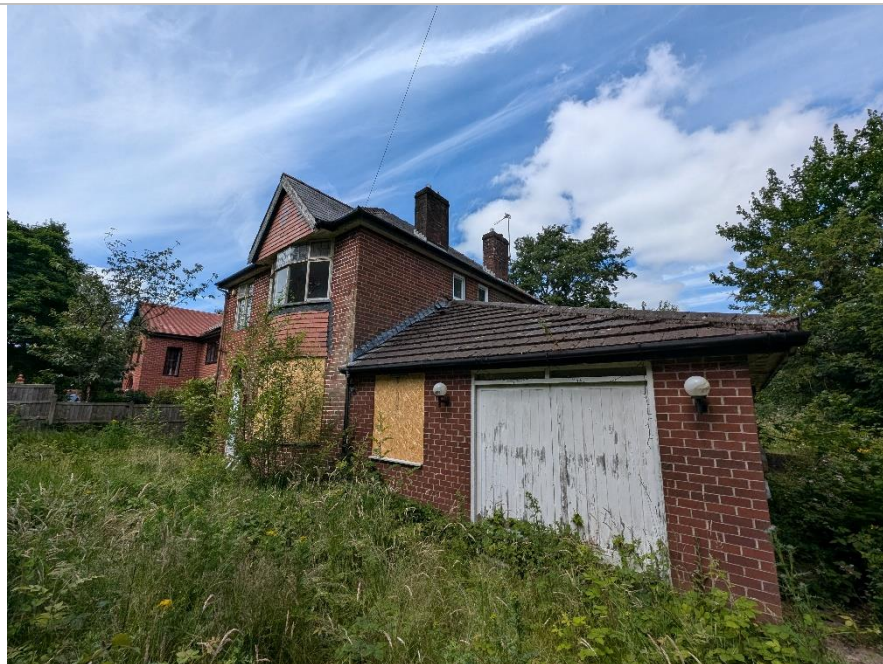
**Photo 2.**  
Front (south  
elevation)

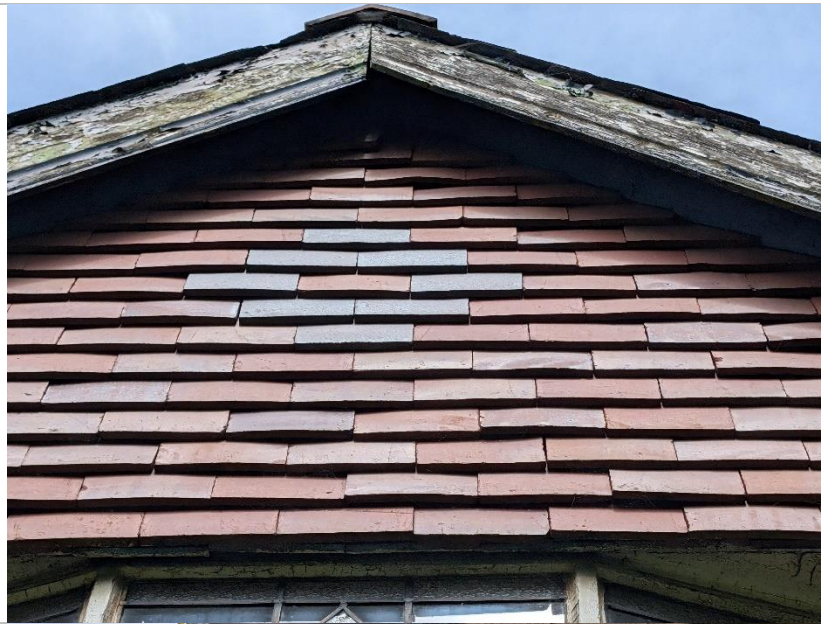
**Photo 3**

The frontage (south) of the house features red clay hanging tiles both above and below the first-floor bay window. Several of these tiles appeared warped and there were numerous gaps underneath the tiles. Such crevices are only expected to be shallow but were potentially suitable for use by bats.

Gaps under hanging  
tiles under roof  
ridge at the front

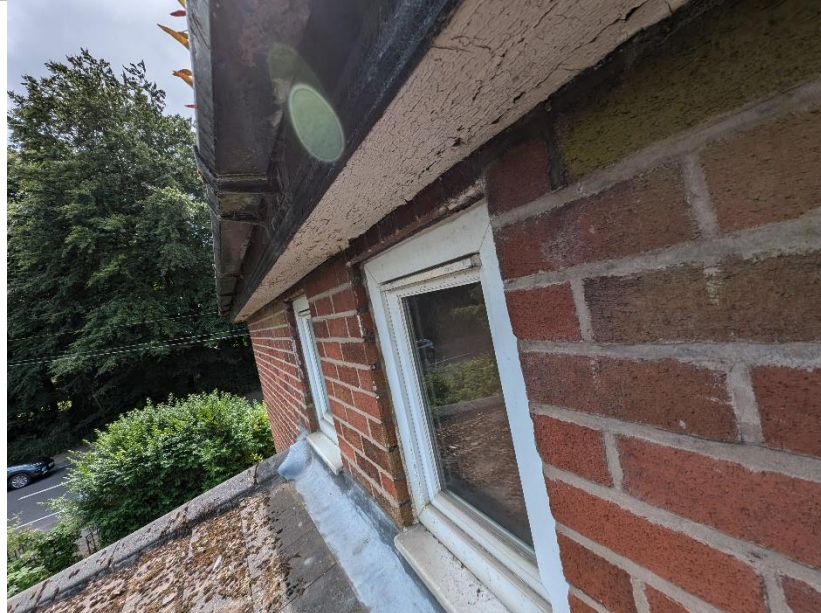
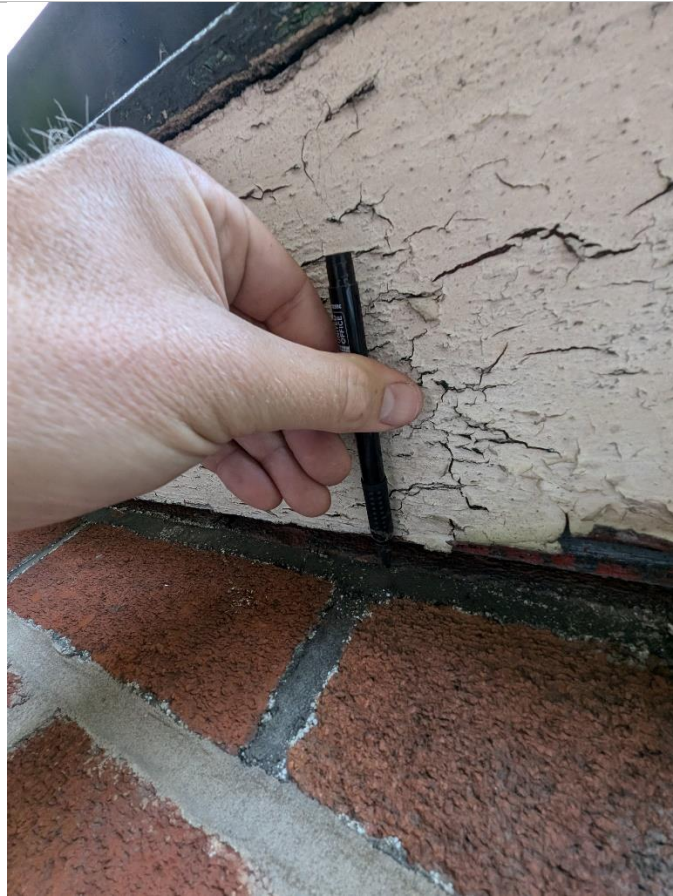
**Photos 4a & 4b**

There were timber soffits on the west, east and south elevations. A small gap measuring around 15-20mm was present underneath the soffits all the way along each elevation which presented a potential roost entrance feature for bats. The roof of the house appeared in good repair overall; however, there were several gaps underneath the ridge tiles and a missing slate was noted on the east aspect which had resulted in a slight gap in the roof. It should be noted that the roof did not have an underlining and there were no recessed crevices in the roof.

Soffit on east  
elevation with small  
gap underneath.

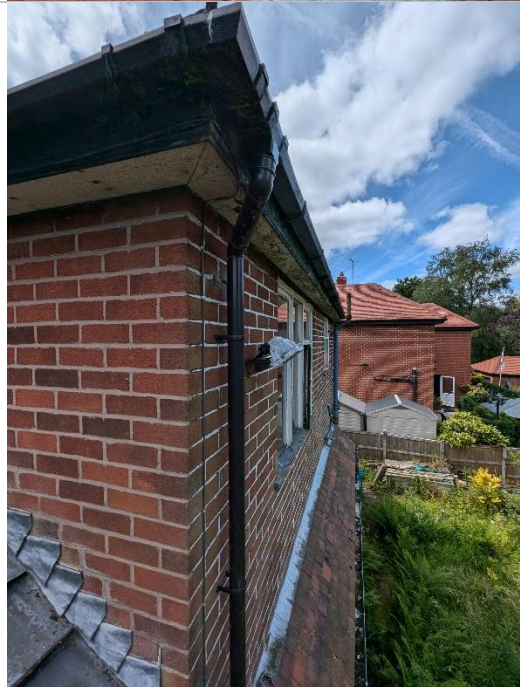
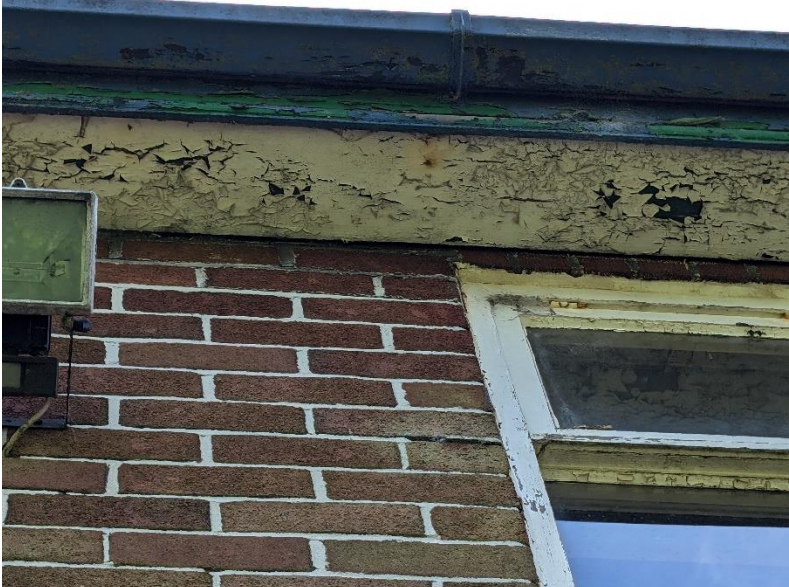
**Photos 5a & 5b**  
Rear elevation &  
soffit

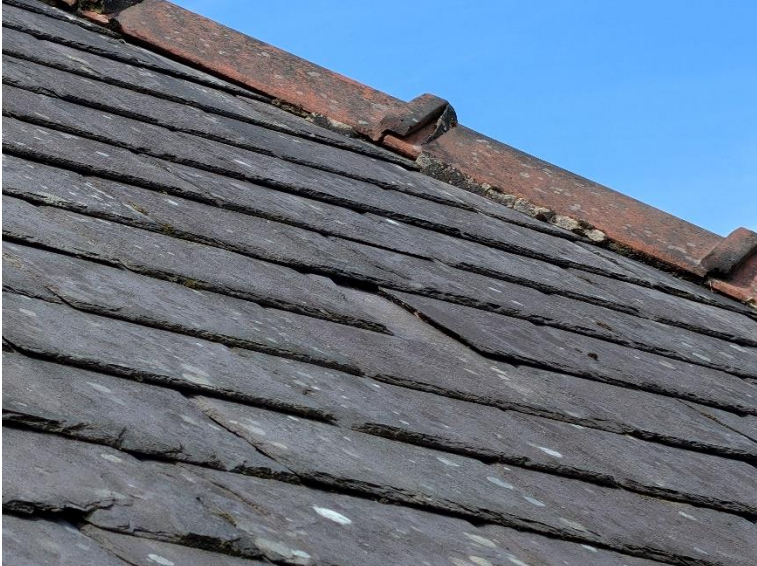
| <p><b>Photo 6.</b><br/>Missing slate and<br/>gap in roof &amp; gap<br/>under ridge tiles<br/>(east aspect).</p> | |

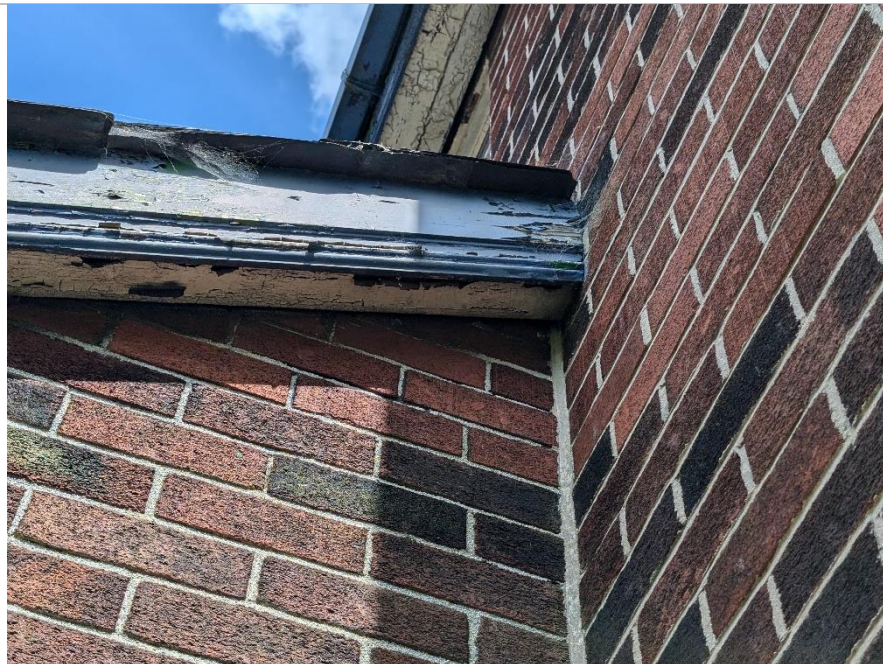
**Photo 7.**  
Gap under soffit on  
west elevation

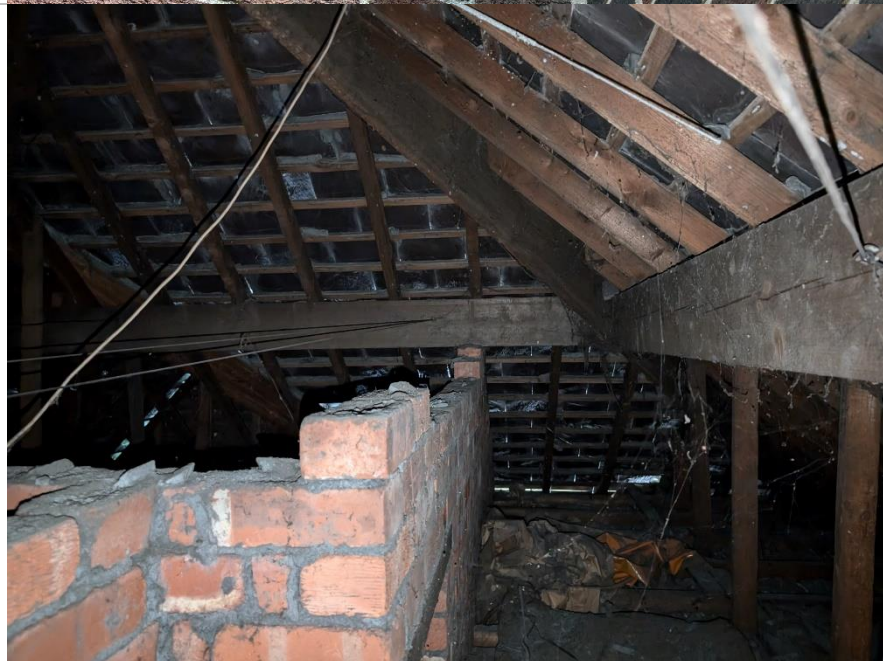
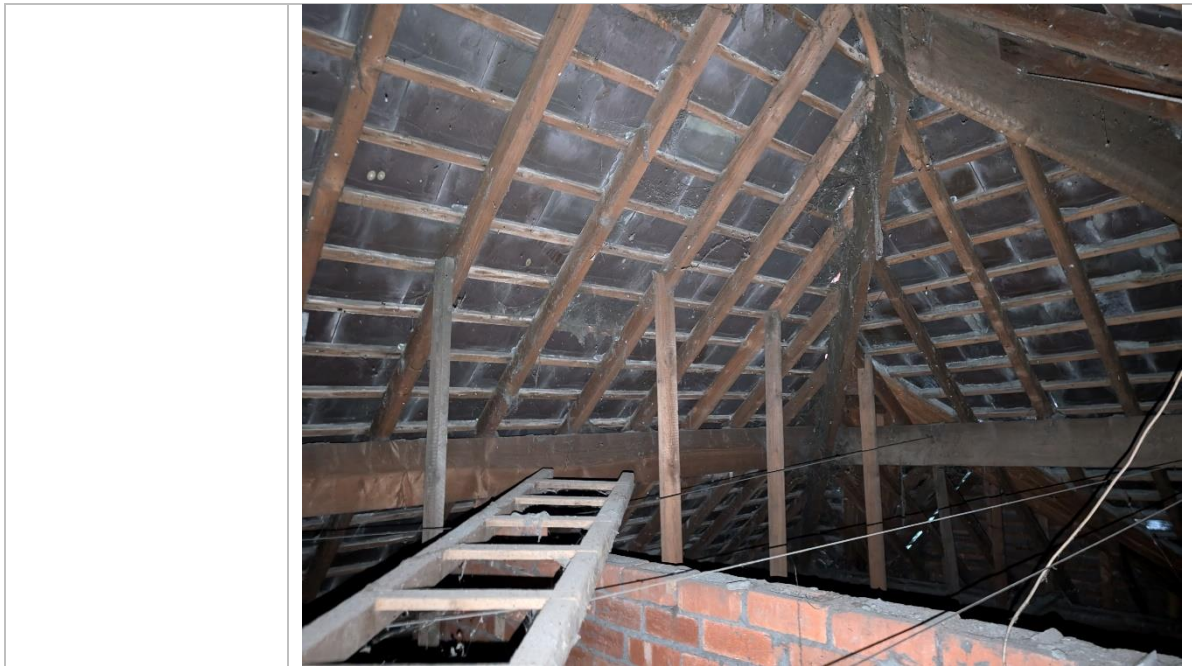
The loft was disused and very dusty with extensive cobwebs throughout. The loft space was relatively uncluttered and high (over 2m from floor to ridge).

**Photos 8a & 8b.**  
Photos of loft and  
underside of roof.
