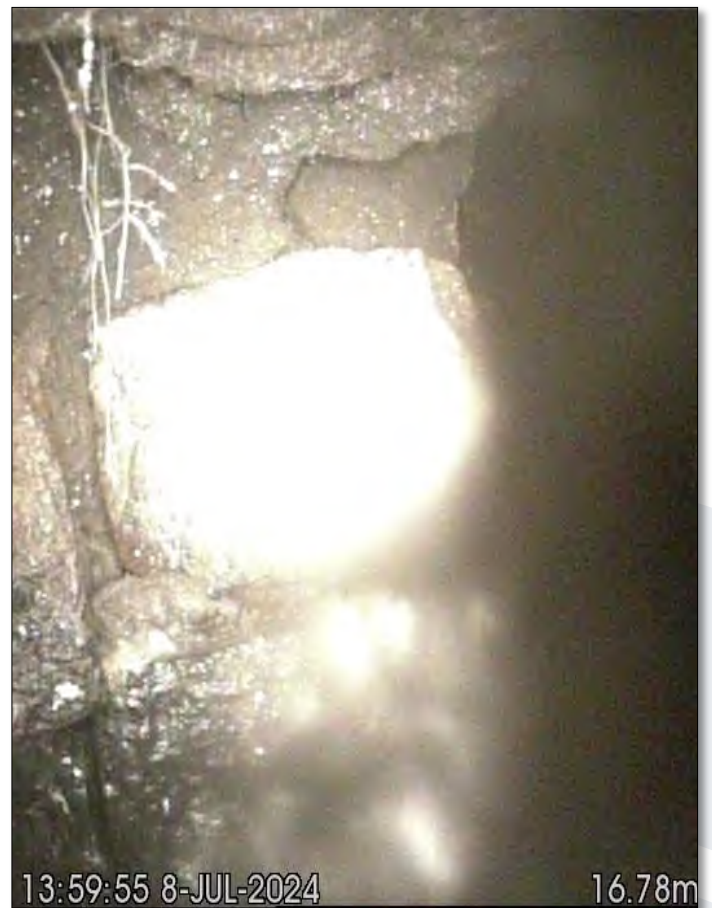
**Possible Chamber/Brick Culvert**

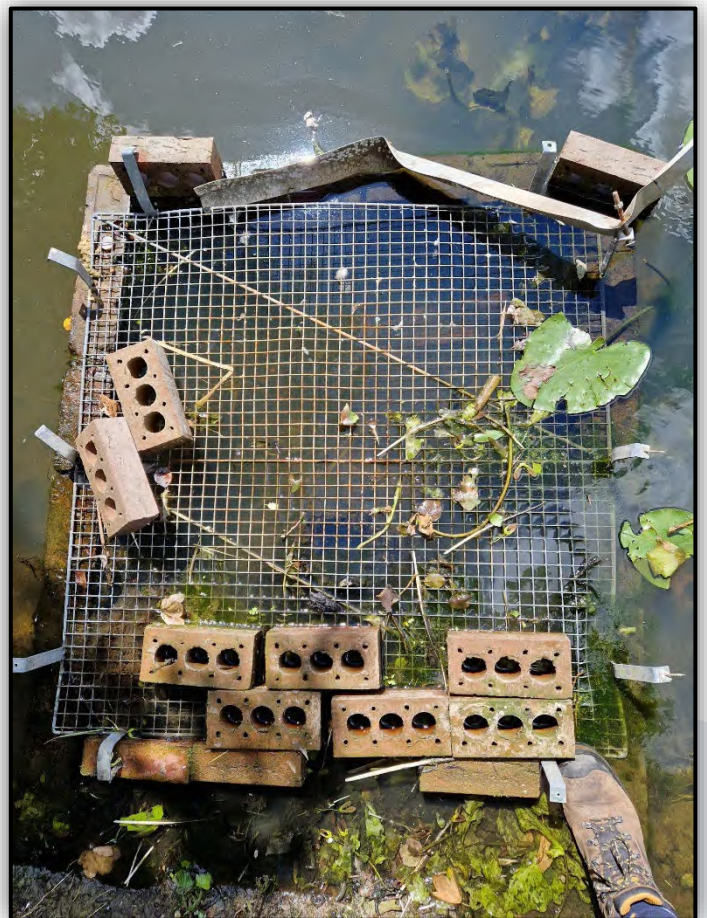
Arranged access with Fisheries contact to gain permission and access to the fishing lakes. A walkover survey confirmed the 5-tiered lakes to be fed via a watercourse running below the A627(M). The fishery lakes connect via linked pipework with water flowing to the bottom tier which contains a brick-built chamber and rising 150mm pipe which were confirmed to be surcharged and not flowing.

**Fishery Lake Outfall Chamber & Pipe View**

- Combination Lorry Jetting Unit to attend site and draw down water level and HPWJ manhole MH1 (see Area 5) located in Stakehill Lane to investigate a possible connection with the fishing lake outlet/provide further recommendations to continue survey.

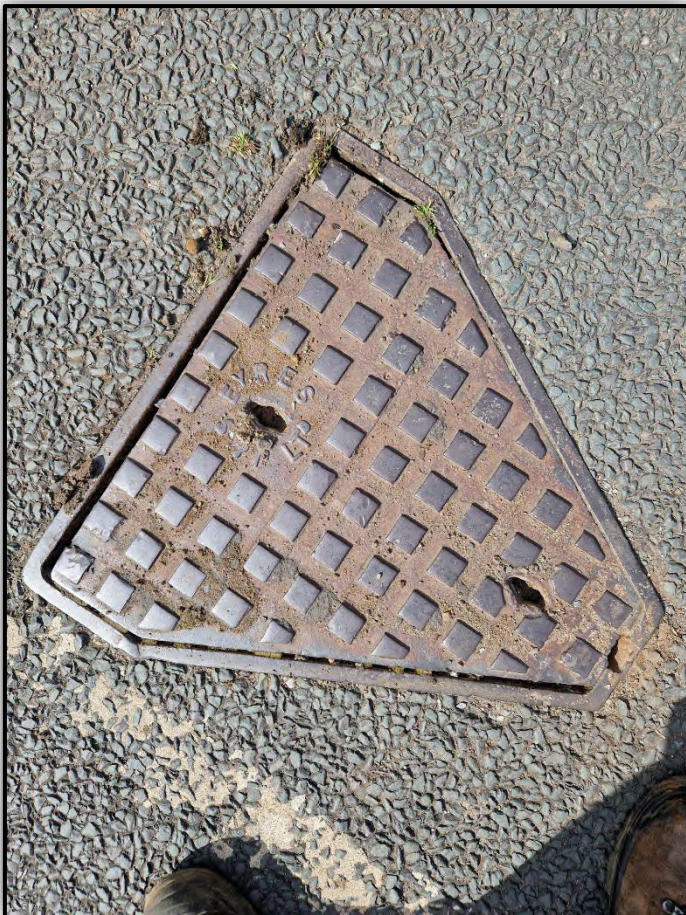
Manhole S2 has become compressed into its frame and could not be lifted after repeated attempts to free it with hand tools and a mechanical lifter.

**S2 Seized Manhole Cover**

- Combination Lorry Jetting Unit to attend site to empty and HPWJ manhole MH1 and undertake further investigation/CCTV survey of any accessible connecting sections.
- Break out and replace seized manholes S2 & C5 to survey manhole chambers and verify connectivity

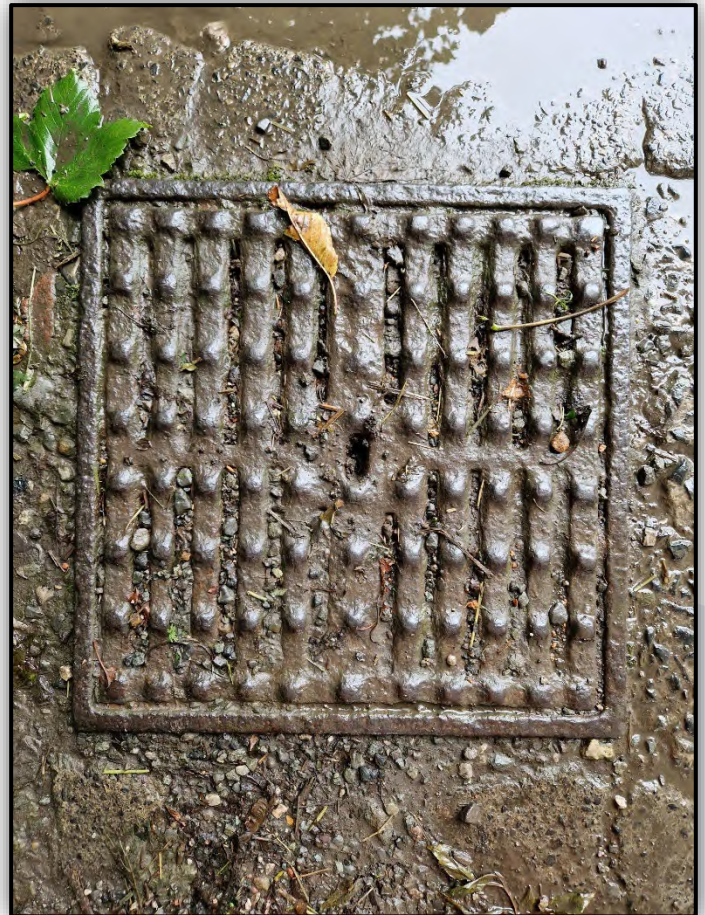
The grated manhole cover on C5 has become seized into its frame and could not be lifted after repeated attempts to free it with hand tools and mechanical lifter.

**C5 Seized Grated Manhole Cover**

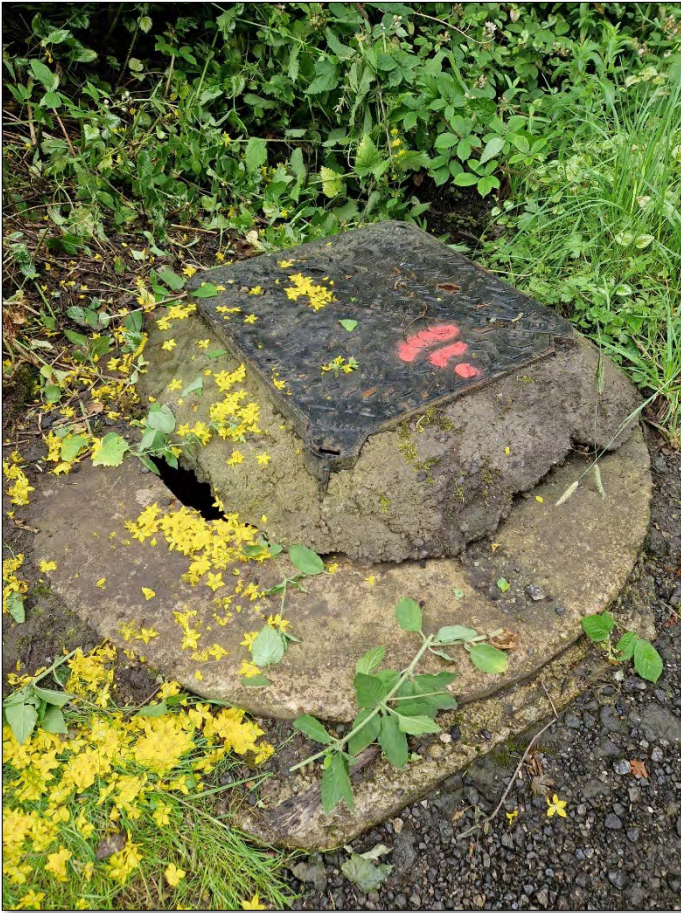
Manhole referenced as MH4 on the connectivity plan was noted to have been damaged cover/frame which have become offset from the cover slab. Care was taken to lift the frame/cover to one side to survey the manhole chamber and electronically traced the downstream line to a concealed manhole on the opposite side of the lane and once completed replaced the cover/frame centrally back over access on the cover slab. Undertook foliage clearance within the area of electronic trace/sonde signal and located/exposed manhole MH5, once lifted recorded all details for manhole card.

**MH4 Manhole Cover Condition View**

- Reposition existing cover & frame MH4 onto cover slab including new fillet surround
- Reposition existing cover & frame MH7 onto cover slab including new fillet surround
- 7.5 tonne Combination Lorry Jetting Unit to attend site to empty and HPWJ manhole MH7 and undertake further investigation/CCTV survey of any accessible connecting sections.
- CCTV survey with crawler unit & cradle extension of the downstream line from MH6 to determine connectivity.
- HPWJ/CCTV survey and line trace of 225mm outfall to watercourse (Access to be arranged with property/landowner prior to attendance)

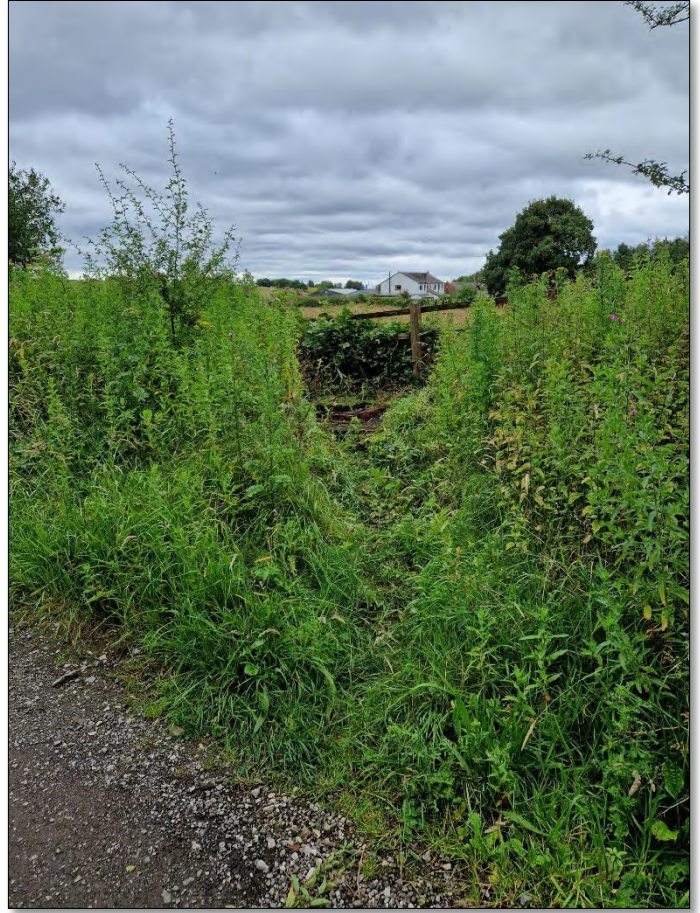
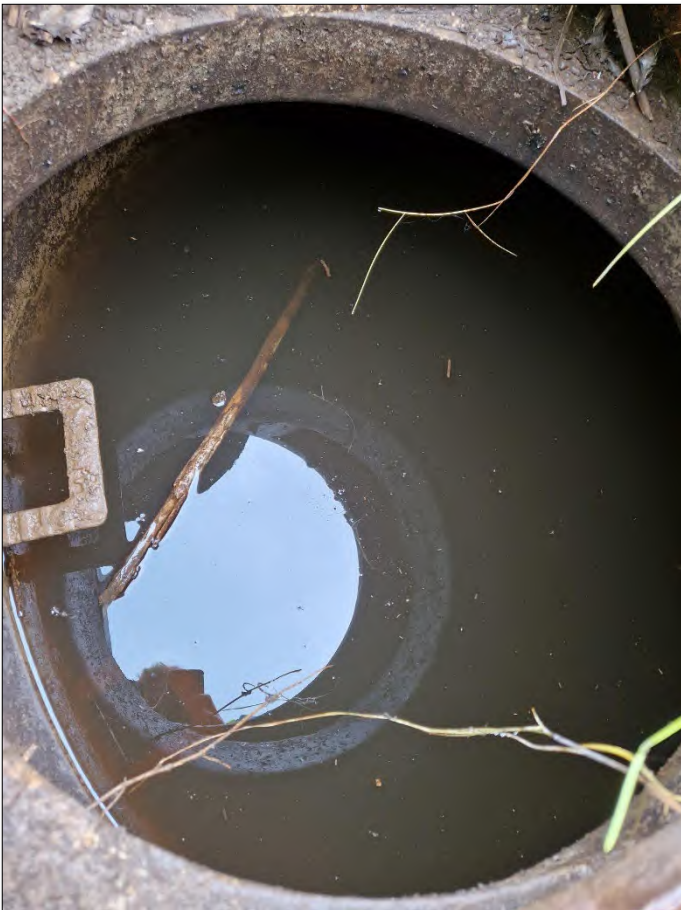
Cleared overgrown foliage to access MH7 and noted the current frame/cover to be loose on cover slab. Lifted manhole and confirmed chamber to be surcharged and recorded visible manhole details from the surface.

**MH7 Location View**

**MH7 Internal View**

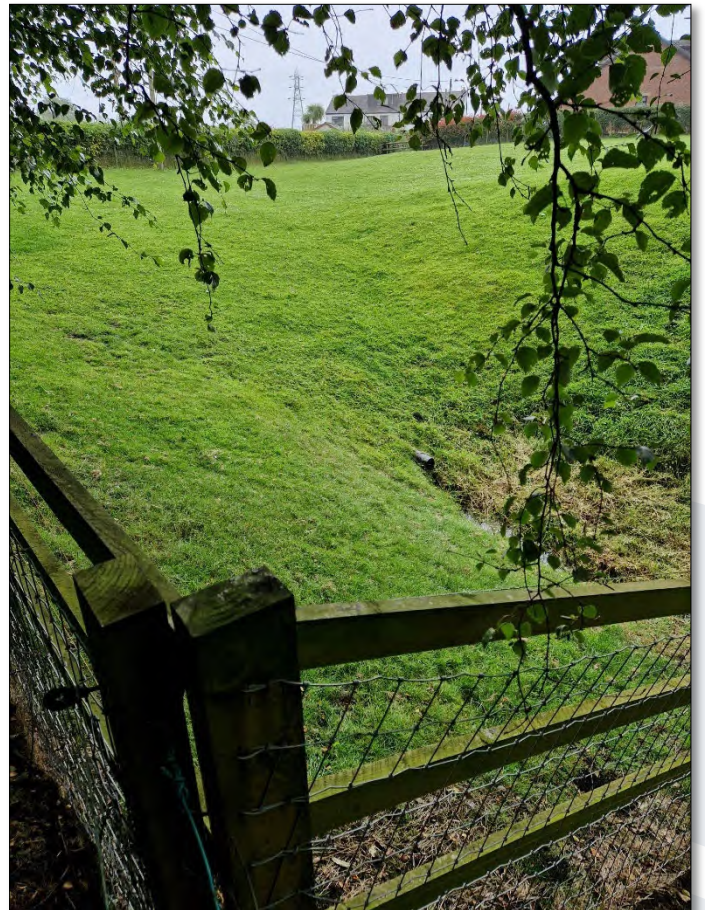
Walk over visual survey of the area, confirmed the water course outfall to be in the farmers land on the opposite side of the A627(M). Cleared overgrown foliage to access a manhole (reference MH6 on plan) which is located on the downstream line of the culvert as detailed on the plan supplied and confirmed the upstream pipe connection with watercourse.

**Outfall into Watercourse**

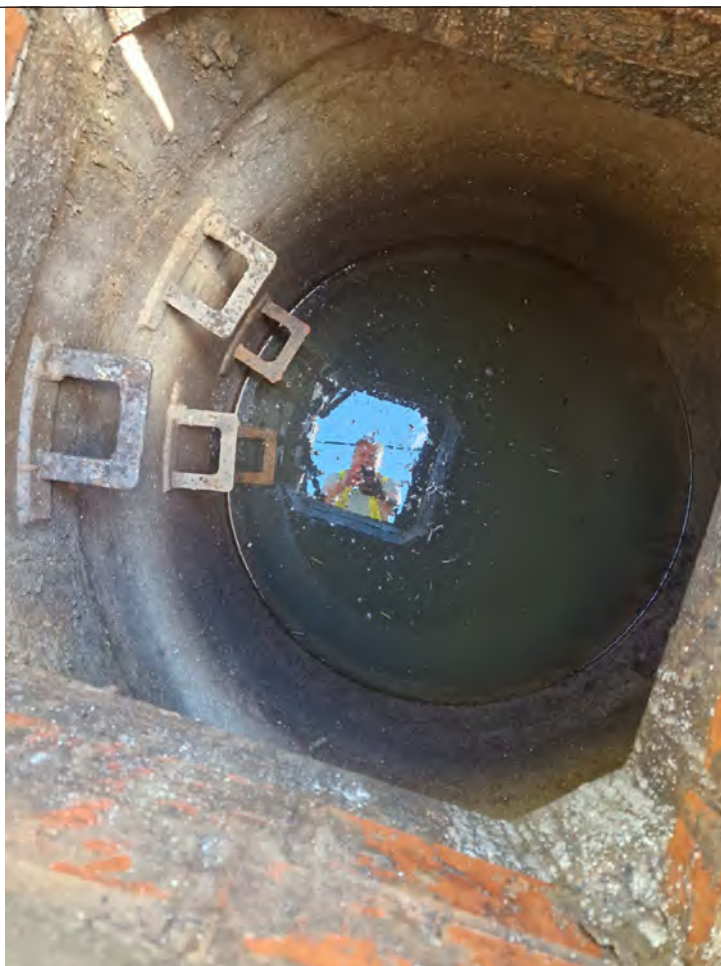
Surcharged manhole no pipes visible

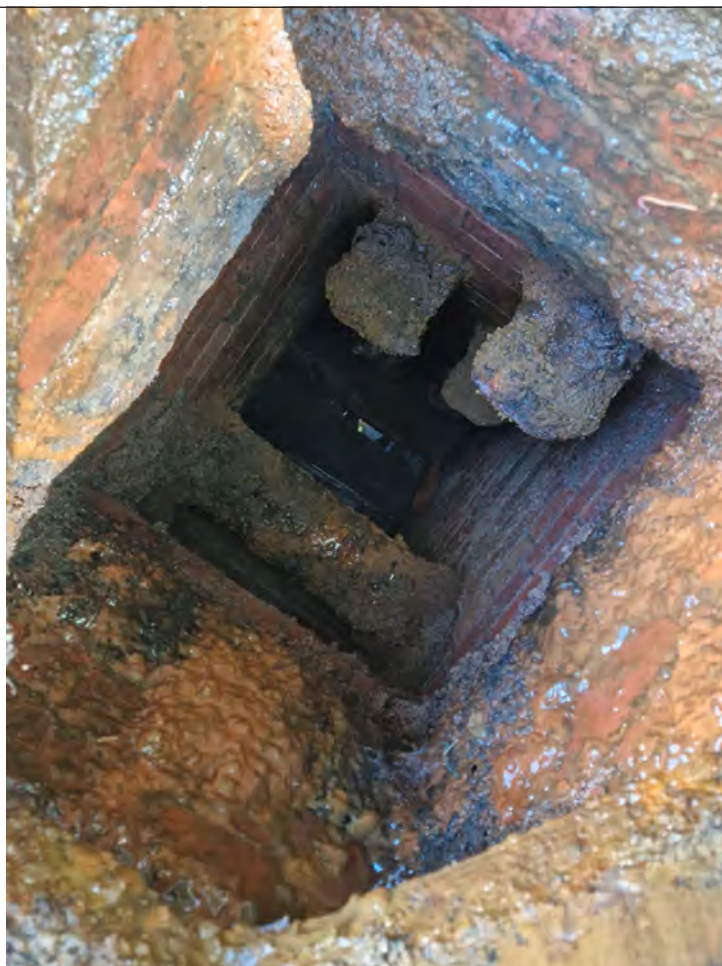
| Service running through chamber at 1.12m<br>Surcharged foul debris covering step irons & benching |

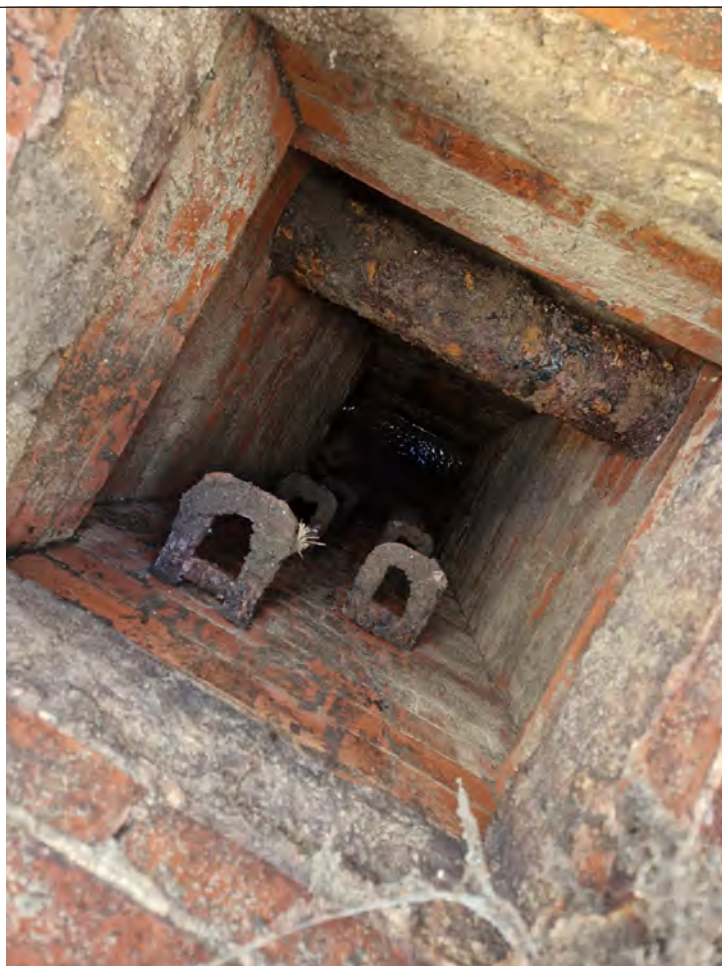
| Service running through manhole at 1.13 |

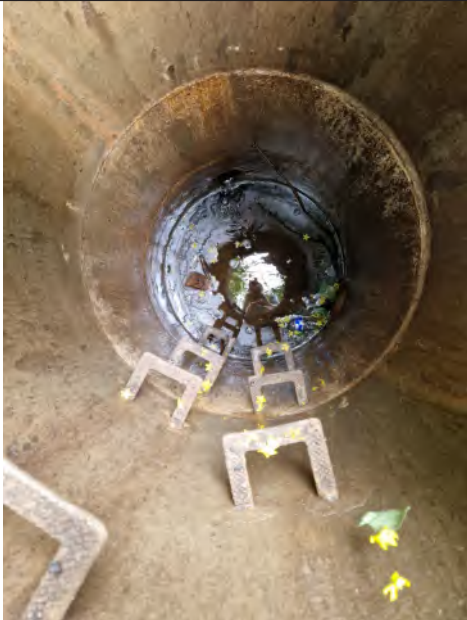
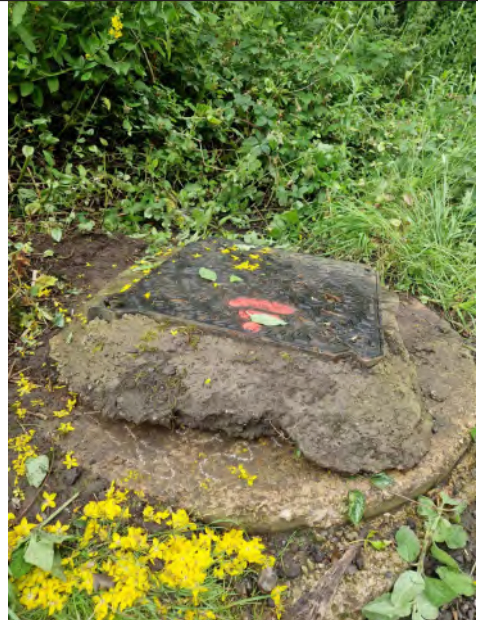
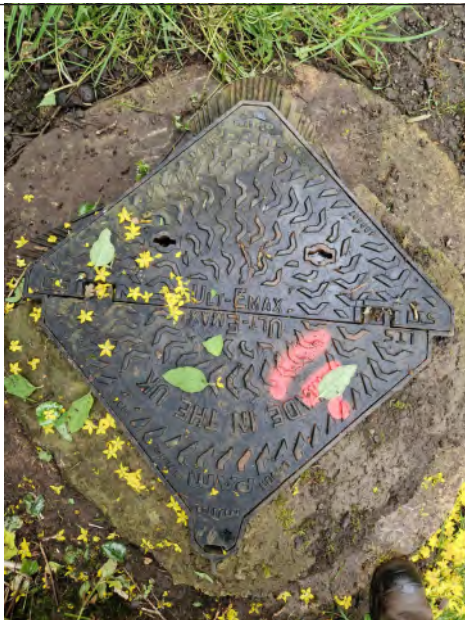
| Cover & frame loose |

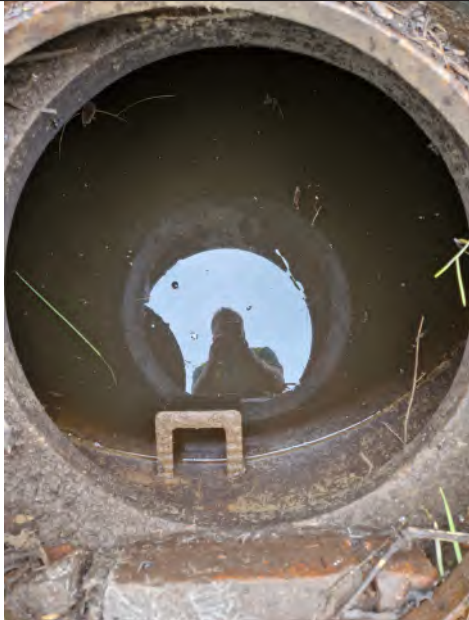
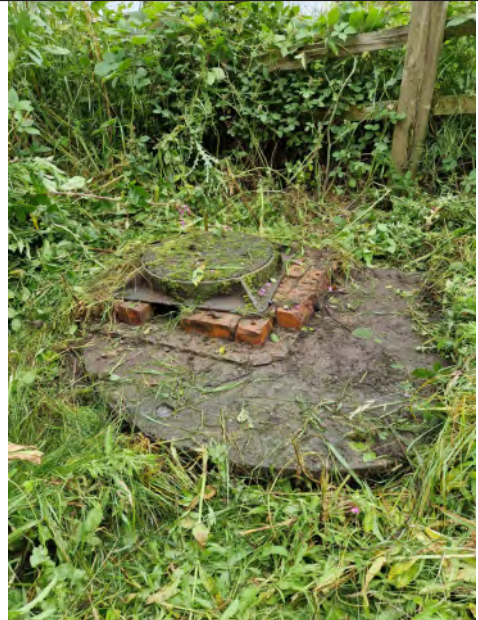
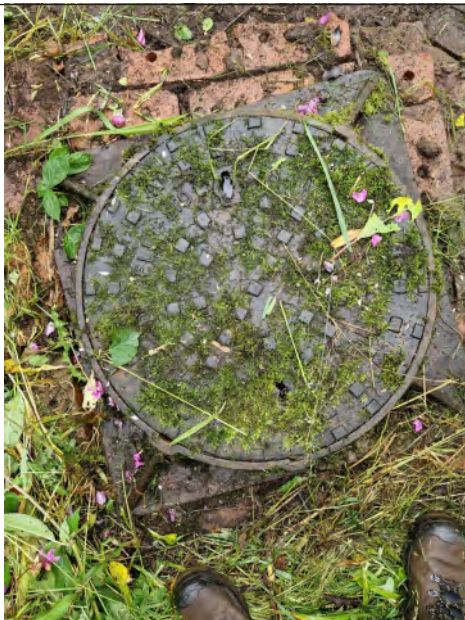
Cover & frame loose

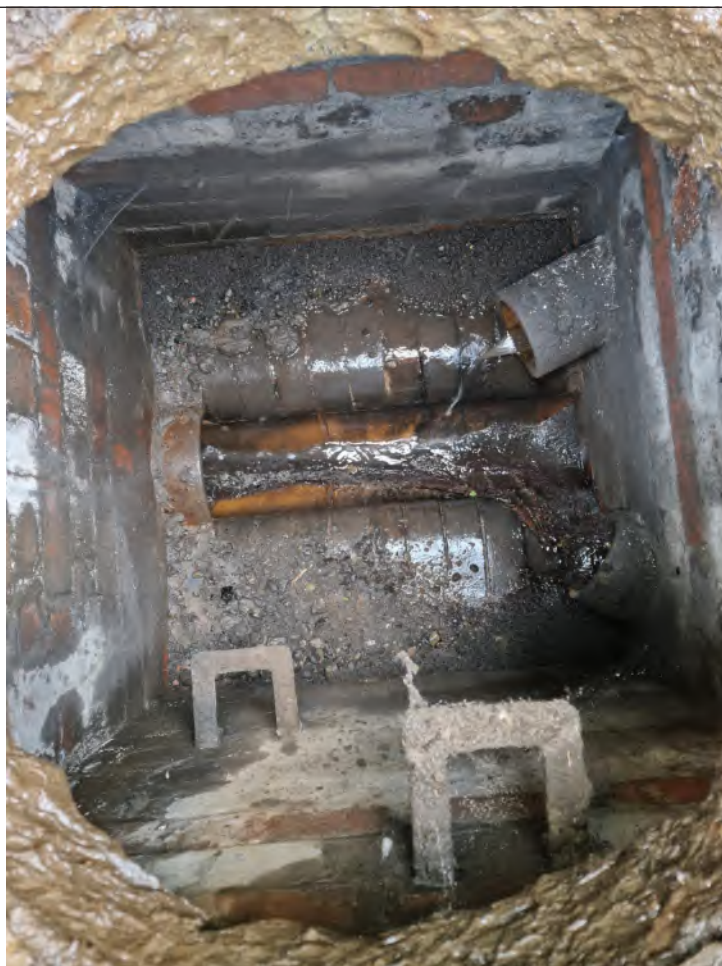
| Debris on benching |

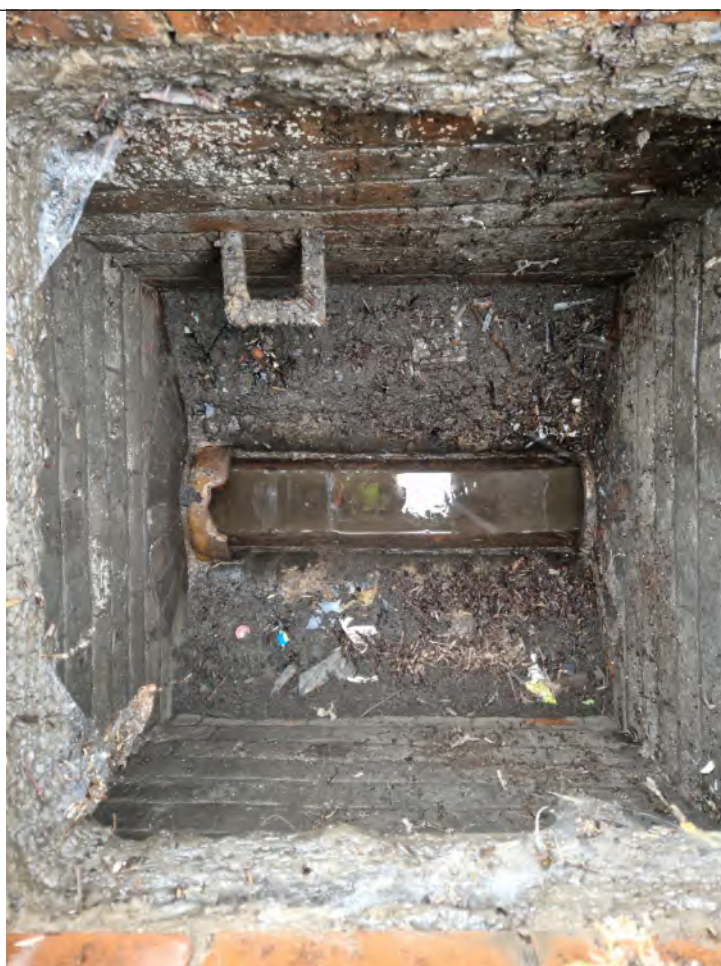
| Debris on benching |
