# **TREE SURVEY & REPORT**

## **TREE SURVEY / SCHEDULE AND REPORT**

Location: Crimble Hall Farm OL11 4AB

Order TPO name: TPO Heywood MB No 1 Heywood Municipal Borough  
ID T195TPO010  
Local Authority: Rochdale

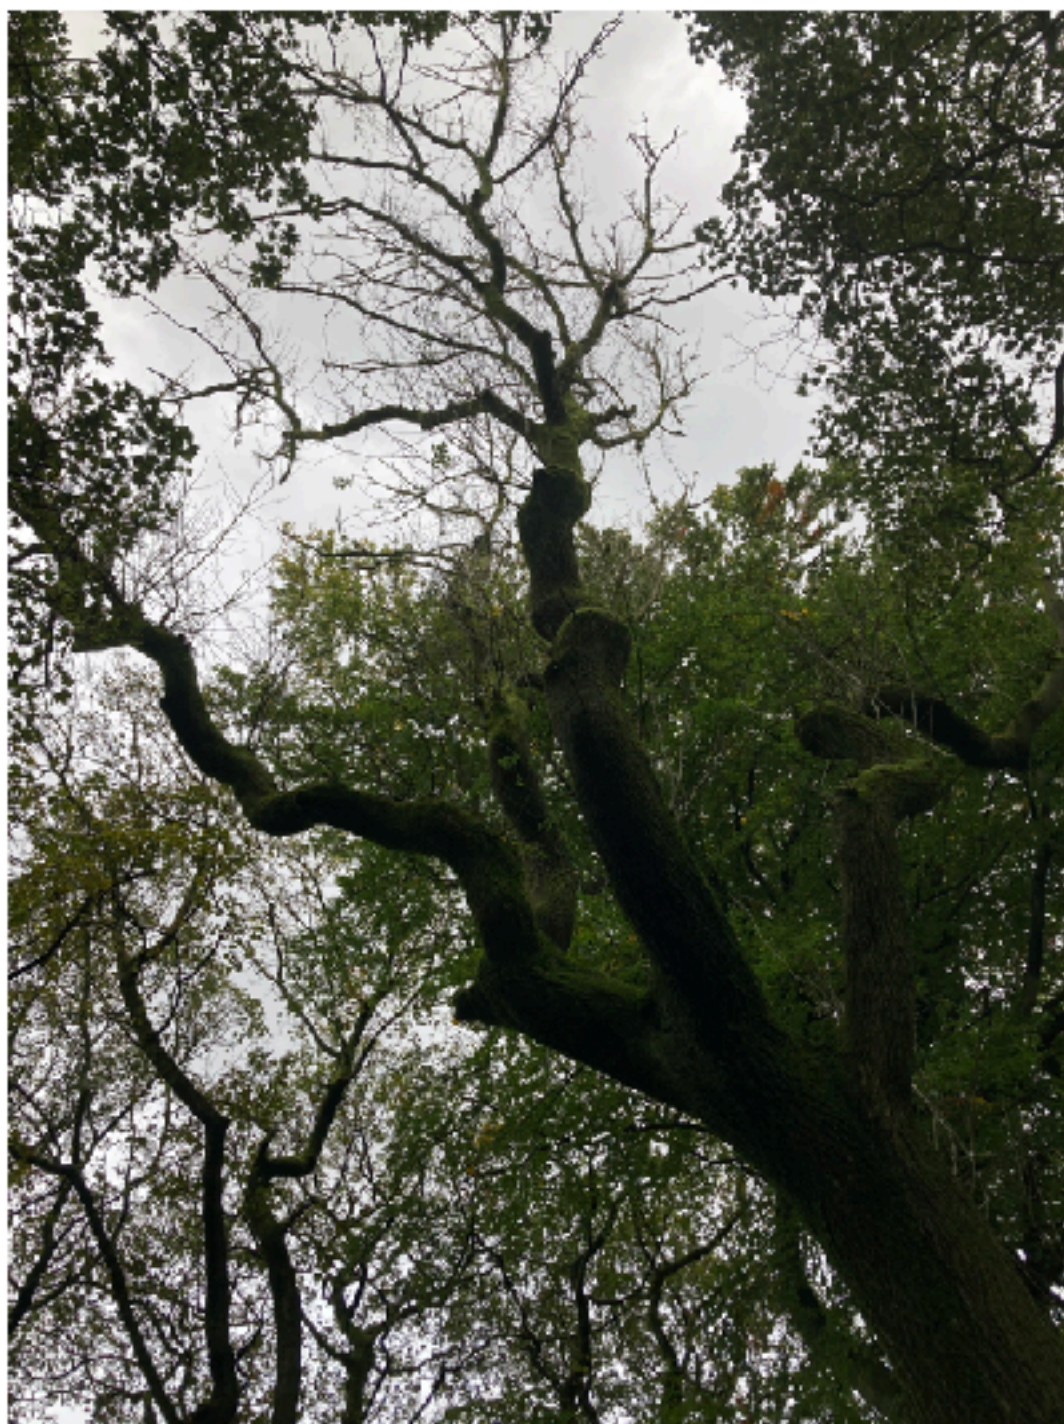
| TREE NO. | SPECIES | D.B.H (CM) | HEIGHT (M) | AGE | CATEGORY BS 5837 | RECOMMENDATION |
|---|---|---|---|---|---|---|
| T5 | FRAXINUS EXCELSIOR (ASH) | 80 | 20 | MA | SS PPP C2 | DYING TREE WITH ASH DIEBACK. REMOVE BY SECTION DOWN OR FELL. REPLANT WITH SUITABLE HARD WOOD EG LIME |

T4 & T5 are Ash trees which have succumbed to the *Chalara* Ash dieback disease.

T5 showing *Hymenoscyphus fraxineus*, Ash dieback

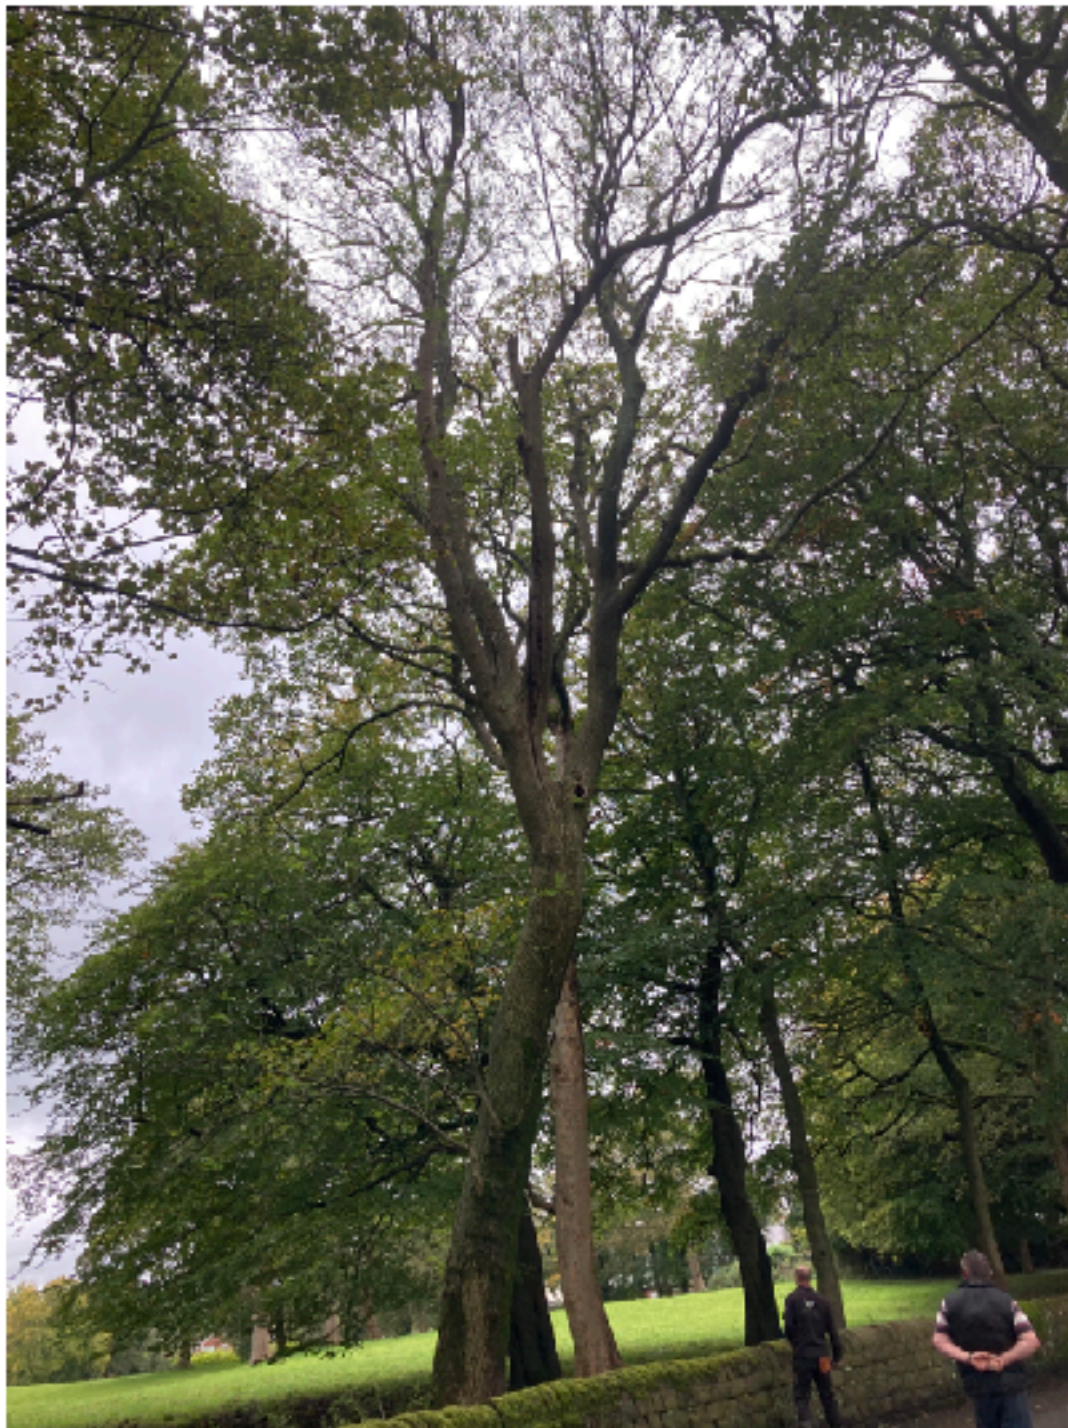
| TREE NO. | SPECIES | D.B.H (CM) | HEIGHT (M) | AGE | CATEGORY BS 5837 | RECOMMENDATION |
|---|---|---|---|---|---|---|
| T4 | FRAXINUS EXCELSIOR (ASH) | 80 | 20 | MA | SS PPP C2 | DYING TREE WITH ASH DIEBACK. NUMEROUS FAULTS INCLUDING SPLIT LIMBS REMOVE BY SECTION DOWN OR FELL. REPLANT WITH SUITABLE HARD WOOD EG LIME |

T4 Ash showing signs of Chalara ash dieback  
numerous defects including a large cracked limb

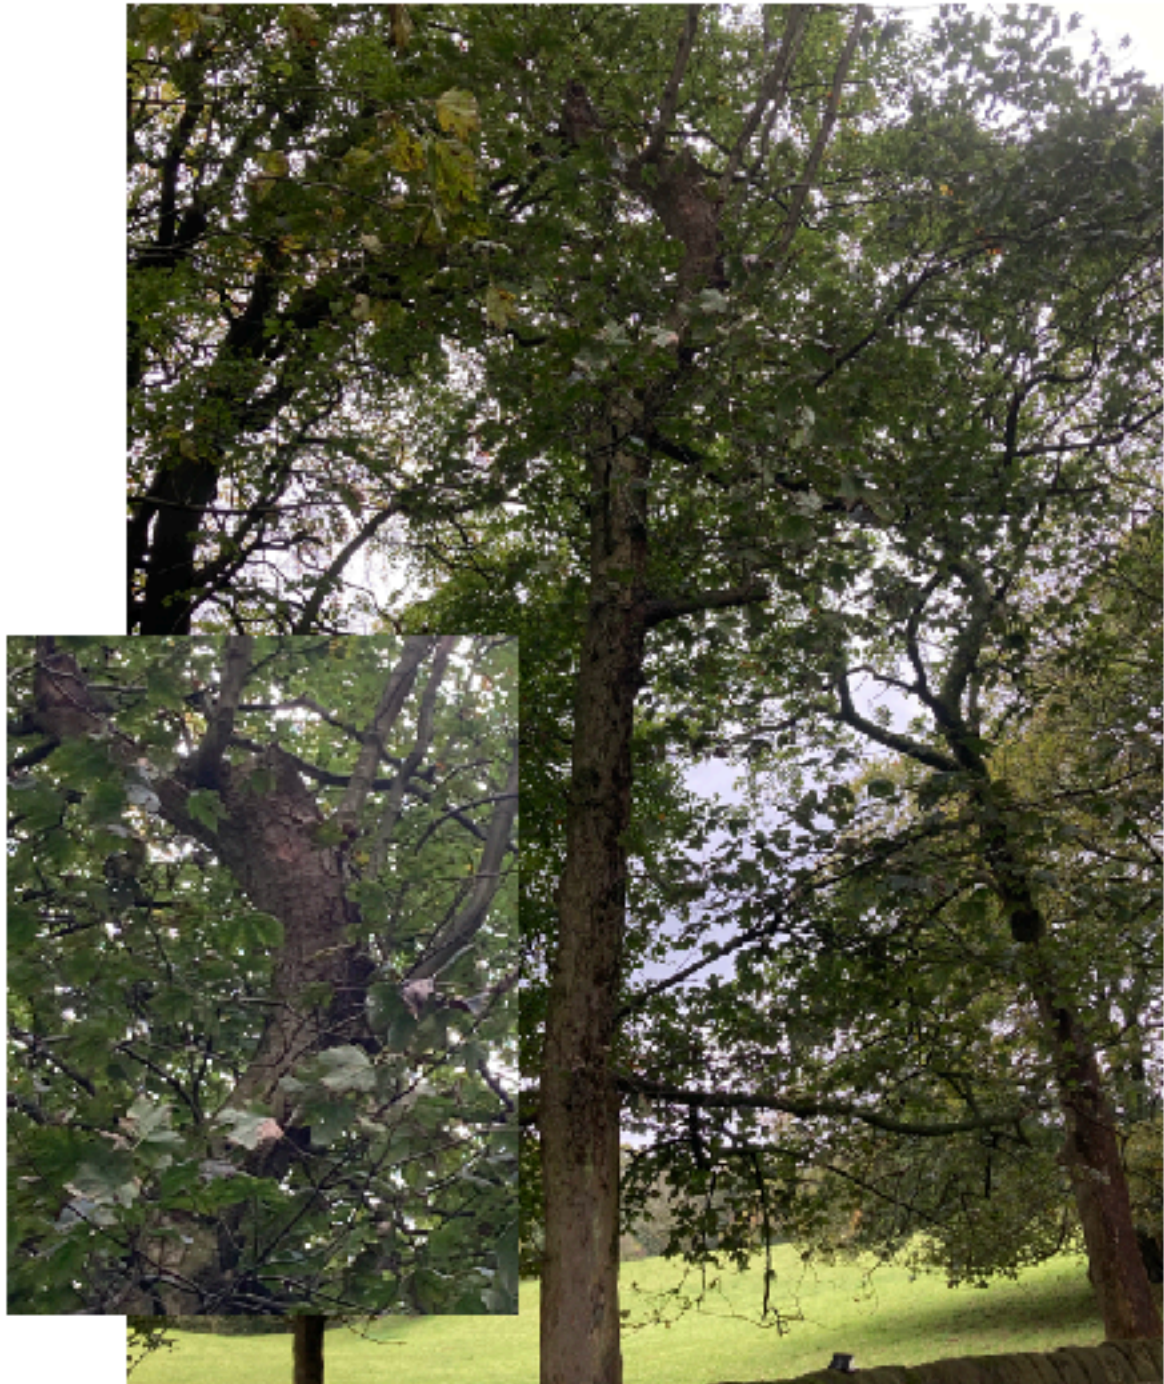
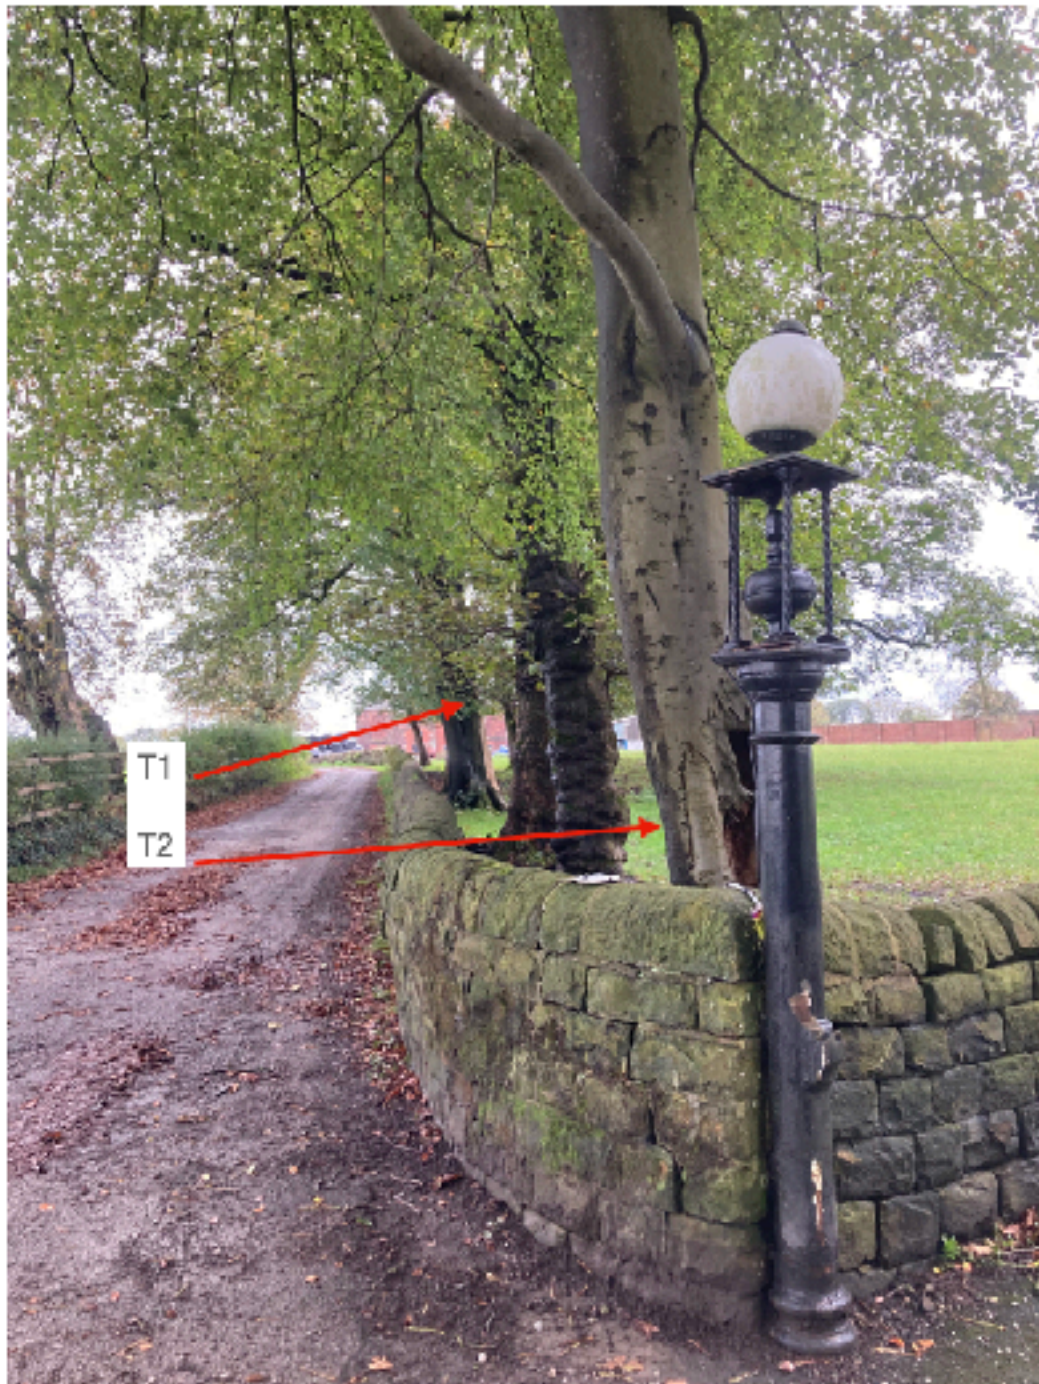
| TREE NO. | SPECIES | D.B.H (CM) | HEIGHT (M) | AGE | CATEGORY BS 5837 | RECOMMENDATION |
|---|---|---|---|---|---|---|
| T3 | ACER PSUEDOPLATANUS (SYCAMORE) | 40 | 15 | SM | SS PPP C2 | POOR TREE WITH WIND BLOWN TOP OUT. REMOVE BY SECTION DOWN OR FELL. REPLANT WITH SUITABLE HARD WOOD EG LIME |

T3 situated just before the Y lane junction is a poor Sycamore with previous wind blown top; Sprouting from the damaged top are new grown branches which left to grow will cause a potential hazardous fault at height.

T3 Sycamore with windblown top out

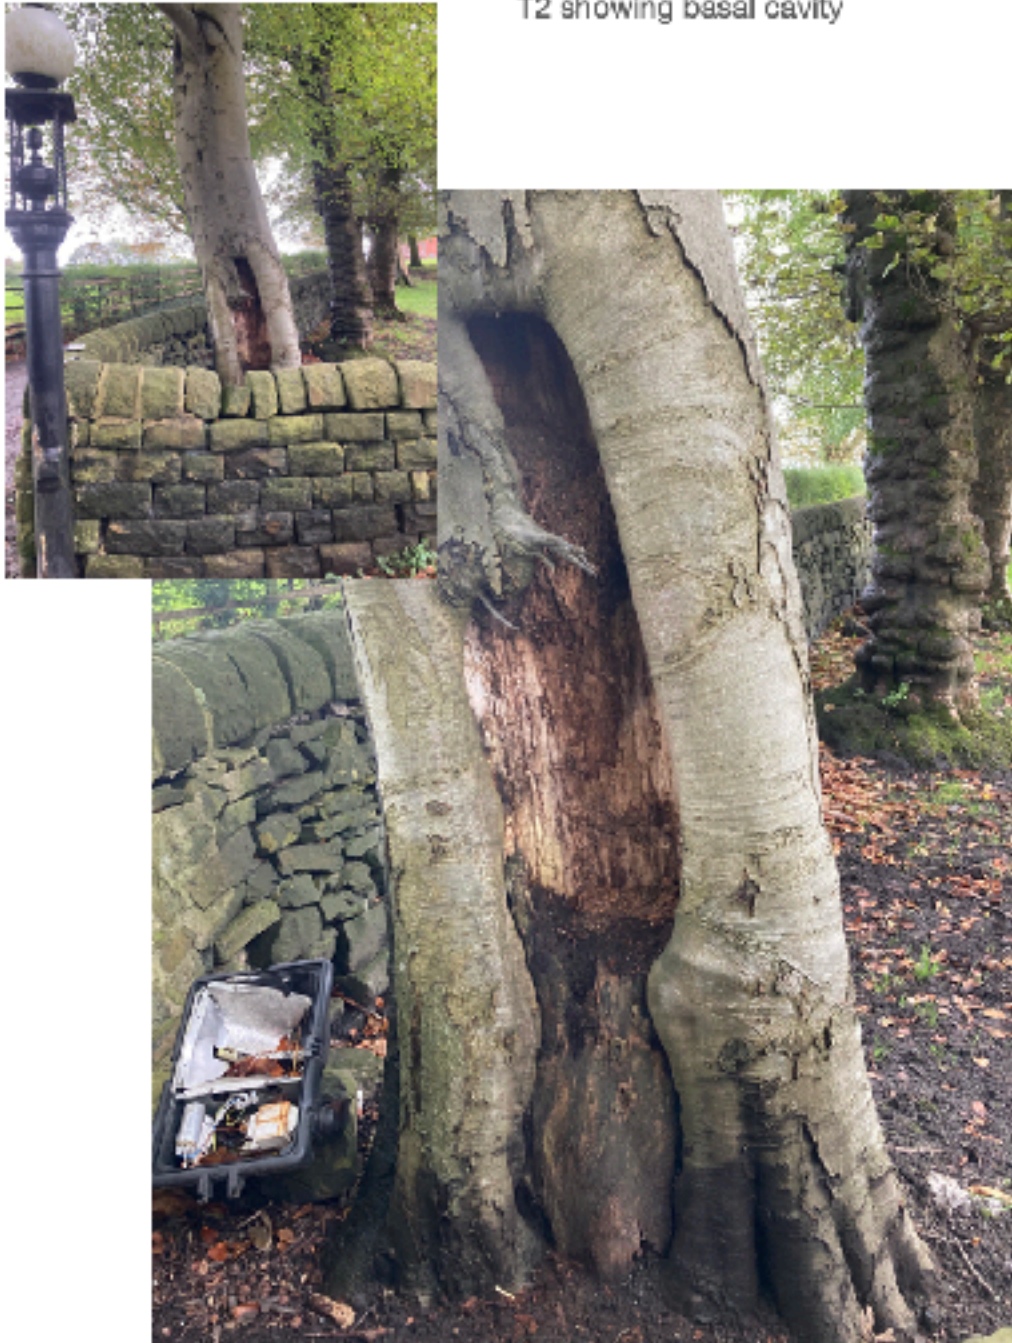
| TREE NO. | SPECIES | D.B.H (CM) | HEIGHT (M) | AGE | CATEGORY BS 5837 | RECOMMENDATION |
|---|---|---|---|---|---|---|
| T2 | Fagus Sylvatica (BEECH) | 60 | 15 | MA | SS PPP C2 | DANGEROUS TREE LARGE BASAL WOUND REMOVE BY SECTION DOWN OR FELL. REPLANT WITH SUITABLE HARD WOOD EG LIME |

T2 situated at the Y lane junction has a very large cavity at its base with a prominent lean to Crimble lane.

T2 showing basal cavity

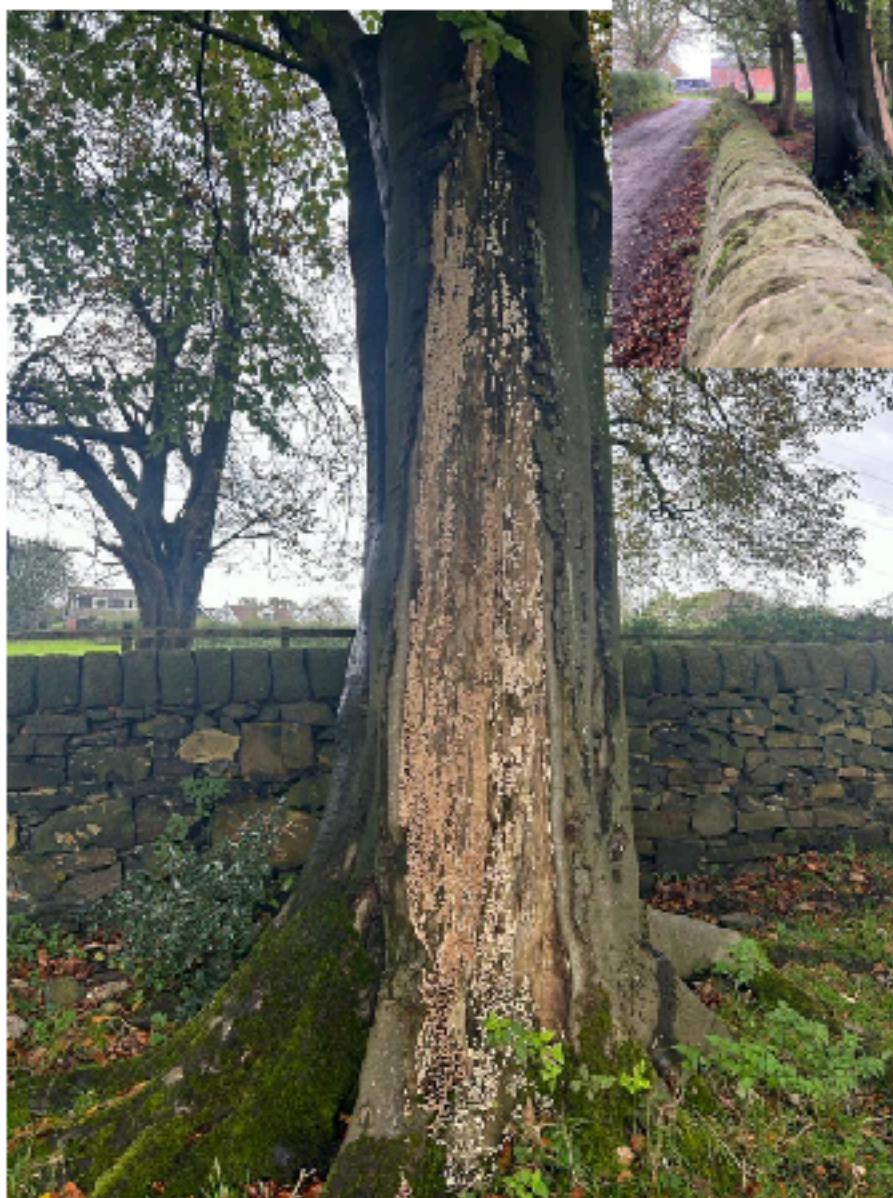
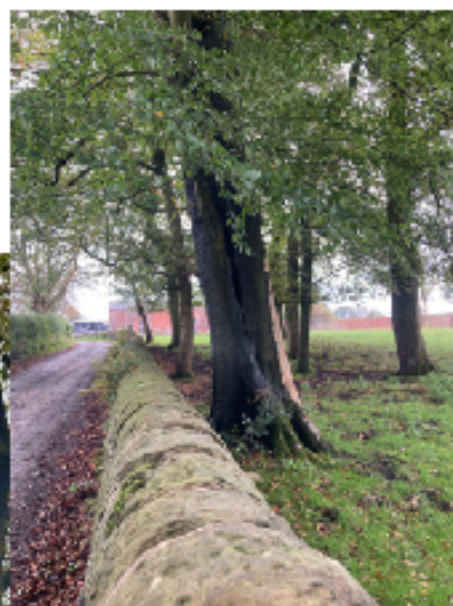
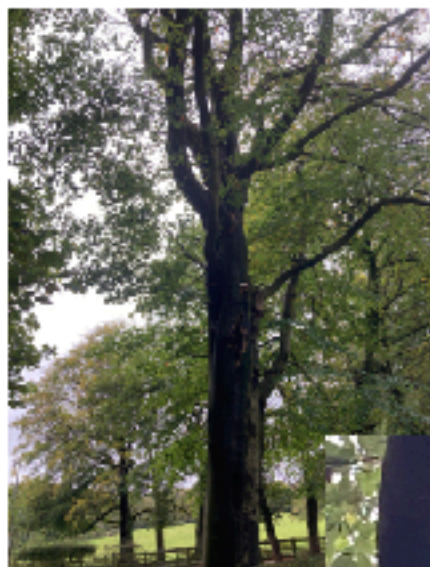
| TREE NO. | SPECIES | D.B.H (CM) | HEIGHT (M) | AGE | CATEGORY BS 5837 | RECOMMENDATION |
|---|---|---|---|---|---|---|
| T1 | Fagus Sylvatica (BEECH) | 80 | 20 | MA | SS PPP C2 | DANGEROUS TREE WITH GANODERMA AND IRPEX LACTEUS FUNGI. REMOVE BY SECTION DOWN OR FELL. REPLANT WITH SUITABLE HARD WOOD EG LIME |

T1 presents the highest concern of failure due to previous failure of scaffold limbs at a branch union with *Ganoderma* fungi and cavities. Also of significance is the formation of *Irpelex Lacteus* fungi from the base stretching upward over 2 metres.

T1 showing *Irpex* fungi (Polyporales)

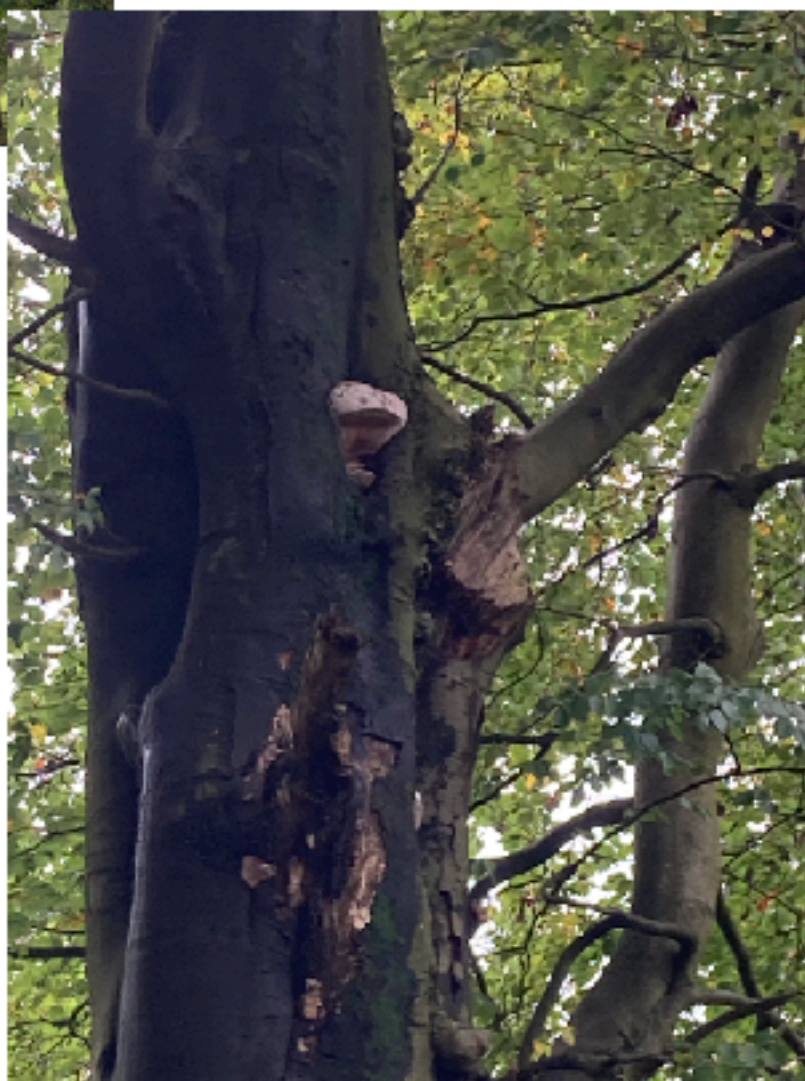
T1 showing Ganoderma,  
previous failed limb, rot and cavities
