**Issue Date**  
6<sup>th</sup> April 2022

**Reference Number**  
HCA02250

## Asbestos Demolition Survey

**Site Address**  
Unit D8  
Fieldhouse Industrial Estate  
Rochdale  
Lancashire  
OL12 0AA

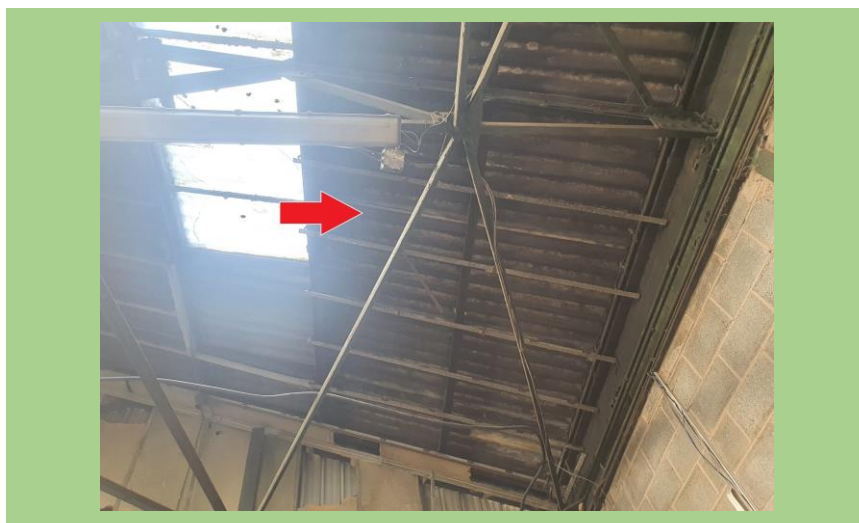
| Sample Number | 2 | Floor Plan Colour | Brown |

| Floor, Room | Ground floor, G.02 | Location | Roof cladding |
| Material | Corrugated cement sheeting | Quantity | 250 sq. m. |

| Material Assessment | | Priority Assessment | |
|---|---|---|---|
| Extent of Damage (0-3) | 3 | Likelihood of Disturbance (0-3) | 1 |

| Remove | Prior to demolition |

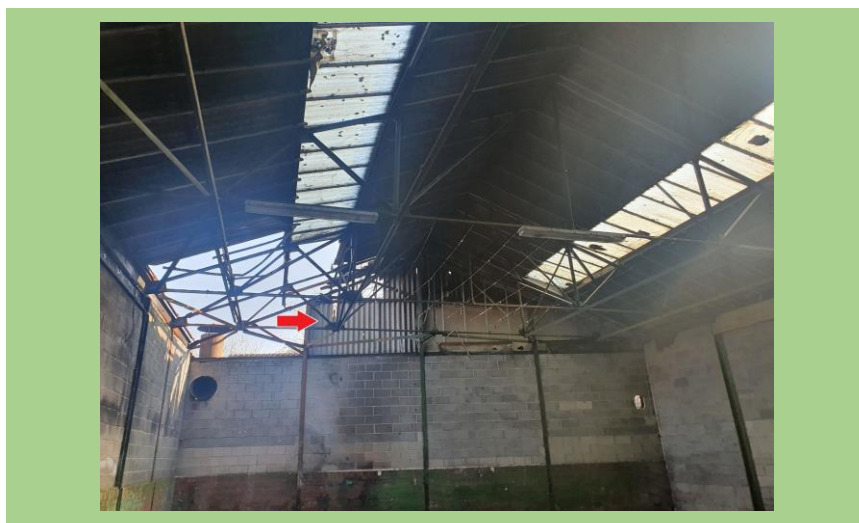
| Sample Number | 4 VI 2 | Floor Plan Colour | Brown |

| Floor, Room | Ground floor, G.02 | Location | High level rear wall cladding |
| Material | Corrugated cement sheeting | Quantity | 25 sq. m. |

| Material Assessment | | Priority Assessment | |
|---|---|---|---|
| Extent of Damage (0-3) | 3 | Likelihood of Disturbance (0-3) | 1 |

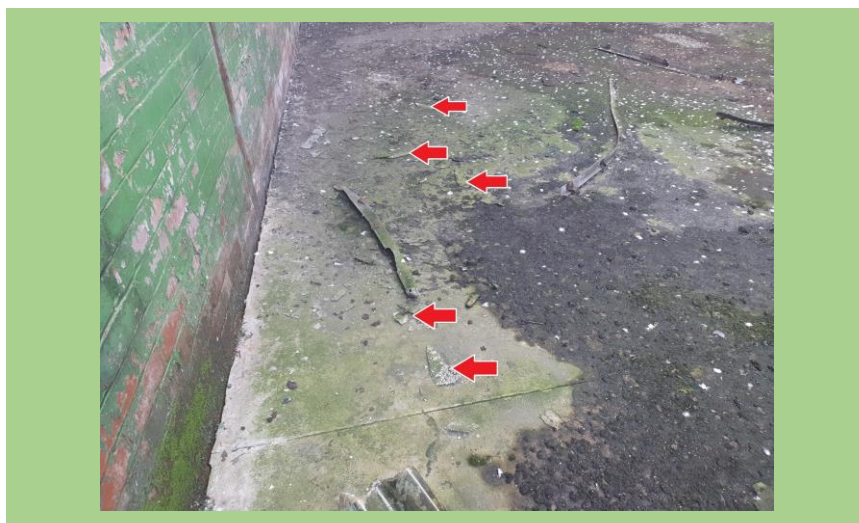
| Sample Number | 8 | Floor Plan Colour | Red |

| Floor, Room | Ground floor, G.02 | Location | Laying loose on the floor |
| Material | Cement debris | Quantity | < 1 sq. m. (visible) |

| Material Assessment | | Priority Assessment | |
|---|---|---|---|
| Extent of Damage (0-3) | 3 | Likelihood of Disturbance (0-3) | 3 |

| Additional Comments |
|---|
| Further asbestos containing debris is likely present, and concealed, amongst the surrounding debris and pigeon faeces. |

| Sample Number | Floor, Room | Location | Material | Quantity | Risk Level Posed | Accessibility | Management Recommendation |
|---|---|---|---|---|---|---|---|
| 8 | Ground floor, G.02 | Laying loose on the floor | Cement debris | < 1 sq. m. (visible) | LOW | EASY | Remove |

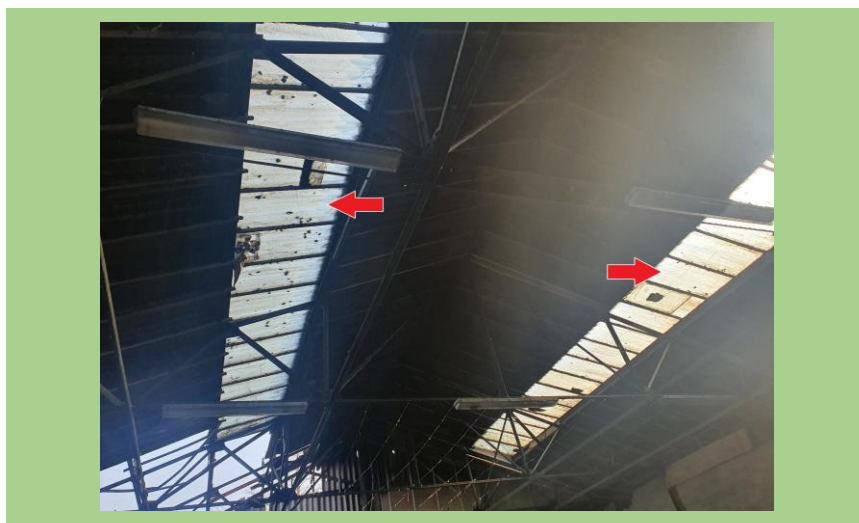
| Sample Number | 9 VI 16 | Floor Plan Colour | Pink |

| Floor, Room | Ground floor, G.02 | Location | Rooflights |
| Material | Textile rope | Quantity | 28 lin. m. |

| Material Assessment | | Priority Assessment | |
|---|---|---|---|
| Extent of Damage (0-3) | 1 | Likelihood of Disturbance (0-3) | 1 |

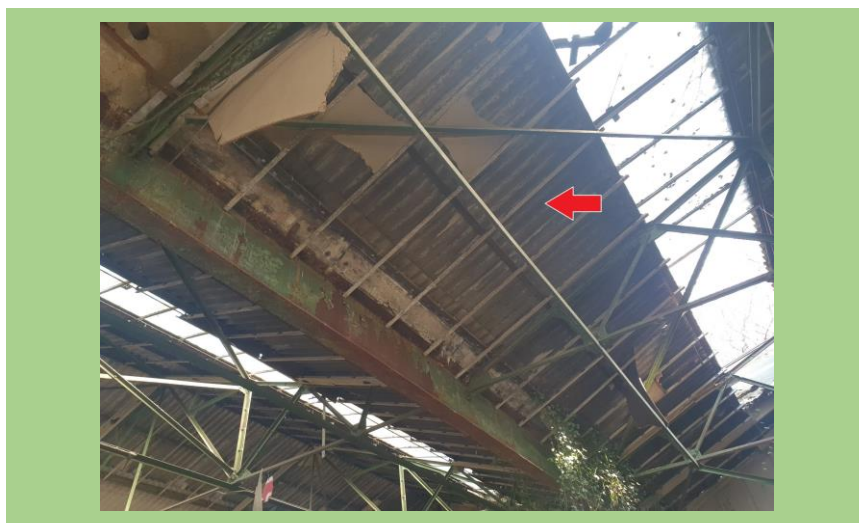
| Sample Number | 11 | Floor Plan Colour | Brown |

| Floor, Room | Ground floor, G.05 | Location | Roof cladding |
| Material | Corrugated cement sheeting | Quantity | 400 sq. m. |

| Material Assessment | | Priority Assessment | |
|---|---|---|---|
| Extent of Damage (0-3) | 3 | Likelihood of Disturbance (0-3) | 1 |

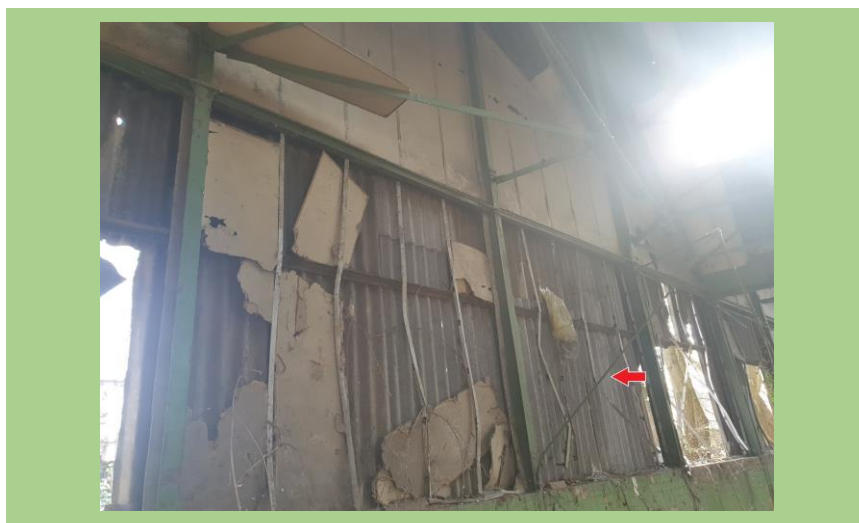
| Sample Number | 13 VI 11 | Floor Plan Colour | Brown |

| Floor, Room | Ground floor, G.05 | Location | Rear and side wall cladding |
| Material | Corrugated cement sheeting | Quantity | 200 sq. m. |

| Material Assessment | | Priority Assessment | |
|---|---|---|---|
| Extent of Damage (0-3) | 3 | Likelihood of Disturbance (0-3) | 2 |

| Additional Comments |
|---|
| This asbestos containing material extends into room G.07. |

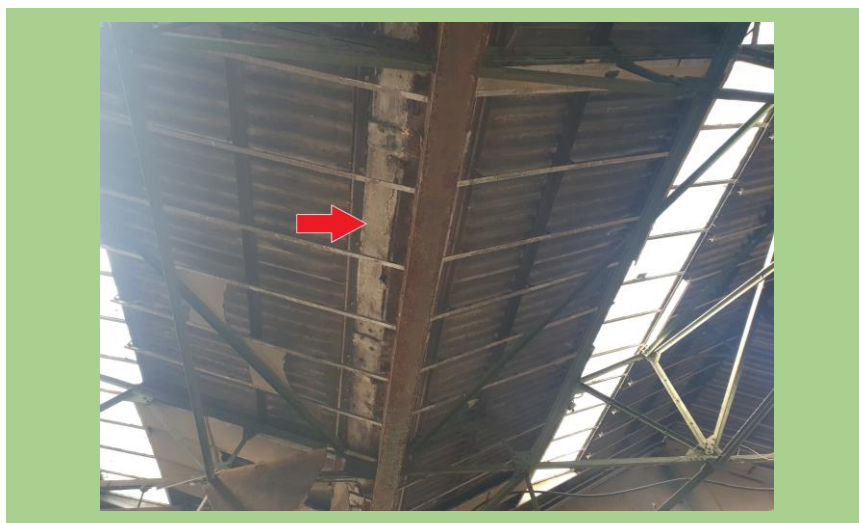
| Sample Number | 15 NS | Floor Plan Colour | Brown |

| Floor, Room | Ground floor, G.05 | Location | Valley guttering |
| Material | Presumed cement | Quantity | 15 lin. m. |

| Material Assessment | | Priority Assessment | |
|---|---|---|---|
| Extent of Damage (0-3) | 3 | Likelihood of Disturbance (0-3) | 1 |

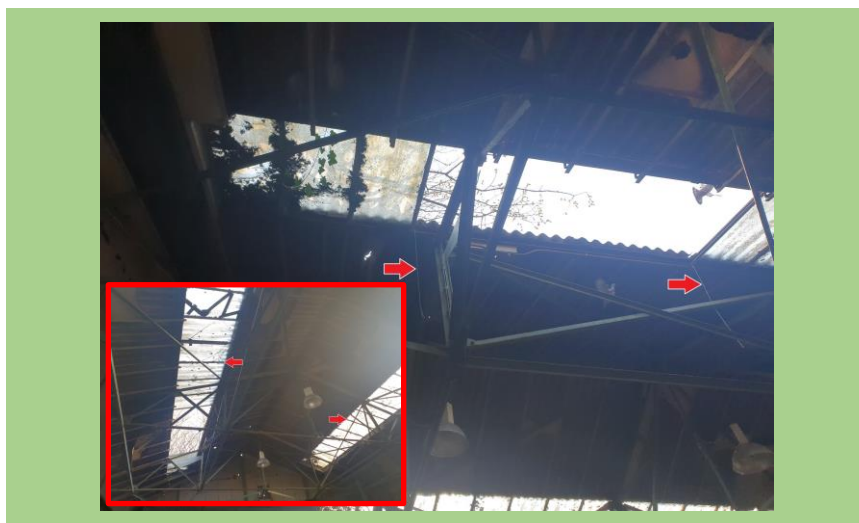
| Sample Number | 16 | Floor Plan Colour | Pink |

| Floor, Room | Ground floor, G.05 | Location | Rooflights |
| Material | Textile rope | Quantity | 50 lin. m. |

| Material Assessment | | Priority Assessment | |
|---|---|---|---|
| Extent of Damage (0-3) | 3 | Likelihood of Disturbance (0-3) | 1 |

| Additional Comments |
|---|
| There are asbestos textile ropes hanging from the roof where rooflights have fallen. |

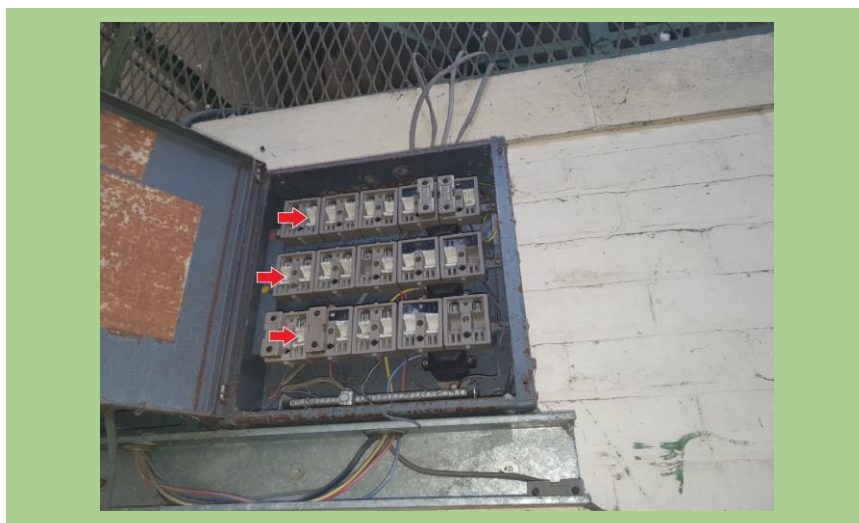
| Sample Number | 17 | Floor Plan Colour | Pink |

| Floor, Room | Ground floor, G.05 | Location | Within the wall mounted fuse box |
| Material | Textile flash guards | Quantity | 24 units |

| Material Assessment | | Priority Assessment | |
|---|---|---|---|
| Extent of Damage (0-3) | 1 | Likelihood of Disturbance (0-3) | 2 |

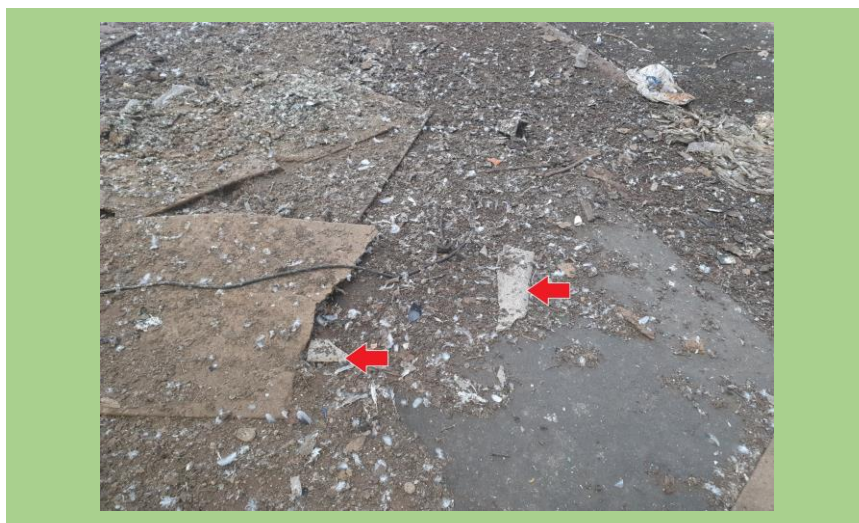
| Sample Number | 18 VI 11 | Floor Plan Colour | Red |

| Floor, Room | Ground floor, G.05 | Location | Laying loose on the floor |
| Material | Cement debris | Quantity | < 1 sq. m. (visible) |

| Material Assessment | | Priority Assessment | |
|---|---|---|---|
| Extent of Damage (0-3) | 3 | Likelihood of Disturbance (0-3) | 3 |

| Additional Comments |
|---|
| Further asbestos containing debris is likely present, and concealed, amongst the surrounding debris and pigeon faeces. |

| Sample Number | Floor, Room | Location | Material | Quantity | Risk Level Posed | Accessibility | Management Recommendation |
|---|---|---|---|---|---|---|---|
| 18 VI 11 | Ground floor, G.05 | Laying loose on the floor | Cement debris | < 1 sq. m. (visible) | VERY LOW | EASY | Remove |

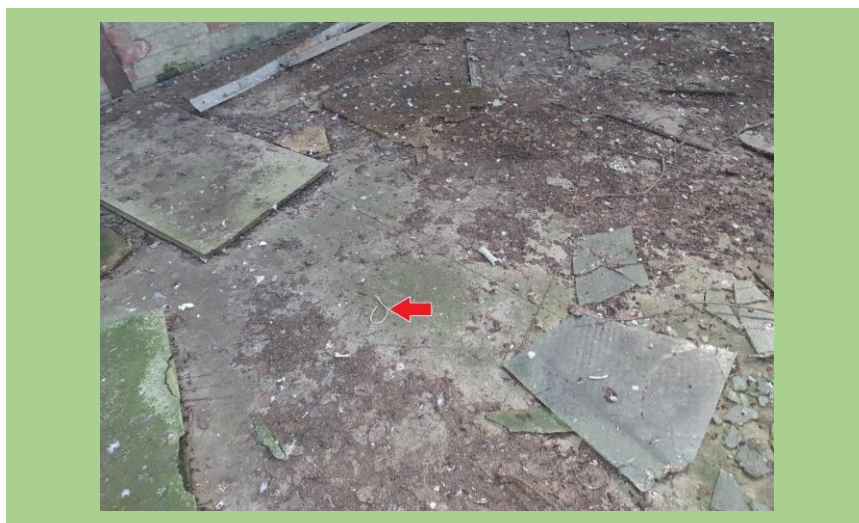
| Sample Number | 20 VI 16 | Floor Plan Colour | Red |

| Floor, Room | Ground floor, G.05 | Location | Laying loose on the floor |
| Material | Textile rope debris | Quantity | < 1 lin. m. (visible) |

| Material Assessment | | Priority Assessment | |
|---|---|---|---|
| Extent of Damage (0-3) | 3 | Likelihood of Disturbance (0-3) | 3 |

| Additional Comments |
|---|
| Further asbestos containing debris is likely present, and concealed, amongst the surrounding debris and pigeon faeces. |

| Sample Number | Floor, Room | Location | Material | Quantity | Risk Level Posed | Accessibility | Management Recommendation |
|---|---|---|---|---|---|---|---|
| 20 VI 16 | Ground floor, G.05 | Laying loose on the floor | Textile rope debris | < 1 lin. m. (visible) | VERY LOW | EASY | Remove |

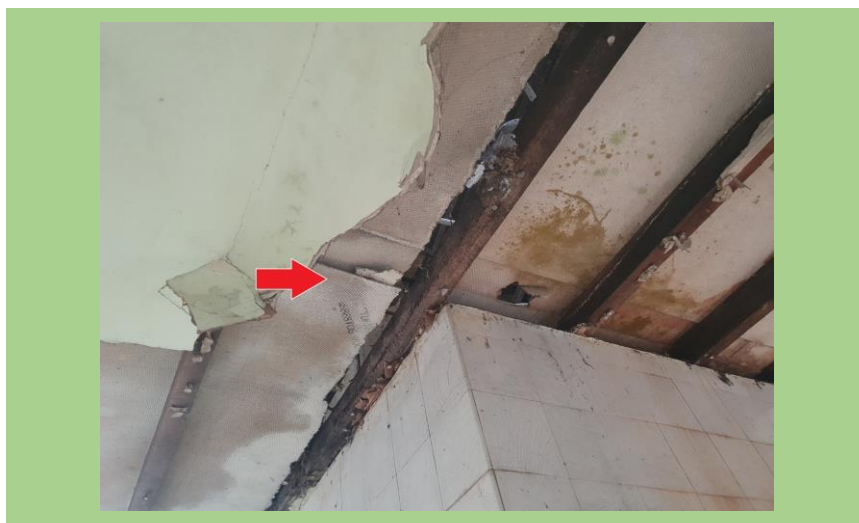
| Sample Number | 21 | Floor Plan Colour | Brown |

| Floor, Room | Ground floor, G.06 | Location | Ceiling, above the plasterboard ceiling |
| Material | Cement sheeting | Quantity | 10.5 sq. m. |

| Material Assessment | | Priority Assessment | |
|---|---|---|---|
| Extent of Damage (0-3) | 2 | Likelihood of Disturbance (0-3) | 1 |

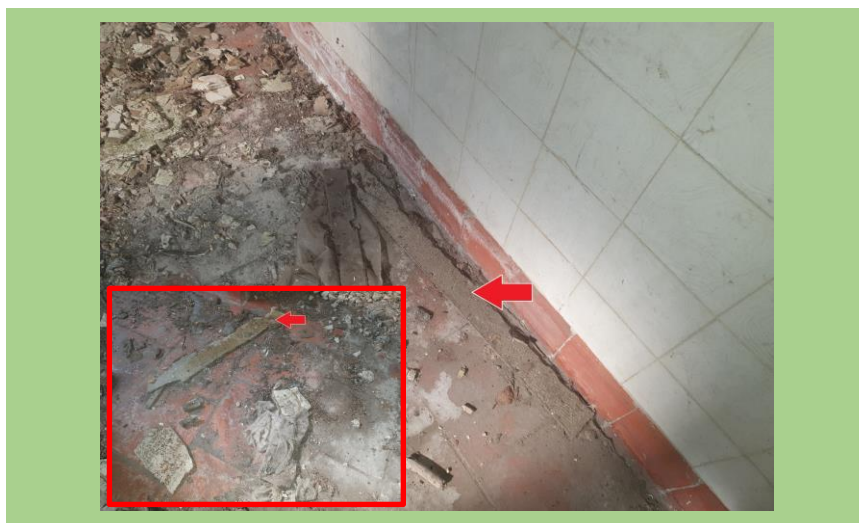
| Sample Number | 22 VI 21 | Floor Plan Colour | Red |

| Floor, Room | Ground floor, G.06 | Location | Laying loose on the floor |
| Material | Cement debris | Quantity | <1 sq. m. |

| Material Assessment | | Priority Assessment | |
|---|---|---|---|
| Extent of Damage (0-3) | 3 | Likelihood of Disturbance (0-3) | 3 |

| Sample Number | Floor, Room | Location | Material | Quantity | Risk Level Posed | Accessibility | Management Recommendation |
|---|---|---|---|---|---|---|---|
| 22 VI 21 | Ground floor, G.06 | Laying loose on the floor | Cement debris | <1 sq. m. | LOW | EASY | Remove |

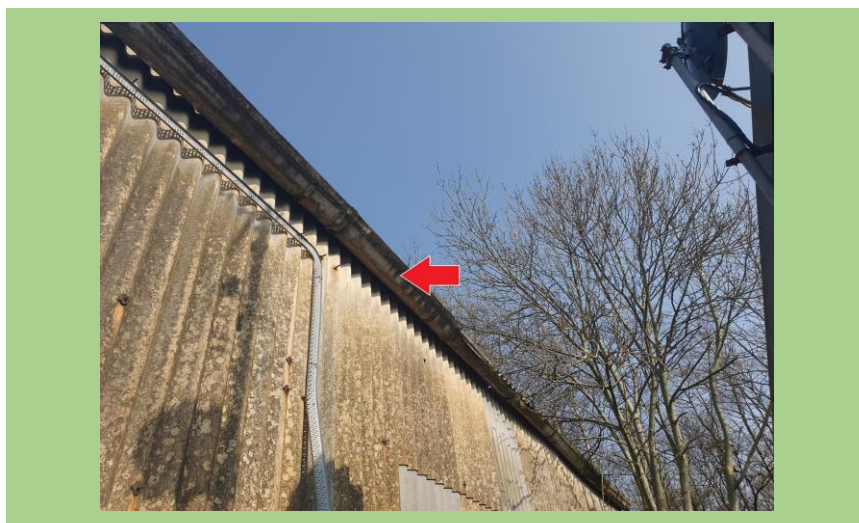
| Sample Number | 23 | Floor Plan Colour | Brown |

| Floor, Room | External, side of the building | Location | Guttering |
| Material | Cement | Quantity | 12 lin. m. |

| Material Assessment | | Priority Assessment | |
|---|---|---|---|
| Extent of Damage (0-3) | 2 | Likelihood of Disturbance (0-3) | 1 |

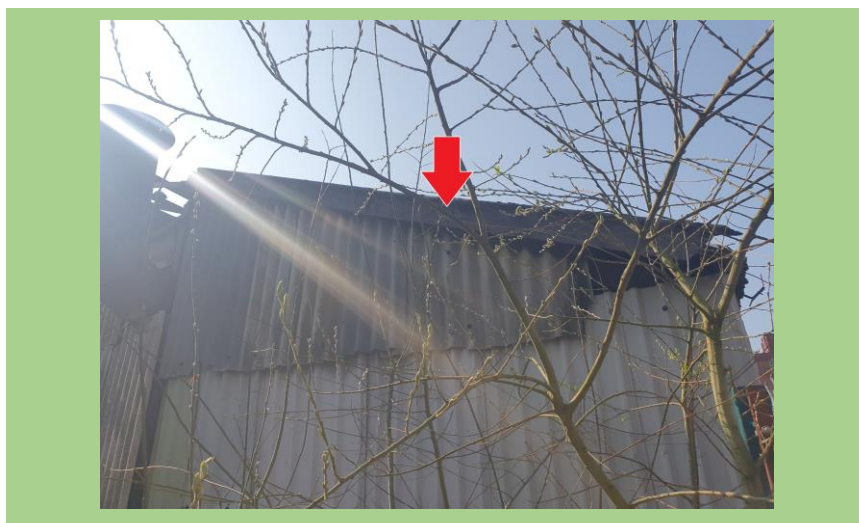
| Sample Number | 24 | Floor Plan Colour | Brown |

| Floor, Room | External, rear of the building | Location | Barge boards |
| Material | Cement | Quantity | 40 lin. m. |

| Material Assessment | | Priority Assessment | |
|---|---|---|---|
| Extent of Damage (0-3) | 1 | Likelihood of Disturbance (0-3) | 1 |

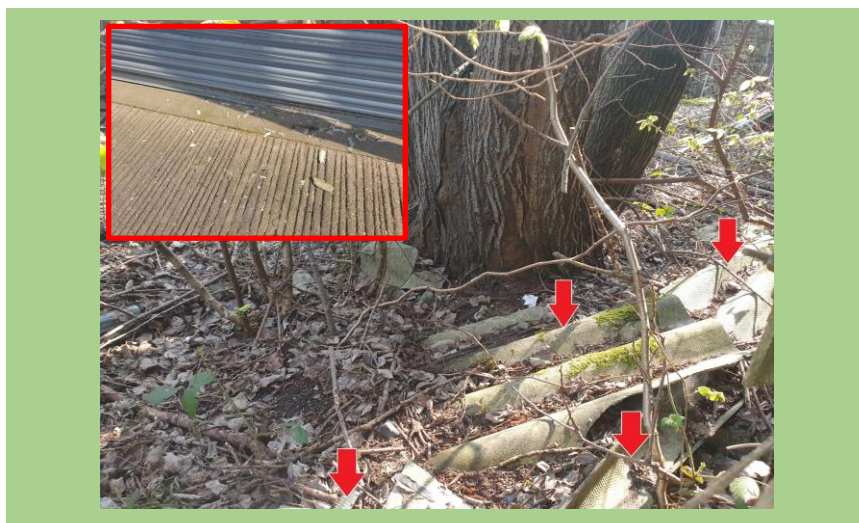
| Sample Number | 26 | Floor Plan Colour | Red |

| Floor, Room | External, perimeter of the building | Location | Laying loose on the floor |
| Material | Cement debris | Quantity | 115 sq. m. |

| Material Assessment | | Priority Assessment | |
|---|---|---|---|
| Extent of Damage (0-3) | 3 | Likelihood of Disturbance (0-3) | 3 |

| Sample Number | Floor, Room | Location | Material | Quantity | Risk Level Posed | Accessibility | Management Recommendation |
|---|---|---|---|---|---|---|---|
| 26 | External, perimeter of the building | Laying loose on the floor | Cement debris | 115 sq. m. | LOW | EASY | Remove |

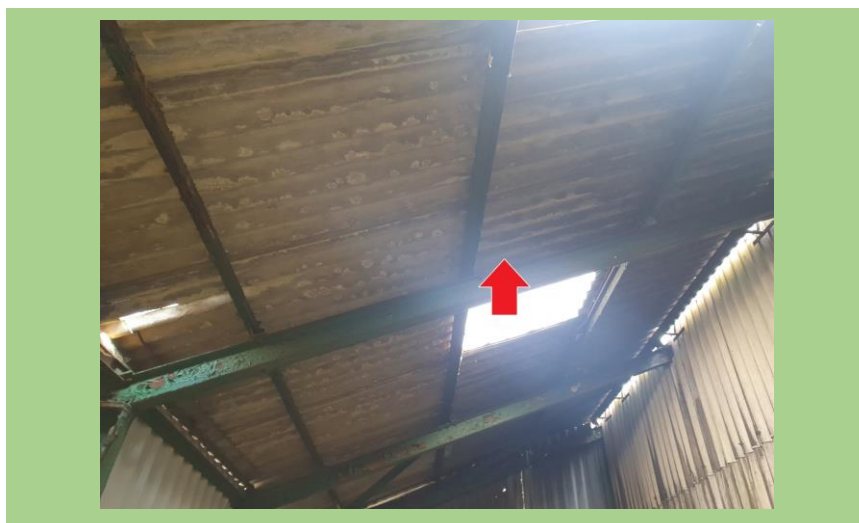
| Sample Number | 30 VI 2 | Floor Plan Colour | Brown |

| Floor, Room | Ground floor, G.09 | Location | Roof cladding |
| Material | Corrugated cement sheeting | Quantity | 80 sq. m. |

| Material Assessment | | Priority Assessment | |
|---|---|---|---|
| Extent of Damage (0-3) | 1 | Likelihood of Disturbance (0-3) | 1 |

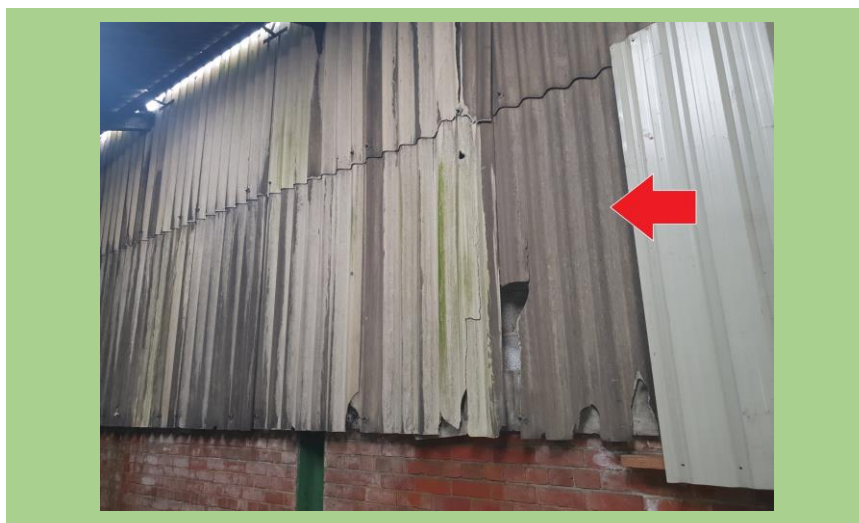
| Sample Number | 31 VI 2 | Floor Plan Colour | Brown |

| Floor, Room | Ground floor, G.09 | Location | Wall cladding |
| Material | Corrugated cement sheeting | Quantity | 80 sq. m. |

| Material Assessment | | Priority Assessment | |
|---|---|---|---|
| Extent of Damage (0-3) | 3 | Likelihood of Disturbance (0-3) | 1 |

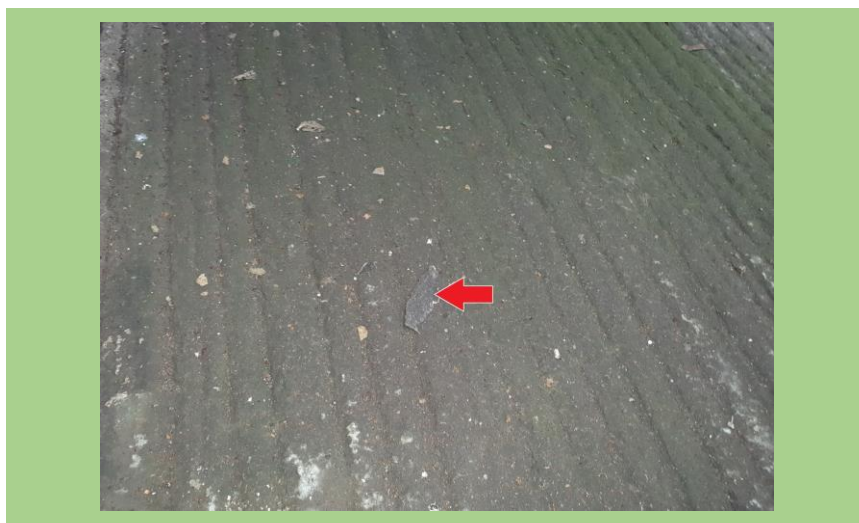
| Sample Number | 32 VI 8 | Floor Plan Colour | Red |

| Floor, Room | Ground floor, G.09 | Location | Laying ;oose on the floor |
| Material | Cement debris | Quantity | < 1 sq. m. |

| Material Assessment | | Priority Assessment | |
|---|---|---|---|
| Extent of Damage (0-3) | 3 | Likelihood of Disturbance (0-3) | 3 |

| Sample Number | Floor, Room | Location | Material | Quantity | Risk Level Posed | Accessibility | Management Recommendation |
|---|---|---|---|---|---|---|---|
| 32 VI 8 | Ground floor, G.09 | Laying ;oose on the floor | Cement debris | < 1 sq. m. | LOW | EASY | Remove |
