**REPORT ON COAL MINING RELATED SITE INVESTIGATIVE WORKS**  
**UNDERTAKEN ON LAND AT**  
**LITTLEBOROUGH FIRE STATION, WHITELEES ROAD, LITTLEBOROUGH OL15 8DU**

***Report on Coal Mining Site Investigative Works undertaken on Land at Littleborough Fire Station, Whitelees Road, Littleborough OL15 8DU.***

**Report Number** : TLC1169

**Report Date** : October 2021

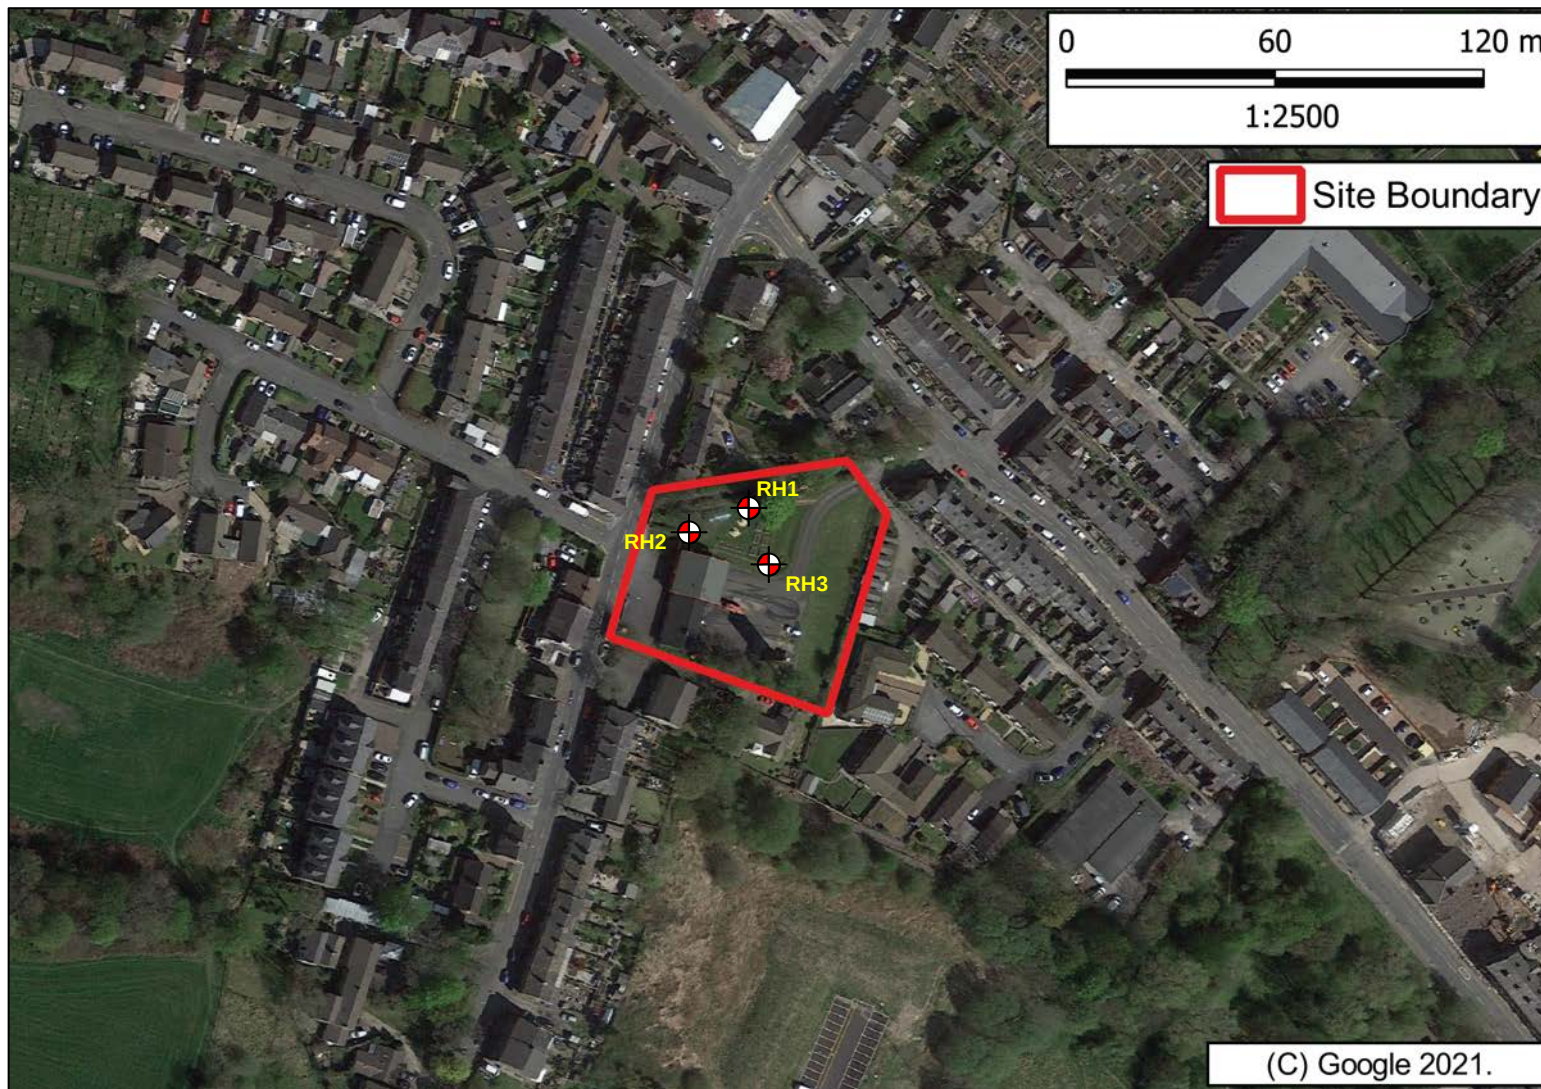
**Drawing No.: TLC1169/02**

- 4.1.3 Drill hole locations are indicated on Drawing No. TLC1169/02 in Appendix A and the logs are presented in Appendix B.
- 4.1.4 The rotary holes were sited away from known service runs (LK Consult Ltd had obtained service plans and made these available to TLC). Hole locations were cleared with a cable avoidance tool. As a final check for services, hand pits were excavated to 1.20m depth. Rotary drilling commenced from the base of each hand pit.

Rotary drill hole locations.

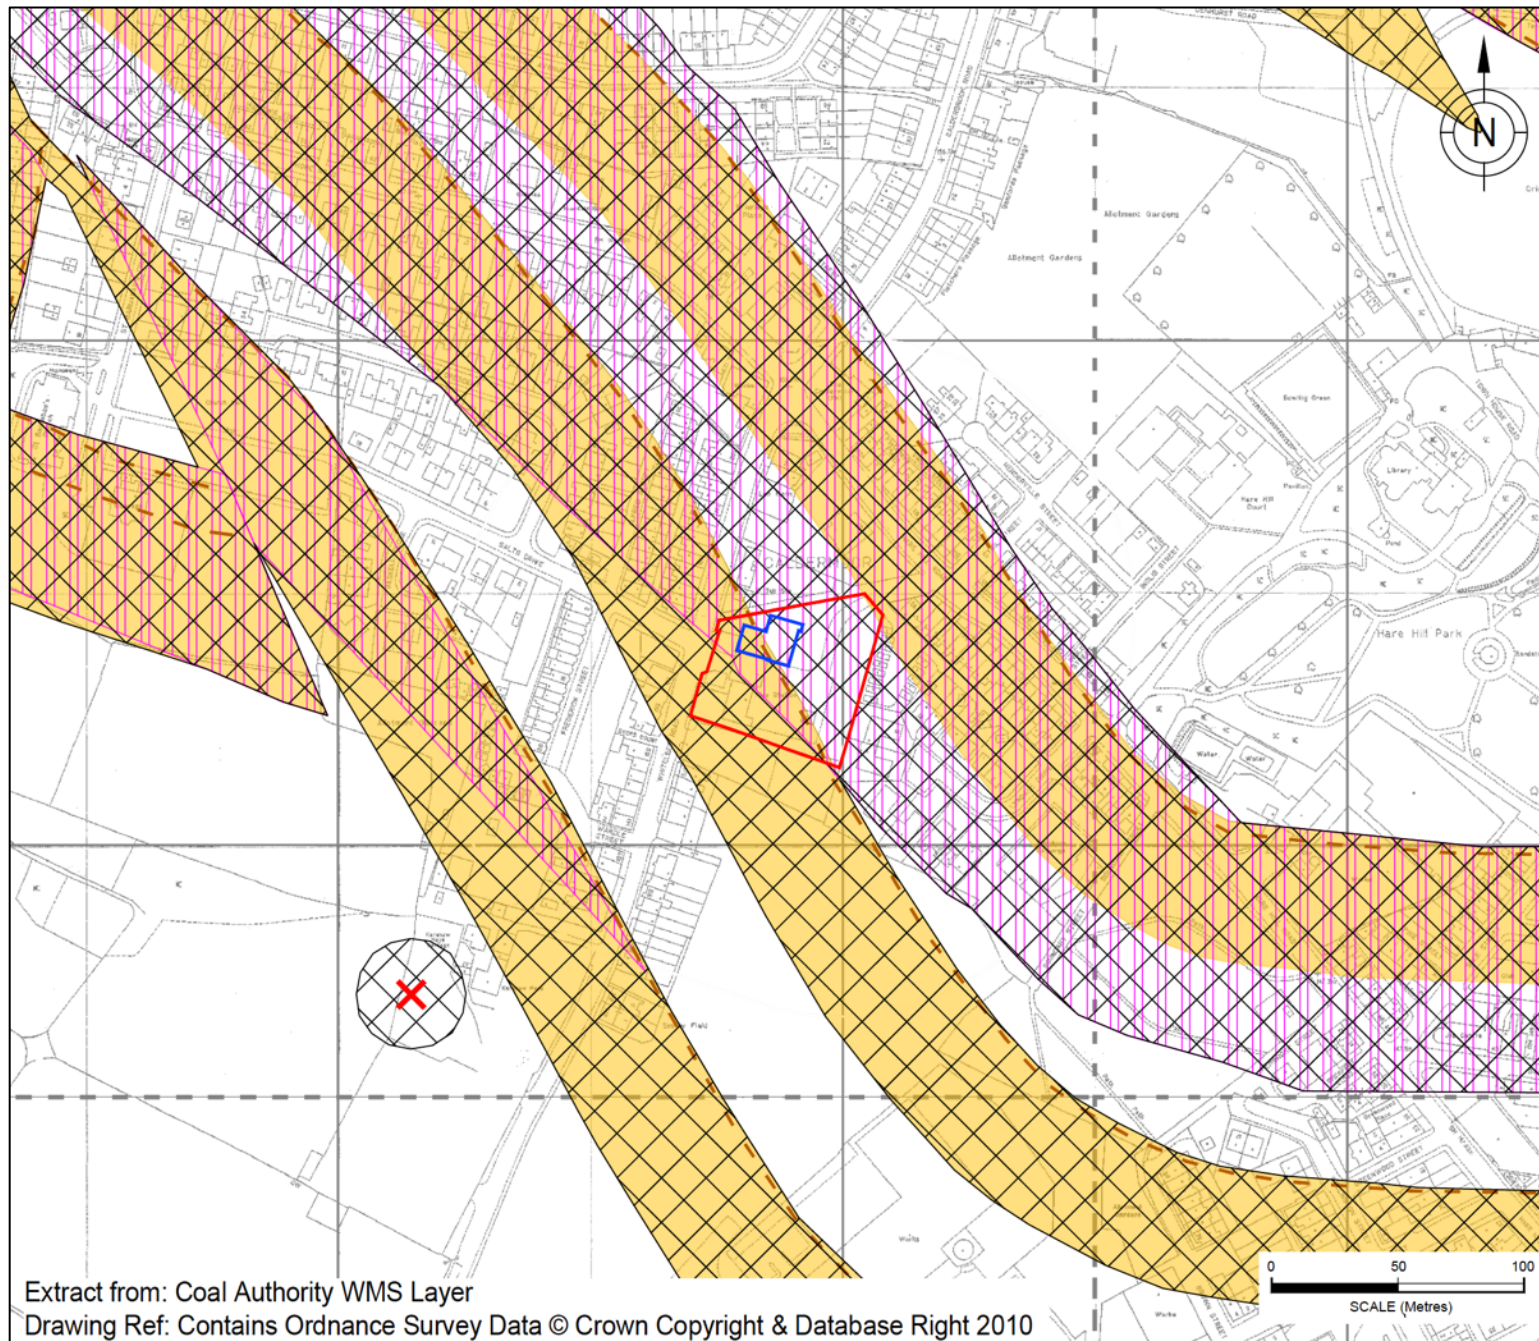
**Drawing No.: TLC1169/04**

| <b>COAL AUTHORITY (CA) INFORMATION</b> | <p>The CA indicate that:</p> <ul style="list-style-type: none"> <li>The NE portion of the site is located within a Development High Risk Area which is associated with an area at risk from unrecorded probable shallow coal workings (<i>within the Bassy coal seam – TLC</i>).</li> <li>Known coal workings are not present beneath the site.</li> <li>No known mine entries are located within at least 100m of the site.</li> <li>The site and surrounding area are not affected by known fissures or breaklines.</li> <li>The site and immediate surrounding area are not affected by known opencast coal mining.</li> </ul> <p>It should be noted that CA records are incomplete prior to 1872.</p> |

- 6.3 The Coal Authority (CA) have no records of mining having had taken place beneath the site. However, the CA indicate that the NE section of the site is at risk from probable unrecorded shallow coal workings – these would be associated with the Bassy coal seam. No mine entries are recorded within influencing distance of the site. It should be noted that the CA's records are incomplete <1872.
