# Drainage Report

**28 WAR OFFICE ROAD  
BAMFORD, ROCHDALE**

**WAR OFFICE ROAD - CCTV Survey Report : 24/08/22**

## Section 1

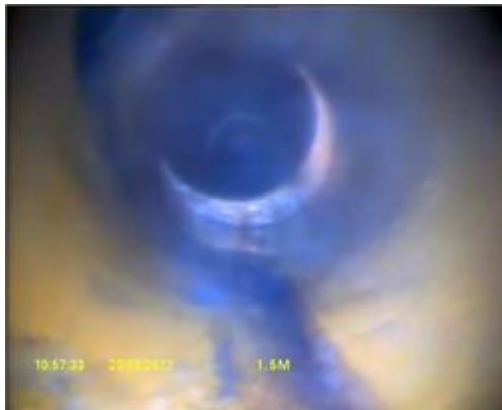
| Position | Code | Description | CD | Pic | Video Ref | |
|---|---|---|---|---|---|--|
| 01.50m | JN | Junction 11 : 100mm Diameter | | 0_2 | 0:00:31 | |

| Pos | Video Ref | Code | Description | Image |
|---|---|---|---|---|
| 01.50m | 0:00:31 | JN | Junction at 11 o'clock: 100mm Diameter | Image Provided - Ref: 0_2<br> |

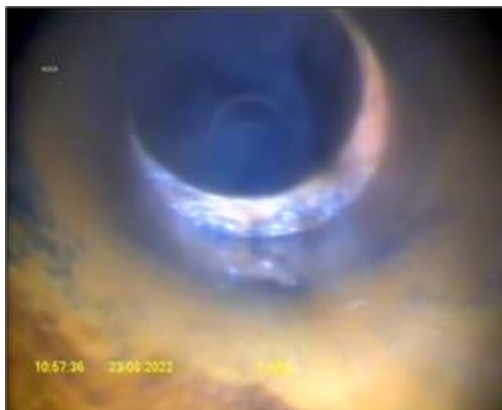
| Position | Code | Description | CD | Pic | Video Ref | |
|---|---|---|---|---|---|--|
| 01.60m | JDL | Joint displaced large | | 0_3 | 0:00:34 | |

| Pos | Video Ref | Code | Description | Image |
|---|---|---|---|---|
| 01.60m | 0:00:34 | JDL | Joint displaced large - Severity 4 | Image Provided - Ref: 0_3<br> |

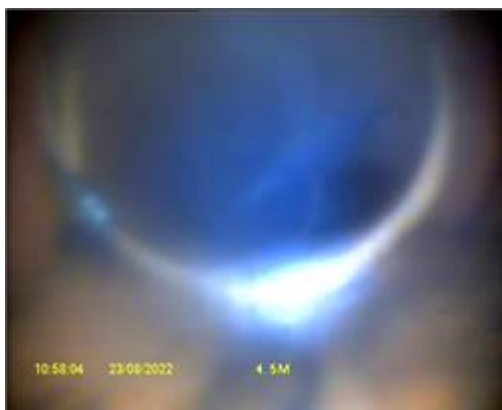
| Position | Code | Description | CD | Pic | Video Ref | |
|---|---|---|---|---|---|--|
| 04.50m | JDM | Joint displaced medium | | 0_4 | 0:01:02 | |

| Pos | Video Ref | Code | Description | Image |
|---|---|---|---|---|
| 04.50m | 0:01:02 | JDM | Joint displaced medium - Severity 3 | Image Provided - Ref: 0_4<br> |

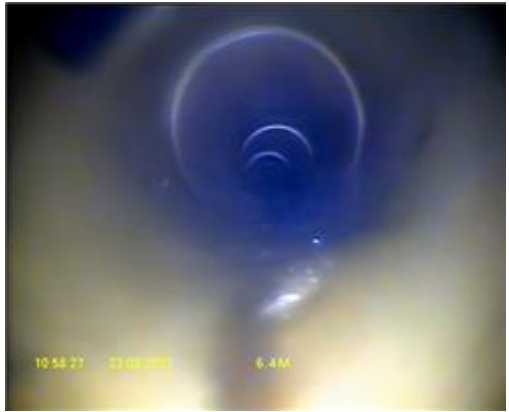
| Position | Code | Description | CD | Pic | Video Ref | |
|---|---|---|---|---|---|--|
| 06.40m | JN | Junction 11 : 100mm Diameter | | 0_5 | 0:01:25 | |

| Pos | Video Ref | Code | Description | Image |
|---|---|---|---|---|
| 06.40m | 0:01:25 | JN | Junction at 11 o'clock: 100mm Diameter | Image Provided - Ref: 0_5<br> |

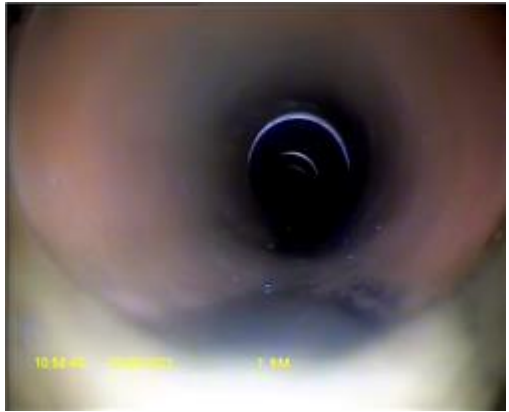
| Position | Code | Description | CD | Pic | Video Ref | |
|---|---|---|---|---|---|--|
| 07.90m | JDM | Joint displaced medium | | 0_6 | 0:01:38 | |

| Pos | Video Ref | Code | Description | Image |
|---|---|---|---|---|
| 07.90m | 0:01:38 | JDM | Joint displaced medium - Severity 3 | Image Provided - Ref: 0_6<br> |

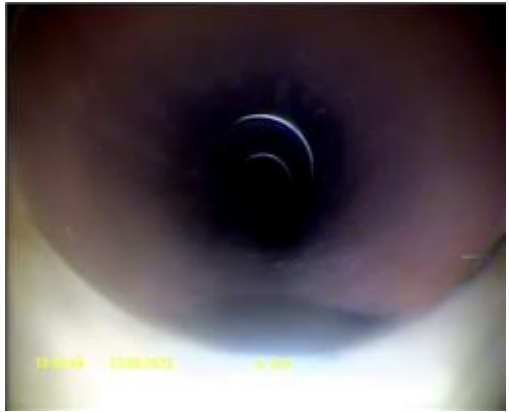
| Position | Code | Description | CD | Pic | Video Ref | |
|---|---|---|---|---|---|--|
| 08.50m | JDM | Joint displaced medium | | 0_7 | 0:01:43 | |

| Pos | Video Ref | Code | Description | Image |
|---|---|---|---|---|
| 08.50m | 0:01:43 | JDM | Joint displaced medium - Severity 3 | Image Provided - Ref: 0_7<br> |

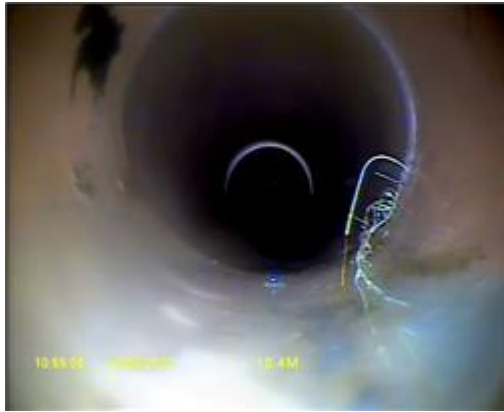
| Position | Code | Description | CD | Pic | Video Ref | |
|---|---|---|---|---|---|--|
| 10.40m | R | Roots | | 0_9 | 0:02:07 | |

| Pos | Video Ref | Code | Description | Image |
|---|---|---|---|---|
| 10.40m | 0:02:07 | R | Roots - Severity 3 | <p>Image Provided - Ref: 0_9</p> |

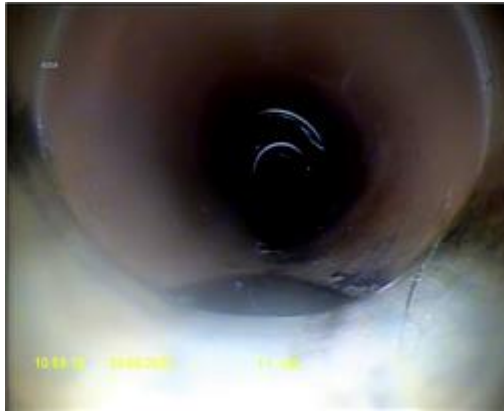
| Position | Code | Description | CD | Pic | Video Ref | |
|---|---|---|---|---|---|--|
| 11.10m | JDM | Joint displaced medium | | 0_10 | 0:02:17 | |

| Pos | Video Ref | Code | Description | Image |
|---|---|---|---|---|
| 11.10m | 0:02:17 | JDM | Joint displaced medium - Severity 3 | <p>Image Provided - Ref: 0_10</p> |

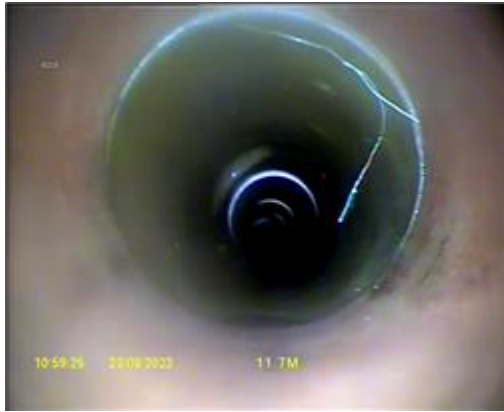
| Position | Code | Description | CD | Pic | Video Ref | |
|---|---|---|---|---|---|--|
| 11.70m | R | Roots | | 0_11 | 0:02:23 | |

| Pos | Video Ref | Code | Description | Image |
|---|---|---|---|---|
| 11.70m | 0:02:23 | R | Roots - Severity 3 | <p>Image Provided - Ref: 0_11</p> |

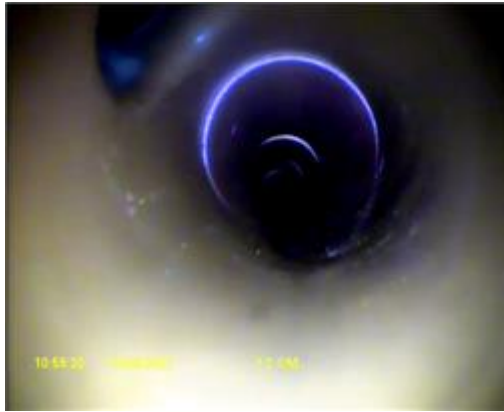
| Position | Code | Description | CD | Pic | Video Ref | |
|---|---|---|---|---|---|--|
| 12.00m | JN | Junction 11 : 100mm Diameter | | 0_12 | 0:02:29 | |

| Pos | Video Ref | Code | Description | Image |
|---|---|---|---|---|
| 12.00m | 0:02:29 | JN | Junction at 11 o'clock: 100mm Diameter | <p>Image Provided - Ref: 0_12</p> |

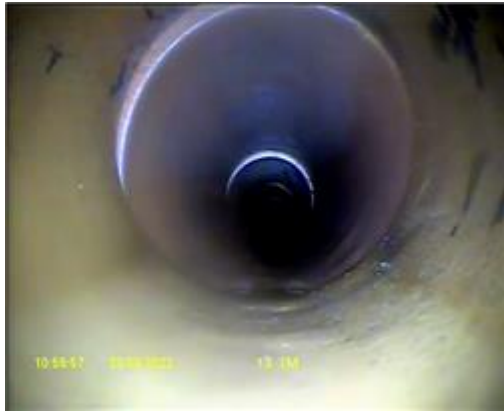
| Position | Code | Description | CD | Pic | Video Ref | |
|---|---|---|---|---|---|--|
| 13.70m | JDM | Joint displaced medium | | 0_13 | 0:02:56 | |

| Pos | Video Ref | Code | Description | Image |
|---|---|---|---|---|
| 13.70m | 0:02:56 | JDM | Joint displaced medium - Severity 3 | <p>Image Provided - Ref: 0_13</p> |

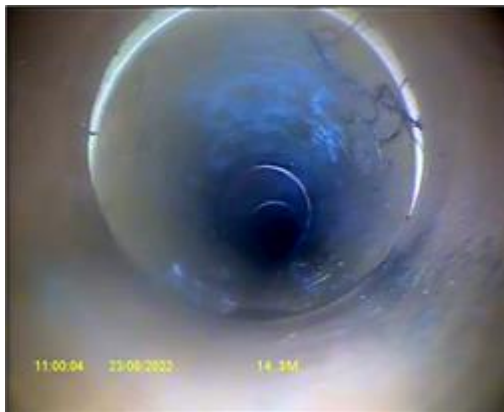
| Position | Code | Description | CD | Pic | Video Ref | |
|---|---|---|---|---|---|--|
| 14.30m | R | Roots | | 0_14 | 0:03:03 | |

| Pos | Video Ref | Code | Description | Image |
|---|---|---|---|---|
| 14.30m | 0:03:03 | R | Roots - Severity 3 | Image Provided - Ref: 0_14<br> |

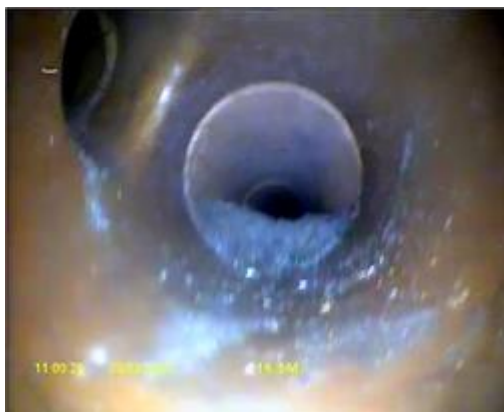
| Position | Code | Description | CD | Pic | Video Ref | |
|---|---|---|---|---|---|--|
| 16.50m | JN | Junction 11 : 100mm Diameter | | 0_15 | 0:03:24 | |

| Pos | Video Ref | Code | Description | Image |
|---|---|---|---|---|
| 16.50m | 0:03:24 | JN | Junction at 11 o'clock: 100mm Diameter | Image Provided - Ref: 0_15<br> |

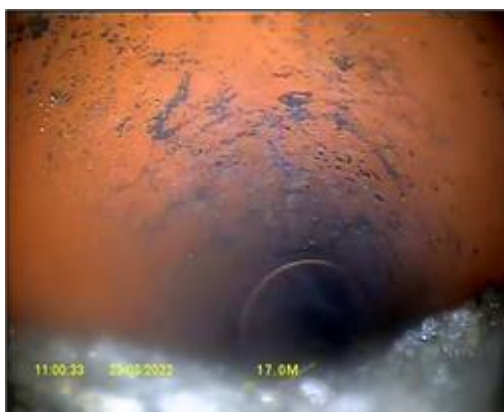
| Position | Code | Description | CD | Pic | Video Ref | |
|---|---|---|---|---|---|--|
| 17.00m | REM | General remark | | 0_16 | 0:03:31 | |

| Pos | Video Ref | Code | Description | Image |
|---|---|---|---|---|
| 17.00m | 0:03:31 | REM | General remark<br>CARRIED OUT PROBE THIS<br>IS ON BOUNDARY OF 28 | Image Provided - Ref: 0_16<br> |
