PROJECT:  
Rochdale Corner PLOT

TITLE:  
Investigation Works  
CCTV Scope

**Project Name:** 2023\_11\_01 34410 Rochdale Corner Plot  
**Project Description:** CCTV Drainage Survey  
**Project Number:** 34410  
**Project Status:** Complete  
**Project Date:** 11/1/2023  
**Inspection Standard:** MSCC5 Sewers & Drainage GB (SRM5 Scoring)

**Reference: - CCTV Report, JN34410, Rochdale**

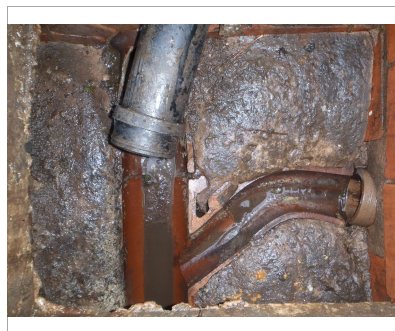
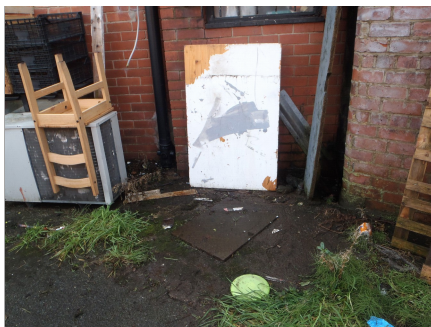
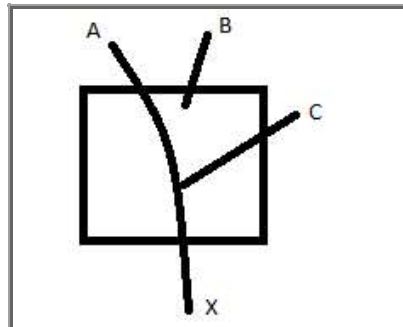
| Number | MH2 | Date Of Survey | 01/11/2023 |

| Cover | OK | Shaft | OK |
| Irons/Ladder | OK | Chamber | OK |
| Benching/Channel | OK | | |

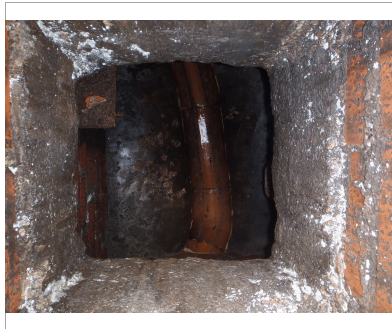
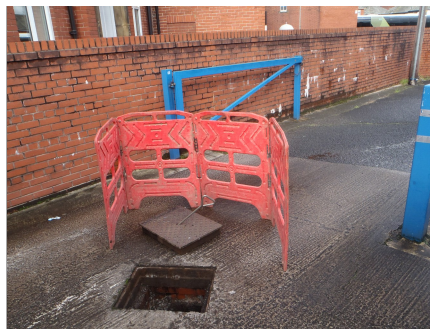
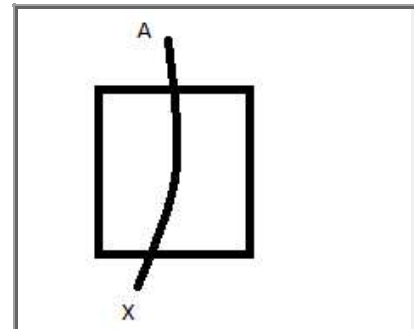
| Number | MH1 | Date Of Survey | 01/11/2023 |

| Cover | OK | Shaft | OK |
| Irons/Ladder | OK | Chamber | OK |
| Benching/Channel | OK | | |
