Preliminary Roost Assessment and Ecological Walkover

Riverside Business Park, Todmorden Road

Reference: 81-593-R1-1

Date: November 2023

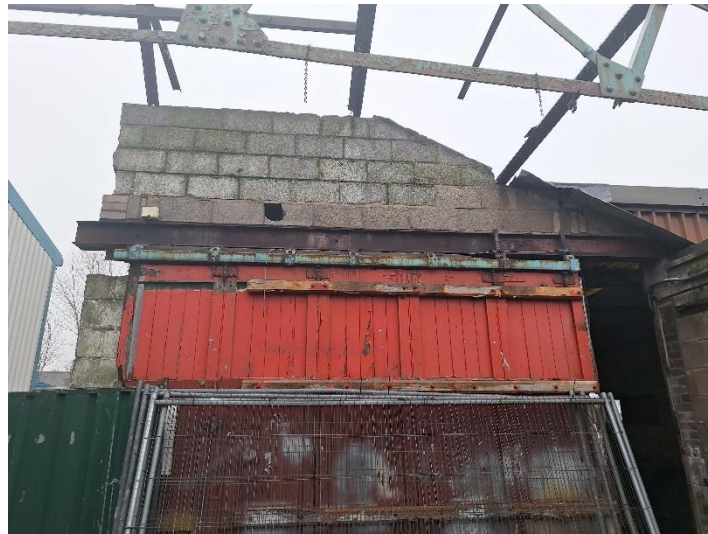
Building 1 (B1) was a single-storey former mechanics, comprising concrete block walls with a corrugated iron and corrugated plastic mono-pitch roof. It is understood that B1 will be demolished to facilitate the development. The concrete walls comprised a single breezeblock layer, and therefore no wall cavity was present. A concrete block parapet wall was present on the north-west aspect of the building. A single wall on the north-west aspect was covered in box profile corrugated iron sheeting. B1 was accessed via

a wooden sliding door with a metal beam mantle on the north-west aspect, which was open at the time of the survey. No artificial lighting was identified in close proximity to B1.

PLATE 1      SHOWING NORTH-WEST ASPECT OF B1

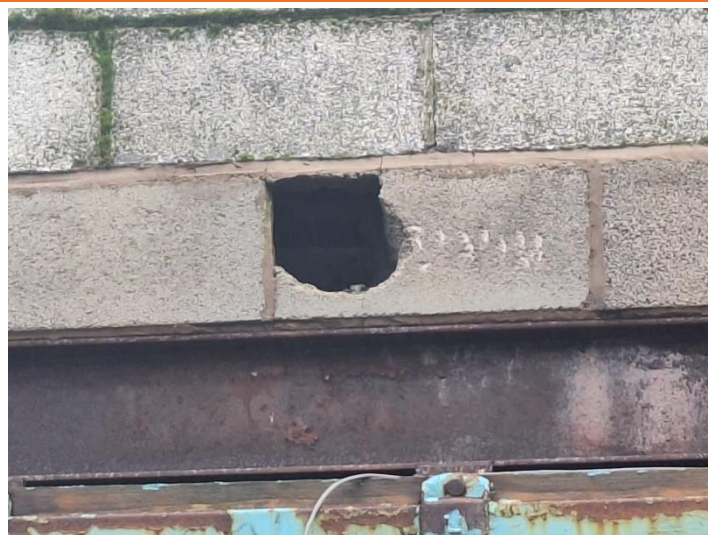
The brickwork on B1 was mostly in good condition; however, an area of concrete brickwork was damaged on the north-east aspect of the building. The area of damage was approximately 10 cm in diameter and 4 m high. The damaged brickwork provided access directly into the building. It was determined that the damaged brickwork would not be suitable to support roosting bat species as no cracks or crevices were present, as well as the exposed nature of the damage.

PLATE 2      SHOWING CLOSE UP OF DAMAGED BRICKWORK ON B1

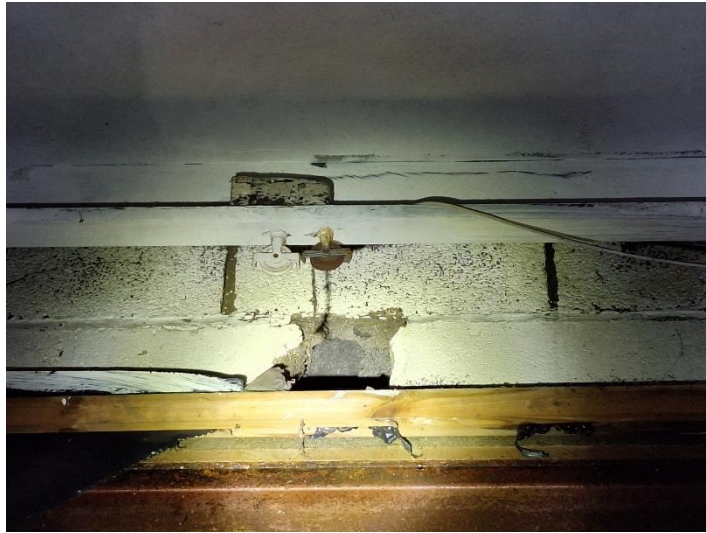
It was determined that the damaged brickwork lead into the building by shining a clulite at the brickwork from outside the building; the light was then observed from within the building through the damaged brickwork.

PLATE 3      SHOWING INTERNAL DAMAGED BRICKWORK OF B1

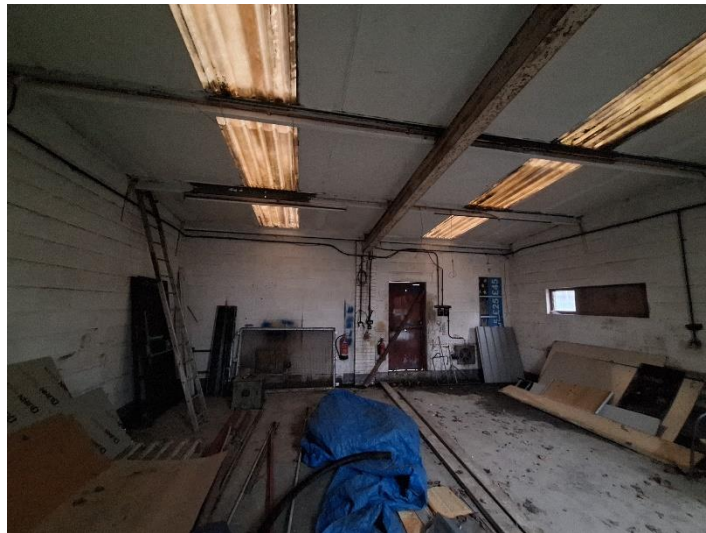
An internal inspection was undertaken on B1. The building was well-lit during the day due to the corrugated plastic sheeting skylights and two windows on the south-west aspect of the building. The building had clearly been undisturbed for a long time, as evidenced by the dust and multiple dried leaves noted on the floor. Therefore, if there was any evidence of roosting bats, such as insect wings or droppings, such evidence would be identifiable. The internal walls were also painted white, which would allow for the identification of any bat staining. No evidence of roosting bats was identified within B1. Due to the wooden sliding door being open, the building was subject to fluctuating temperatures, as any heat would be lost through the open door, therefore lowering its overall suitability for roosting bats.

PLATE 4      SHOWING B1 INTERNALS

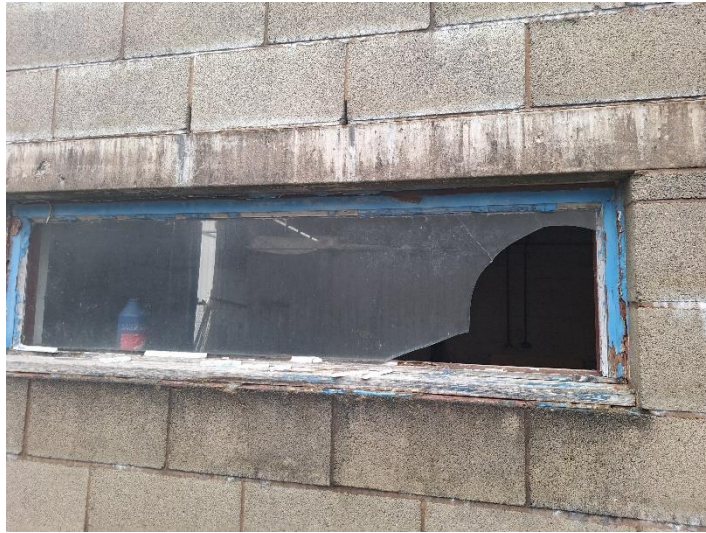
Two single-pane windows with wooden frames were present on the south-west aspect of the building. The windows were in poor condition, with one of the windows having been broken. Two weep holes within the brickwork were present above the broken window; however, these were approximately 0.5 cm across, and therefore determined to be too narrow to support roosting bats.

PLATE 5      SHOWING BROKEN WINDOW ON SOUTH WEST ASPECT OF B1

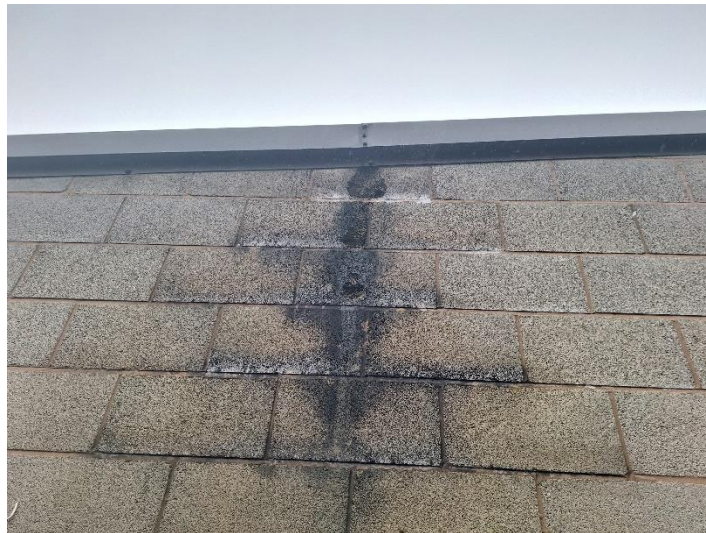
The external brickwork was mostly in good condition and well-sealed; however, water damaged brickwork was noted on the north-east aspect of the building. Despite the water damaged brickwork on the north-east aspect, no obvious cracks or crevices were present that could be utilised by roosting bat species. Barge boards were present at the top of the wall plate along all aspects of the building, excluding the north-west aspect. The barge boards were flush against the wall, and therefore no crevices were present which could be utilised by crevice-dwelling bats, such as pipistrelle species (*Pipistrellus* sp.).

PLATE 6      SHOWING DAMAGED BRICKWORK ON NORTH-EAST ASPECT

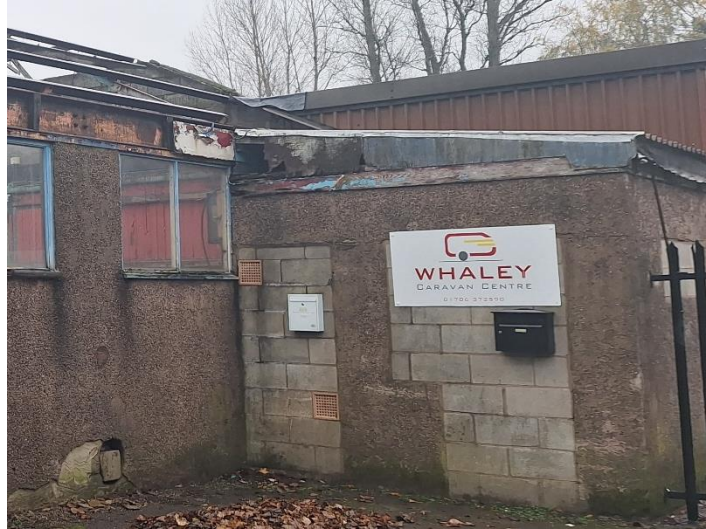
A single-storey concrete block extension with a corrugated iron mono-pitch roof was present adjacent to the north-west aspect of the building. The north-west and south-west aspects of the extension were part-rendered with pebble-dash. The extension was inactive at the time of survey. The extension is accessed internally by a metal door on the north-east aspect of the building. The metal door was sealed shut and was difficult to open to gain internal access, likely due to the metal rusting as a result of the extension being undisturbed for several years.

PLATE 7      SHOWING B1 EXTENSION

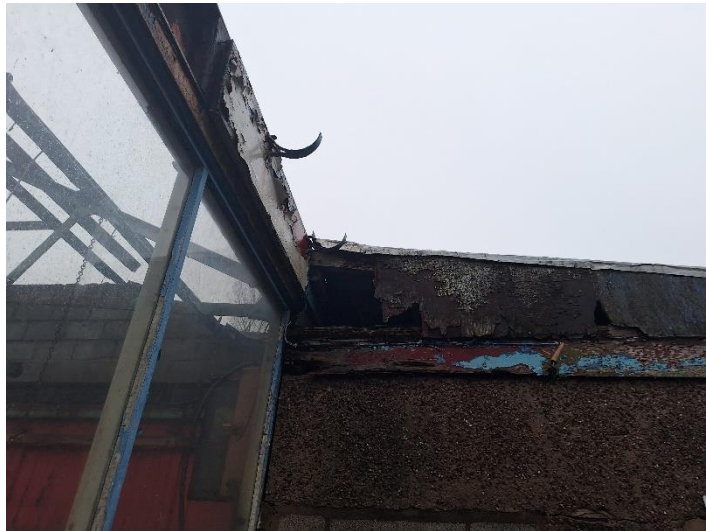
A damaged wooden soffit, which was covered in felt, was present on the western aspect of the extension on B1. The damaged soffit potentially may allow access into the extension for bat species. No scratch marks were observed around the damaged soffit. This was not determined to be a potential roost feature, as the soffit is too exposed and subject to temperature fluctuations.

PLATE 8      SHOWING DAMAGED SOFFIT ON WESTERN ASPECT OF B1

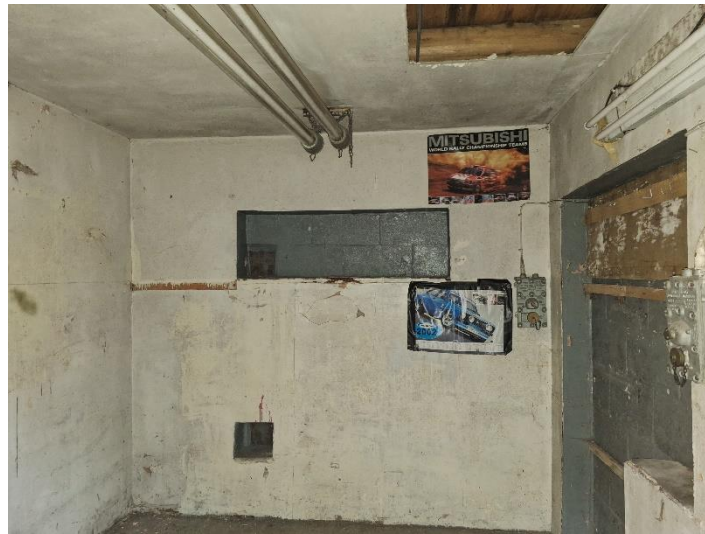
An internal inspection of the extension on B1 was conducted. The extension had clearly not been accessed for multiple years, as undisturbed dust was on the floor. If any bat droppings were present, they would be identifiable due to the extension having not been disturbed; however, no bat droppings were identified. The walls were painted white, which would allow for the identification of any bat staining if present; however, no bat staining was identified within the extension. It was determined during the internal inspection that there were no suitable bat roost features that could be utilised by roosting bat species; there were no features within the extension that bats would be able to utilise. It should also be noted that it was cold within the extension, likely due to the missing plasterboard and damaged soffit.

The extension is likely to experience temperature fluctuations during the day, therefore reducing its overall suitability for roosting bats.

PLATE 9      SHOWING B1 EXTENSION INTERNALS

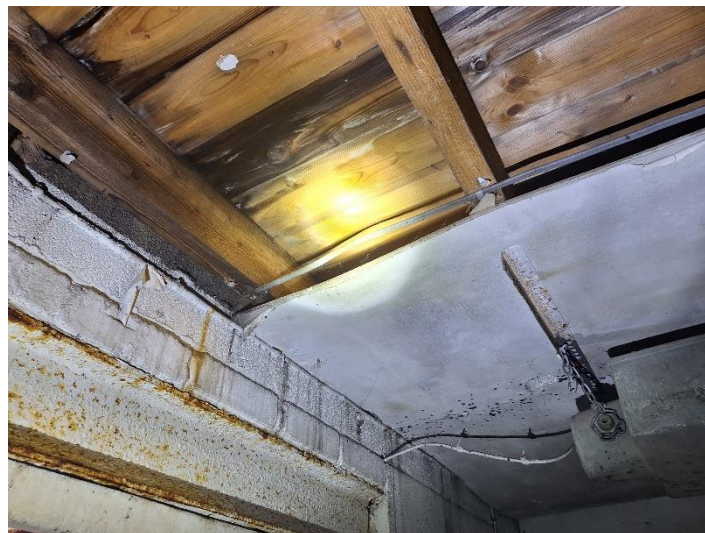
A white plasterboard ceiling was present within the extension. No evidence of bat staining or scratch marks were identified. One panel of plasterboard was missing from the ceiling. Through the damaged soffit on the western aspect and the missing panel, the extension could be accessed by bats. However, as there were no suitable bat roost features within, it was determined that the extension had Negligible potential to support roosting bats.

PLATE 10      SHOWING MISSING PLASTERBOARD CEILING WITHIN B1 EXTENSION

Overall, B1 was assessed as having Negligible bat roosting potential due to a lack of suitable bat roost features and temperature fluctuations exhibited within the main building and the extension.

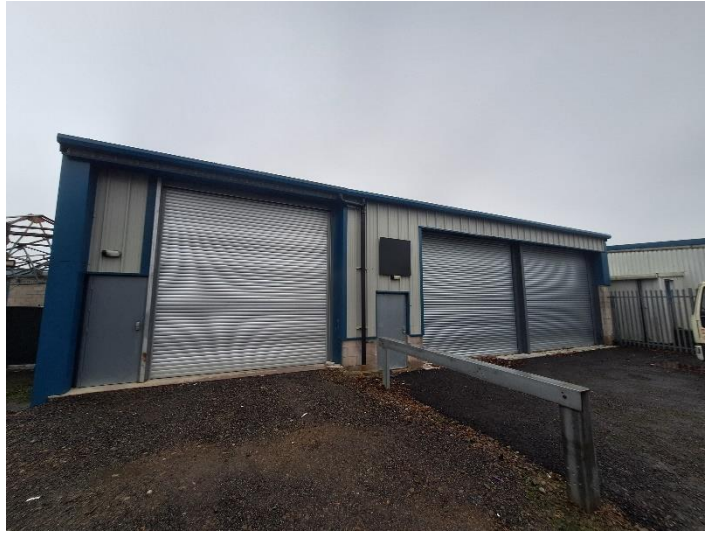
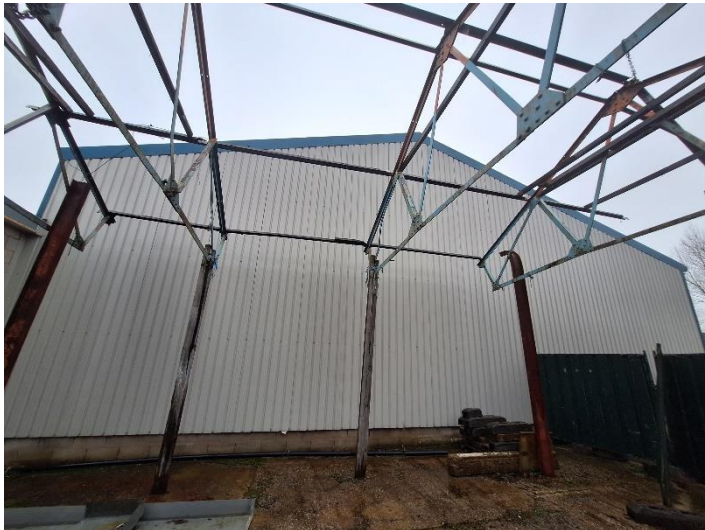
Building 2 (B2) was an active commercial building. It is understood that no works will be undertaken on the building to facilitate development. The building could not be accessed internally due to being privately tenanted. The building comprised concrete block walls covered with box profile corrugated iron, a gable-to-gable corrugated iron pitched roof, and metal roller doors. No windows were present. Utilising satellite images from previous years, it was determined that B2 had been built within the past 5 years. As such, the building was in good condition, with no obvious cracks or crevices that could be utilised by opportunistic bat species.

PLATE 11      SHOWING WESTERN ASPECT OF B2

PLATE 12      SHOWING SOUTHERN ASPECT OF B2

B2 was therefore assessed as having no ('None') bat roosting potential due to a lack of suitable features to support roosting bats.

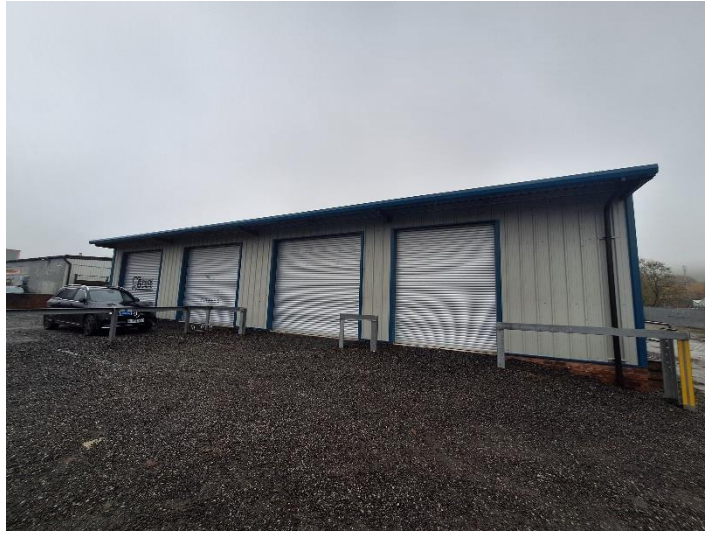
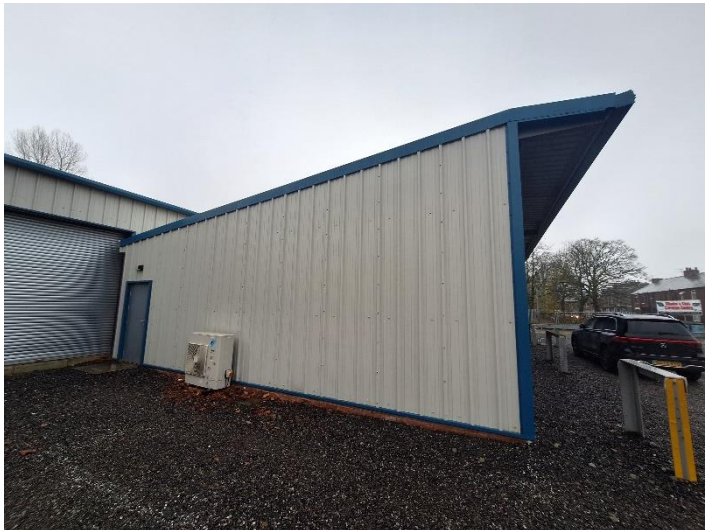
Building 3 (B3) was an active commercial building. It is understood that no works will be undertaken on the building to facilitate development. The building could not be accessed internally due to being privately tenanted. The building comprised concrete block walls covered with box profile corrugated iron, a gable-to-gable corrugated iron pitched roof, and metal roller doors. Utilising satellite images from previous years, it was determined that B3 had been built within the past 5 years. As such, the building was in good condition, with no obvious cracks or crevices that could be utilised by opportunistic bat species.

PLATE 13      SHOWING NORTH-WEST ASPECT OF B3

PLATE 14      SHOWING NORTH-EAST ASPECT OF B3

B3 was therefore assessed as having no ('None') bat roosting potential due to a lack of suitable features to support roosting bats.

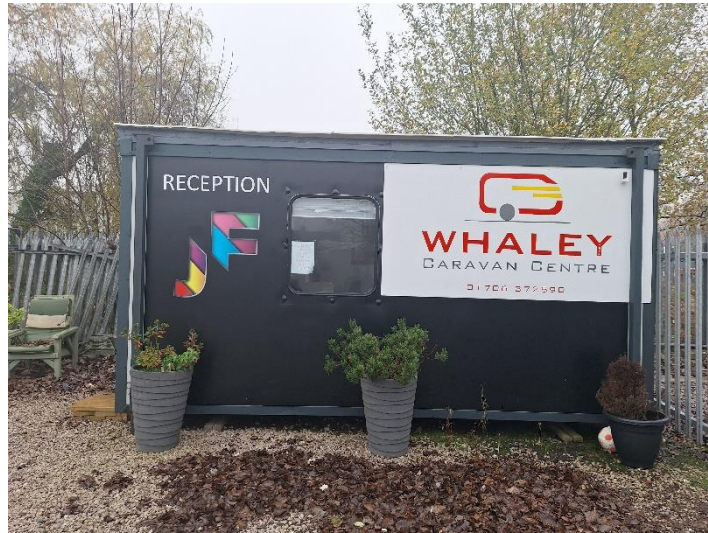
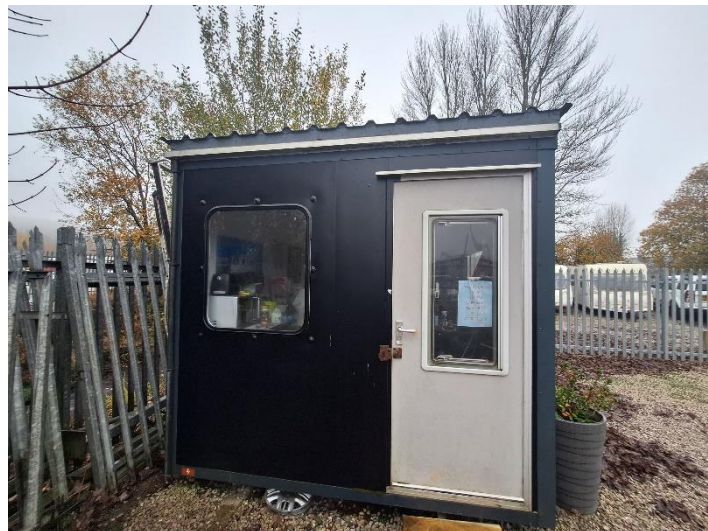
Building 4 (B4) was an active portacabin commercial unit located in the south-east of the site. No works will be undertaken on the building to facilitate development. The building could not be accessed internally due to being privately tenanted. The building comprised a metal frame, black metal sheeting and a corrugated iron flat roof. Utilising satellite images from previous years, it was determined that B4 had been placed on-site within the past 2 years. As such, the building was in good condition, with no obvious cracks or crevices that could be utilised by opportunistic bat species.

PLATE 15      SHOWING NORTH-WEST ASPECT OF B4

PLATE 16      SHOWING NORTH-EAST ASPECT OF B4

B4 was therefore assessed as having no ('None') bat roosting potential due to a lack of suitable features to support roosting bats.

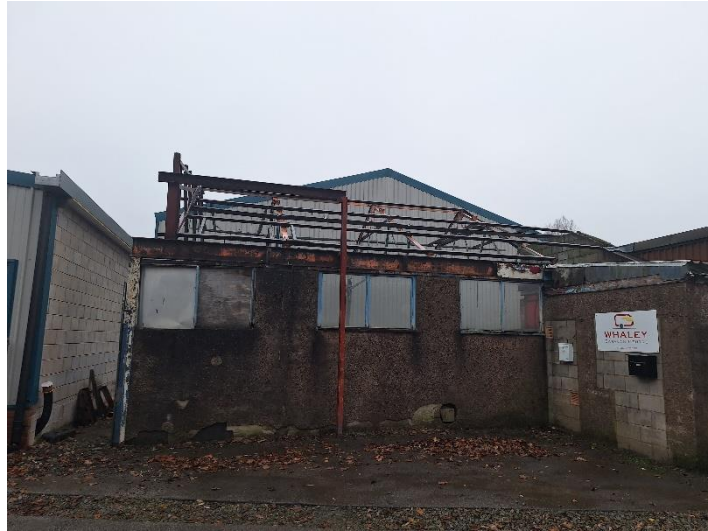
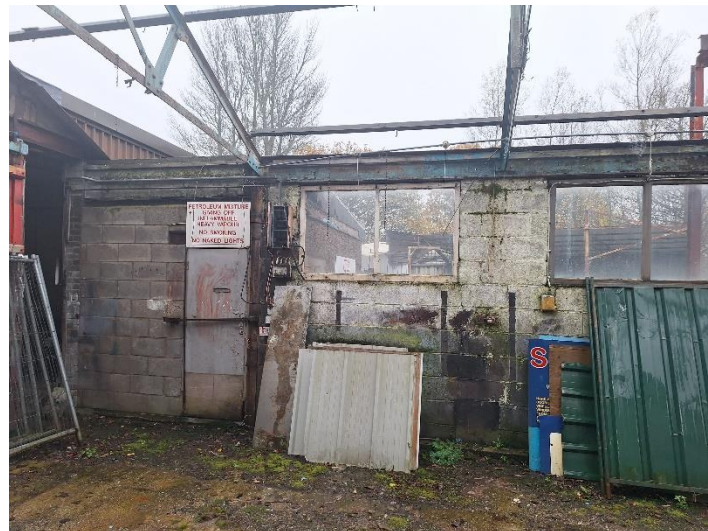
Structure 1 (S1) was located in the centre of the site, adjacent to B1, B2 and B3. It is understood that the demolition of S1 will be required to facilitate development. The structure comprised a steel metal frame and a single concrete block wall, with the south-west aspect of the wall rendered in pebble dash. The north-west aspect of the wall was not rendered. Three single-pane windows with wooden frames were present within the wall. The window frames and brickwork were in good condition and well-sealed, with no obvious cracks or crevices that could be utilised by crevice dwelling bat species.

PLATE 17      SHOWING SOUTH-WEST ASPECT OF S1

PLATE 18      SHOWING NORTH-EAST ASPECT OF S1

S1 was therefore assessed as having Negligible bat roosting potential due to a lack of suitable features to support roosting bats.

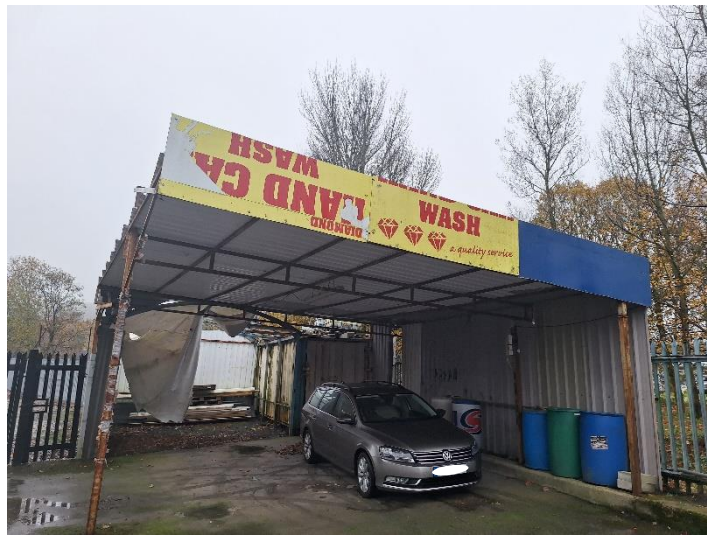
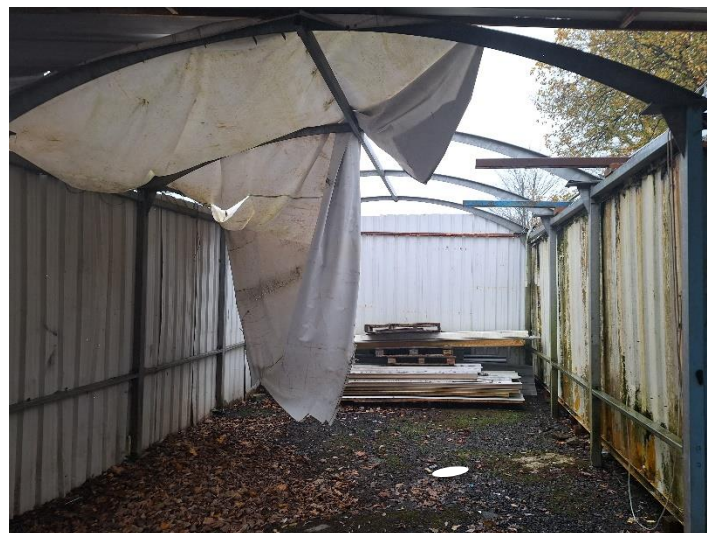
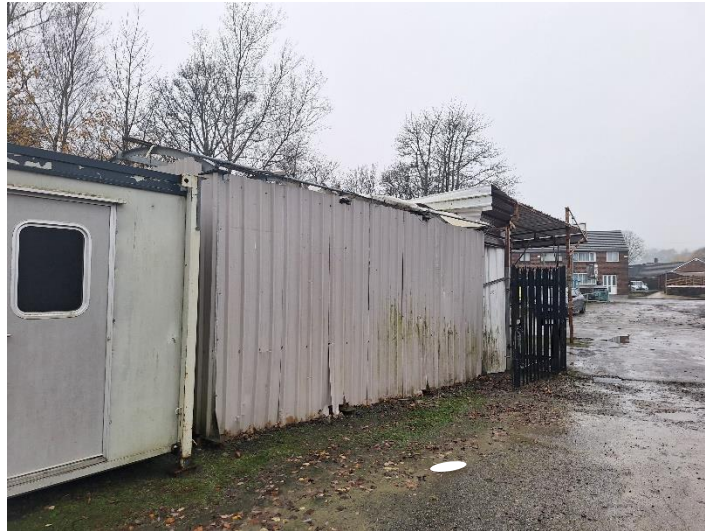
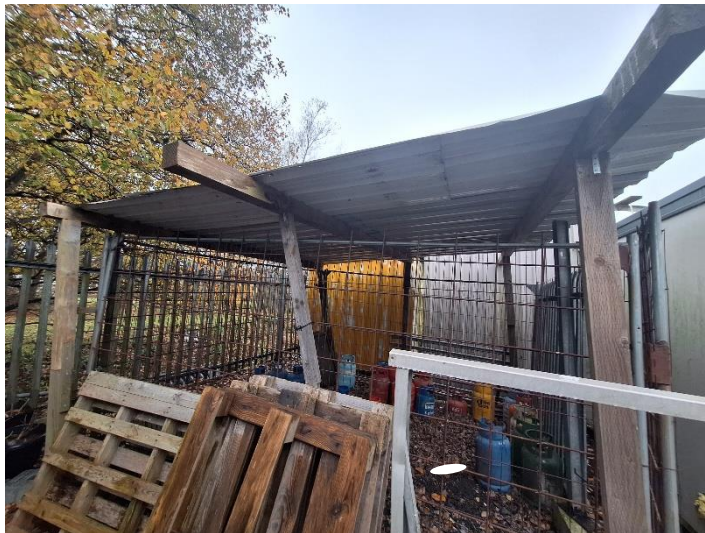
Structure 2 (S2) was a disused covered car wash. The structure comprised various sections. The north-west of the structure comprised a steel frame covering with a corrugated iron roof. Adjacent to the steel frame was a separate covering section that appeared to previously have been covered with tarpaulin. The frame was bordered by box profile corrugated iron sheet walls. A small static office room was adjacent to the steel frames and accessed via a door on the north-east aspect. The room could not be accessed due to being privately tenanted. The office room comprised metal walls and a metal flat roof. Adjacent to the office room, along the south-east site boundary was a wood frame covering with a corrugated iron pitched roof. It was determined that the structure provided no suitable bat roost features due to the materials that the structure comprised, there being no suitable cracks and crevices present, the exposed nature of the frames and corrugated rooves, and fluctuations in temperatures.

PLATE 19      SHOWING NORTH WEST ASPECT OF S2

PLATE 20      SHOWING TARPAULIN COVERING OF S2

PLATE 21      SHOWING NORTH-EAST ASPECT OF S2

PLATE 22      SHOWING SOUTH-EAST ASPECT OF S2

S2 was therefore assessed as having no ("None") bat roosting potential due to a lack of suitable bat roost features.

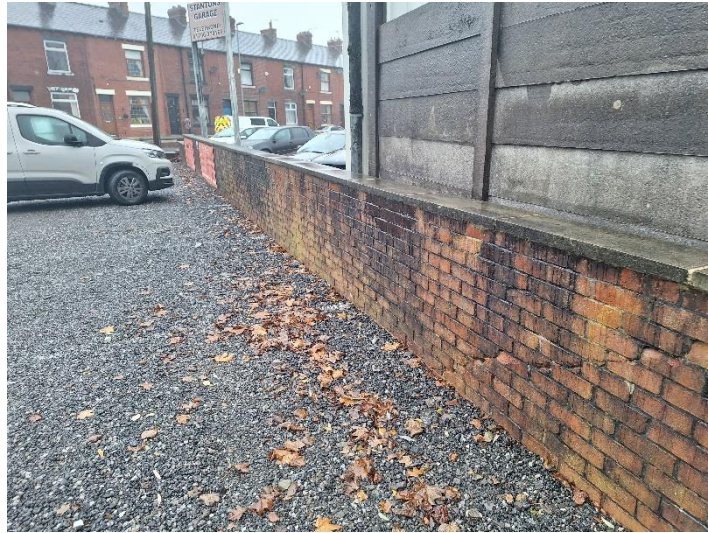
A redbrick wall was present along the north-west site boundary. The wall was approximately 1 m high and 30 m in length. The brickwork and mortar were mostly in good condition, with no obvious cracks or crevices that were deep enough to be utilised by roosting bat species.

PLATE 23      SHOWING NORTHERN ASPECT OF B3

The wall was therefore assessed as having no ('None') bat roosting potential due to a lack of suitable bat roost features.

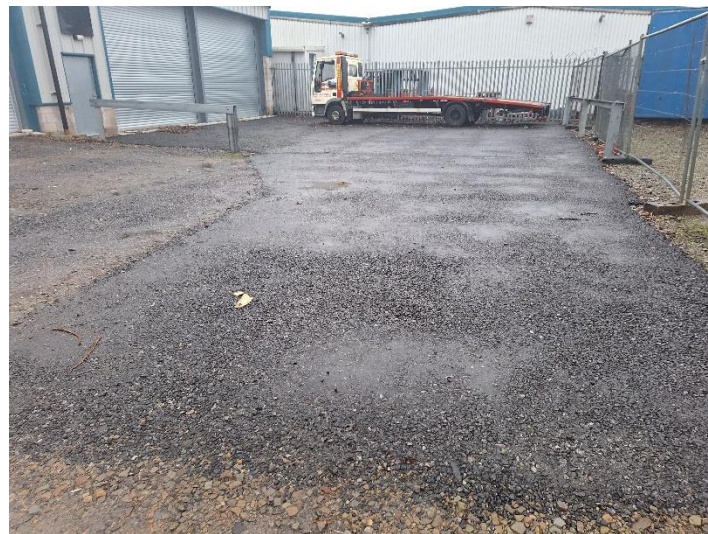
Tarmac hardstanding was present adjacent to B2 in the north-east of the site. The concrete had been colonised in parts by species comprising cock's-foot (*Dactylus glomerata*), a *Crepis* species, and petty spurge (*Euphorbia peplus*).

PLATE 24      SHOWING HARDSTANDING

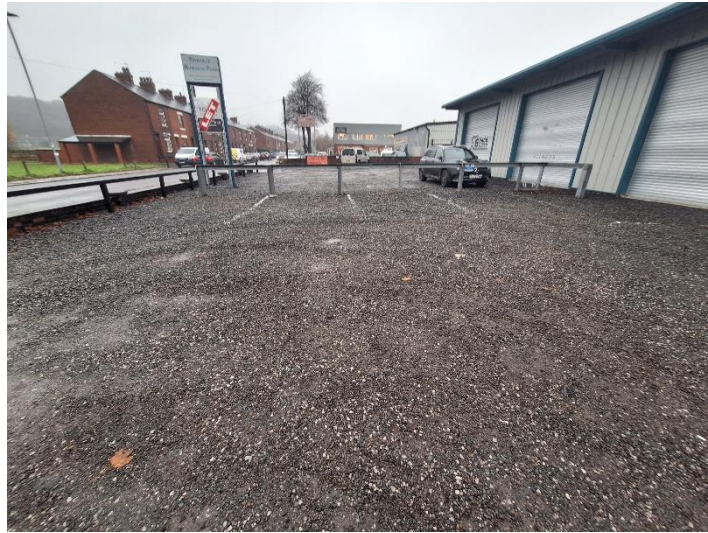
A large area of gravel bare ground was present in the north-west, south, and south-east sections of the site.

PLATE 25      SHOWING BARE GROUND
