TEF 92545  
HIGH BOOTH HOLLINS FARM  
LITTLEBOROUGH

SHALLOW MINING  
SITE INVESTIGATION WORKS

**Job Number:** LKC 22 1443  
**Date:** July 2023  
**Client:** Clarke Telecom

| <b>LK Consult</b><br><b>Document Verification</b> | | | |
|---|---|---|---|
| <b>Report Title</b> | Shallow Mining Investigation Works | | |

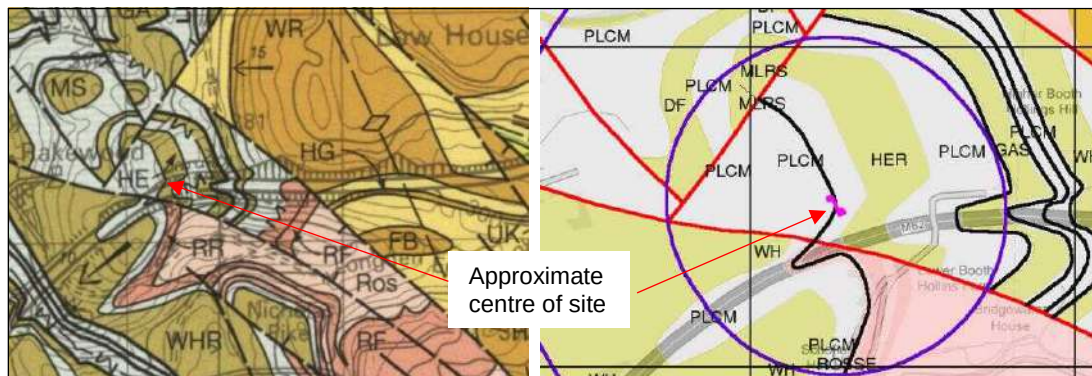
Plate 2-1: Extracts from geological mapping. Left: 2008 1:50,000 sheet mapping, right: 2010 1:10,000 digital mapping. Not to scale.

A coal seam is shown to on BGS mapping to cross the site trending north-south. The cutting of the M62 motorway immediately to the south of the site also indicates that the coal seams are dipping down to the west to southwest.

A coal seam is not present on the BGS 2008 mapping however it is present on digital mapping. Plate 2-2 shows an extract of the generalized vertical section from Sheet 76 showing the section of strata expected on and below the site. Based off the vertical section, it would appear likely that it is the Upper Mountain (Hogards) Coal seam present on or close to the site at shallow depth.

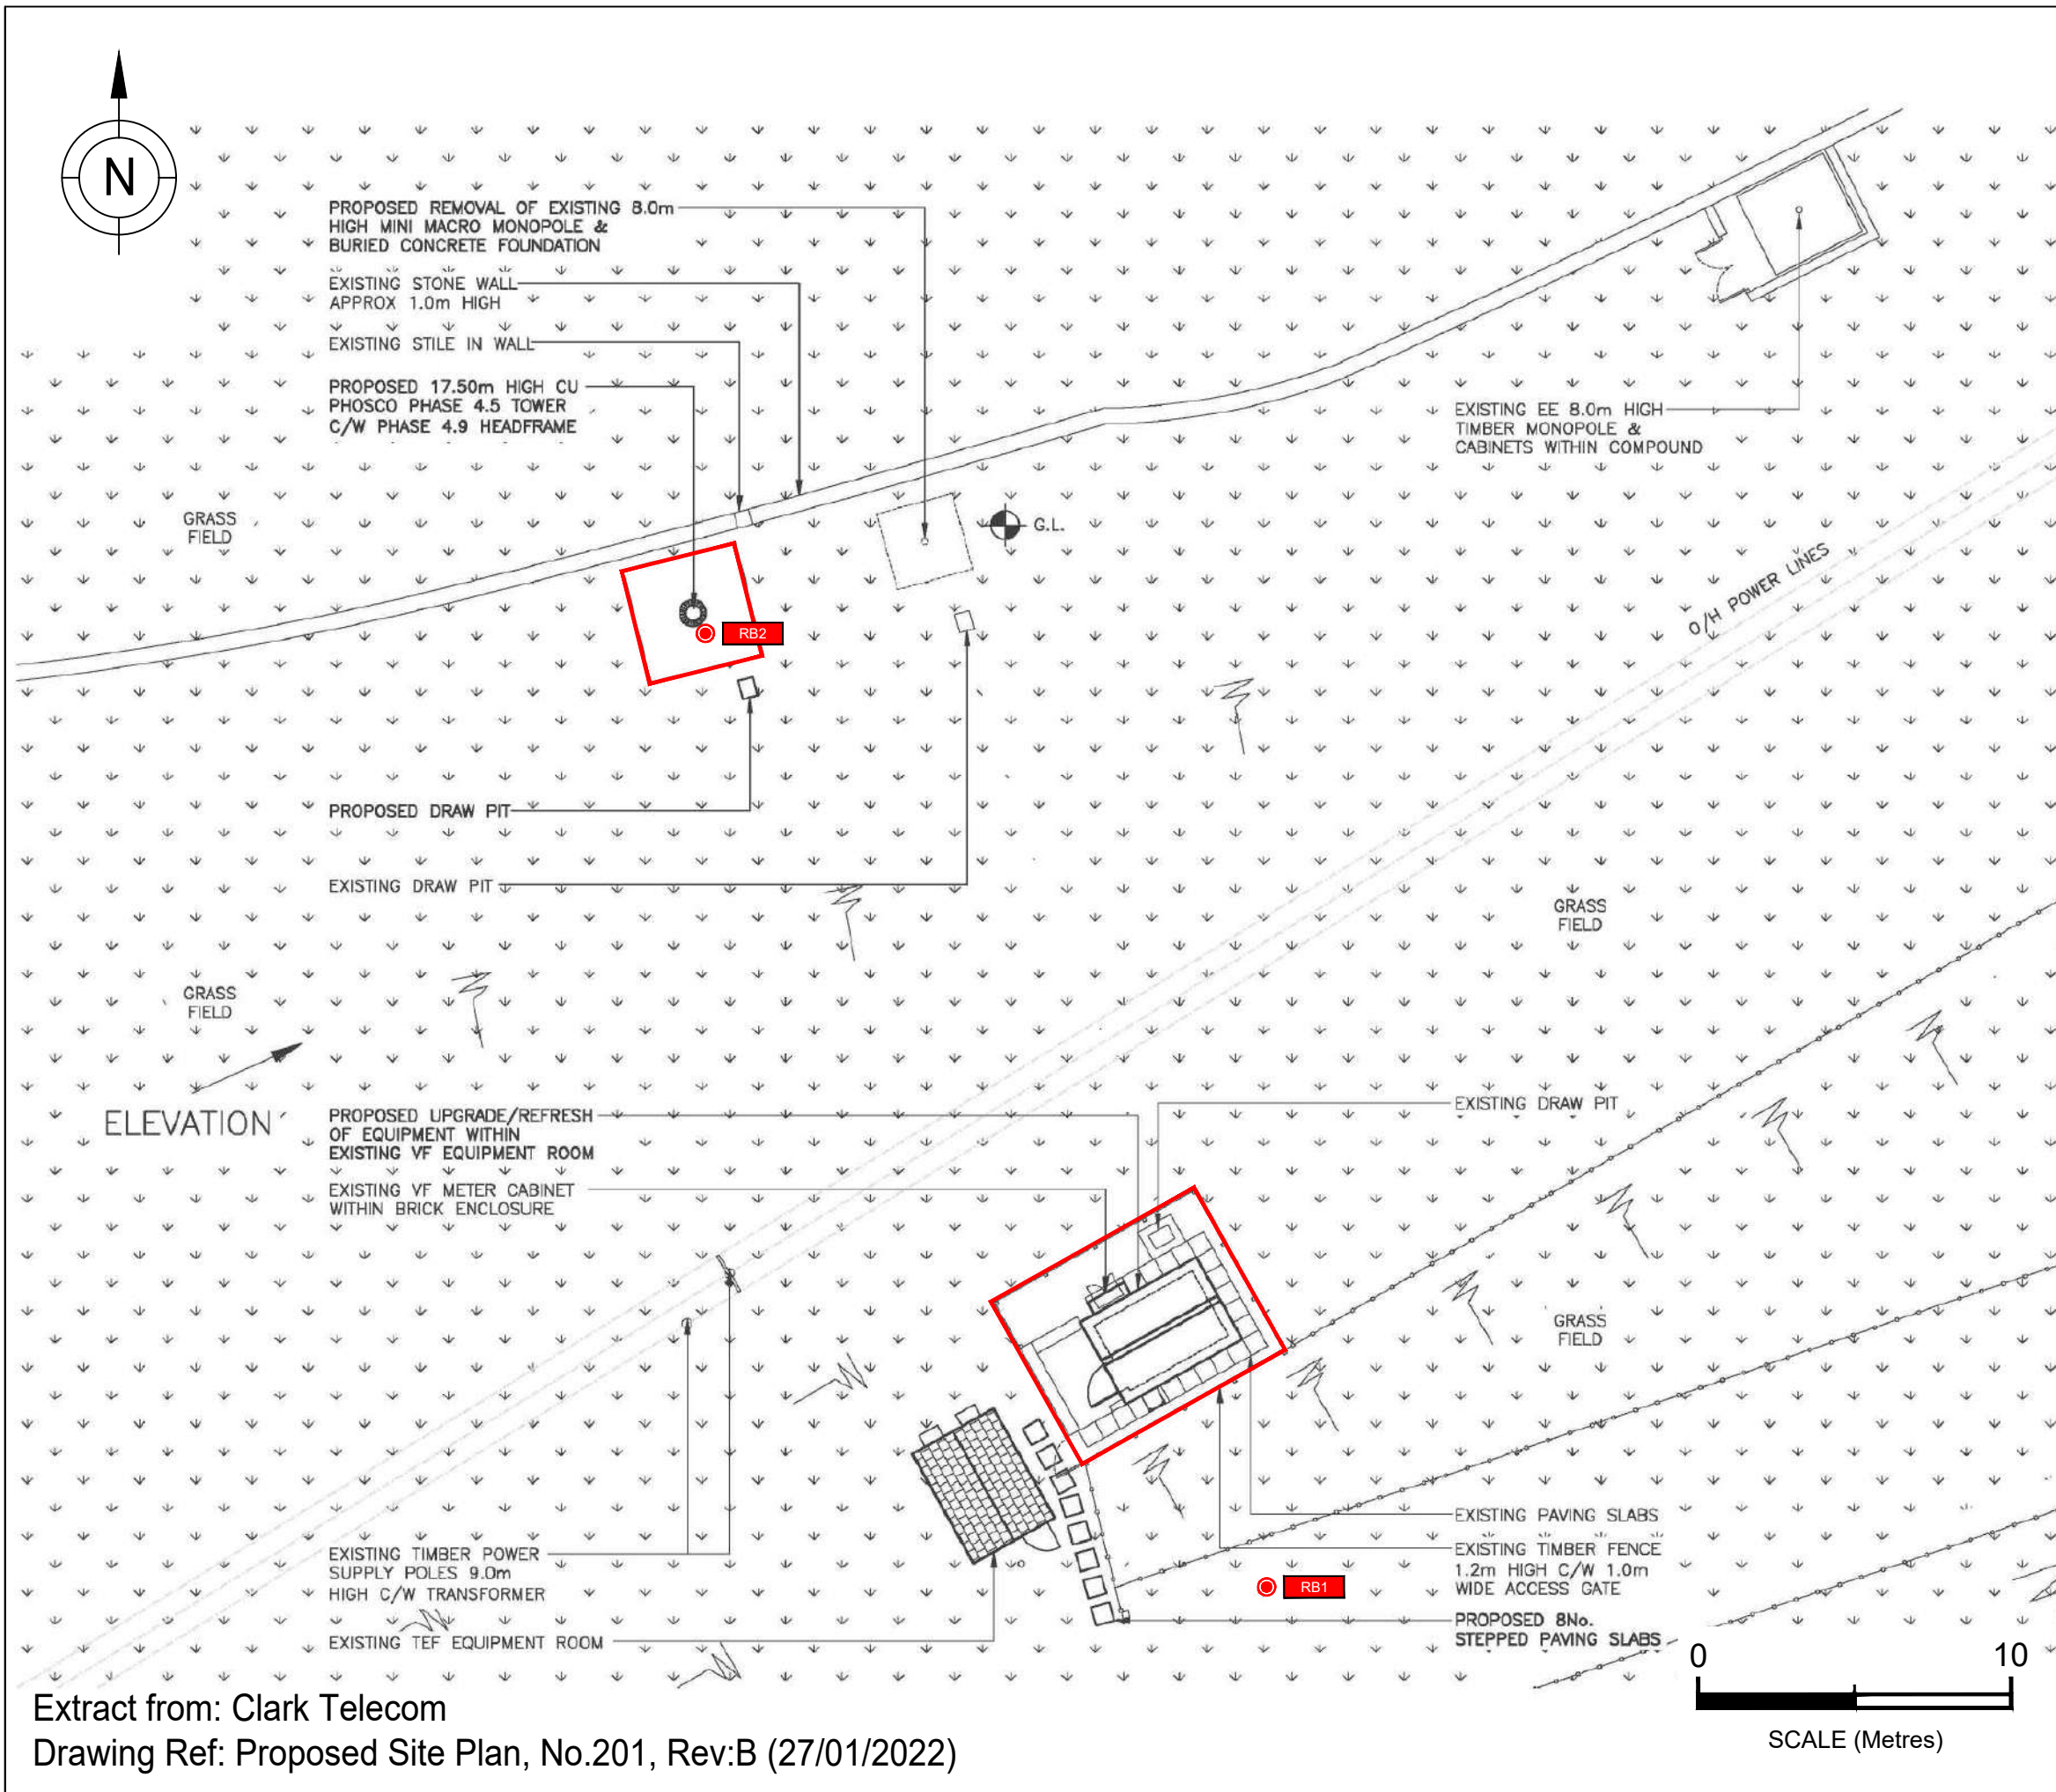
| Borehole Location Plan | | | |

Made ground was encountered in RB1 only and comprised light brown sandy GRAVEL with limestone to 0.50mbgl.

- Intact **coal** was recorded in RB1 between 12.00 and 13.20mbgl.
- Intact **coal** was recorded in RB2 between 16.00 and 16.60mbgl and between 24.50 and 25.30mbgl.

It should be noted that evidence for the presence of coal workings can include (but is not limited to) partial or total loss of flush, broken drilling, voids, fast drilling or the sudden dropping of the drill string. No loss of flush, fast / soft drilling or broken drilling was recorded either borehole.

Intact **coal** was recorded in RB1 between 12.00 and 13.20mbgl and in RB2 between 16.00 and 16.60mbgl and between 24.50 and 25.30mbgl. The seam identified at 24.50-25.30mbgl is likely to represent the Lower Mountain seam as indicated in the desk based CMRA. The shallower seams encountered at depths of 12.00mbgl (RB1) and 16.00mbgl (RB2) is assumed to represent the Upper Mountain seam based on the desk based CMRA.

Although the desk based CMRA concludes that recorded shallow workings are present beneath the site (at 23m beneath site), no evidence of workings were recorded in the 2no. boreholes drilled.

Stabilisation work is recommended beneath the proposed mast tower. Stabilisation works should be designed by an appropriately experienced and qualified contractor using the information provided.

Given that no significant groundworks are proposed beneath RB1 where the upgrade to an existing equipment room will be undertaken, stabilisation work is not considered necessary in this area as, based upon Coal Authority exemptions list justifications, LKC assume that no significant groundworks are proposed.
