**Planning reference; 20/00253/FUL – Erection of 5 detached dwellings, 4 detached double garages, and associated access road and infrastructure following demolition of existing dwelling.**

### Site Investigation Report

| Report Details | |
|---|---|
| Project Name: | 43 Bamford Way |

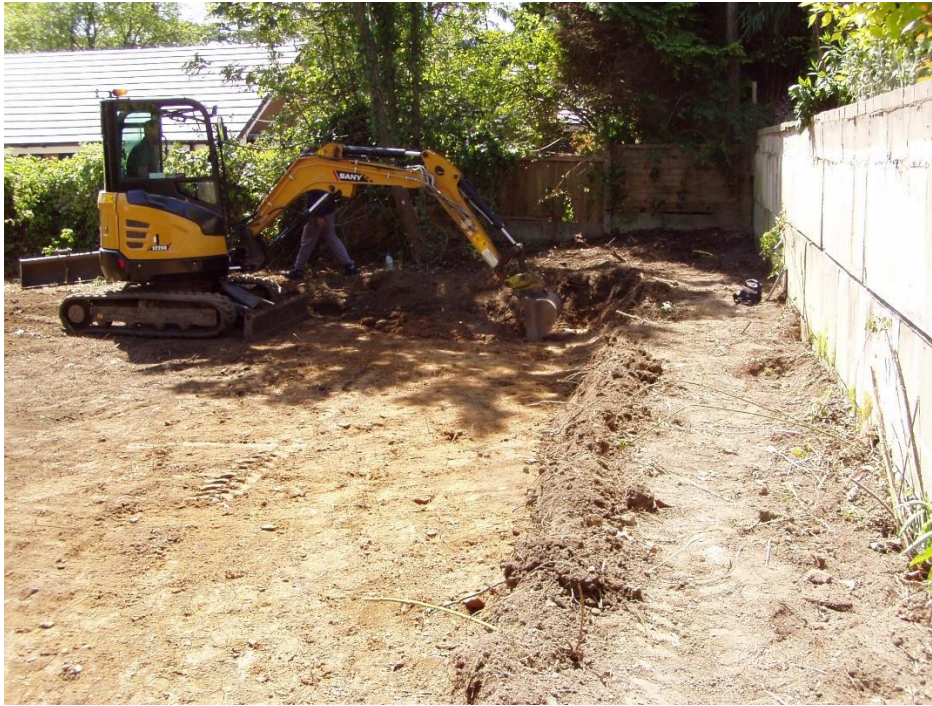
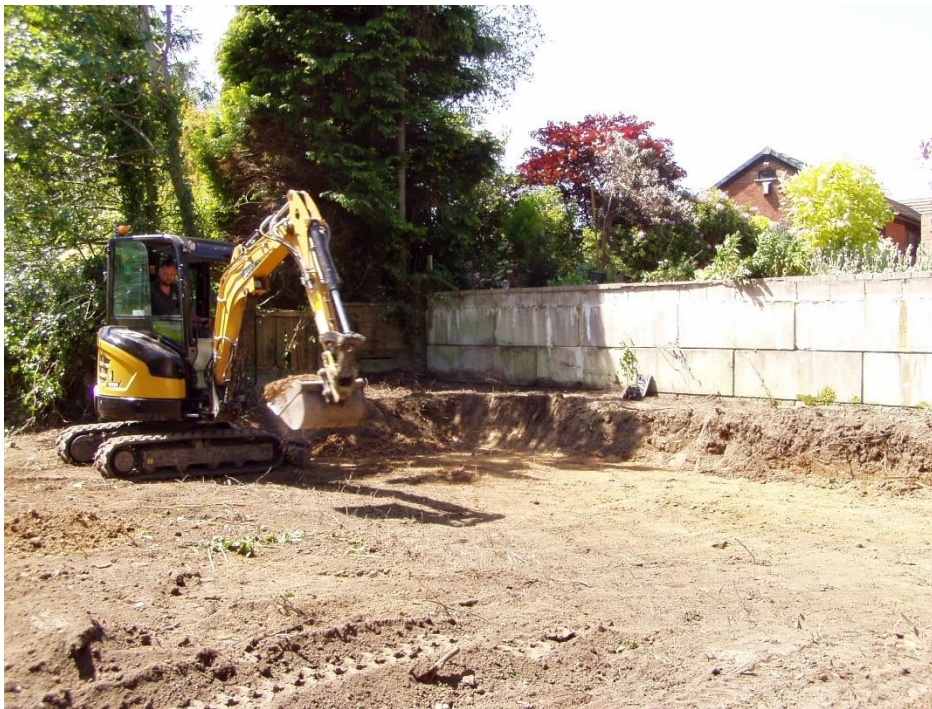
**Site plan showing location of garage to plot 2 which was commenced on 05/06/2023.**

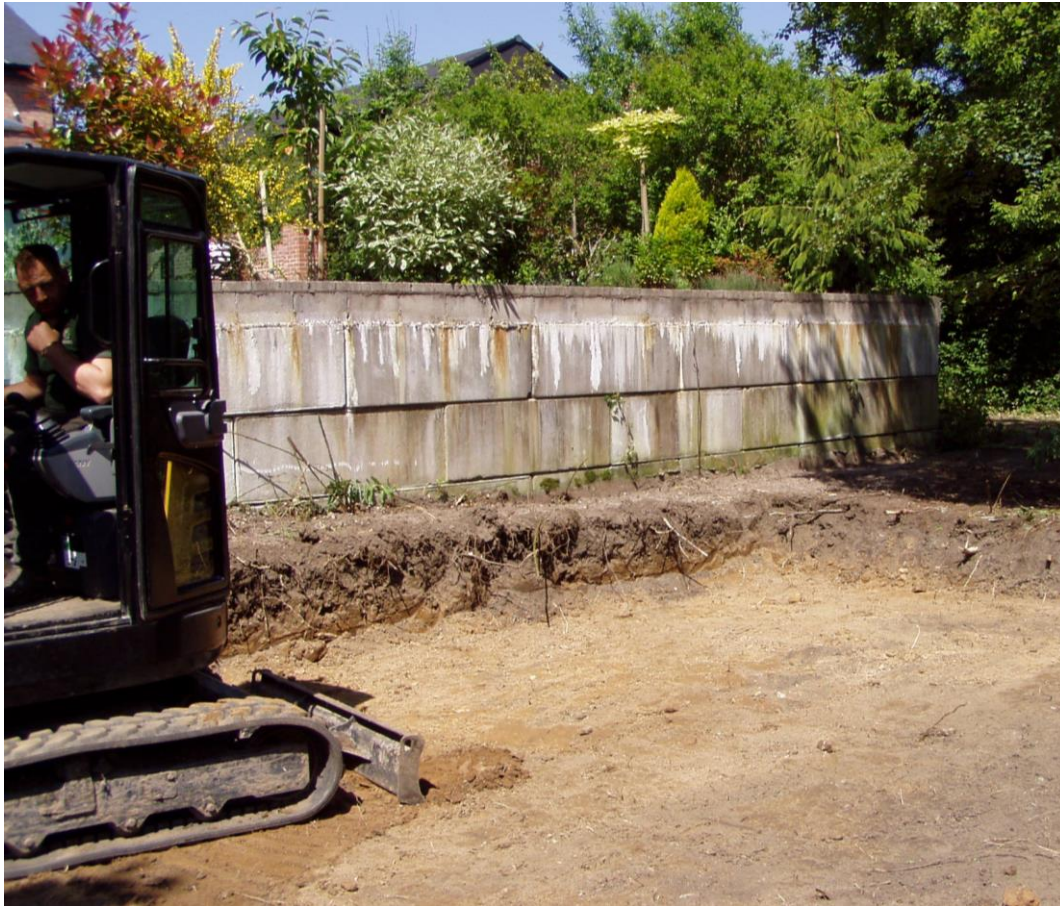
**Two views of site clearance area with ground taken down to formation level for detached garage to plot 2.**

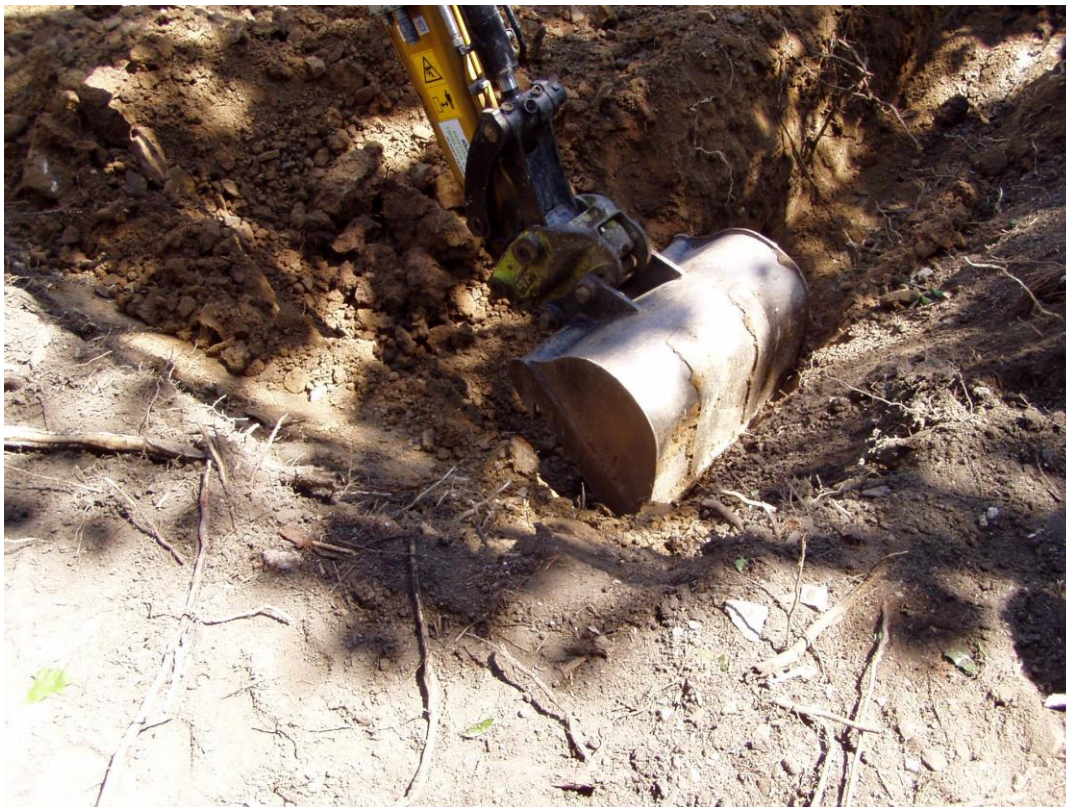
**Close up view of levelled area in location of detached garage to plot 2.**

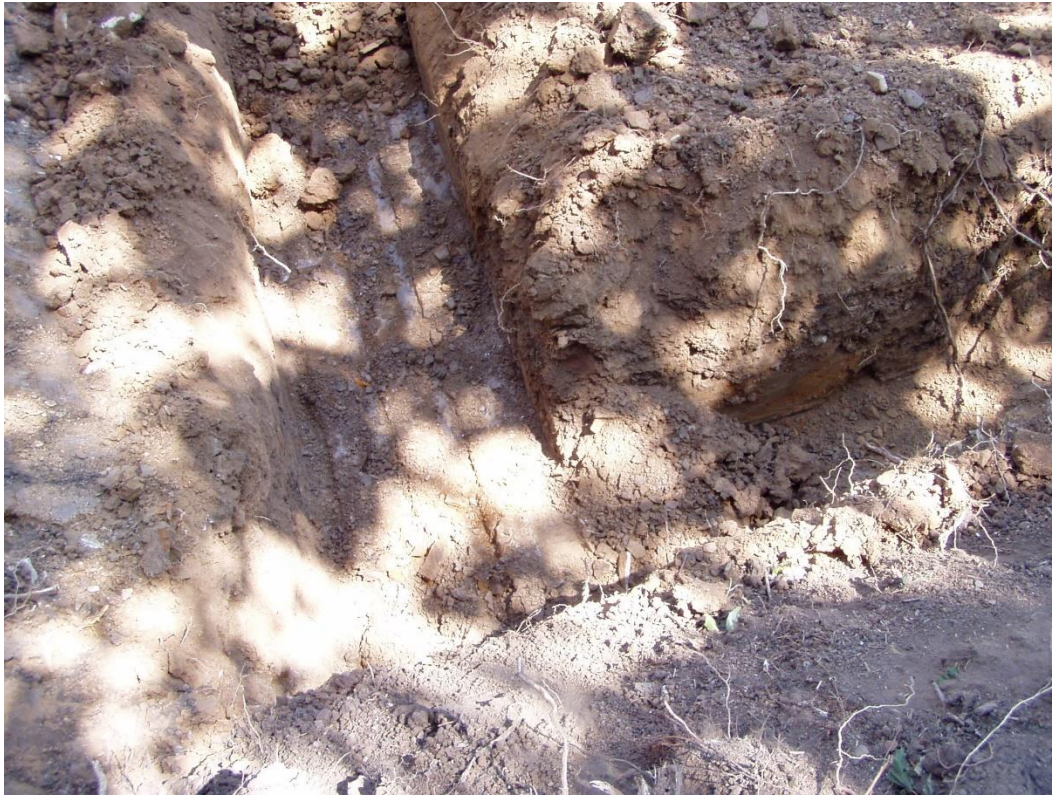
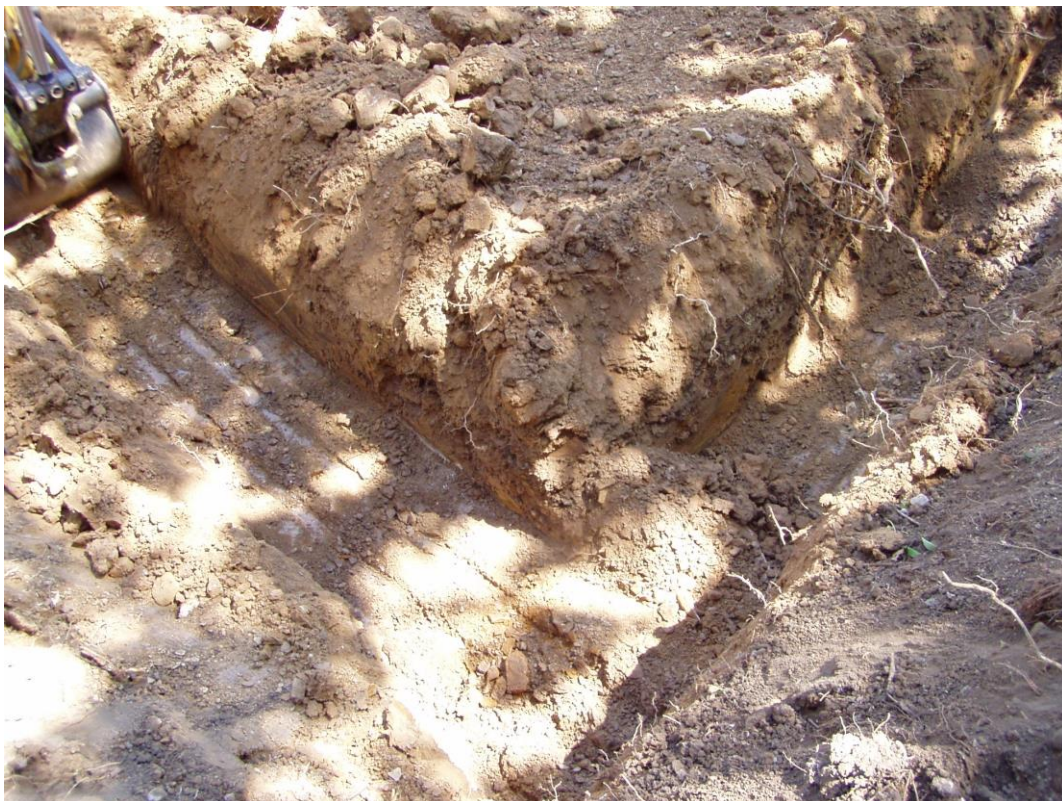
**Two views of foundation trench excavation showing very stiff clay over weathered bedrock (very stiff to hard shale) as noted in site investigation report.**

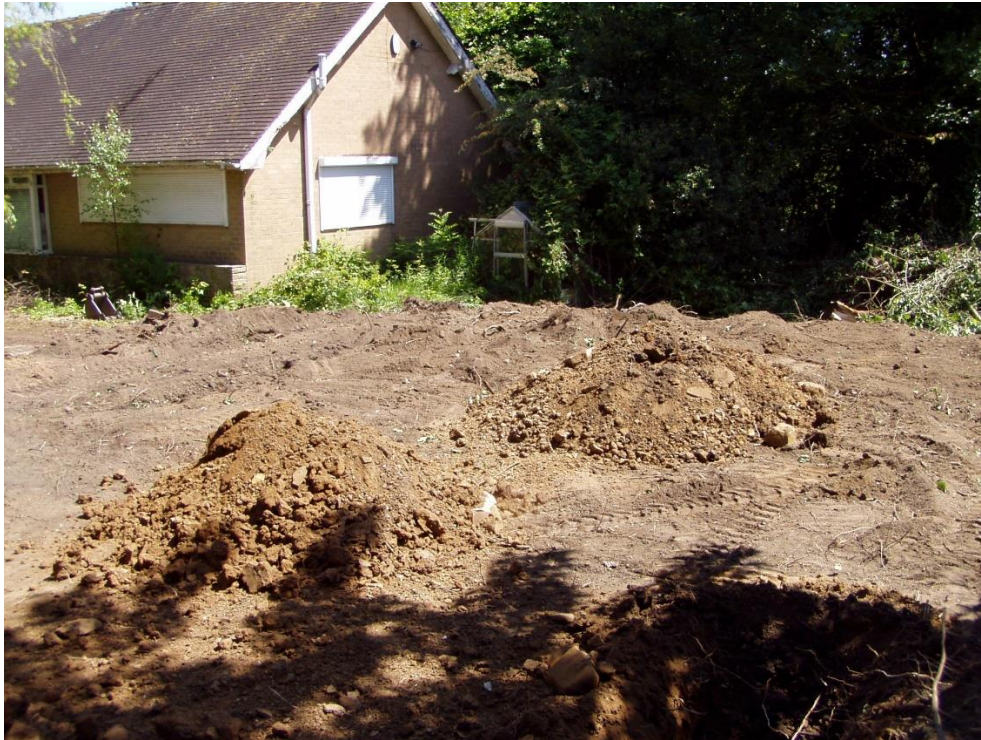
**View towards existing bungalow – used as temporary site facilities – showing piles of excavated material.**

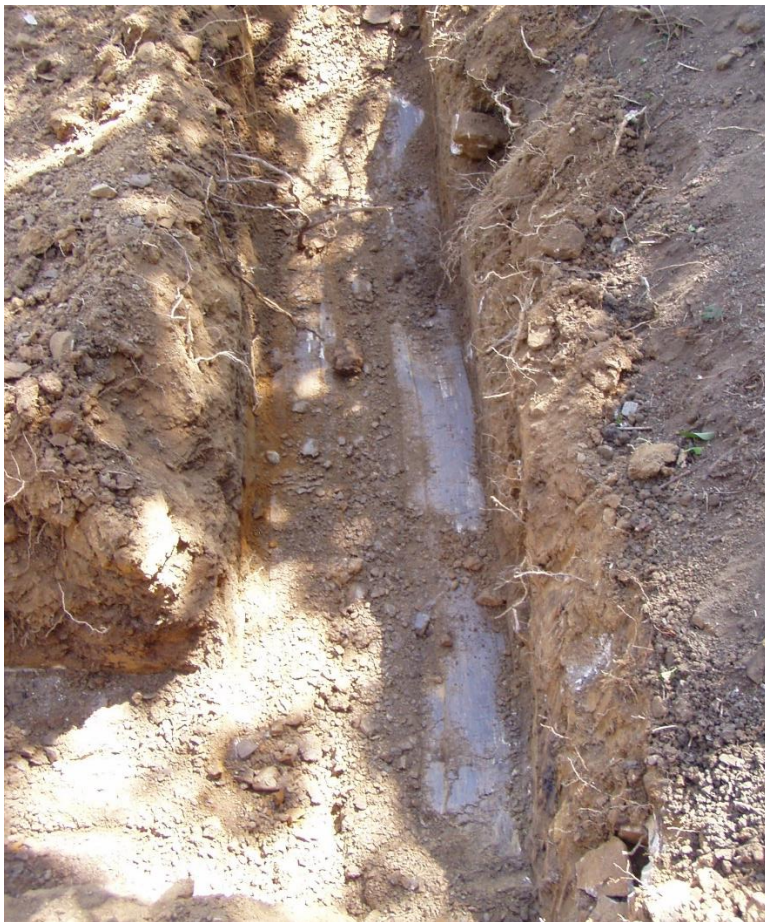
**Bottom of foundation trench.**

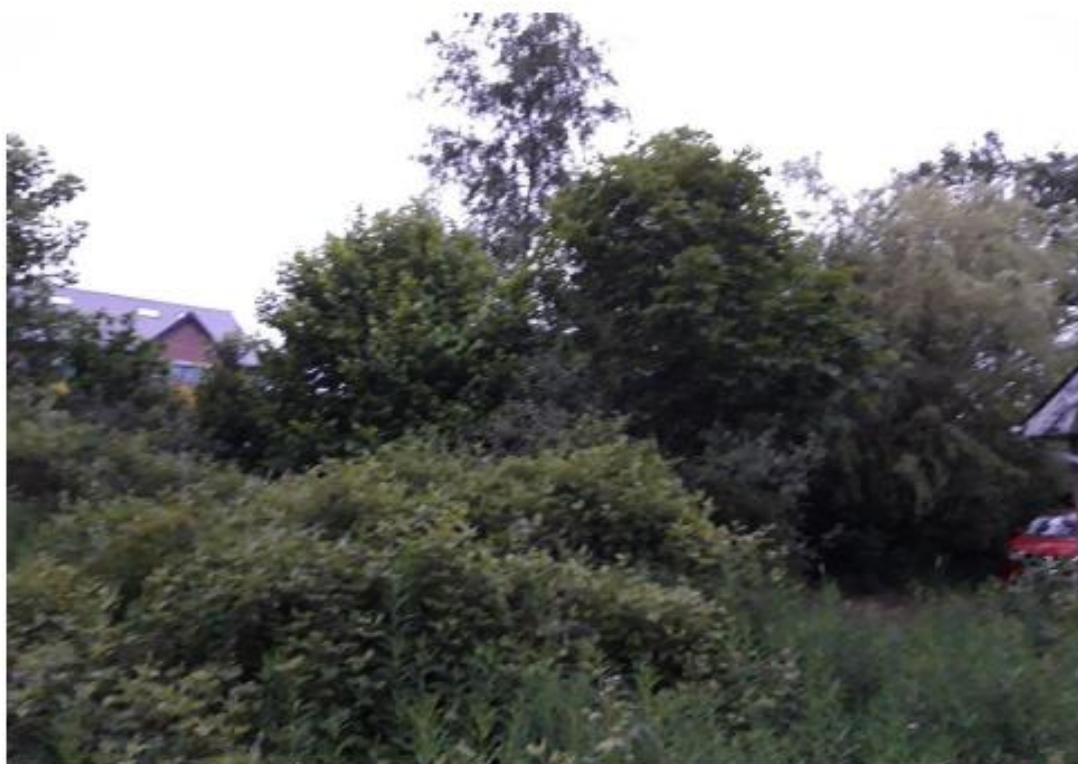
| Results | |
|---|---|
| 5 | Observations ceased at 08:00, with no evidence for bird nesting having been found. |

Photo 1: Area 1 inspected for nesting birds.

| Recommendations |
|---|
| Vegetation must be cleared from the areas assessed within 24 hours of the end of this survey i.e., 08:00 on 06/06/23. If this does not happen, a resurvey will be required. |

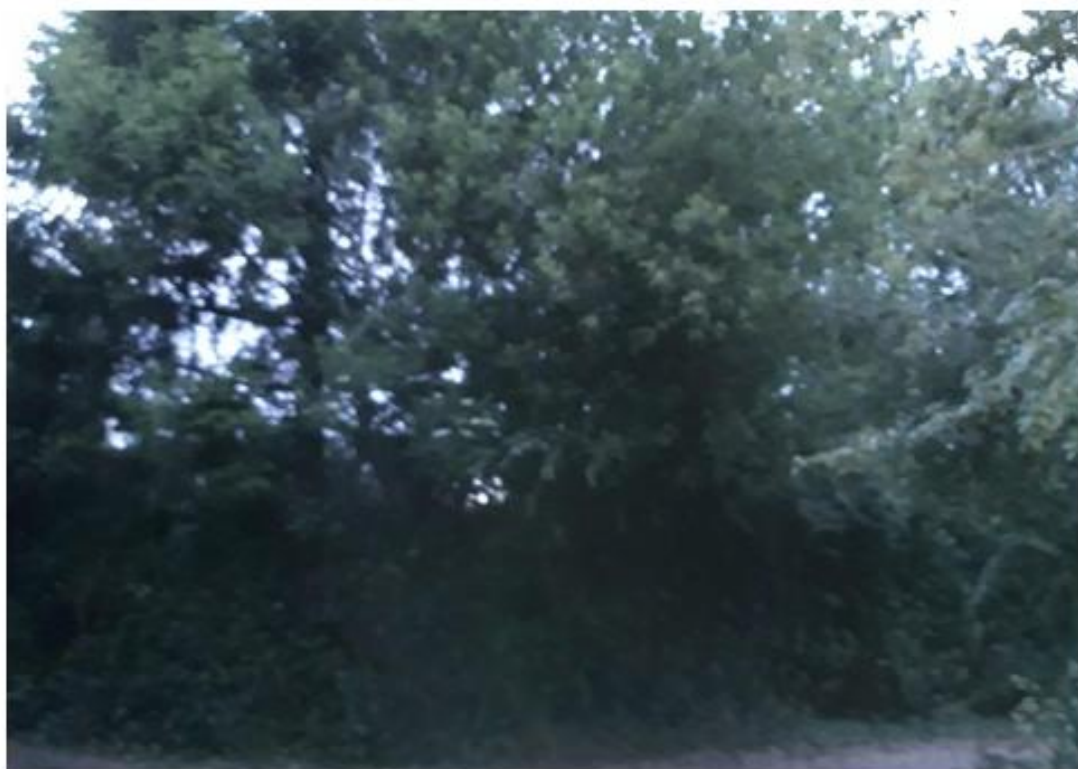
Photo 2: Area 2 inspected for nesting birds.
