# Proposed Stone Repairs

St James's Church, Ramsden Road, Wardle, Rochdale, OL12 9NX

February 2023– 129042

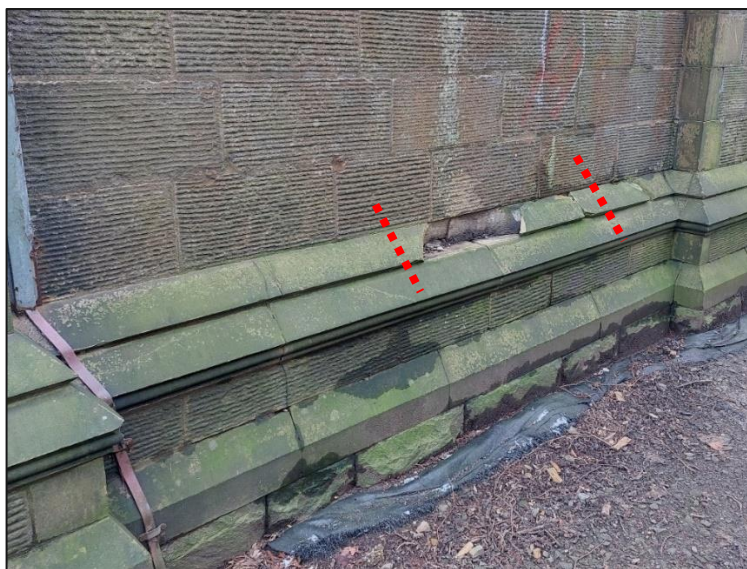
Fig.1

The plinth capping is damaged and in parts missing, between the dashed lines indicated in the images below. The plinth capping forms part of the wall structure and appears to have split, in line with the main walls above the plinth. This work is required for aesthetic purposes and to prevent water saturation to masonry below plinth level.

- a) Remove loose section of stone to the left-hand side of line b, indicated above.
- b) Prepare opening based on inserting 2no. new stones to match profiles of existing, with joint line at mid-point between lines a and b. Stones to be inserted in 2no. sections so as not to cause settlement of masonry above. Proposed joint line is at line C above.
- c) Perpendicular joints to match existing.
- d) Stone type to match existing.
- e) Pointing to be in lime mortar as described elsewhere.

The stone between lines C and B has a visible split in line with the wall above. The proposal to replace the splintered stone between lines C and B rather than retaining and re-fixing using adhesive and dowels is proposed to achieve the most durable and long-lasting solution, given the plinth will receive high quantities of water run off from the tower walls above.

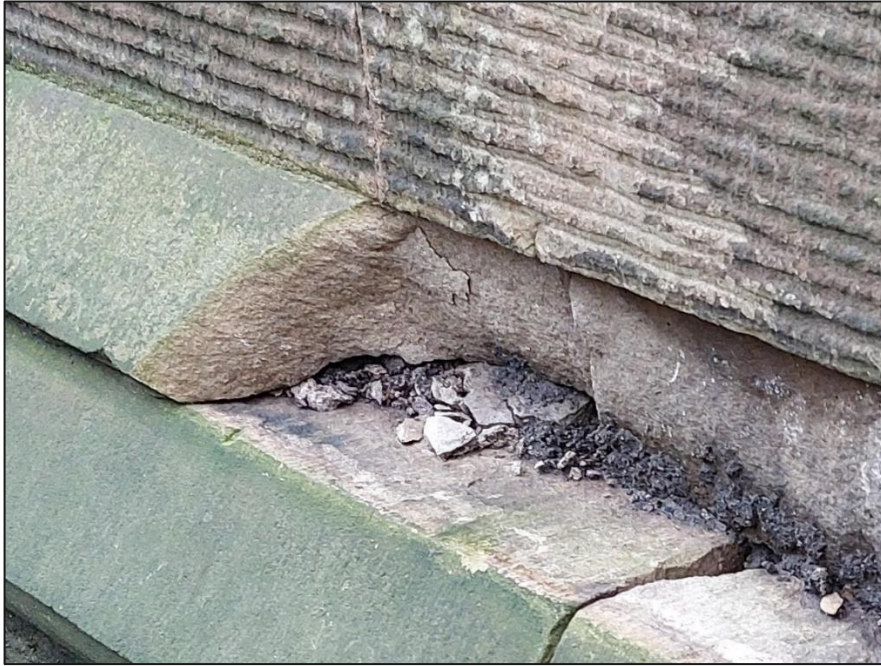
As can be seen in Fig.2 above, the plinth capping forms a solid block, continuing behind the line of the tower masonry above. To repair the same, part of this stone should be removed.

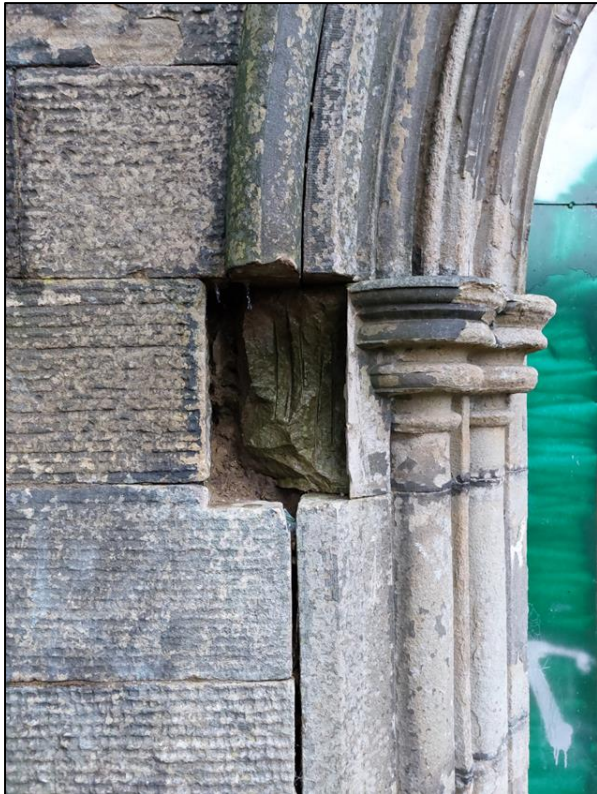
The stone carving to the left-hand side of the tower doorway is missing (Fig.1 in appendix). This will be replaced with a new carving to a detail and material approved by the Local Authority, following the instruction of a stone mason as part of the building works, to complement the existing carving to the right-hand side of the Tower doorway (Fig.2).

Fig.1 - Missing carving to left hand side to tower door.

The missing stone carving to the tower door will be replaced with new to restore a characteristic of the building. Stone carvings are also present to the west elevation door into the Nave.

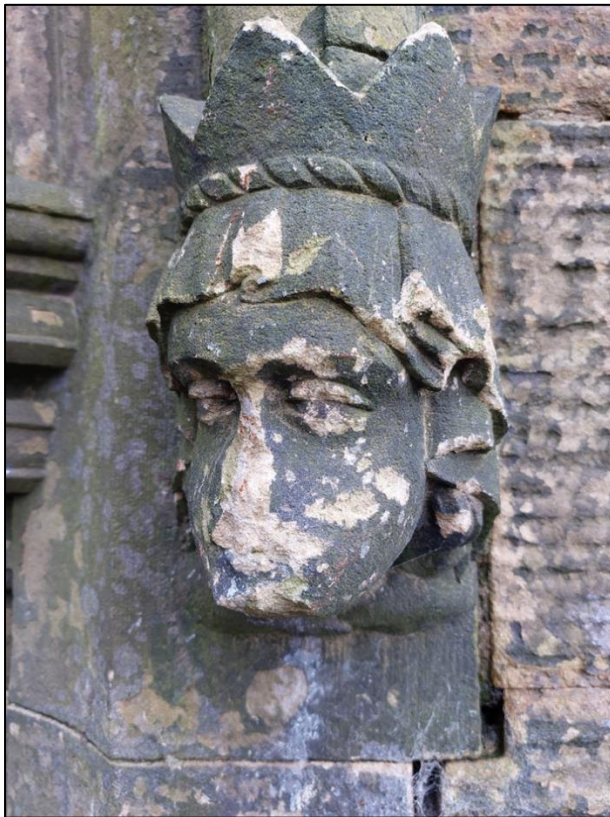
Fig.2 – Carving present to right hand side tower door. To be used as an historical reference for the reinstatement to the left-hand side

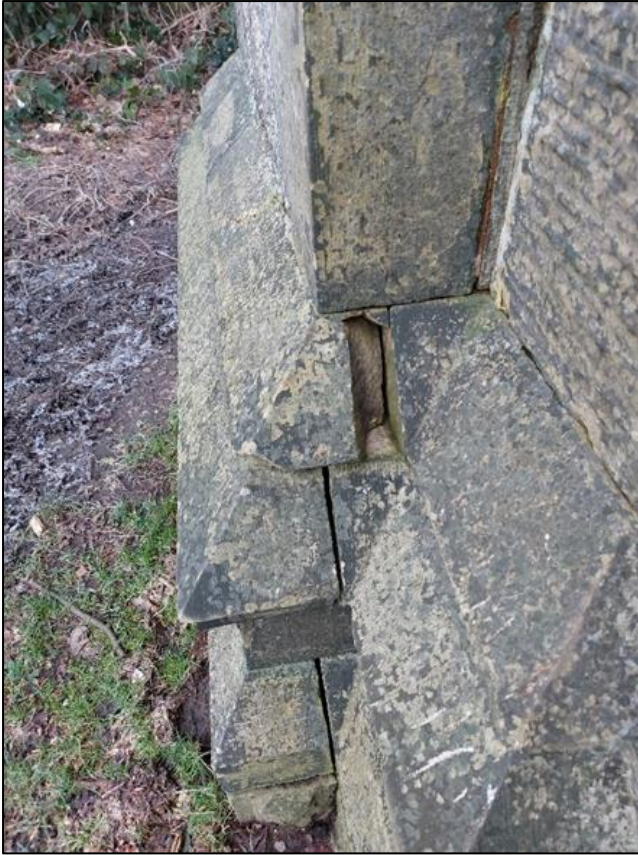
As indicated on the photographs in the appendix (Fig.3, 10, 20) and appended annotated drawings, there are several areas where small pieces of stone are missing to various string details. This stone is providing an architectural function but also a waterproofing function, encouraging water to be shed off the building as a 'drip' detail.

Fig.3 – Indent repair required adjacent to tower door opening.

The proposal is to undertake indent repairs where this has occurred, to reinstate these details, to match the profile, joint characteristics, and finishing/tooling of adjacent areas. The maximum amount of fabric will be retained.

Indents to be installed on well prepared beds and secured using lime mortar with joints injected with lime grout.

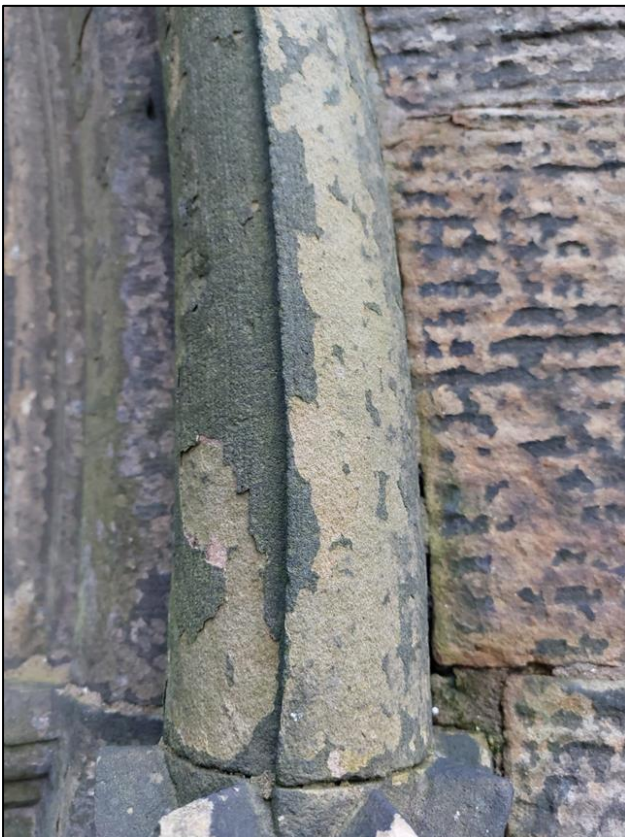
Fig.4 – Contour scaling to stone around tower door opening. De-frass.

Where frassing has occurred to stonework around windows and doors and within reveals, the same are to be brushed off using a stiff brush.

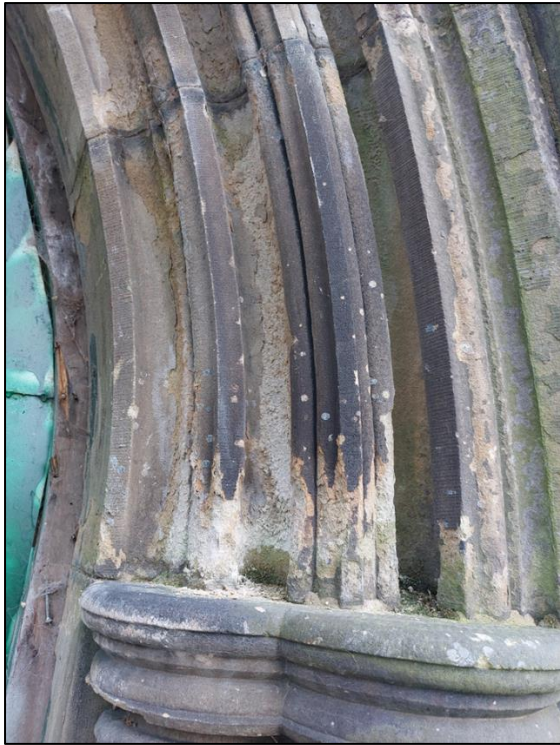
Fig.5 – General weathering and loss of section to stonework to Tower arch. De-frass

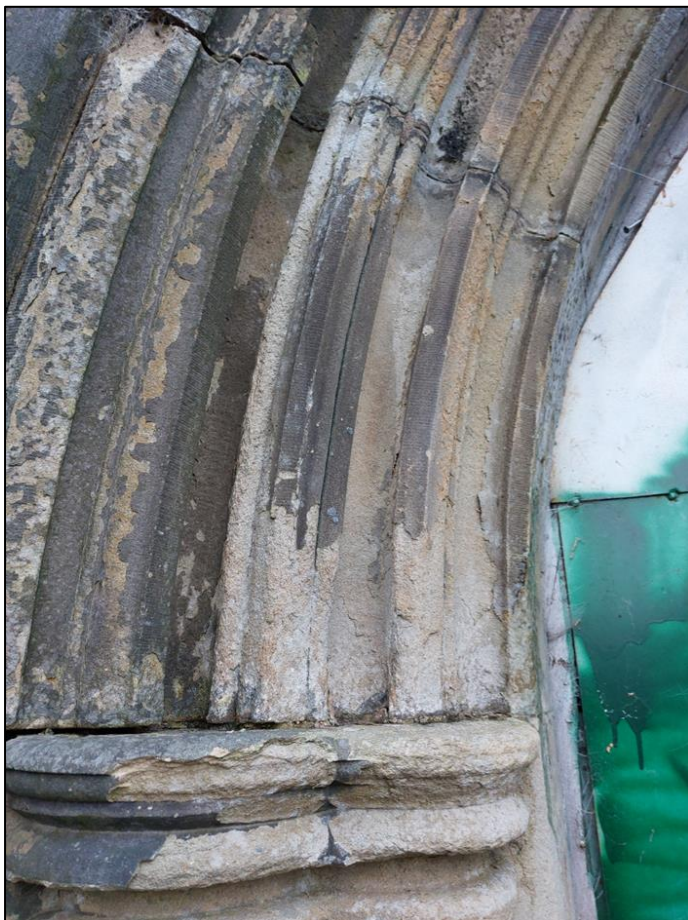
Fig.6 – General weathering and loss of section to stonework to Tower arch, contour scaling, missing pointing. De-frass and pointing of joints proposed.

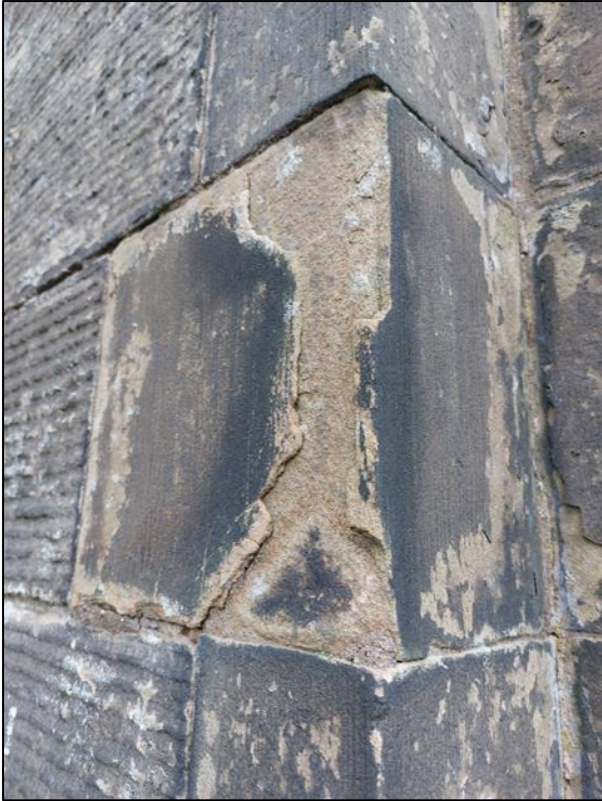
Fig.7 – Contour scaling to quoin block. Proposed to de-frass.

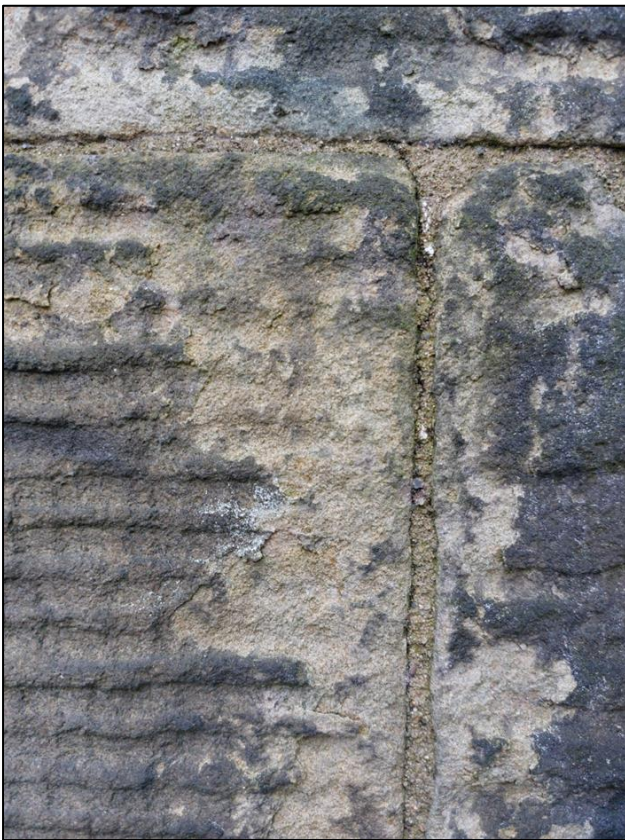
Similarly, minor contour scaling has occurred in numerous areas, as indicated in the appendix photographs. This process is common in sandstone and involves the thin outer layer effectively delaminating from the main stone. This is a natural process of weathering and at St James Church, is primarily affecting the tooled surface of the stone. The proposals do not intend to reverse or accelerate this process, or to restore any lost material.

Fig.8 – Contour scaling to stone generally. No work proposed.

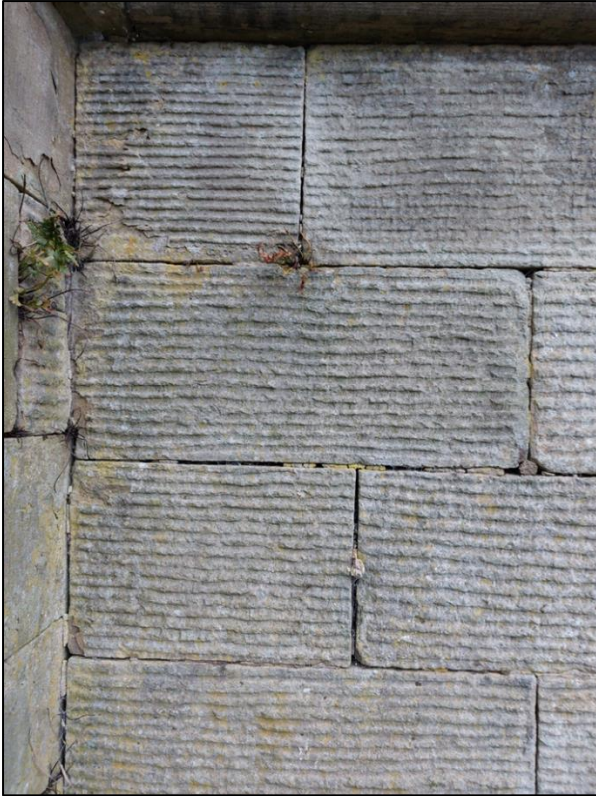
Fig.9 – Example of missing pointing. Repoint all open joints.

Joints to be prepared by removing loose mortar using hand tools to a depth of 10mm. No mechanical tools, including circular saws to be used, to prevent damage to arises to stonework.

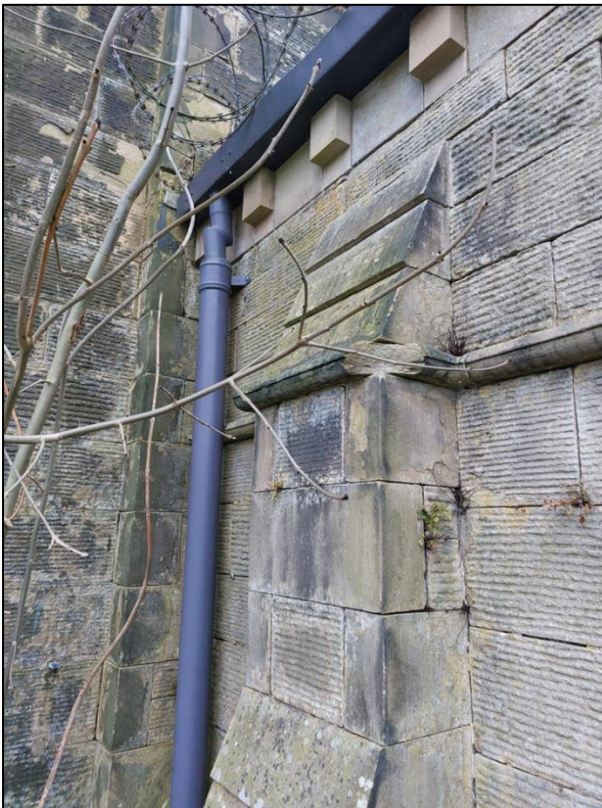
Fig.10 – Lost weather detail to buttress. Indent repair to string detail around buttress

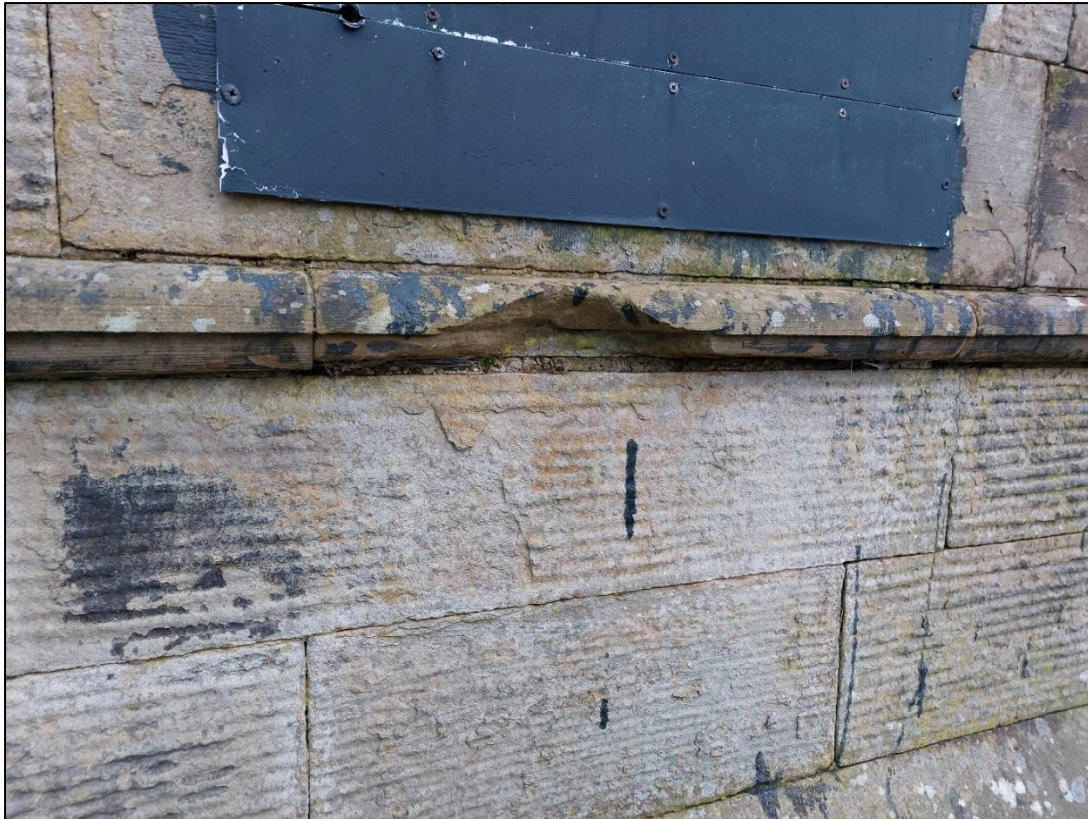
Fig.11 – Loss of section to drip detail. Proposed indent repair to reinstate drip detail.

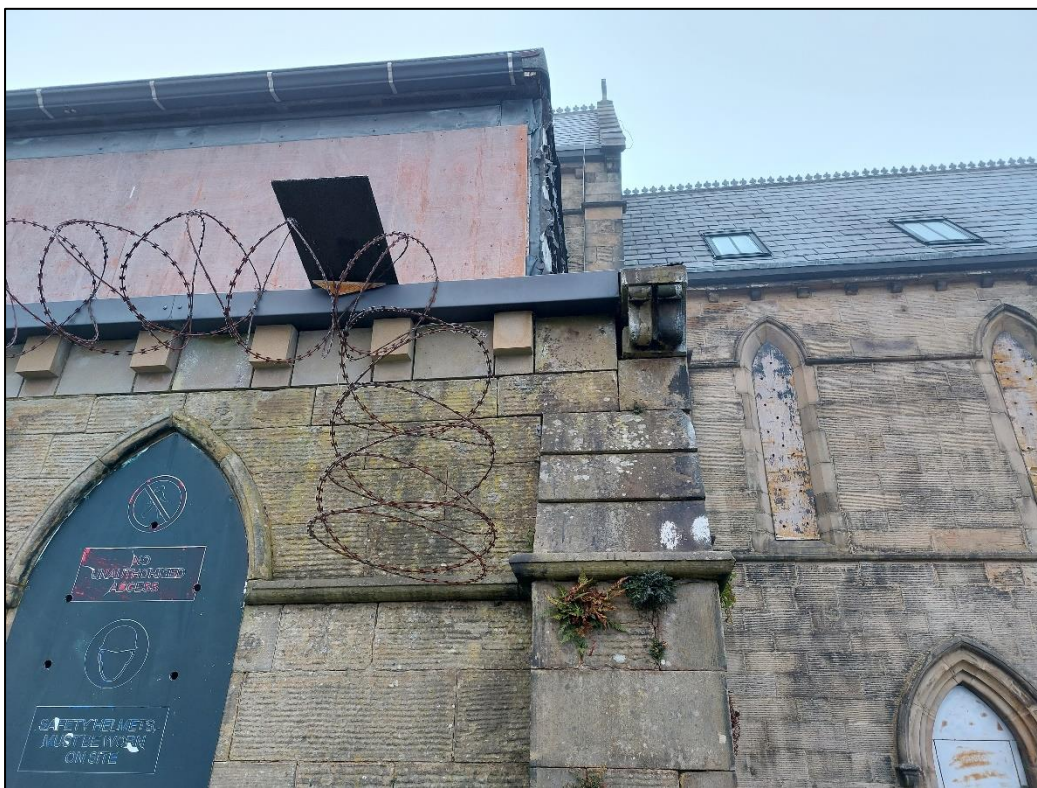
Fig.12 – Algal growth to be removed.

This in practice means for example, there are no proposals to steam clean external stonework. Where there is localised algal growth, graffiti, and corrosion run-off, this will be cleaned manually using proprietary solvent-based solutions, following tests to determine the best method. This is to minimise damage to underlying stone.

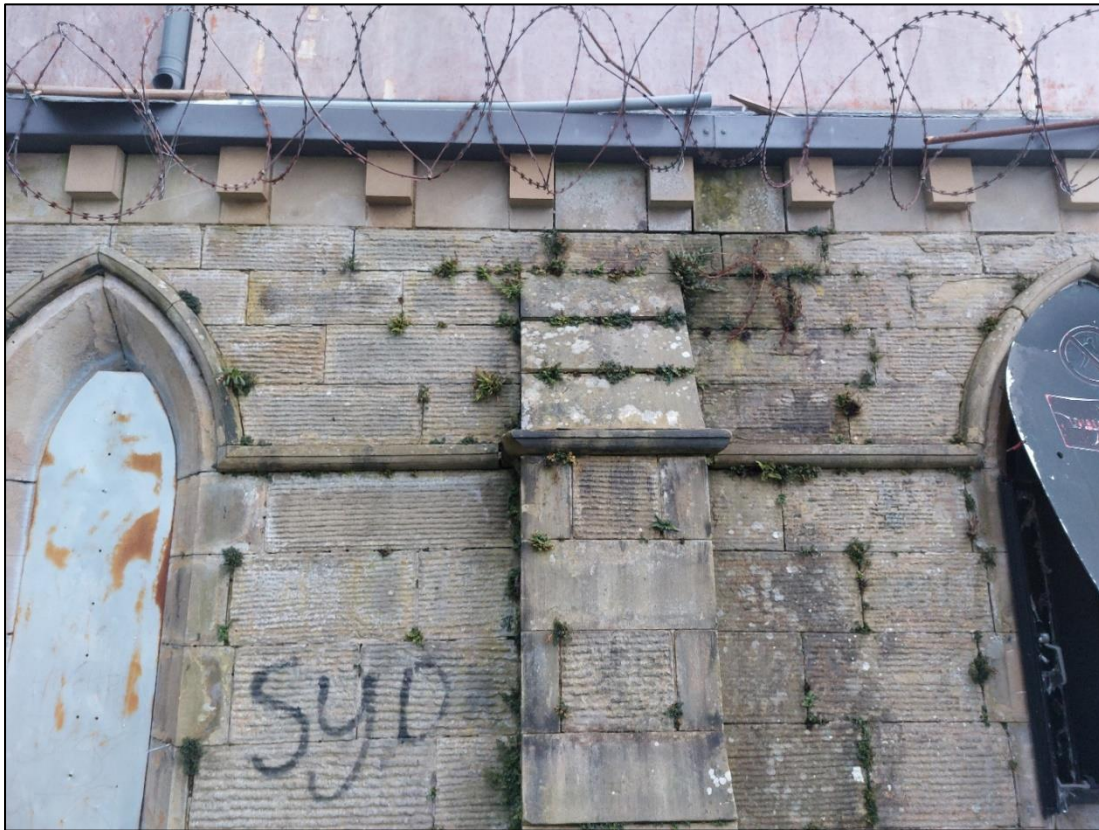
Fig.13 – Algal growth and graffiti to be removed

Tests to be undertaken to determine the best method of removal, and an appropriate level of cleaning. Graffiti to be removed using proprietary solvent-based graffiti removal spray rather than sand-blasting or mechanical methods.

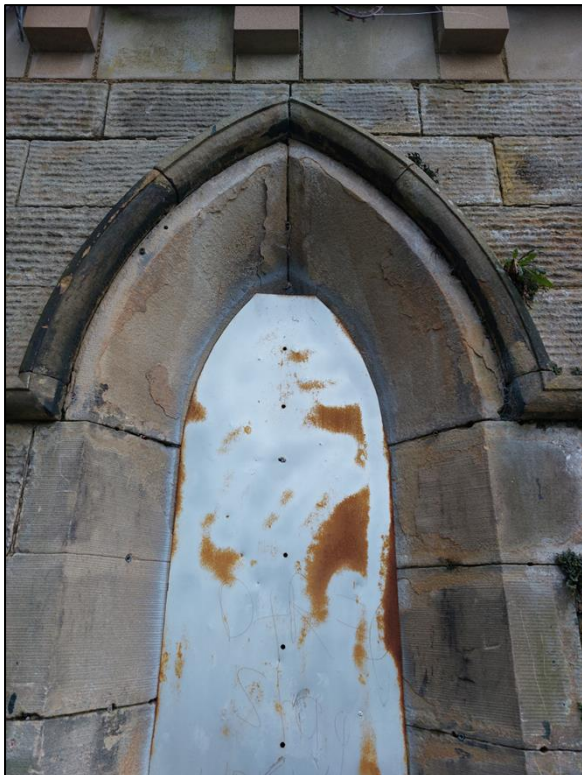
Fig.14. Contour scaling to chancel door. De-frass.

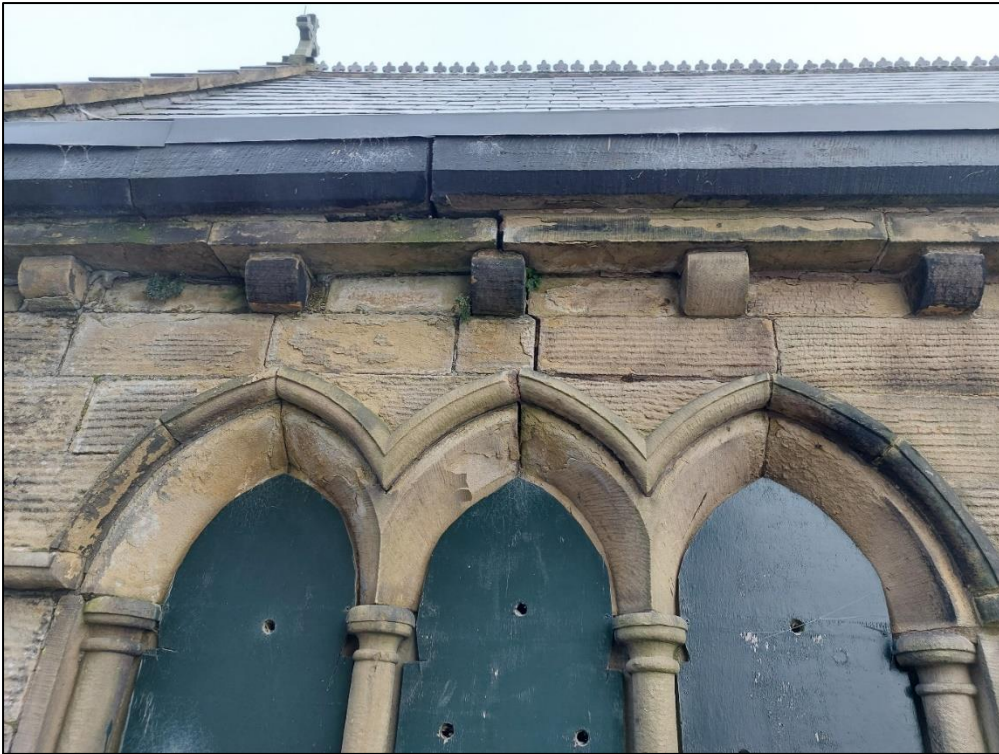
Helical ties are proposed above the Nave Window to tie joint between the vertical crack, and potentially between quoins and the main wall structure to the eastern corner to the south aisle to tie these areas together, given the width of the joint appears to have opened.

Fig.15 – Open joint above first floor window to south Nave

Given the narrow joints to the stonework, 4.5mm diameter helical ties are proposed. Installation to follow supplier's recommendation, and briefly as follows;

- Removal of mortar along selected bed joint. This will be done using hand tools. The use of circular saws is strictly forbidden as this will open up and provide uniformity to stone arises.
- Flush joint with clean water, insert helical tie to manufacturer recommended dimensions assuming to be 45mm, and bond with proprietary grout supplied by preferred system manufacturer.
- Bars to be spaced at 300mm to 450mm intervals to selected areas. Following installation of bars, bed joints to be pointed in lime mortar to match specification used elsewhere.

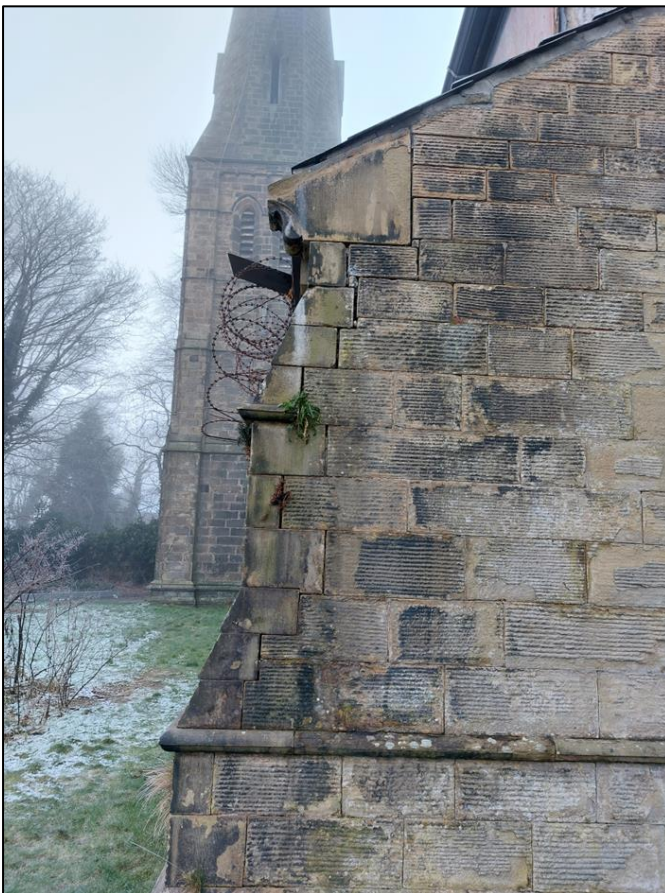
Fig.16 – Open joints between quoins and main wall. Deep pointing to wide joints to quoins. Helical ties if quoins are loose.

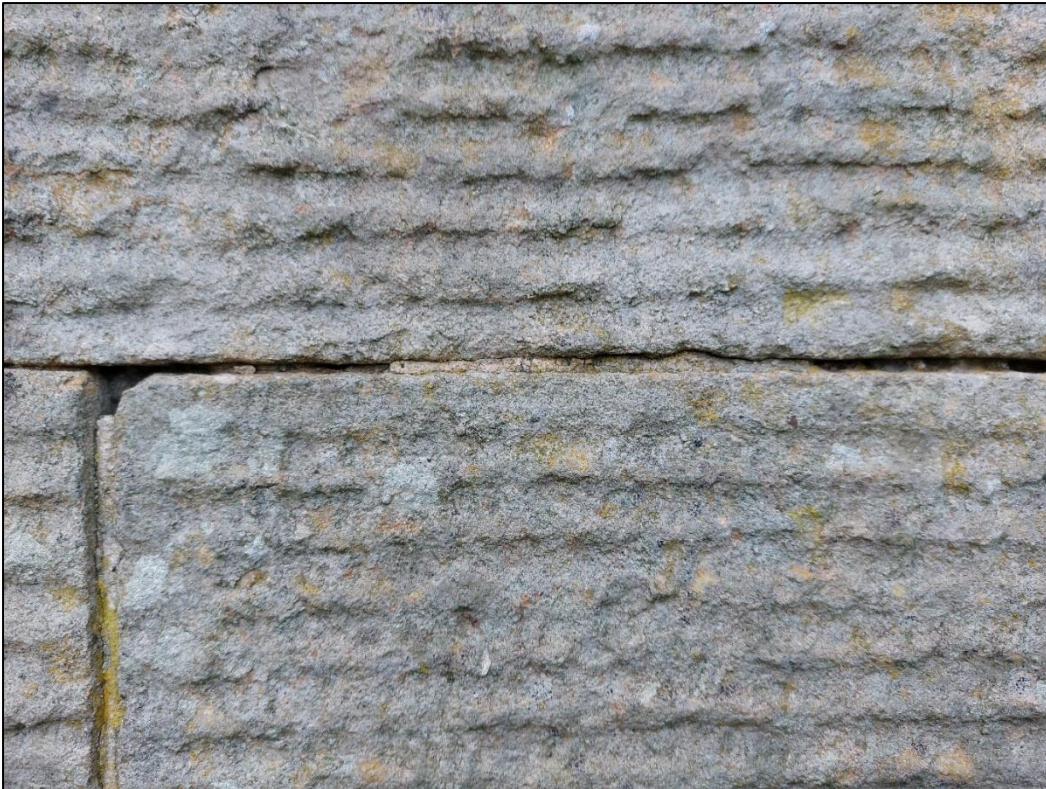
Fig.17 – Photograph to show narrow joints in blocks.

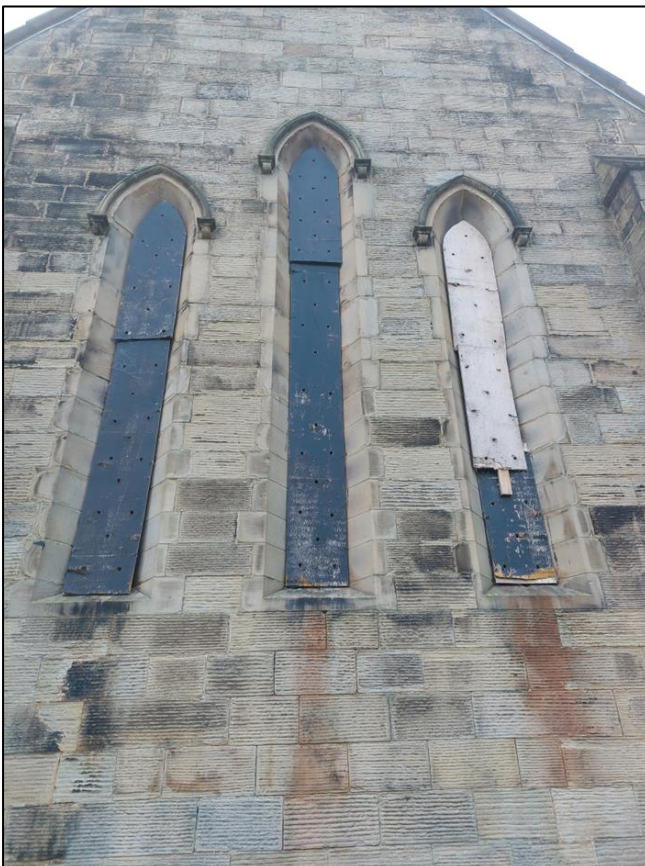
Fig.18 – Corrosion run off from metal shutters to be removed.

Similarly, a proprietary solvent-based rust removal solution to be used to clean stone following corrosion run off from the metal security shutters, following tests to determine the best method of removal.

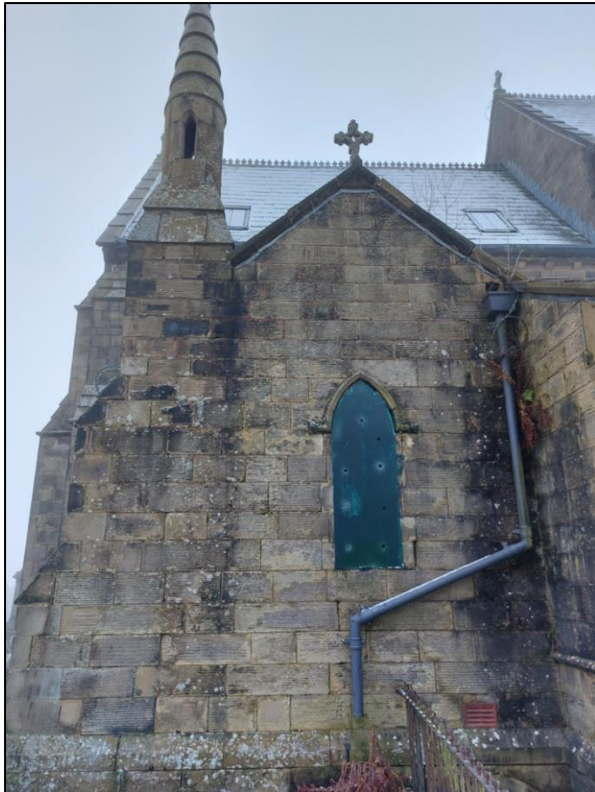
Fig.19 – Soiling following saturation of stone adjacent to guttering. To be manually cleaned/brushed off with water.

Where soiling to stone has occurred following failure of rainwater goods, this will be removed using a proprietary solvent-based mould and algae removal, manually and not pressurised water.

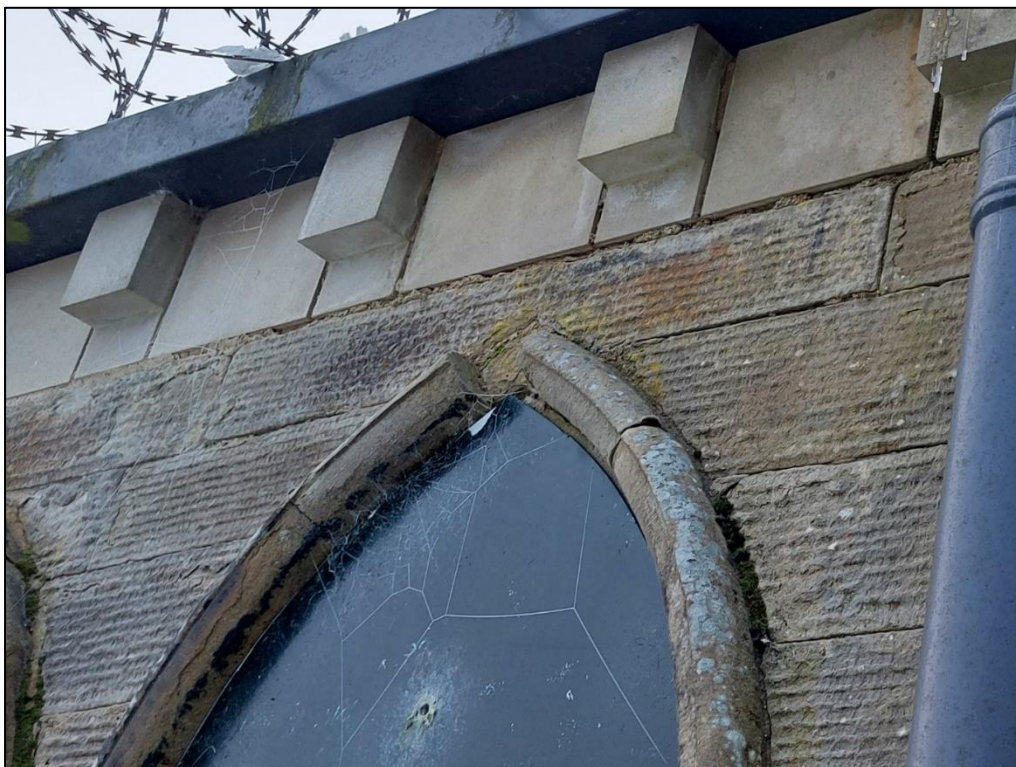
Fig.20 – Missing stone to string detail over windows. New indent repair proposed to reinstate string detail at head of window

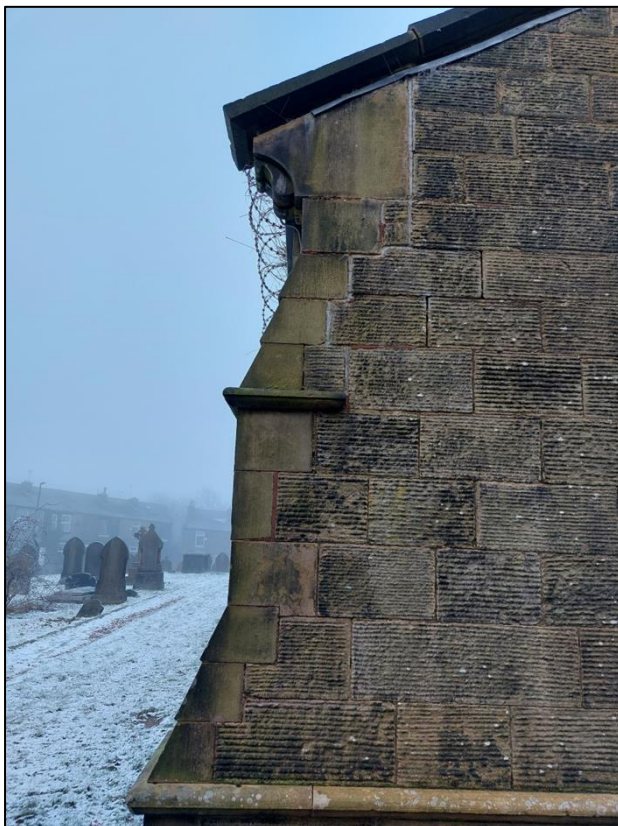
Fig.24 – Inappropriate sealant filler to west elevation of north aisle. Proposed to remove and point.

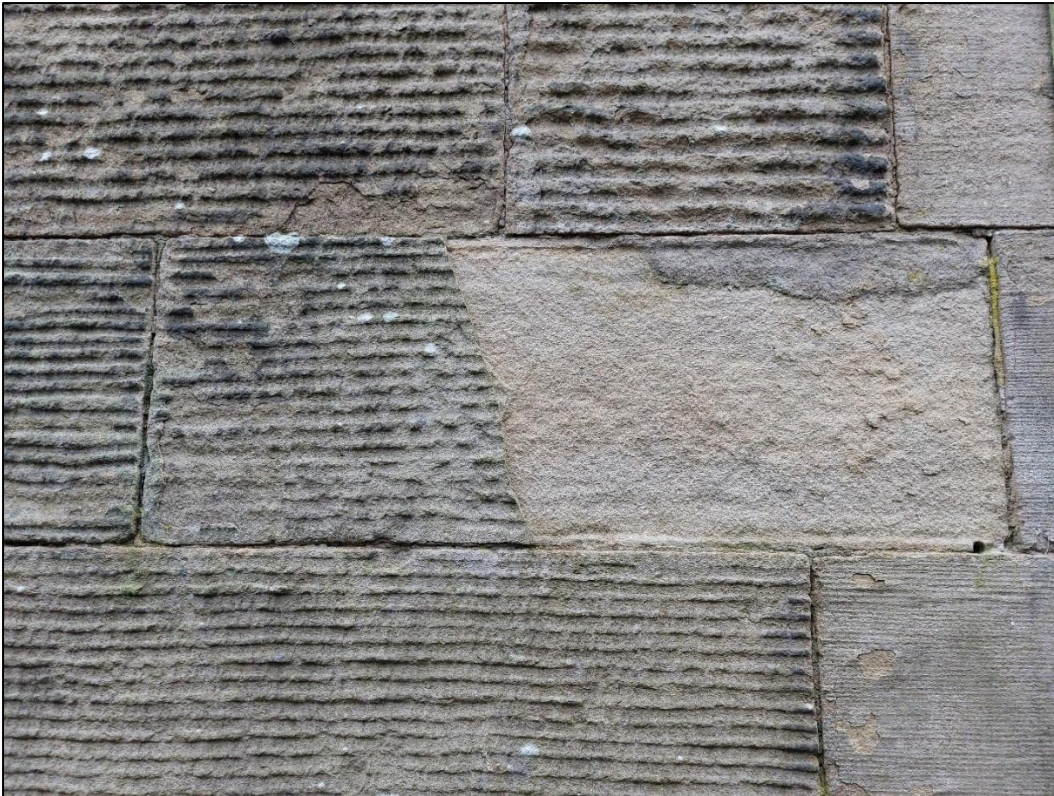
Fig.25 – Contour scaling on isolated block to west elevation. De-frass and remove loose stone.

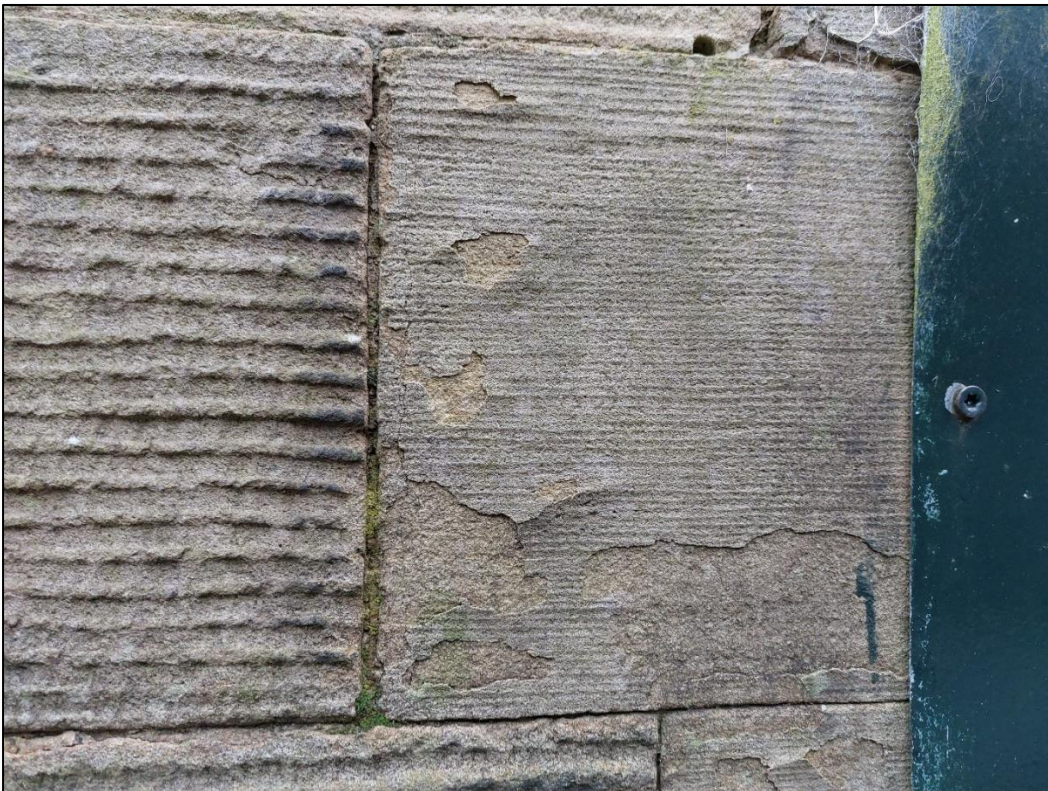
Fig.26 – Contour scaling on isolated quoin block to west elevation. De-frass.

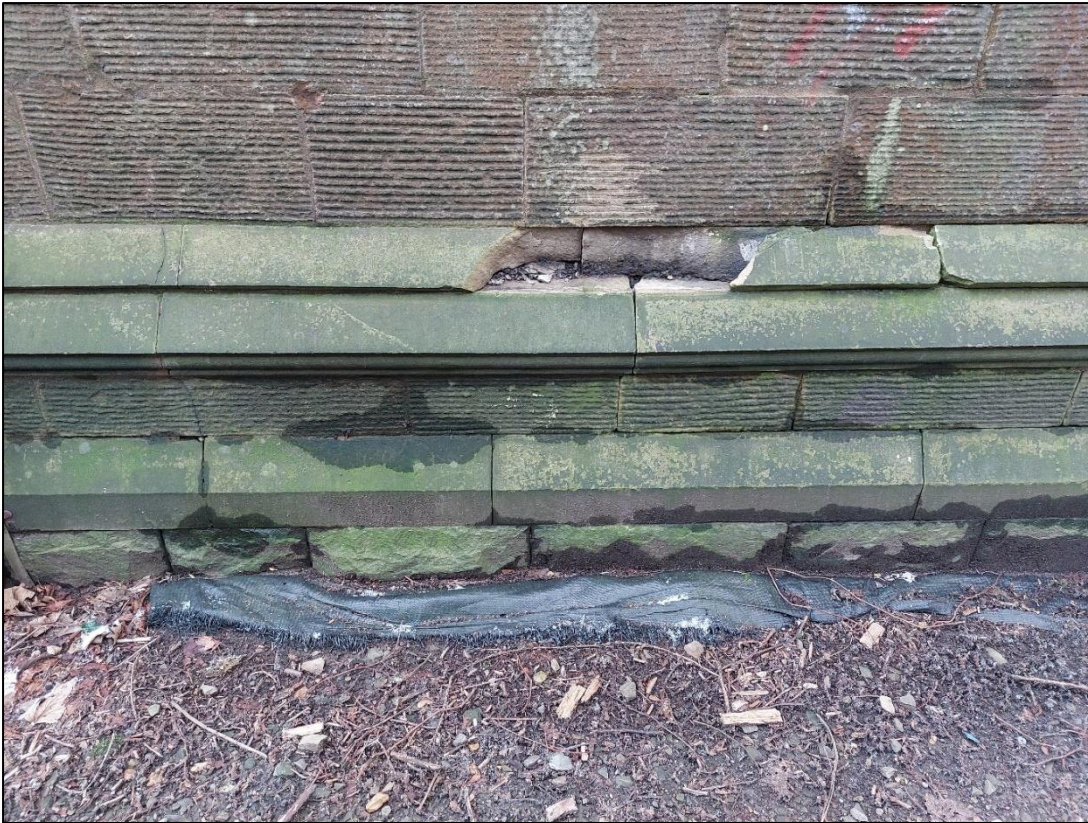
Fig.27 – Missing plinth capping stone to west elevation to tower.

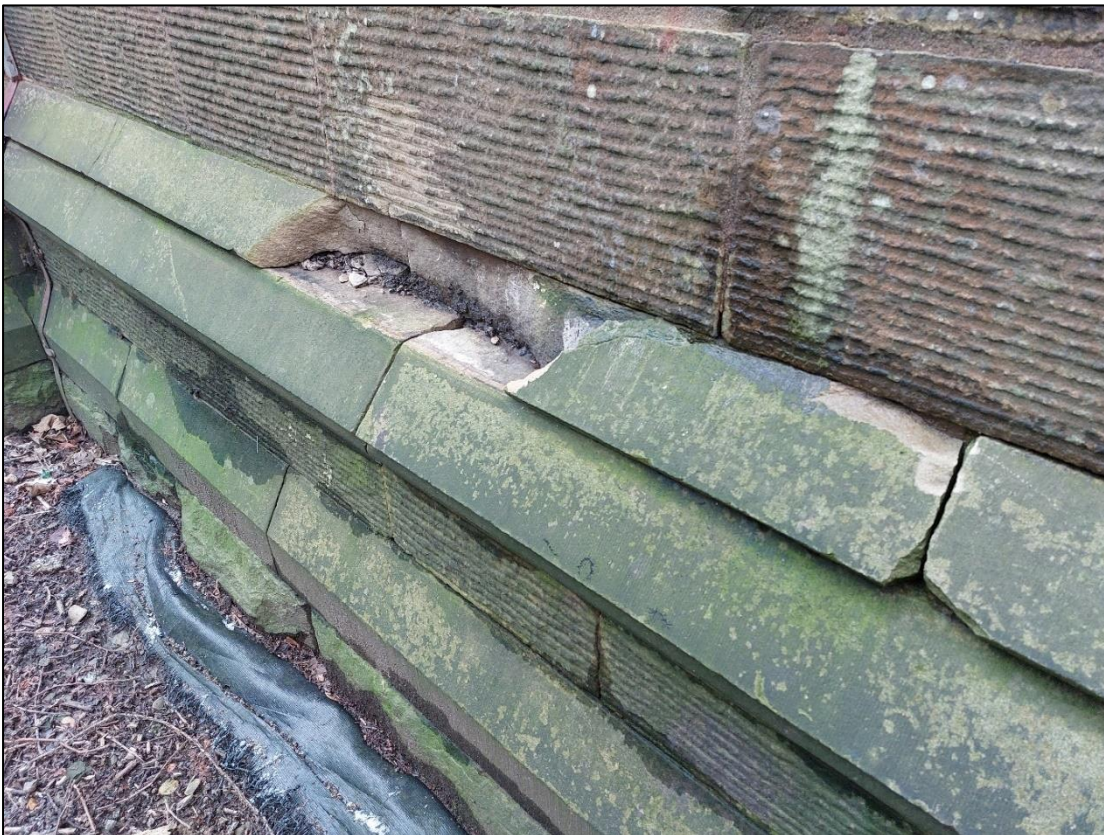
Fig.28 – Missing plinth capping stone to west elevation to tower.

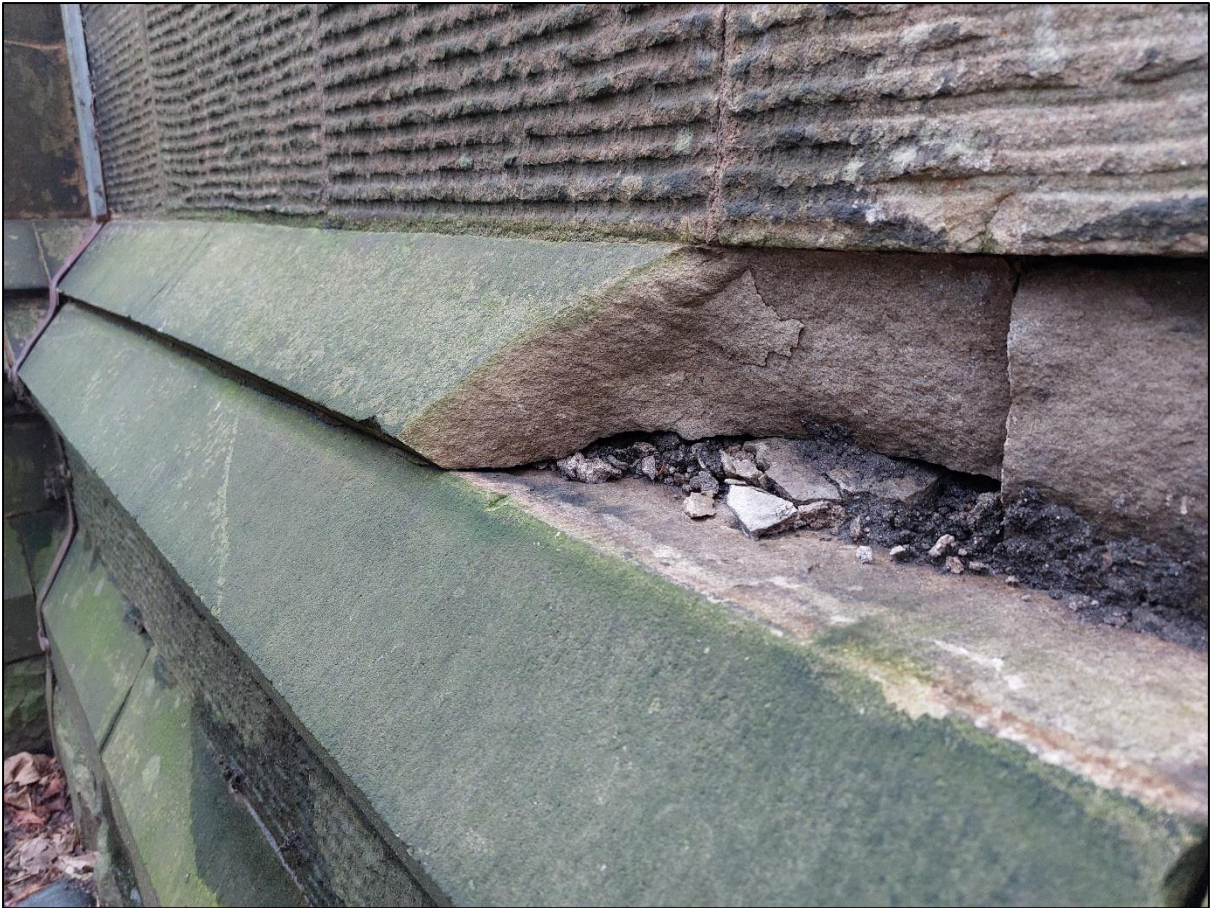
Fig.29 – Missing plinth capping stone to west elevation to tower.
