## GAS MEMBRANE VALIDATION

**Site: Boothroyden Road, Middleton**

Project Number: 13-500

Plots Validated: 40,41,44

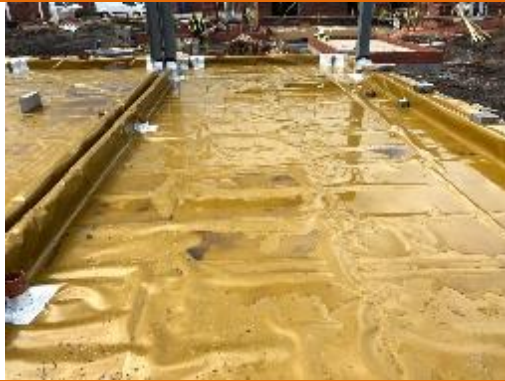
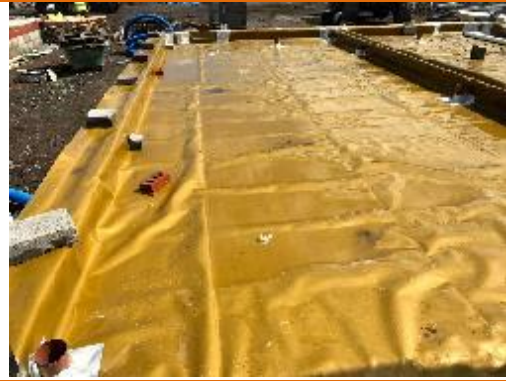
**Plot – 40**

**General Condition of Membrane-Good Condition**

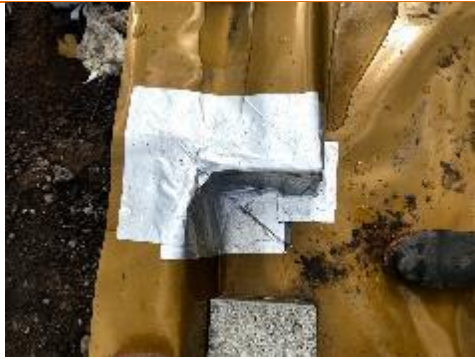
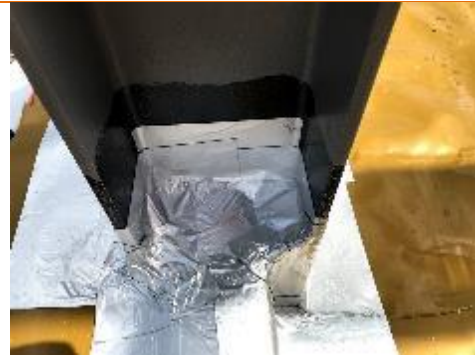
**Verification of Joints and Seals-Good Condition**

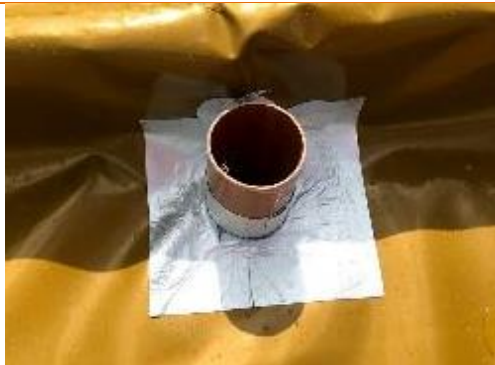
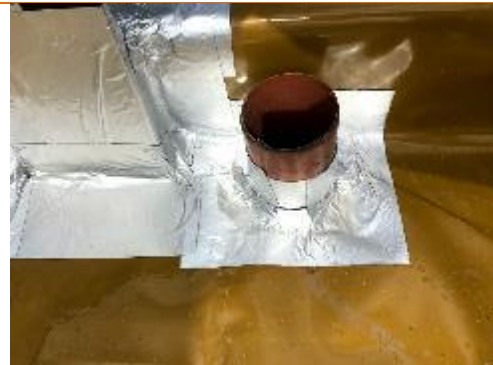
**Verification of Service Penetrations-Good Condition**

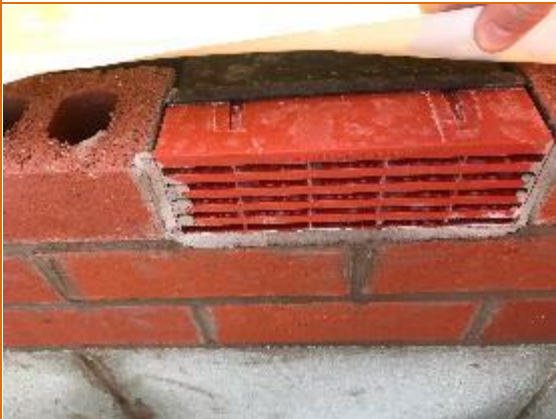
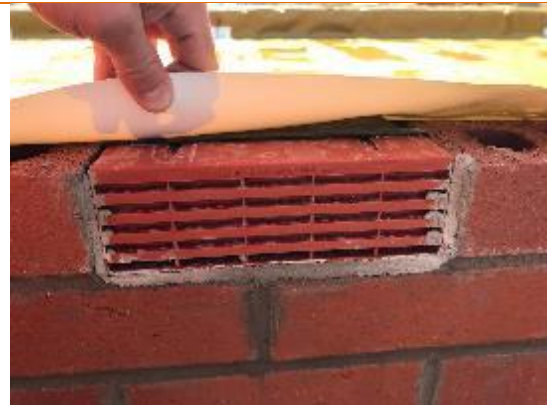
**Verification of Ventilation-Good Condition**

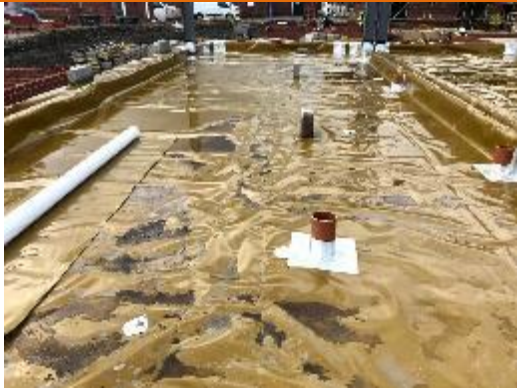
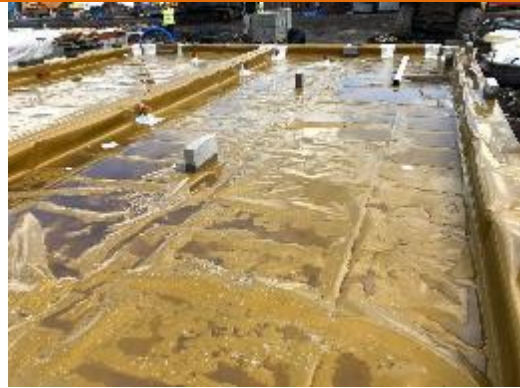
**Plot - 41**

**General Condition of Membrane-Good Condition**

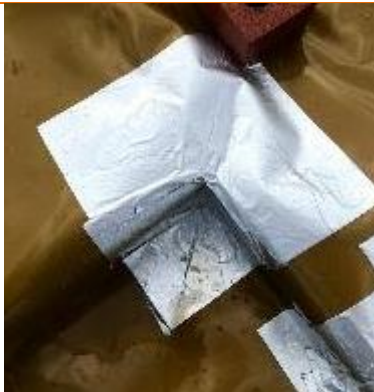
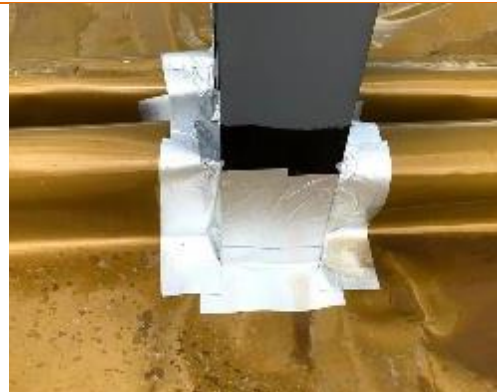
**Verification of Joints and Seals-Good Condition**

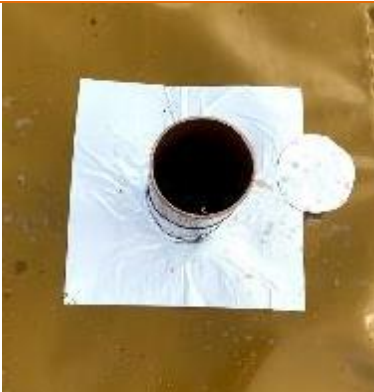
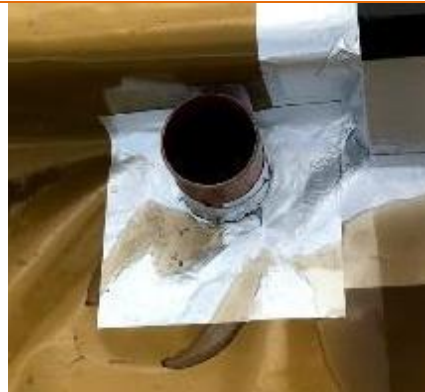
**Verification of Service Penetrations-Good Condition**

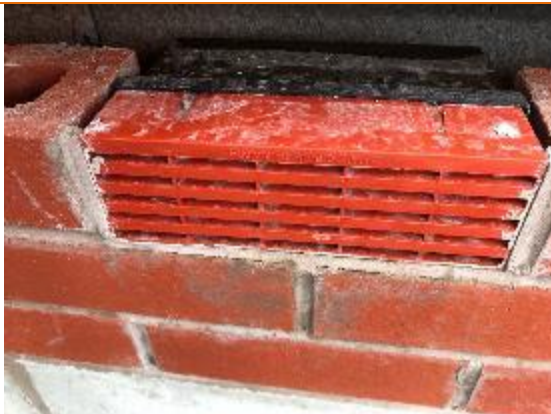
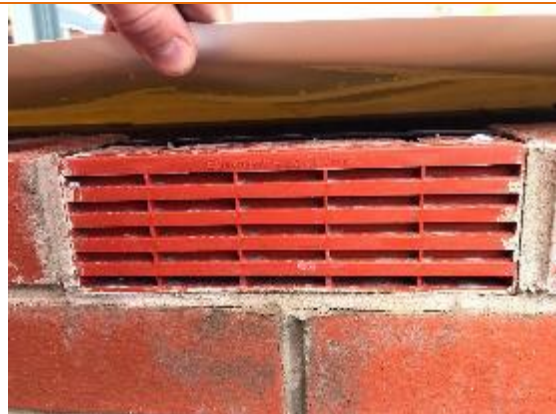
**Verification of Ventilation-Good Condition**

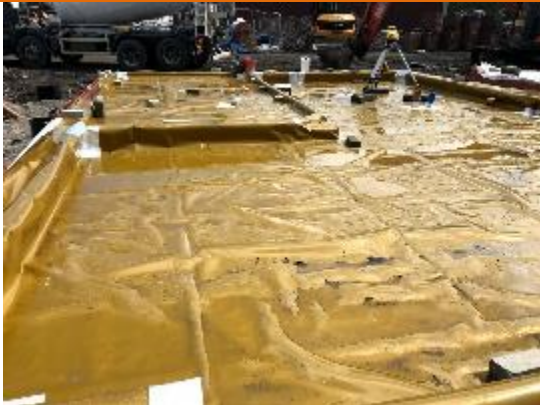
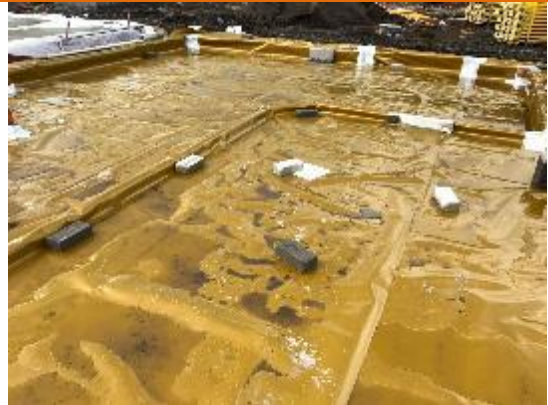
**Plot - 44**

**General Condition of Membrane-Good Condition**

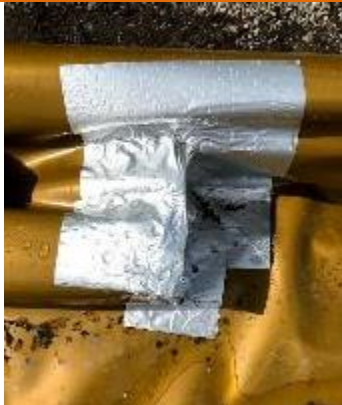
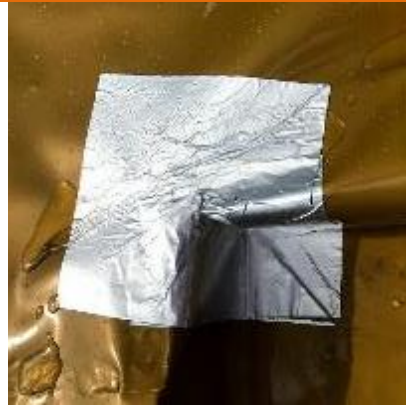
**Verification of Joints and Seals-Good Condition**

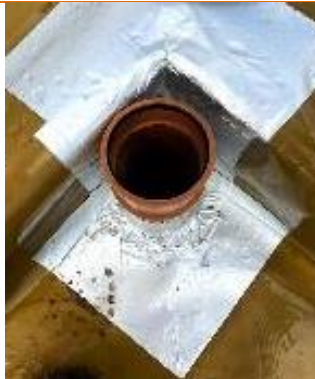
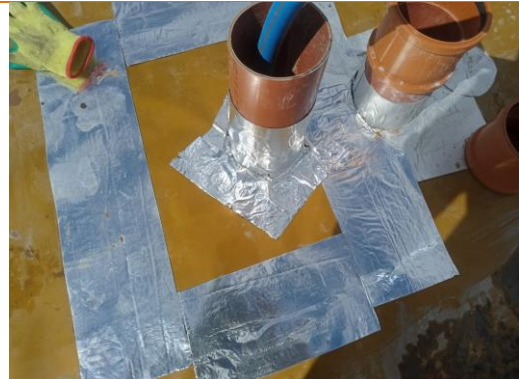
**Verification of Service Penetrations-Good Condition**

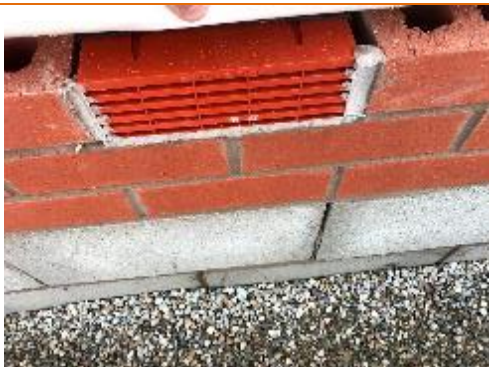
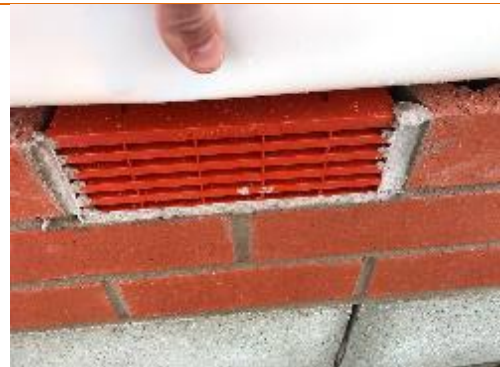
**Verification of Ventilation-Good Condition**
