SITE: STAKEHILL LANE, MIDDLETON

## Terrain Surveys Site Attendance Report

**Client:** BWB Consulting (Birmingham)  
**Contact:** Lucy Reeves  
**Date:** 8<sup>th</sup> July 2024  
**Site:** Stakehill Industrial Estate  
**Job Ref:** TS24-386

Attended site to undertake an investigation/connectivity survey of the surface water and foul water drainage systems within the land to the north and east of Stakehill Industrial Park, focusing on specific sections of drainage systems & watercourses.

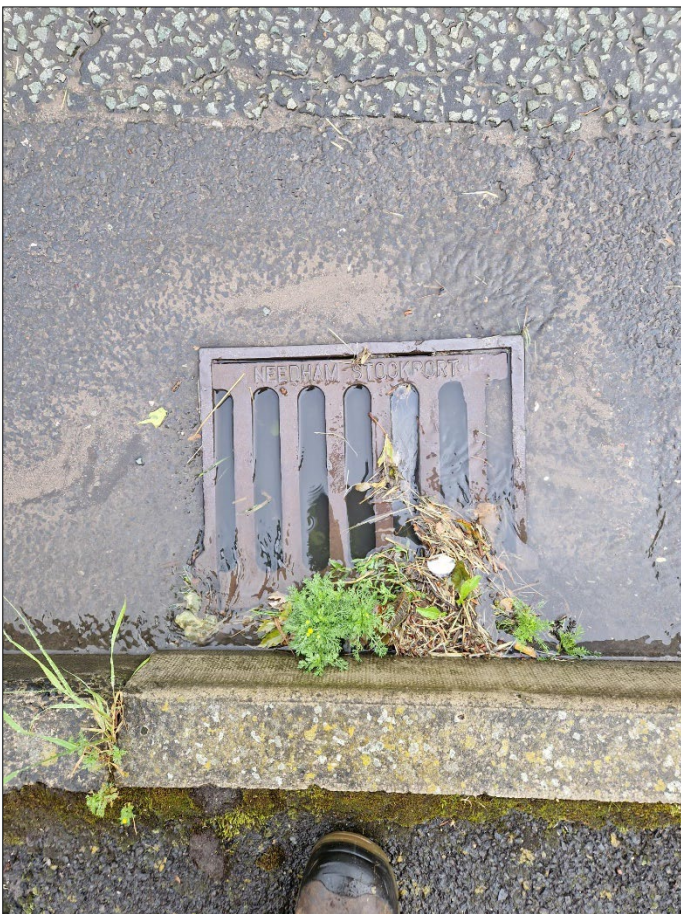
The main line was noted to be free flowing although during the survey several of the road gullies were observed to be blocked and causing localised flooding.

Road Gully Condition Example

- Combination Lorry Jetting Unit to attend site to empty and HPWJ all road gullys serving Bentley Ave
- Break out and replace seized manhole MH2 to complete survey of chamber and verify possible connectivity with MH3 (see Area 2)

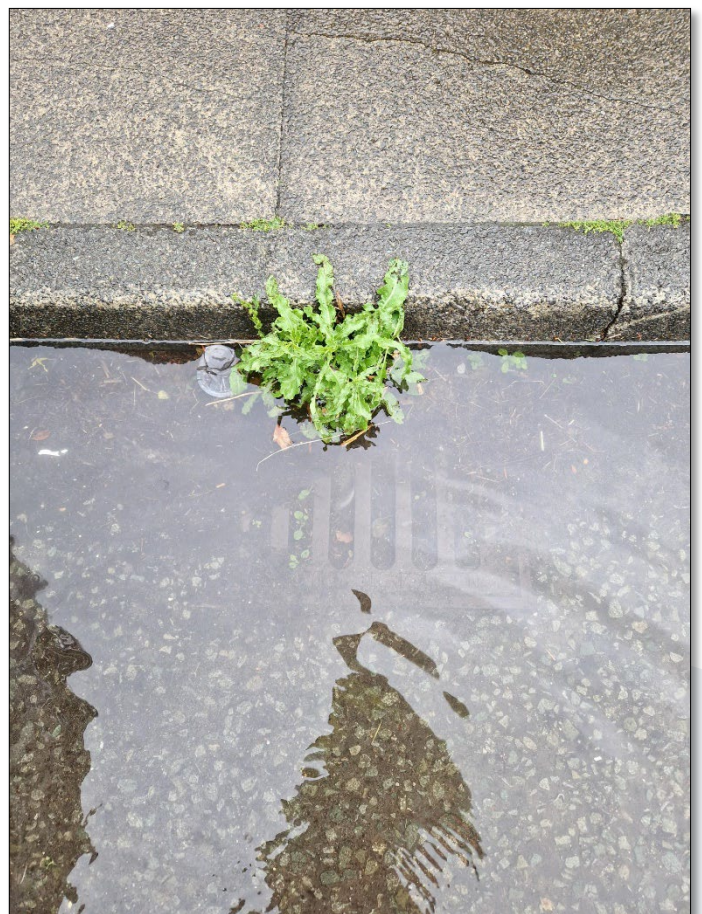
Road Gully Condition Example

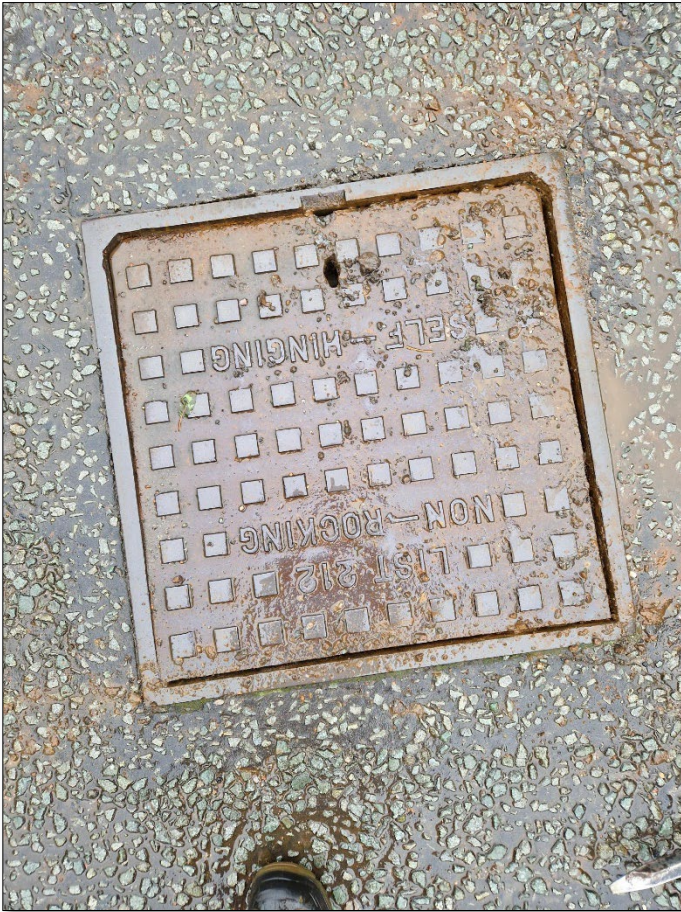
MH2 Cover Condition View

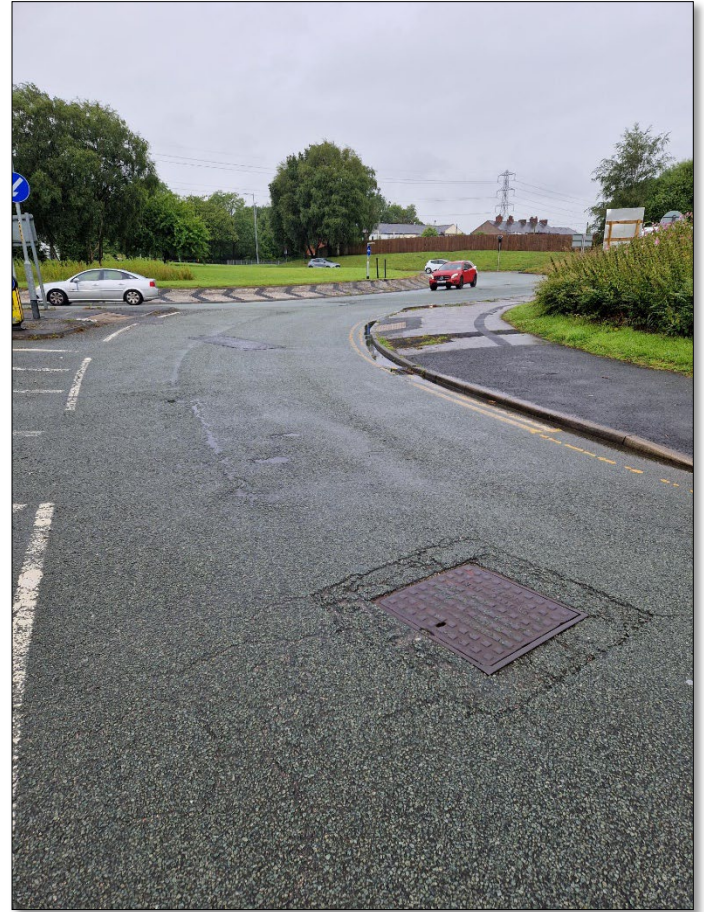
Manhole S5 was confirmed to be the head of the surface water run serving this section of carriageway before flowing downstream through to manhole S8.

Manhole S8 Location View

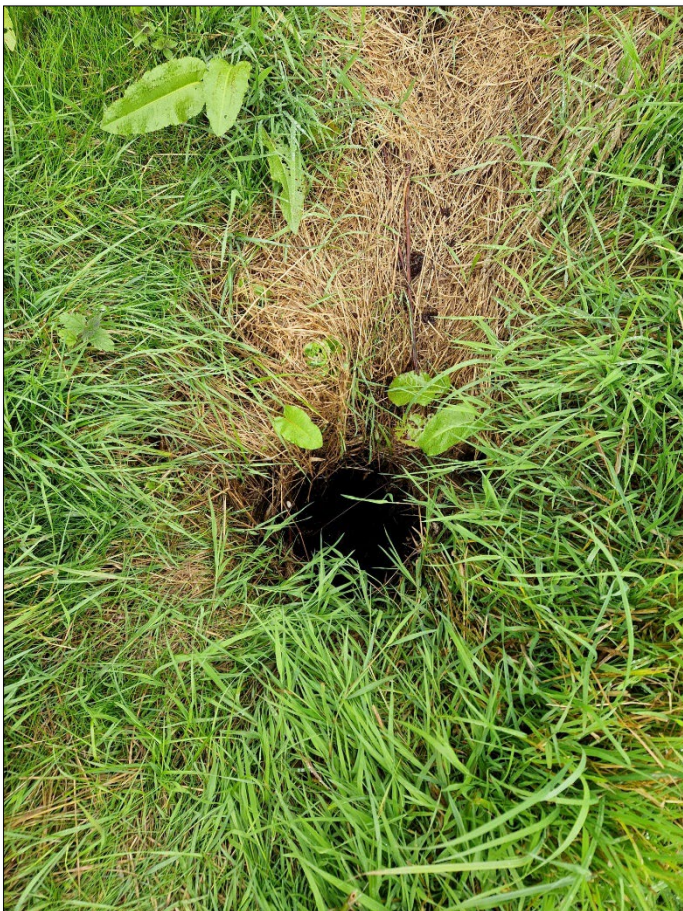
Undertook visual survey of the culverted watercourse route as detailed on the plan supplied. The open section of ditch/watercourse located within the farmers field to the north of Bentley Ave is enclosed within dense foliage and appears to have become silted as an outlet could not be located. The farmers field running along the downstream route of the culvert has been built up to create an enclosed storage bund at the field entrance off the north section of Stakehill Lane. This bund has become heavily vegetated and any possible existing culvert access points along this section could not be located. There is a large flag stone laying in the field possibly located on the route of the culvert which was lifted to investigate but no chamber was concealed beneath. Noted an open void in the field nearby, undertook investigation and cleared vegetation for access confirming the void to be a catchpit made up of a brick-built shaft with a 225mmØ piped outlet (referenced MH3 on the connectivity plan).

**MH3 Location View**

- Combination Lorry Jetting Unit with remote hose reel to attend site to HPWJ MH3 located within the field to facilitate access to CCTV survey for condition and trace the line.
- Break out and replace seized manhole MH2 (See Area 1) to complete survey of chamber and verify any potential connectivity with culvert.
- Install a new raised 600 x 600 D400 manhole cover & frame on MH3.
- Cut/back clear vegetation to locate the ditch/watercourse end, excavate to investigate any potential outfall into the culverted section to further assess condition including any further recommendations for HPWJ/CCTV.
- Combination Lorry Jetting Unit to undertake HPWJ upstream of petrol interceptor to clear the obstruction and facilitate access to complete the trace line and CCTV condition survey.  
(Access to be arranged/agreed with unit owners prior to attendance)

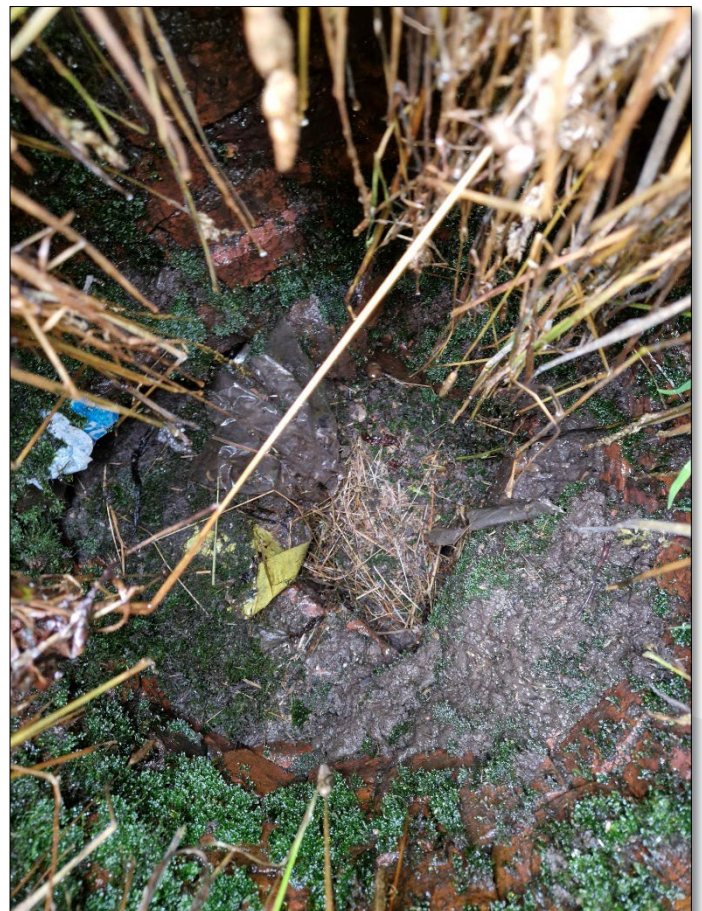
**Note:** MH3 has various inlet pipes from 150mmØ to 300mmØ connected with all pipework containing large amounts of silt/debris/soil due to it being unmaintained, no further tracing could be undertaken from this point. The flag stone may have been originally placed over MH3, due to its size & weight we were unable to lift it safely back on top of the chamber and would recommend a raised manhole cover to be fitted over this chamber to prevent potential injury and provide future safe access.

**MH3 Internal View Before Clearing**
