# **TREE SURVEY & REPORT**

## **TREE SURVEY / SCHEDULE AND REPORT**

Location: Crimble Bungalow OL11 4AB

Order TPO name: TPO Heywood MB No 1 Heywood Municipal Borough  
ID T195TPO010  
Local Authority: Rochdale

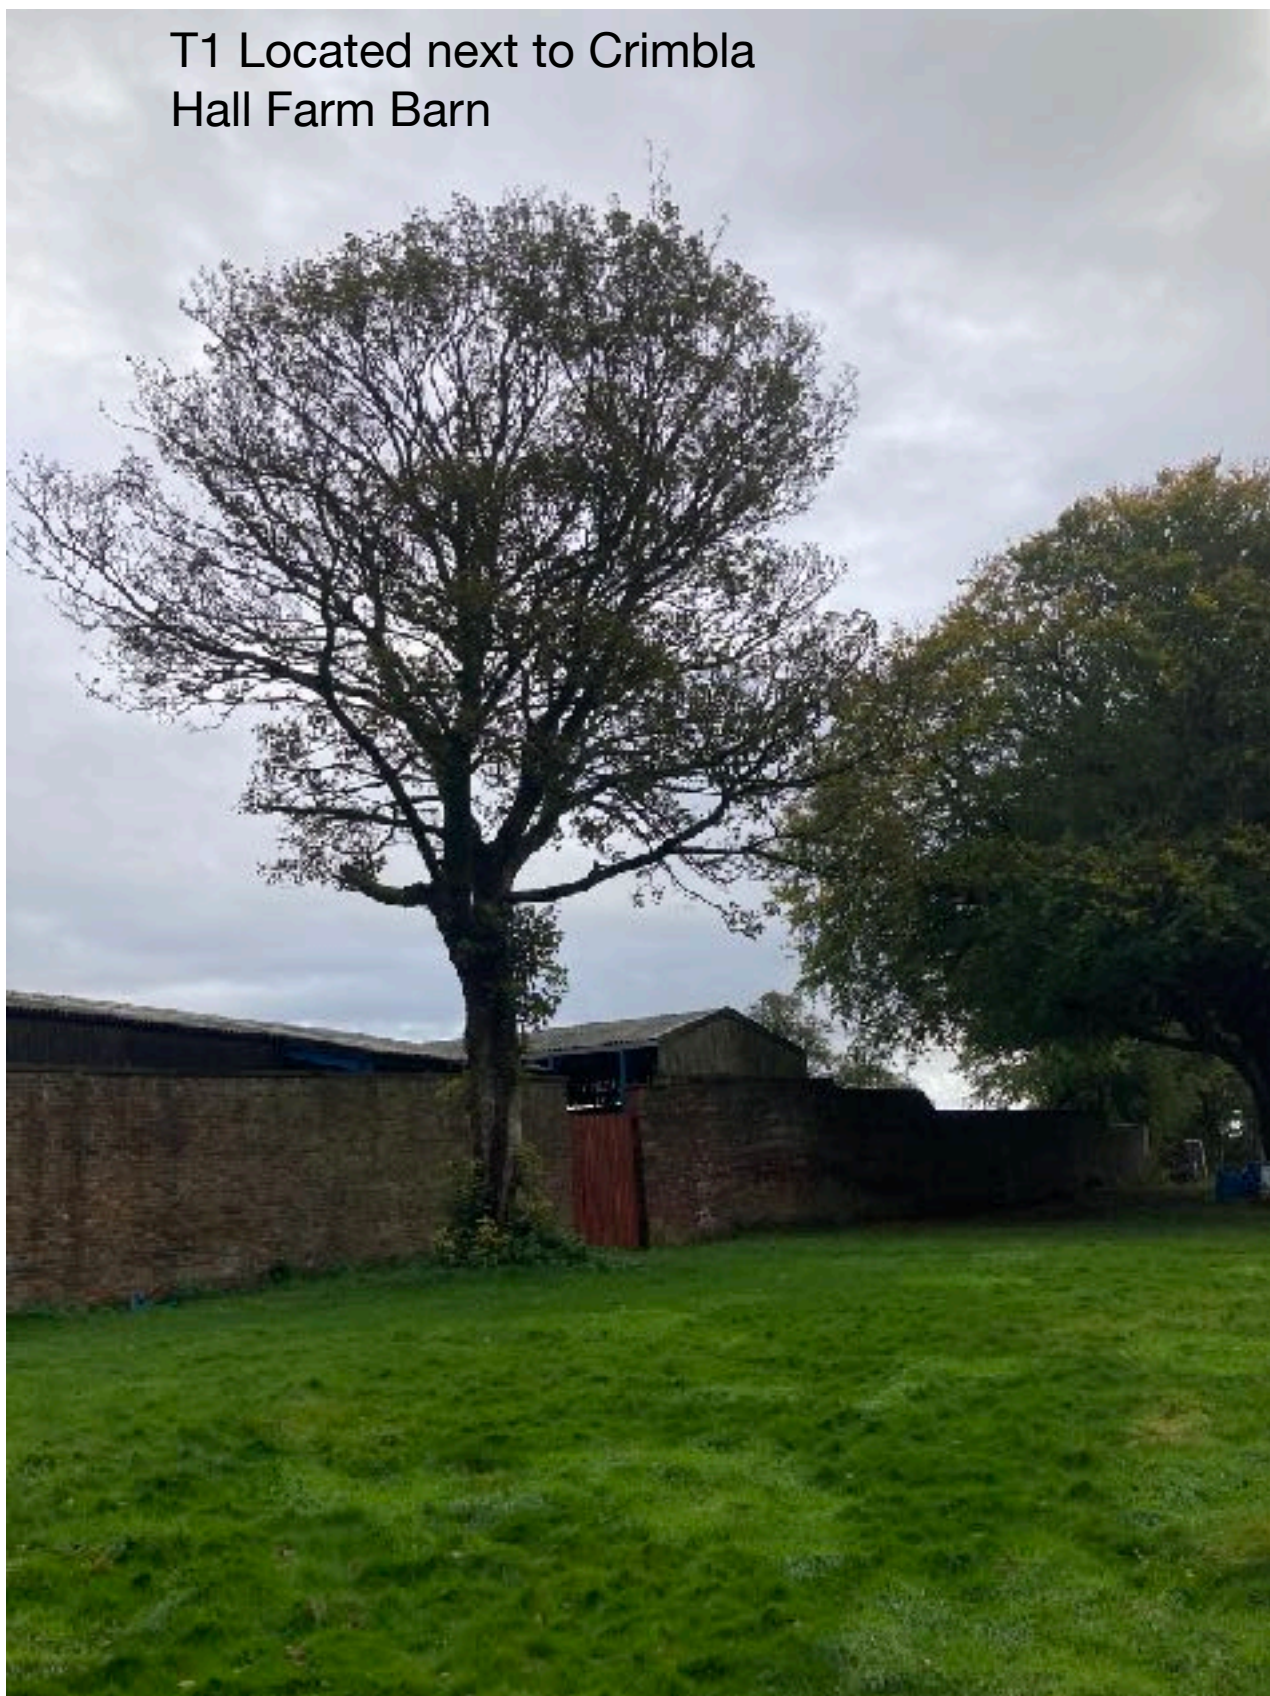
The tree is extremely close to the neighbouring barn and its crown predominantly overhangs the property so its crown leans more over the barn by several metres, causing great concern given its size, proximity and the fact it has a decaying main stem and declining canopy; which will only decay further and get worse, making the tree dangerous & unsafe and more liable to fail in a bad storm.

T1 Located next to Crimbla  
Hall Farm Barn

T1 - Sycamore - FELL

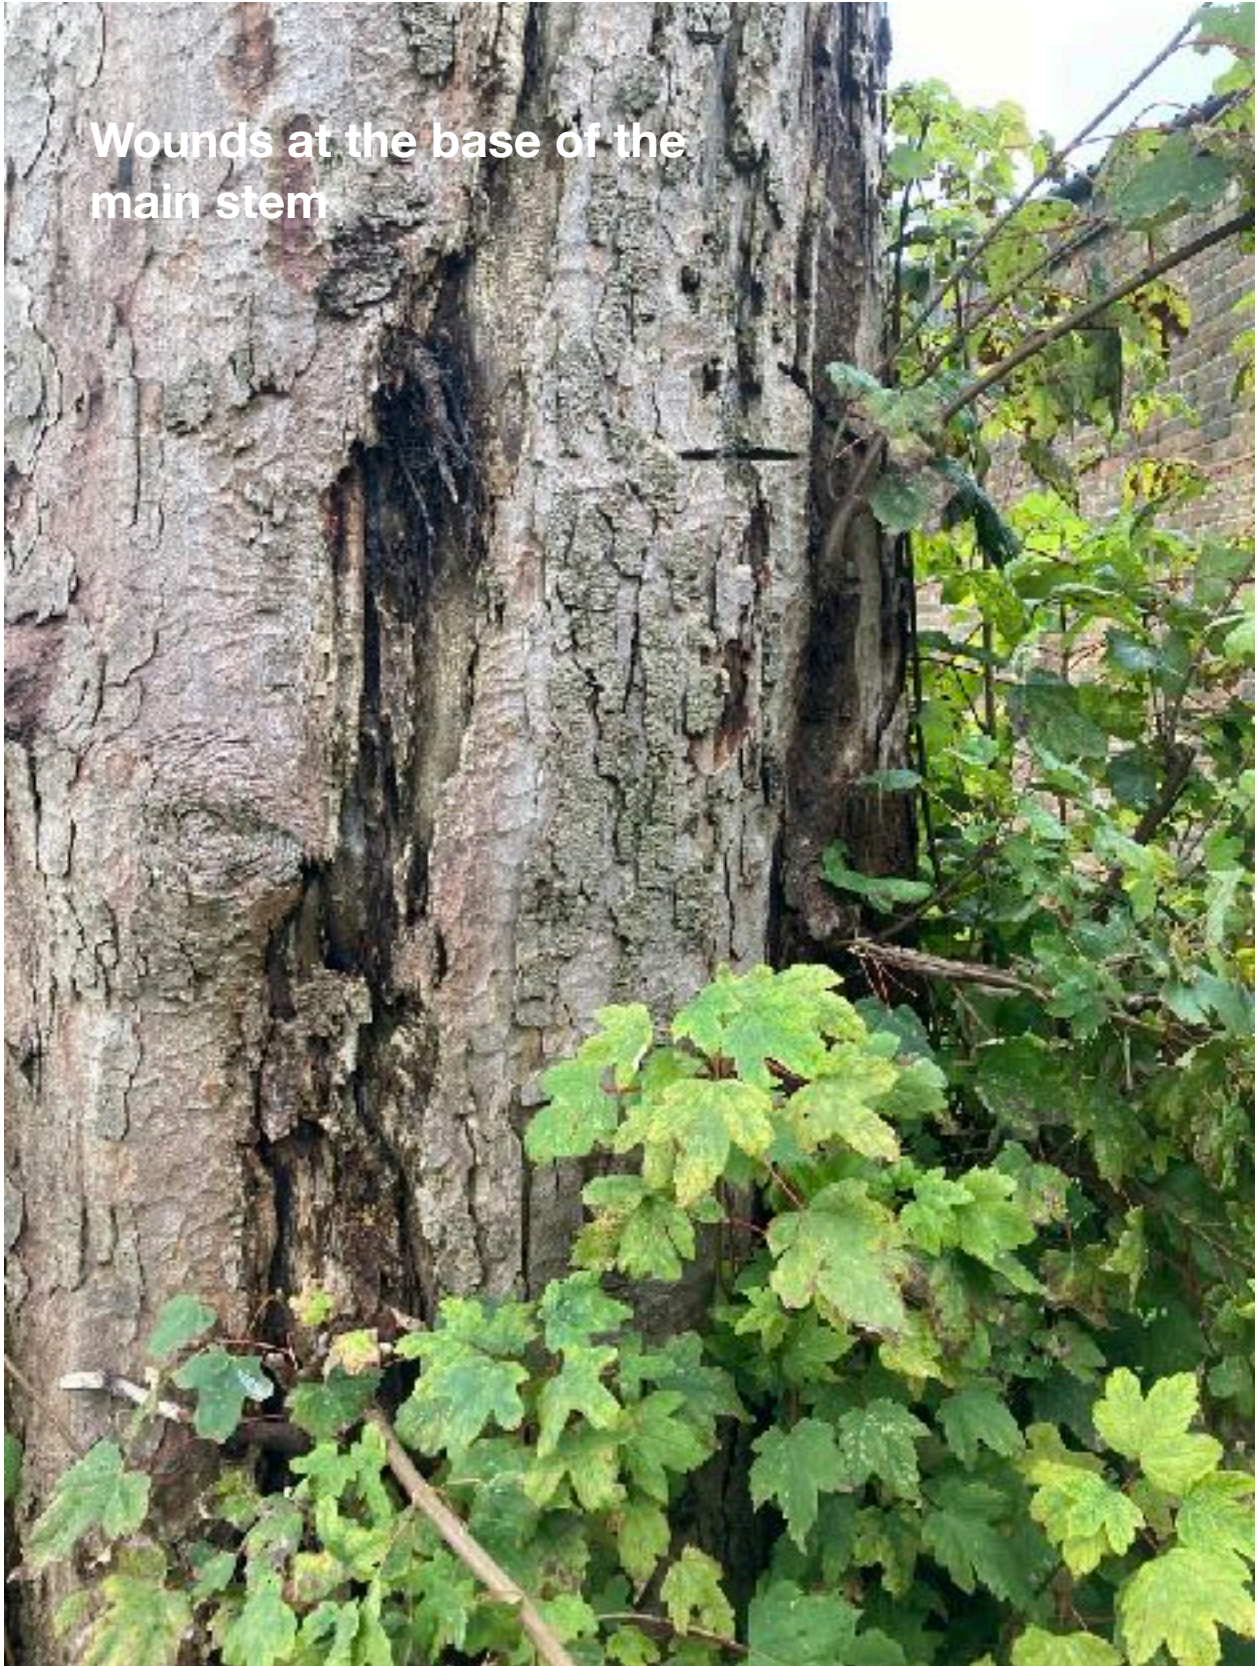
This is an over mature Sycamore tree within the grounds of an old farm, it is a poor specimen and has some very bad wounds leading to decay.

Wounds at the base of the  
main stem

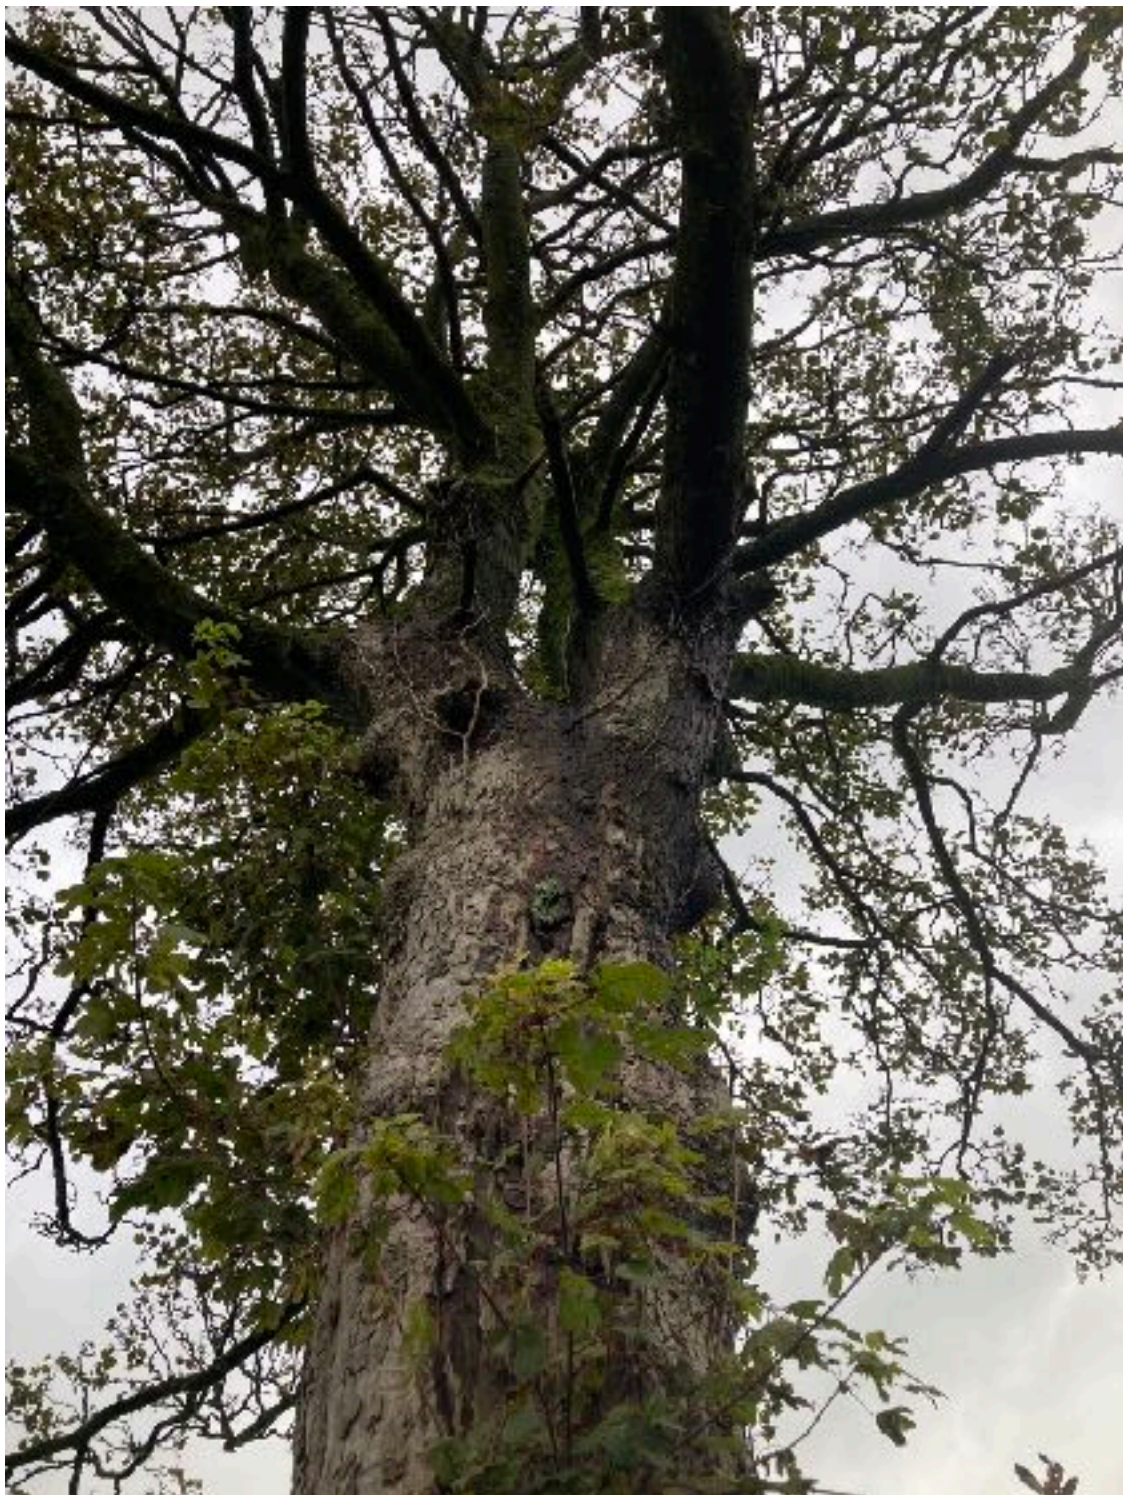
Fell Mature Sycamore tree which is showing crown decline and main stem decay. It has several cavities through out the main stems.

T1 Showing a declining canopy

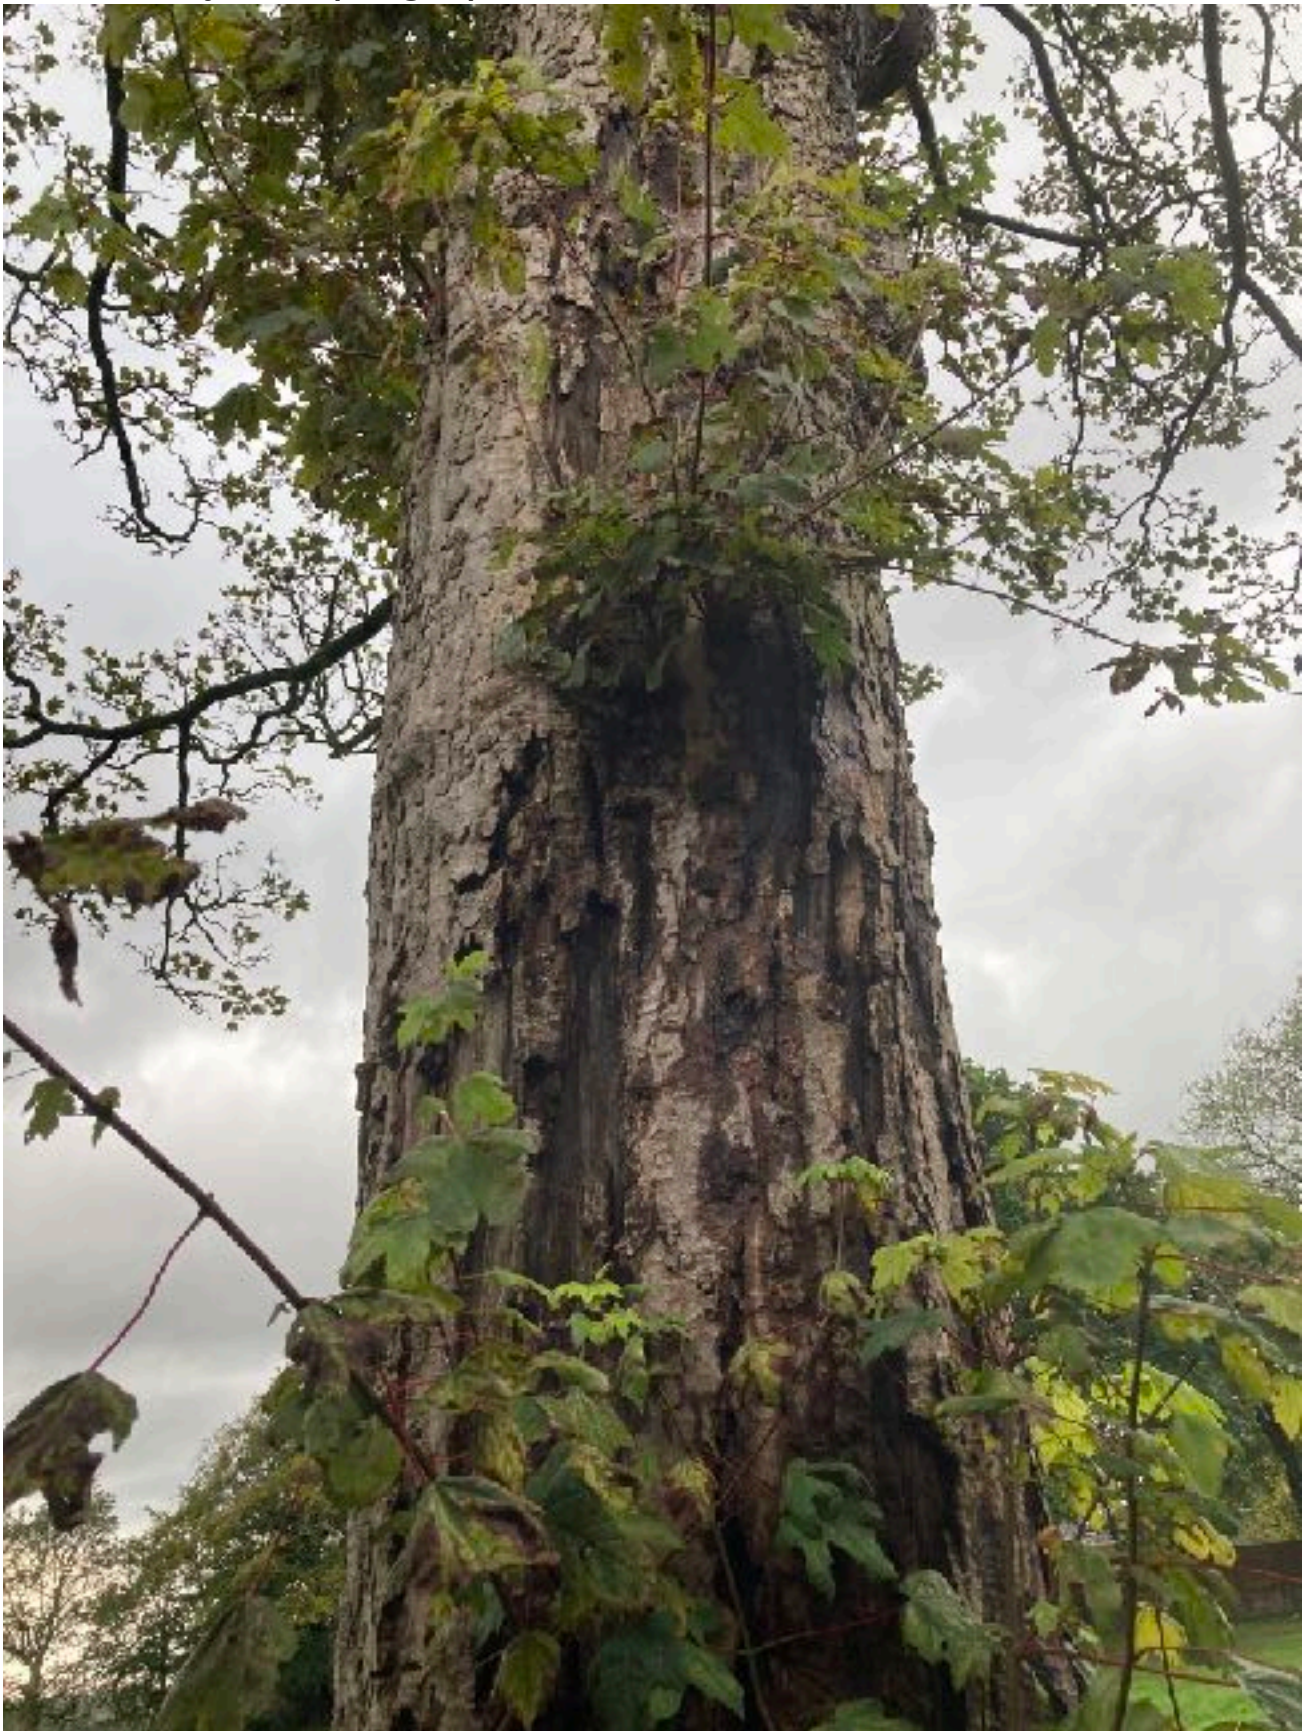
Decay creeping up the main stem from the base
