## **Tree Surgeons Ltd**

### **Mini Tree Report**

**Date: 10/11/2020**

Mr Simon Byrn  
Ref land at the junction of Bradshaw St and Manchester St  
Heywood

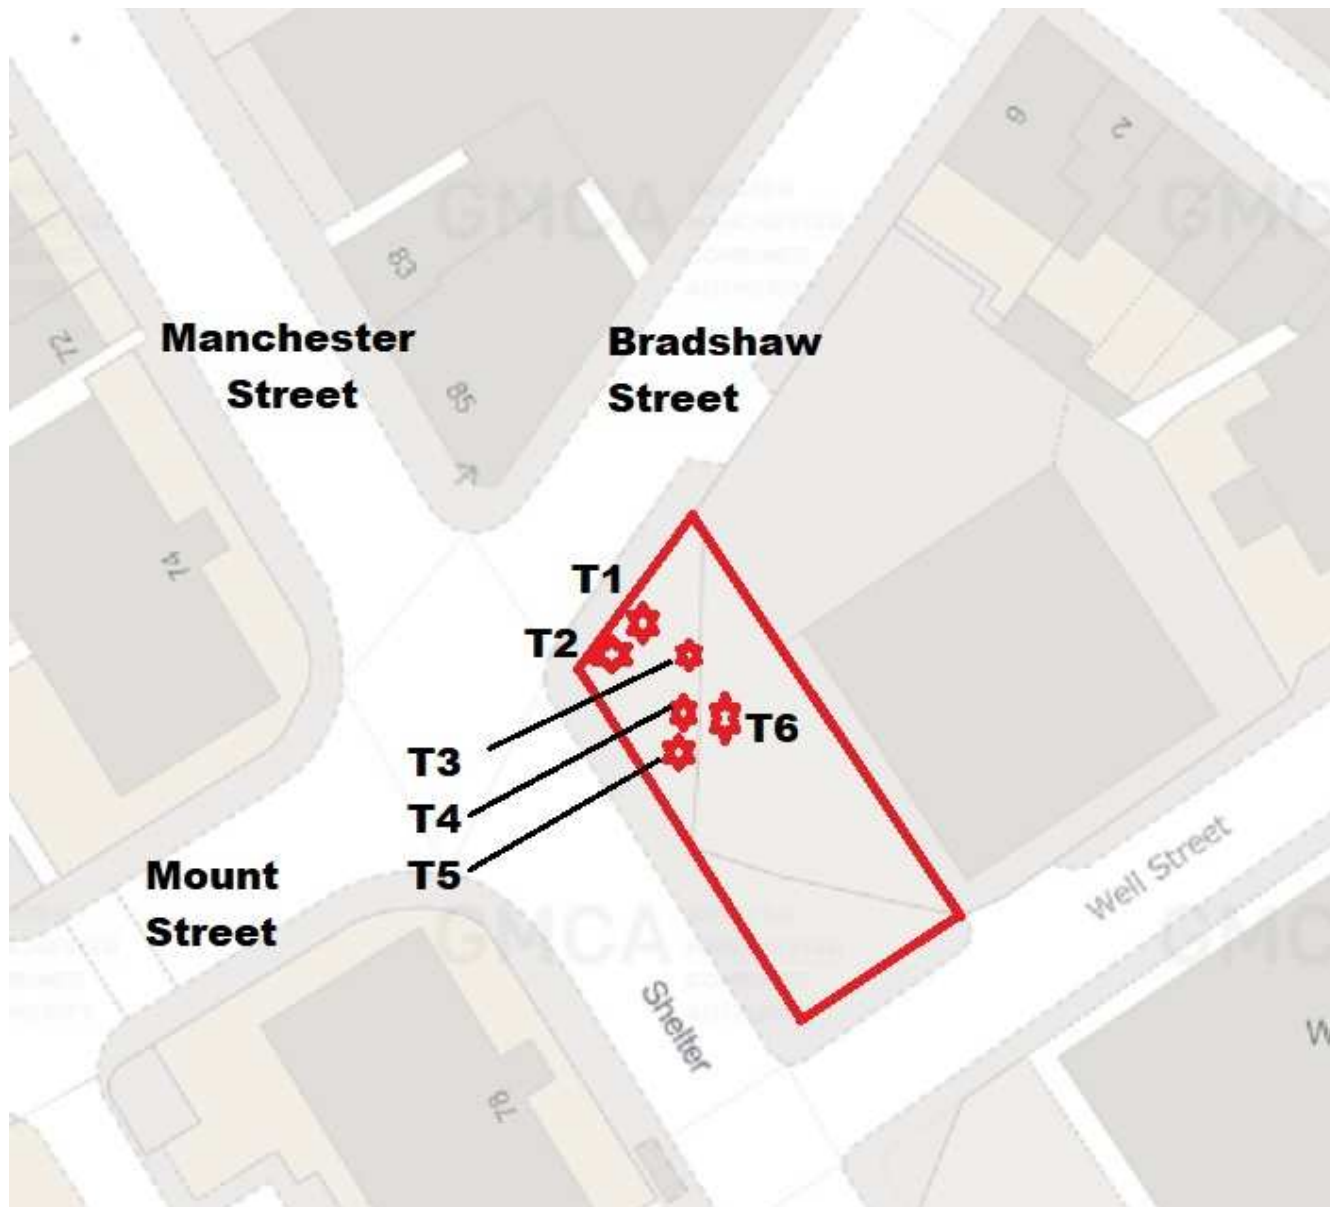
Five willows and a birch tree, all small and appear to of self-seeded referenced T1-T6 on the plan.

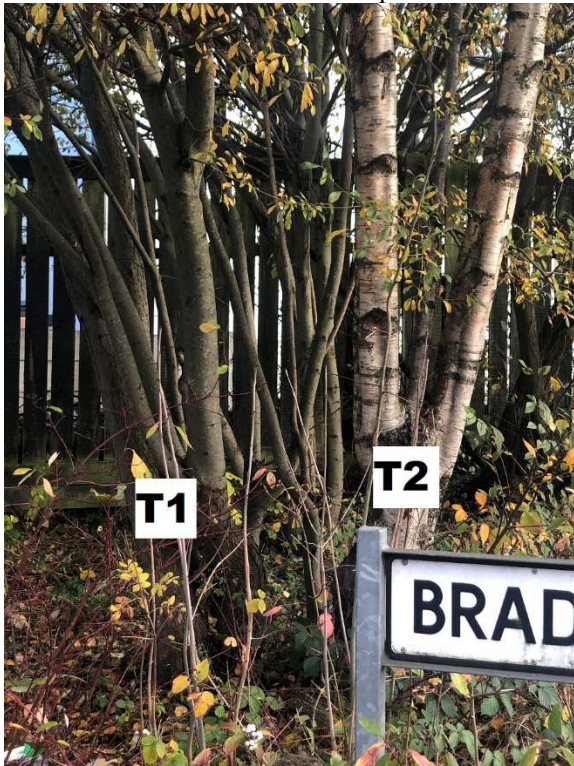
T1 = Willow 8-meter that bifurcates at its base then goes multi stemmed from 1.5 meter where it was coppiced and regenerated. Poor example

T2 = Birch 9 meter that has grown immediately next to T1, bifurcates at 1 meter into 2x 140mm stems. Poor example.

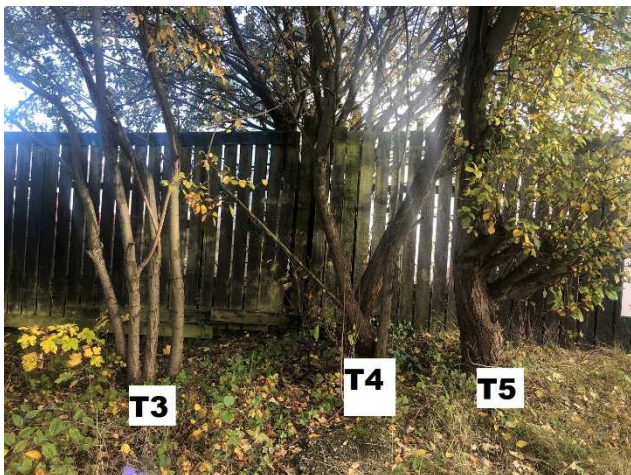
T3 = Willow 5-meter multi stemmed from base Poor example.

T4 = Willow 8-meter multi twisted overlapping stems from base. Poor example.

T5 = Willow 8-meter 180mm DBH leaning with regrowth emanating from poor previous branch removals. Poor example.

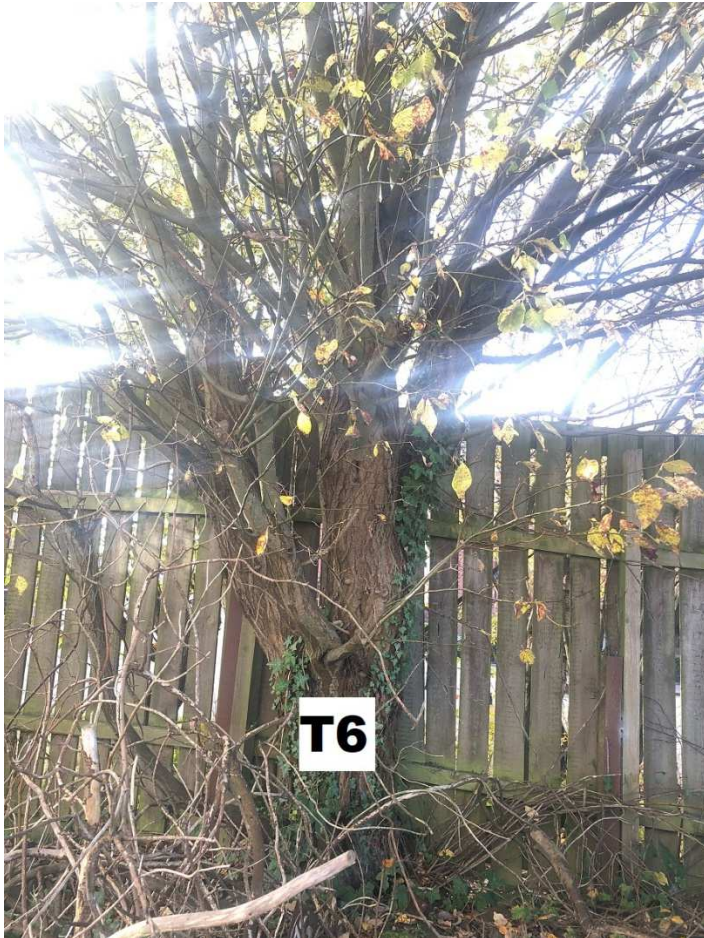
T6 = Willow 8 meter bifurcates at 1 meter previously pollarded to 3 meter and regrown a dense canopy. Poor example.
