# BRIEF ENVIRONMENTAL AUDIT

Branch Road Farm

Littleborough

Author: Daniel Slattery  
Client: Mr Wildman.  
Reference: rep-tjba-wildman-branch rd farm-brief env  
audit-101219.docx

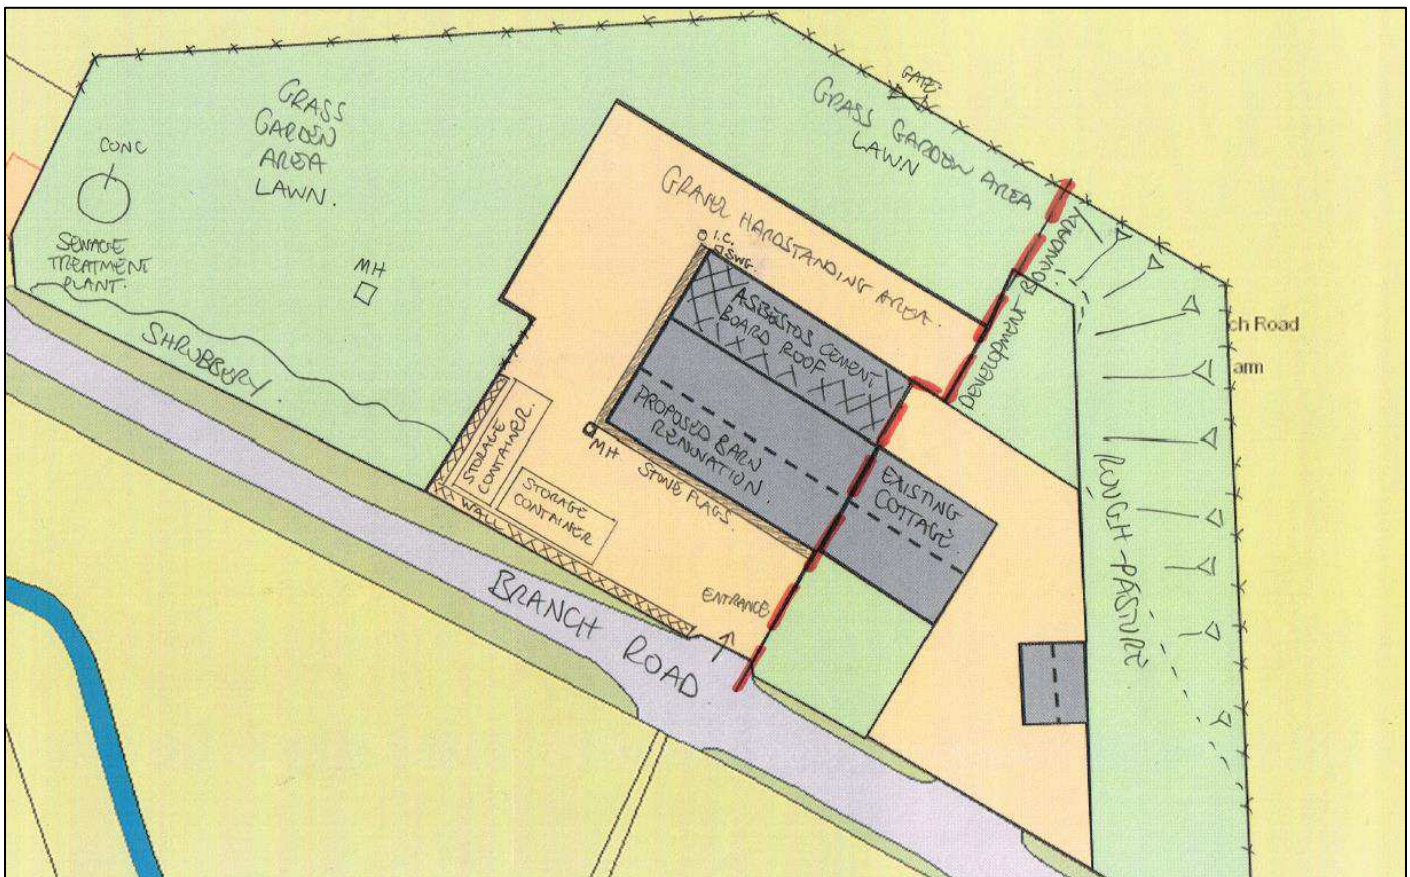
### 8.2. Existing External Plan/Reconnaissance Plan.

| Details of existing structures: | <p>The Site comprised the existing farmhouse to the SE side, and the barn to be converted to the NW generally separated front and rear by a stone wall.</p> <p>The barn was accessed from the front S corner of the Site off Branch Road. Simply the development site comprised the original barn with lean-to shippen to the rear. Surrounding the barn on all sides was a gravel hardstanding driveway, with a grass/lawn garden area surrounding.</p> <p>On the hardstanding to the front of the Site were two shipping containers assumed to be used for additional storage.</p> |

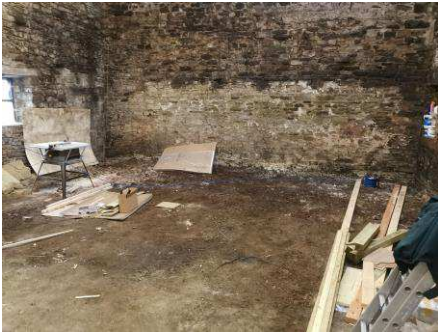
| Nature and integrity of existing floors and hardstandings: | <p>The main barn at the personnel entrance comprised concrete floors to a private household storage area. Moving through to the main barn formerly used for cattle and hay bailing was a compacted soil floor to the centre to NW side of the building. There were stone flags to the SE part leading from the vehicular opening to the shippen to the rear. The shippen itself comprised a concrete slab floor.</p> <p>Externally the Site comprised a gravel hardstanding driveway, assumed to be of good construction given the compactness and strength under foot &amp; vehicle weight.</p> |

Photo 1. Exposed soil ground to barn interior.

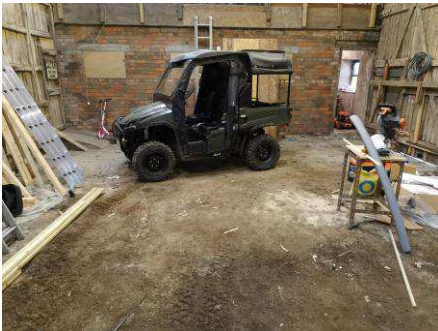
Photo 2. Exposed soil ground to barn interior with stone flags in background.

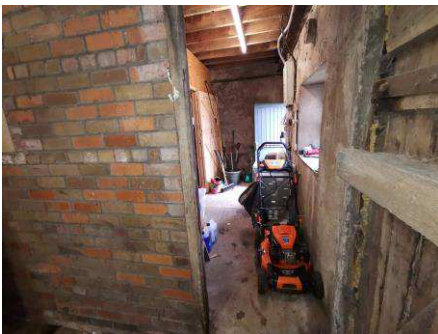
Photo 3. Concrete floor slab to barn interior storage area.

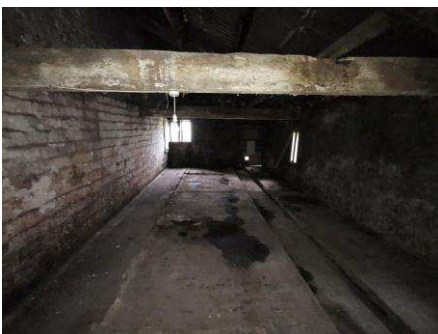
Photo 4. Concrete floor slab to shippen.

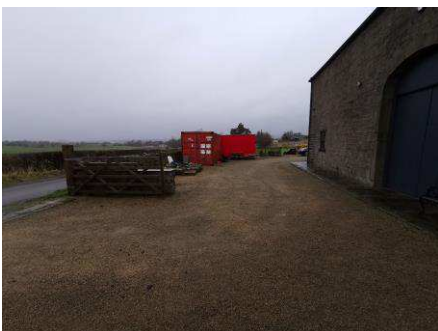
Photo 5. Front external gravel hardstanding.

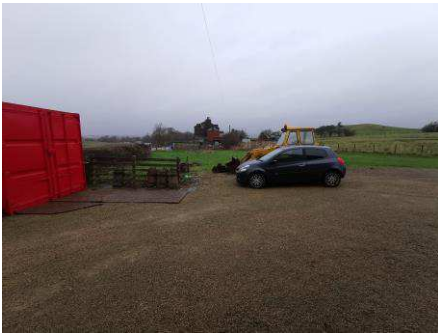
Photo 6. Front/NW side gravel hardstanding and lawns to background.

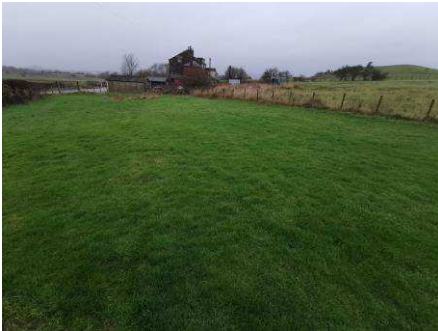
Photo 7. Lawns to NW side.

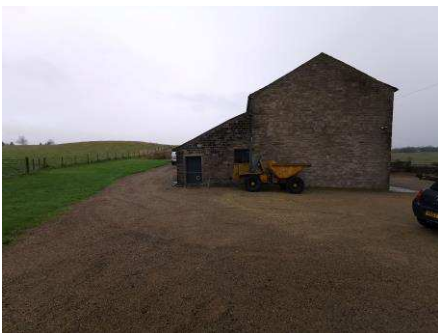
Photo 8. NW elevation.

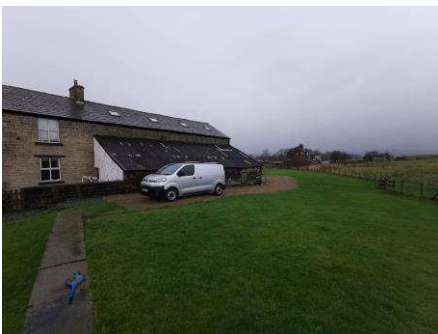
Photo 9. Rear NE side garden and elevation.

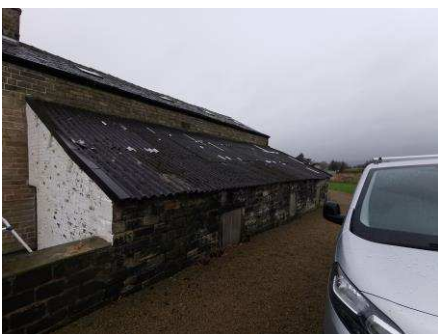
Photo 10. Rear NE elevation showing asbestos board roof to outrigger.

The asbestos roof to the outrigger should be carefully removed, bagged and taped strictly in accordance with the HSE guidance for ACM fibreboard removal, and be disposed of in a suitable waste facility only. The HSE website provides information on the non-licensed removal of such products provided they are in good condition.
