Week 3– Stage Floor lifted to reveal oriel window support frame

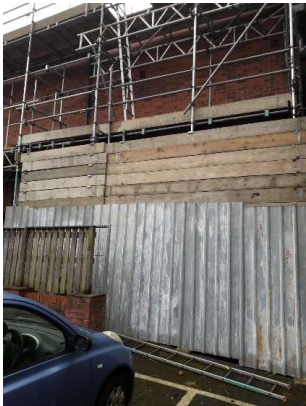
Additional access control to the rear following unauthorized access to the scaffolding

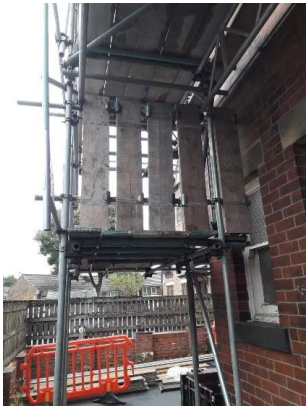
Additional hoarding – scaffold on-going

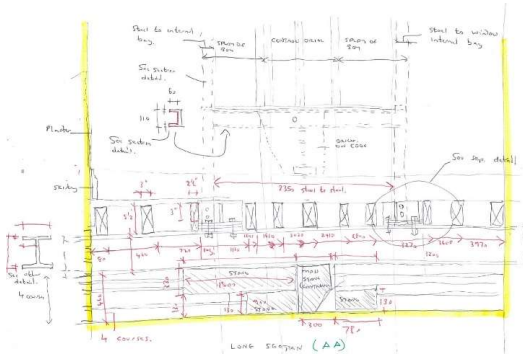
Detailed survey by architect of existing oriel window support structure

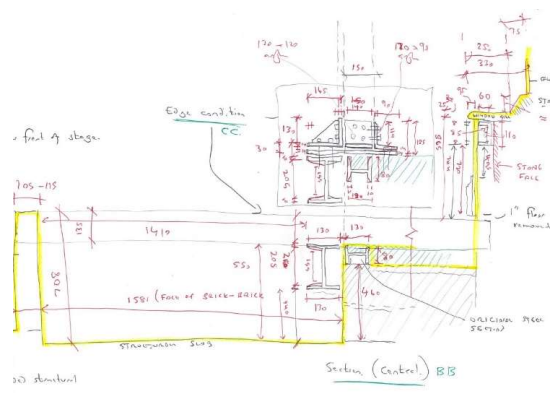
Sketched and photographs issued to the Structural Engineer for comment and recommendations
