### **Area 3 Works Overview**

# Manhole Record Card

| Job No | TS24-386 | Project | Stakehill Industrial Estate |

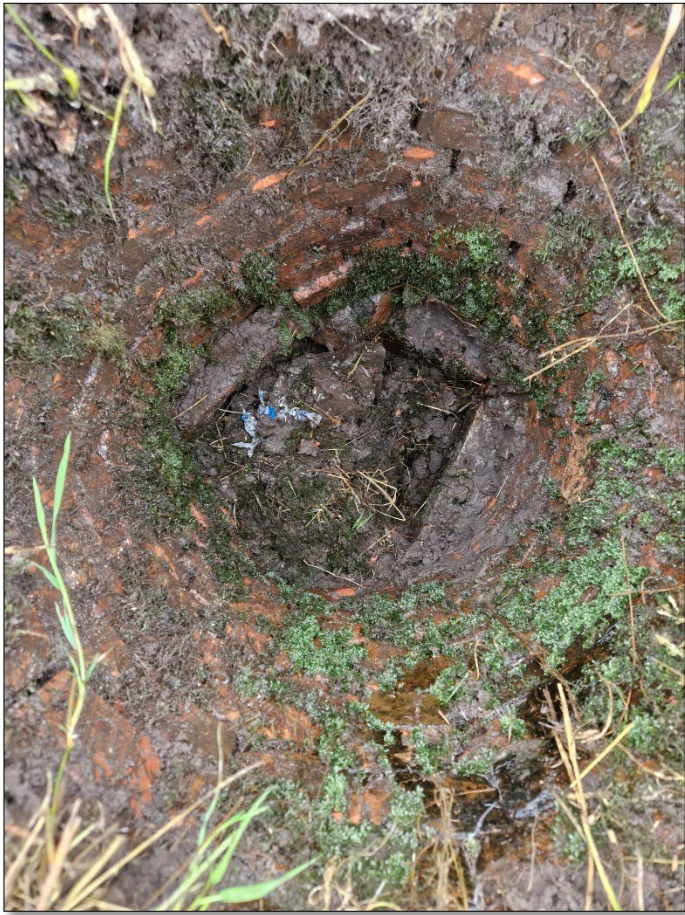
**MH3 Internal View During Clearing**

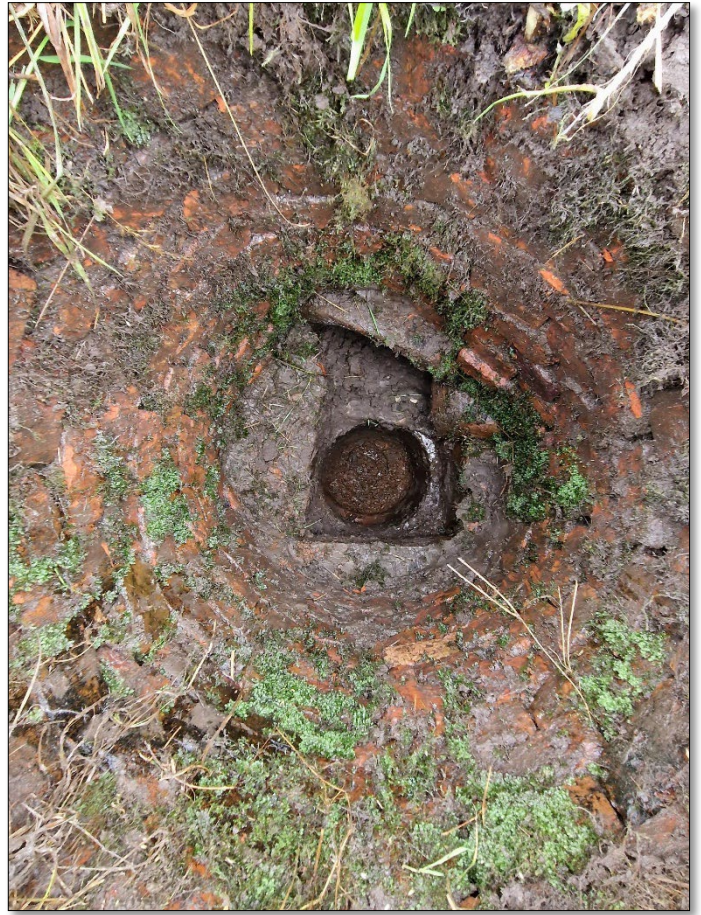
**MH3 Internal View**

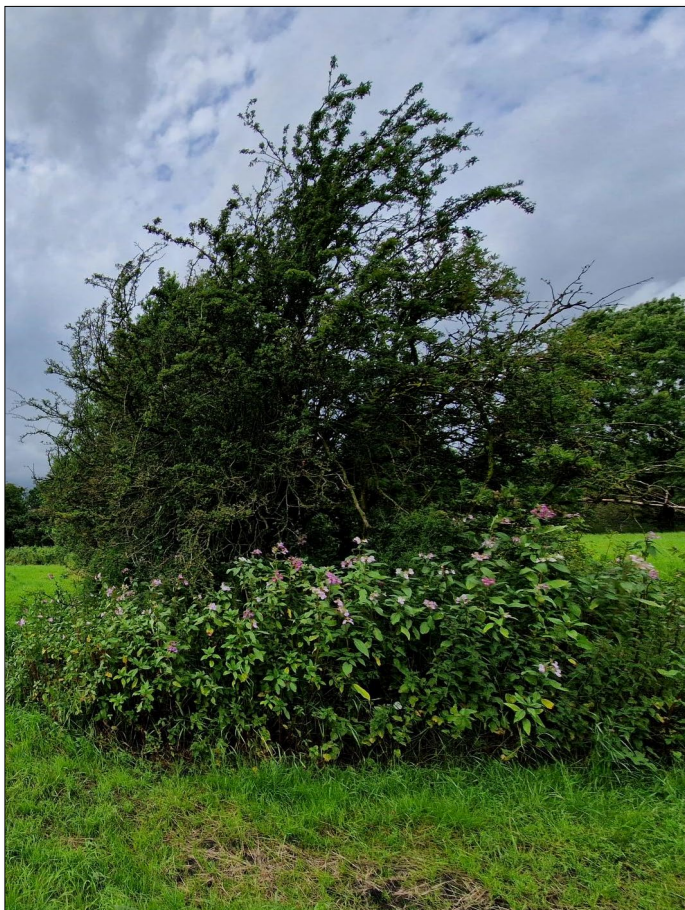
**Watercourse/Ditch Location View**

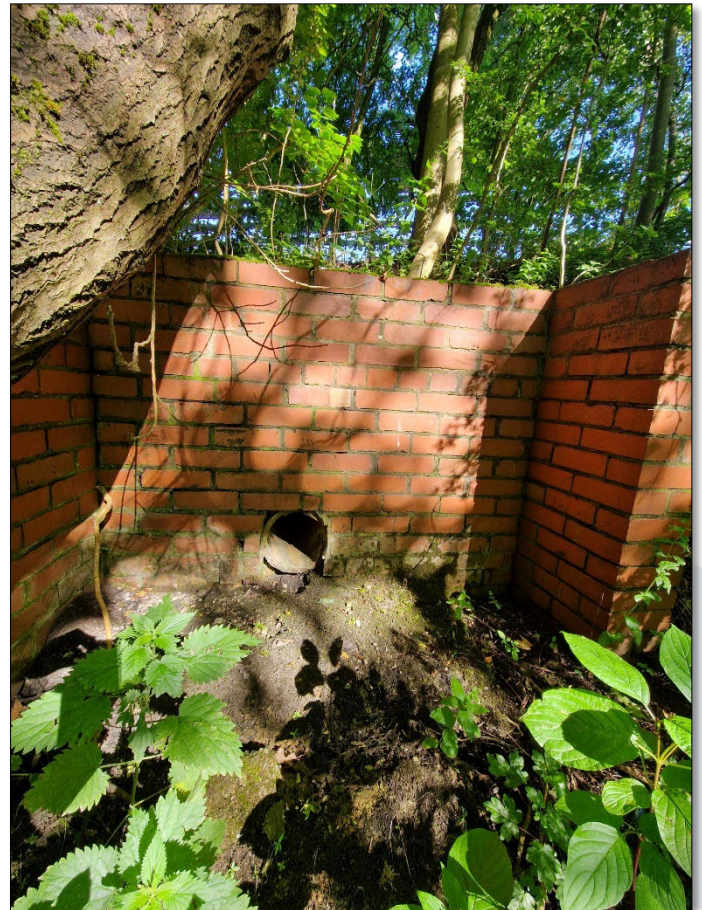
**Pond Inlet Headwall**

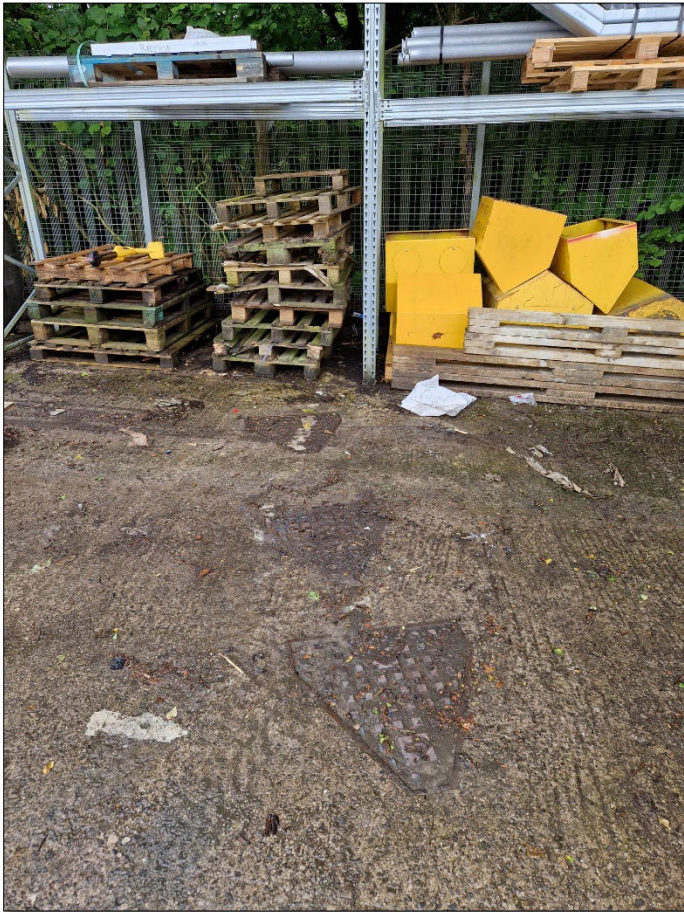
**Petrol Interceptor Location View**

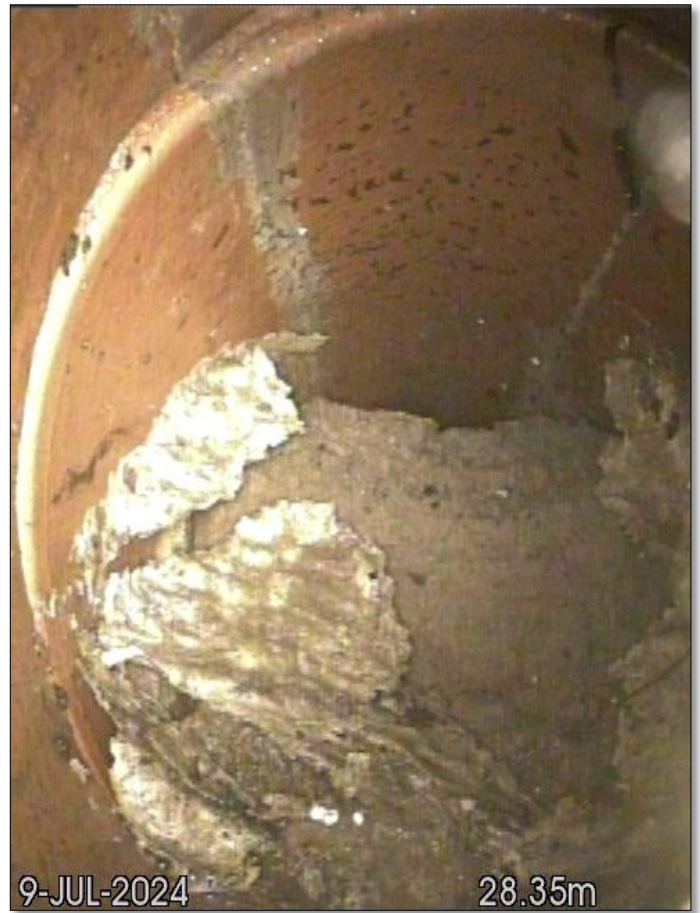
**PI Upstream Pipe Condition View**

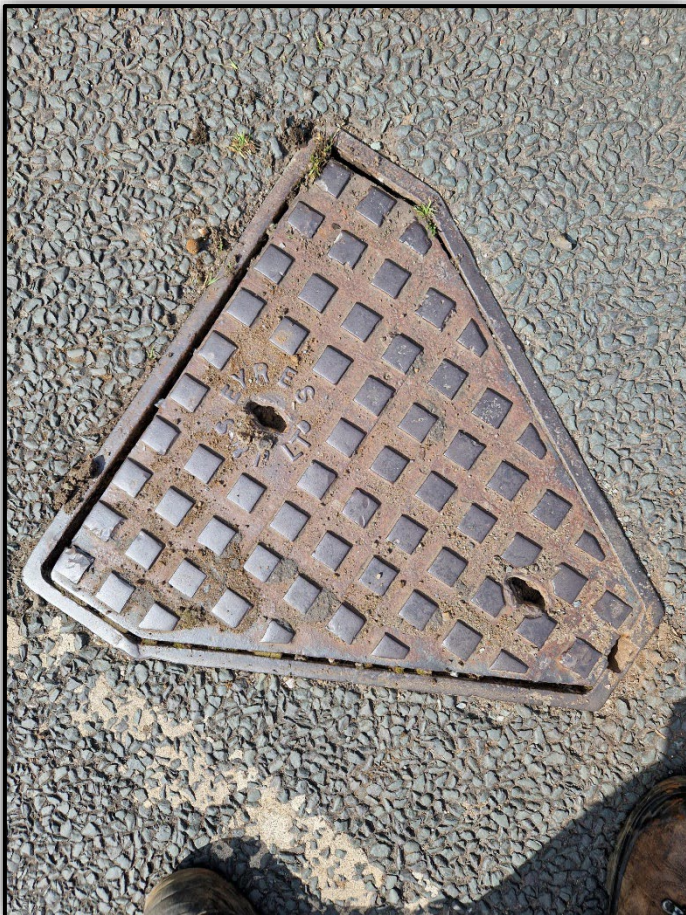
Manhole S2 has become compressed into its frame and could not be lifted after repeated attempts to free it with hand tools and a mechanical lifter.

**S2 Seized Manhole Cover**

- Combination Lorry Jetting Unit to attend site to empty and HPWJ manhole MH1 and undertake further investigation/CCTV survey of any accessible connecting sections.
- Break out and replace seized manholes S2 & C5 to survey manhole chambers and verify connectivity

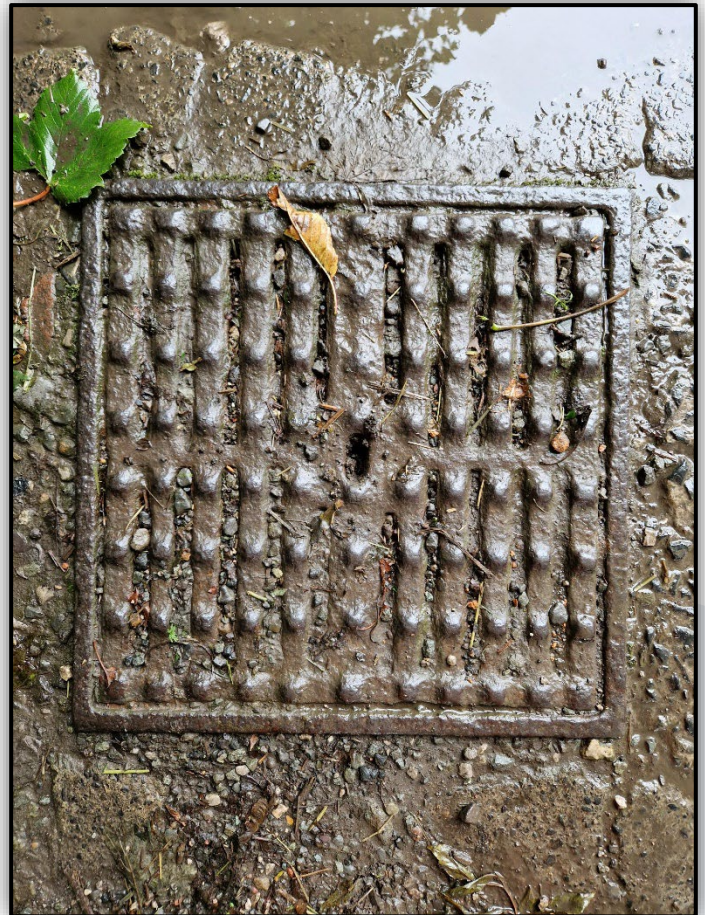
The grated manhole cover on C5 has become seized into its frame and could not be lifted after repeated attempts to free it with hand tools and mechanical lifter.

**C5 Seized Grated Manhole Cover**
