R3838

244 HARBOUR LANE, MILNROW, OL16 4EN

JULY 2024

# REPORT ON STRUCTURE

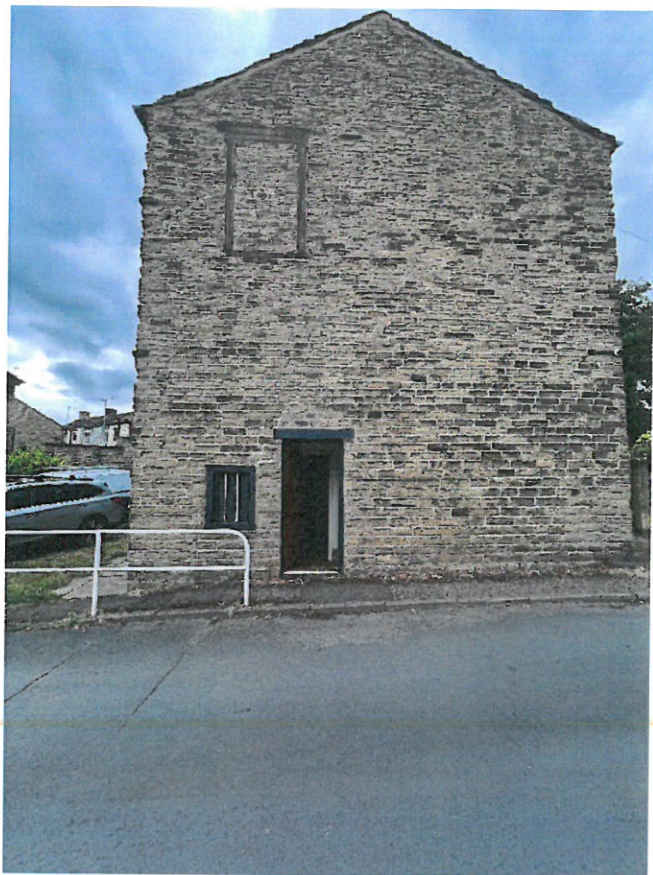
Photograph 1

**2.01** No 244 Harbour Lane is a three storey, stone built, dwelling. The gable elevation fronts Harbour Lane. These are three openings in the gable. A door and window around floor and an infilled window / door at second floor. Photograph 1.

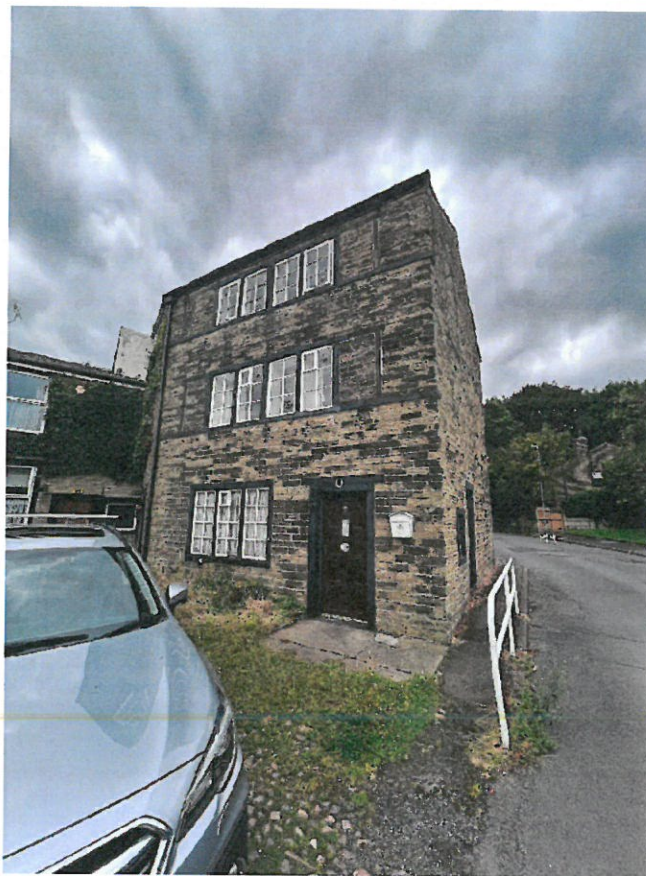
Photograph 2

The front elevation comprises of a door on the right of ground floor with a three mullion windows to the left. At first floor there is a set of 6 mullion windows two of which have been stoned up in the past. A similar set of windows occurs at second floor. Photograph 2.

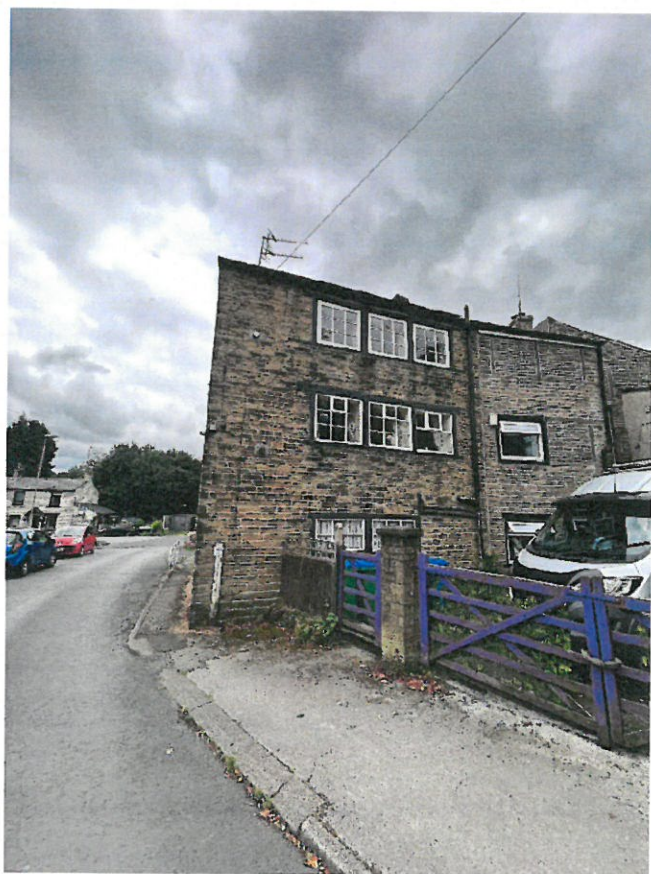
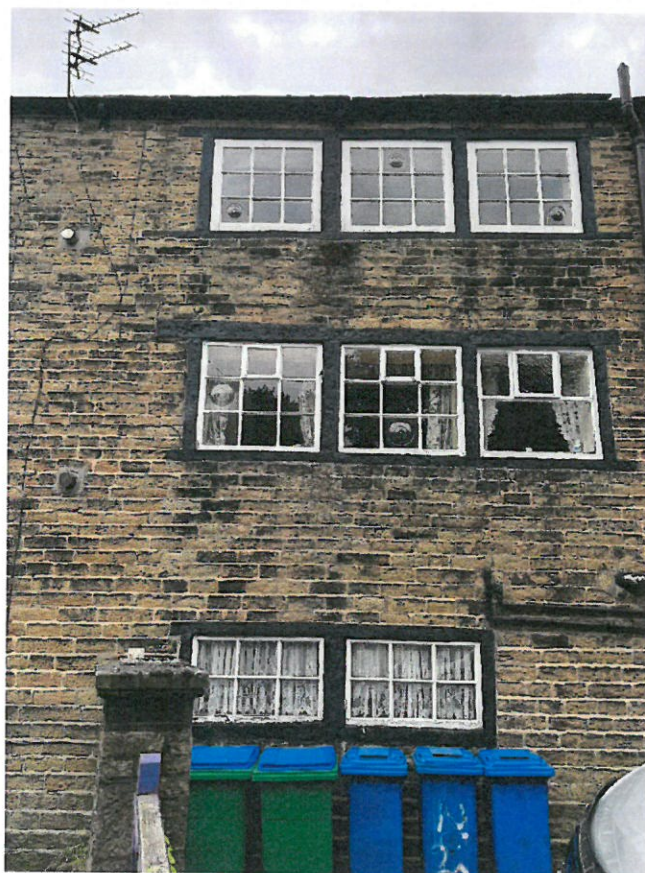
**2.03** On the rear elevation there is a double mullion window at ground floor and three large mullion windows at first floor and second floors. Photographs 3 & 4.

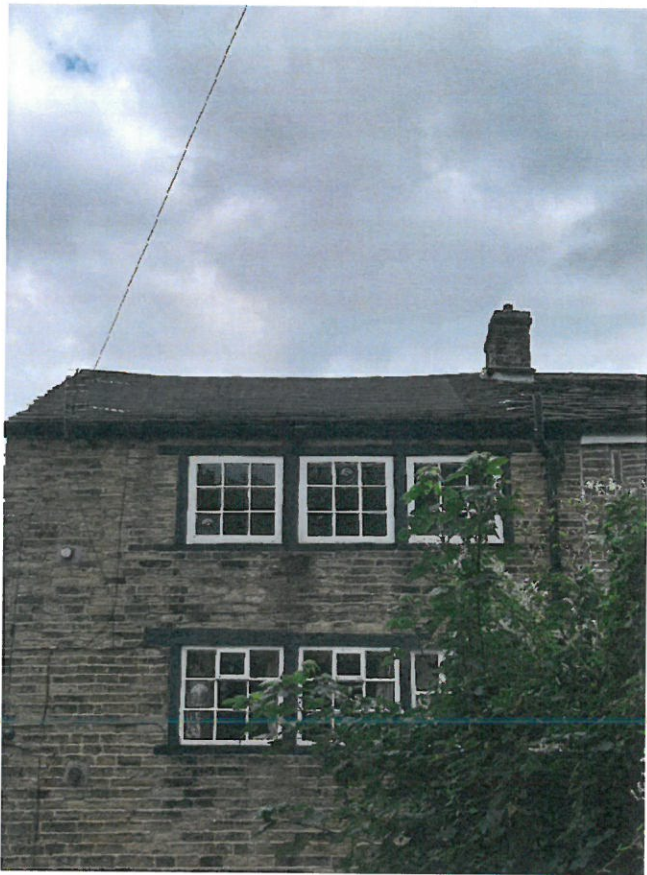
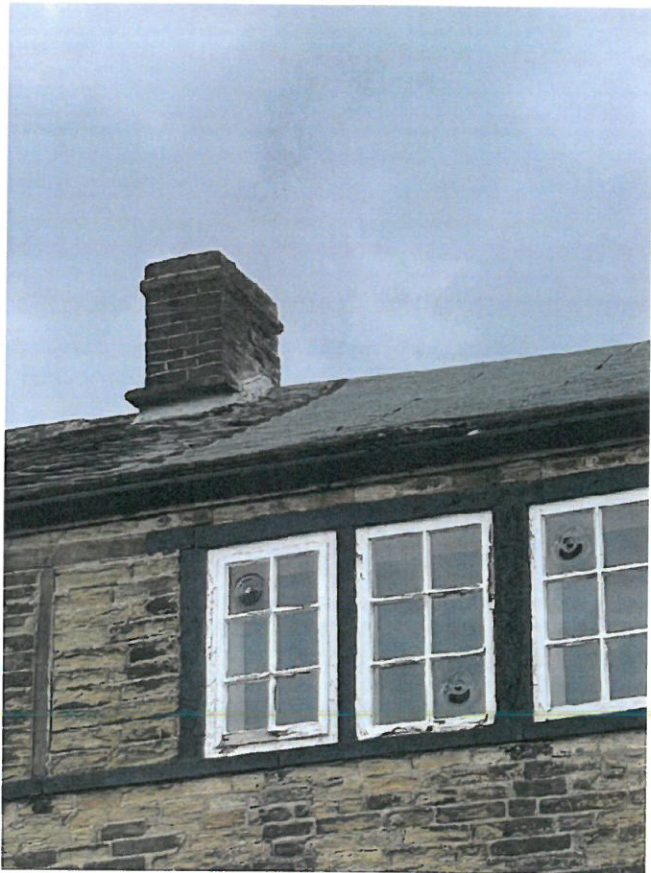
There is a single chimney stack straddling the ridge and positioned over the party with number 248. Photographs 5 & 6.

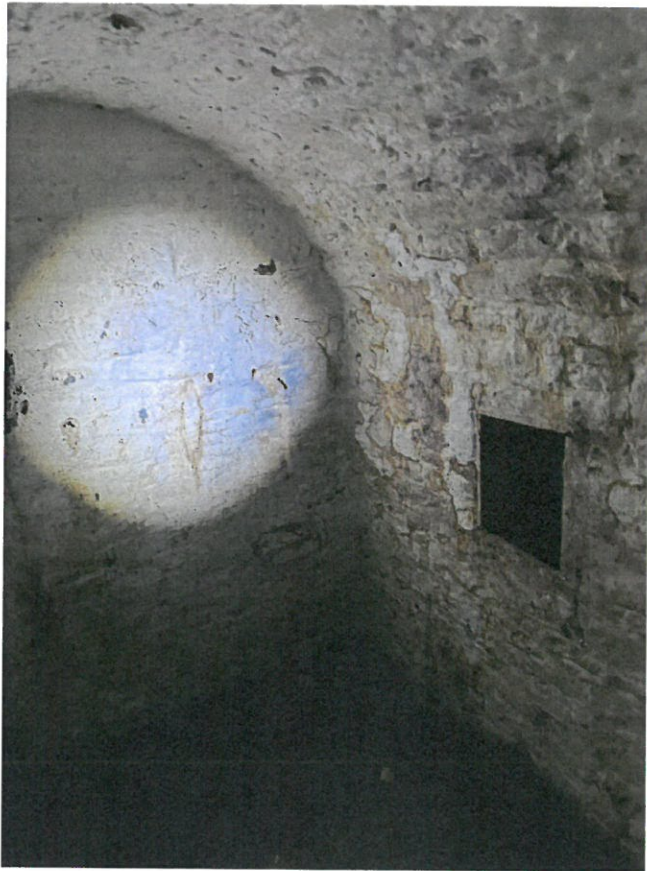
Photograph 7

**2.11** There is a nominal coal cellar with a stone vaulted arch roof. This is located under the front right-hand corner of the building. Photograph 7.

The cellar occupies the area beneath the front right-hand corner only. This is damp.

The cellar should be used for selective purposes only.

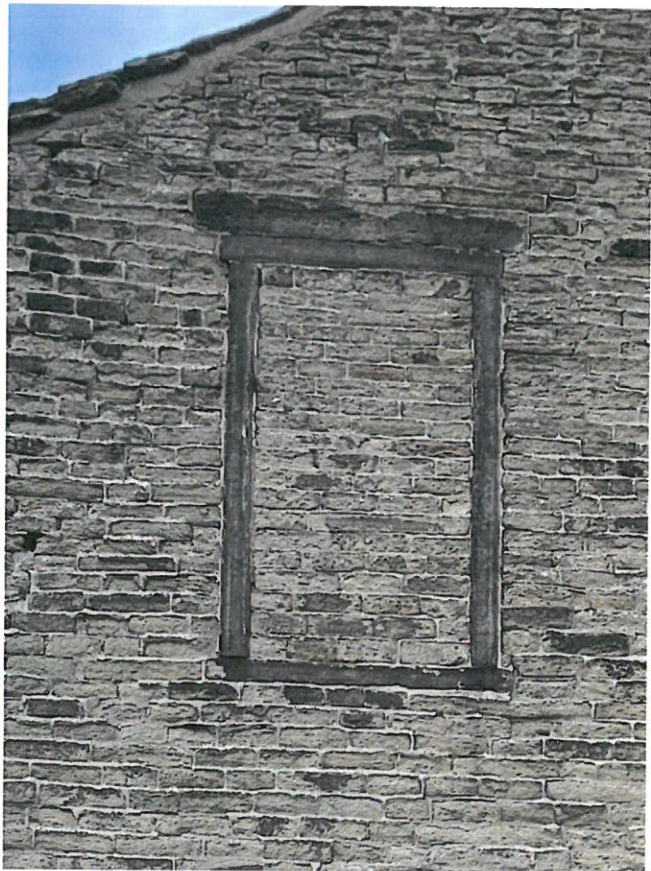
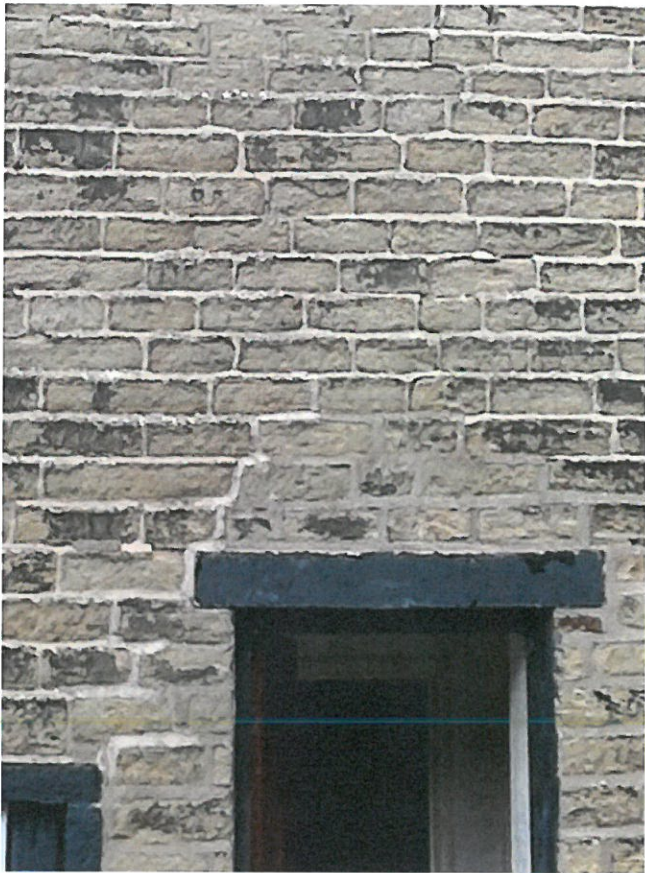
The external walls are faced with a natural stone. The stone is generally coursed with varying course sizes. The inner leaf is of brick. There are nominal areas of past cracking and other forms of distress. Photographs 8 & 9 are typical.

These are of an old and longstanding nature do not give cause for concern. No significant remedial action is deemed necessary.

Local repointing with a lime base mortar will suffice.

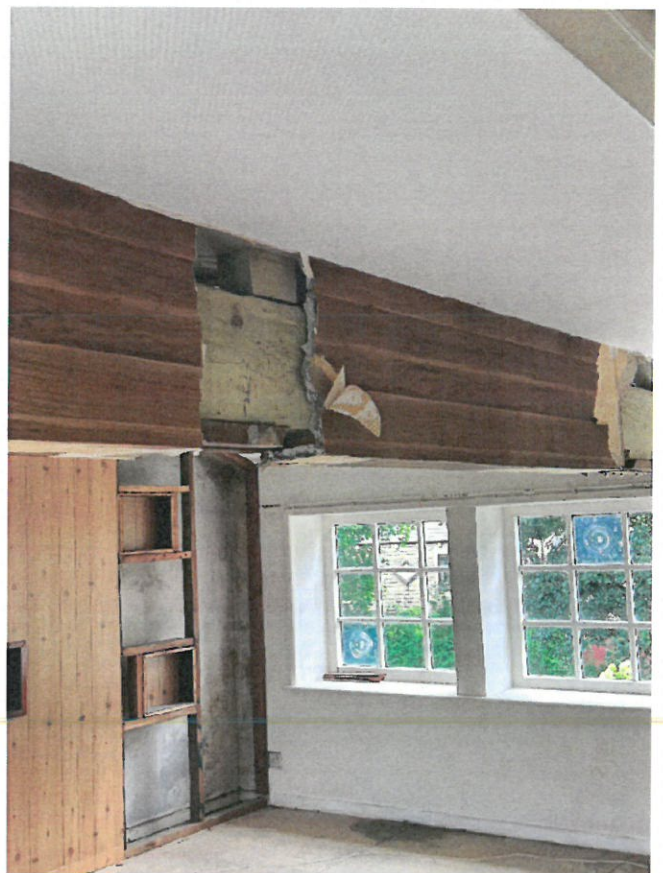
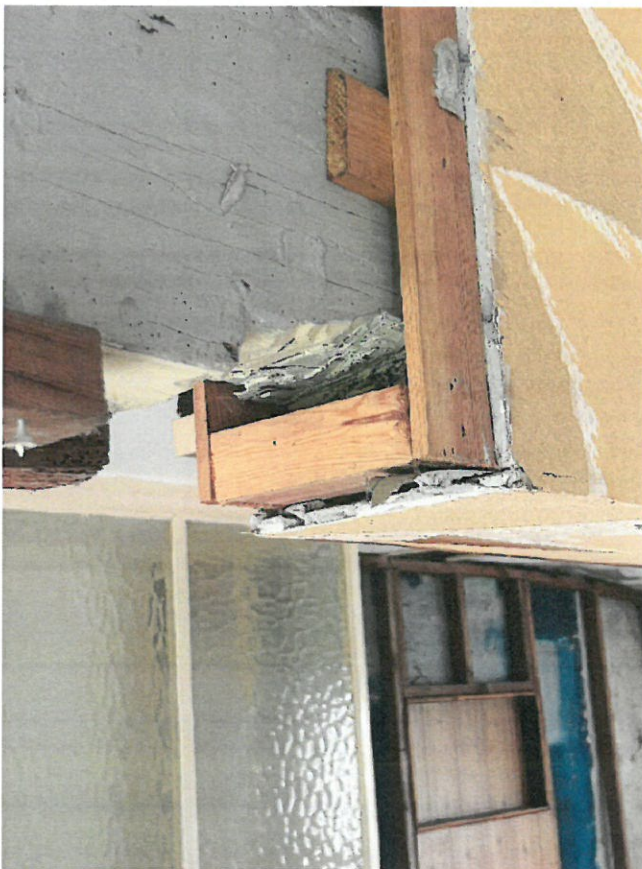
The bottom boom of this is partially visible below the second-floor ceiling where it has been clad. Photographs 10 & 11.

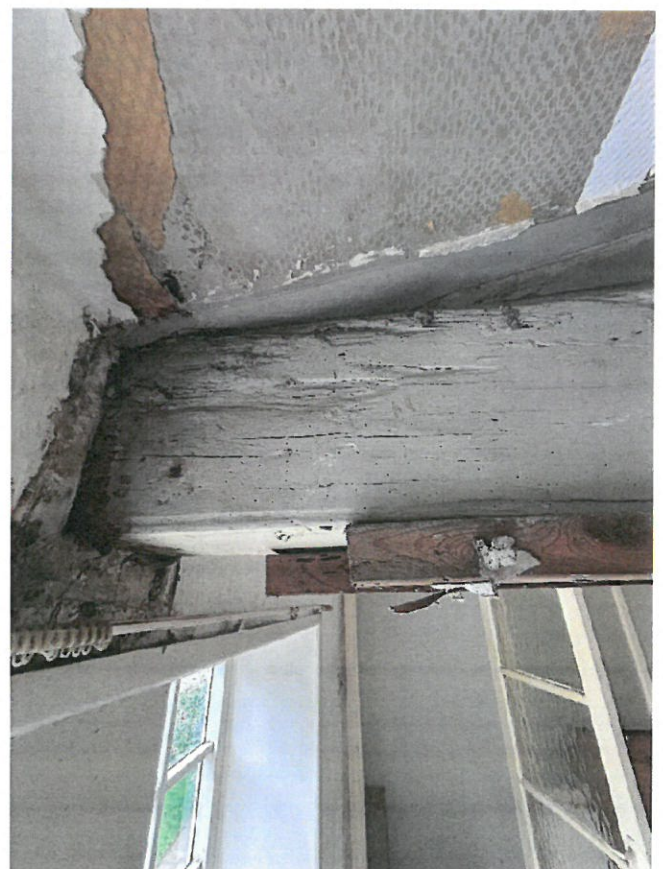
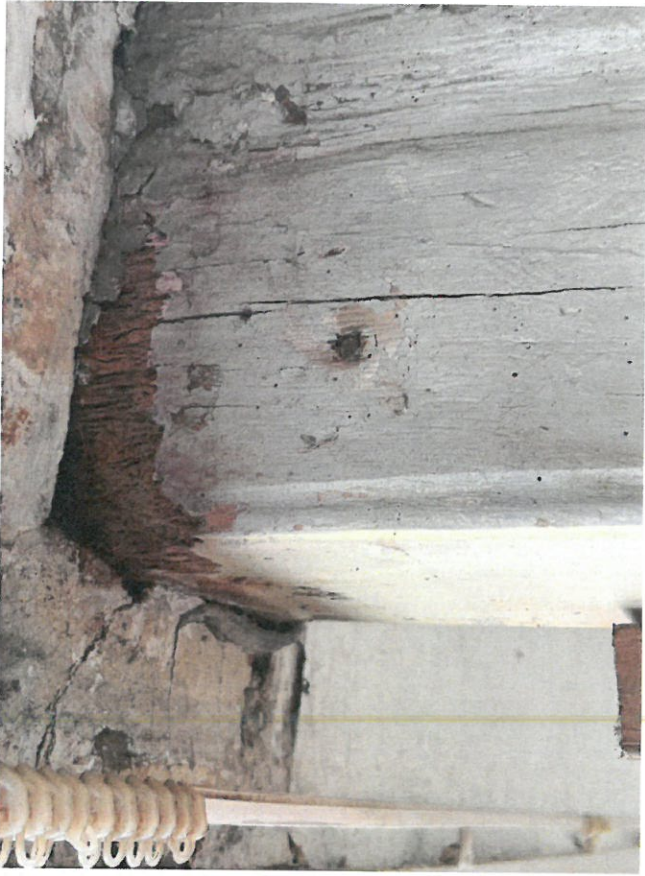
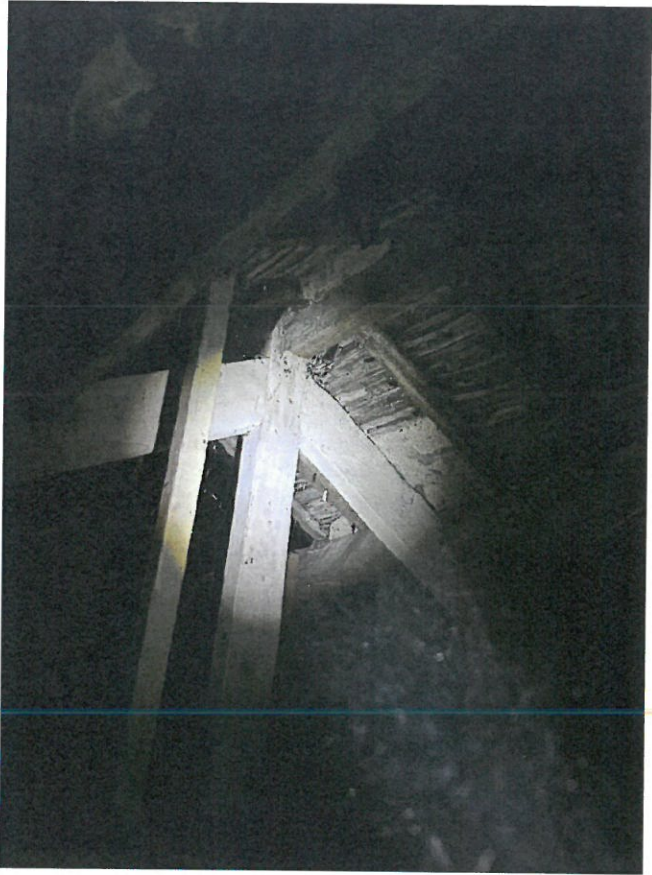
The bottom boom has been notched in place. The ends of the truss are partially visible. Photographs 12 & 13. Photograph 14.

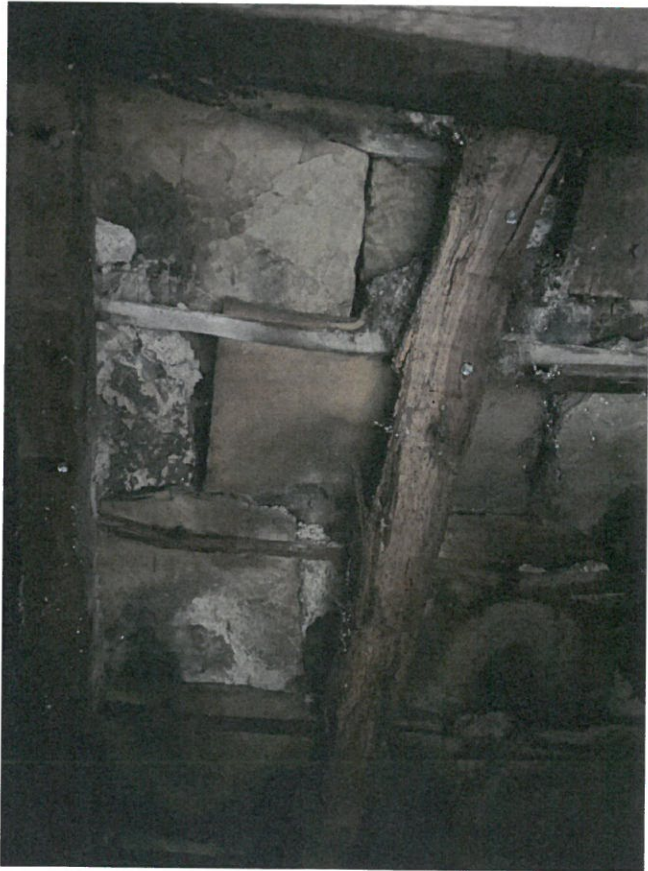
Photograph 15

In the roof void it is clear that the roof covering is of a natural stone slate. Photograph 15.

The stone slates may be salvageable, but this will only be known when the roof is stripped of the membrane.

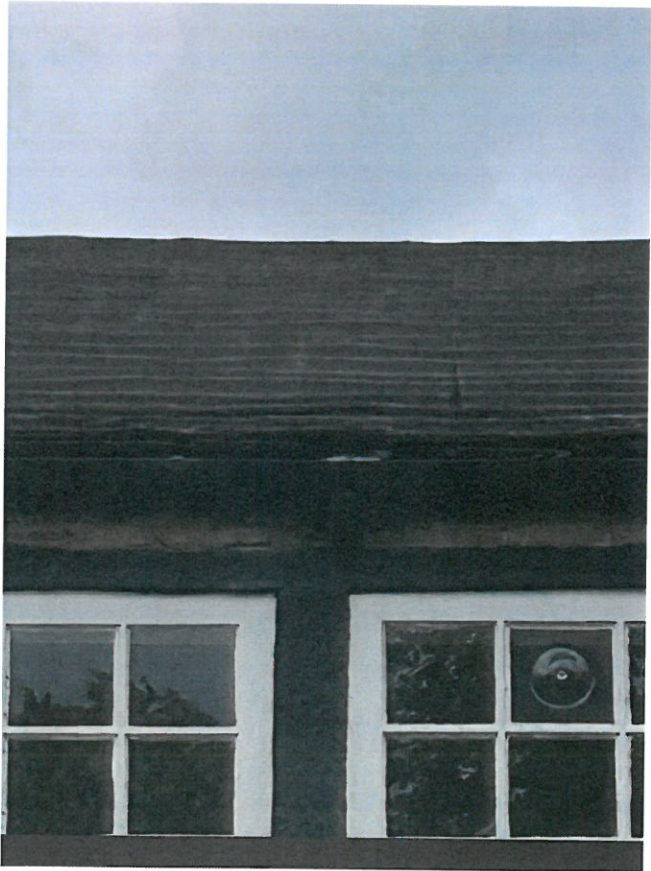
Photograph 16

Externally the roof covering on each slope have been covered with a membrane. Photograph 16. This restricts the air flow in the roof void, and as a result, a number of rafters can be seen to have suffered with rot and infestation. Photograph 17.

- 4.03** The roof covering is provided by a stone slate. These have been covered with a membrane.

It is unlikely that these will be salvageable, but sometimes these can be reversed. It will be imperative to salvage as many of the original slates as possible.

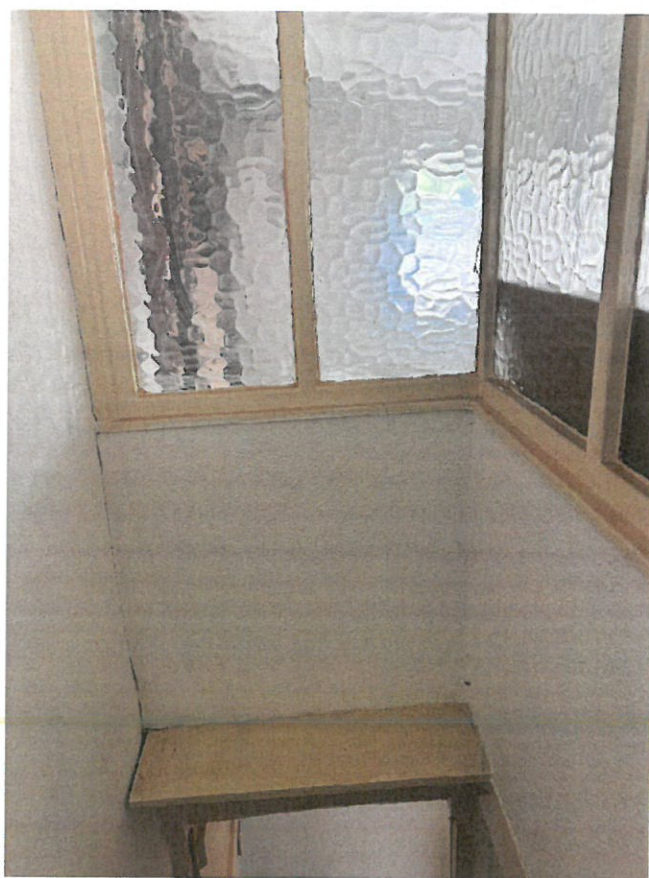
Photograph 18

The second floor comprises of a single room accessed by a timber stair. The stair is encased with a timber and glazed screen with no structural or architectural merit. Photograph 18.

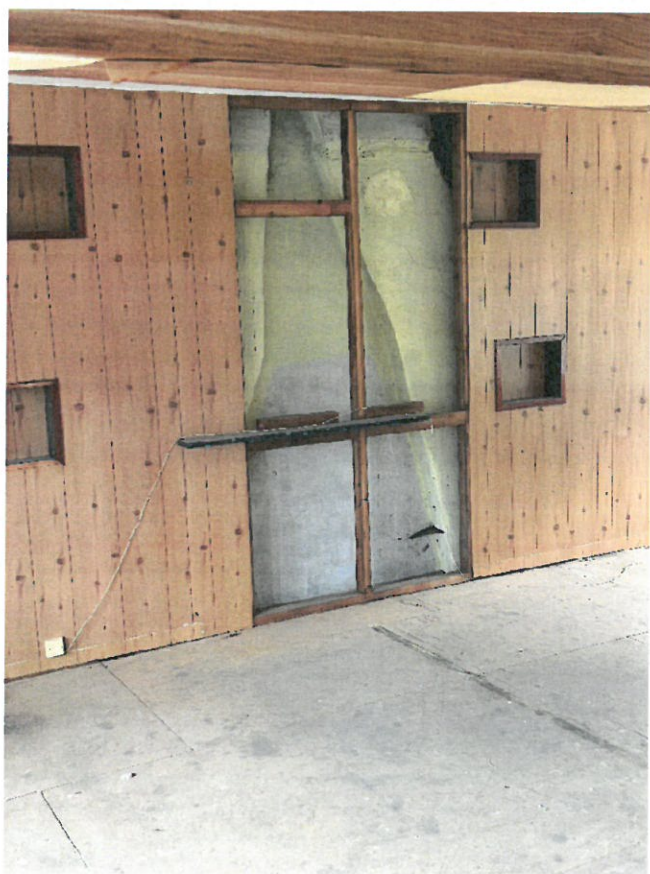
Photograph 19

The party wall has been clad with a board that was obviously a later addition. The boarding was partially removed to assist this report. Photograph 19.

The original party wall was visible in part. This appeared to be structurally satisfactory.

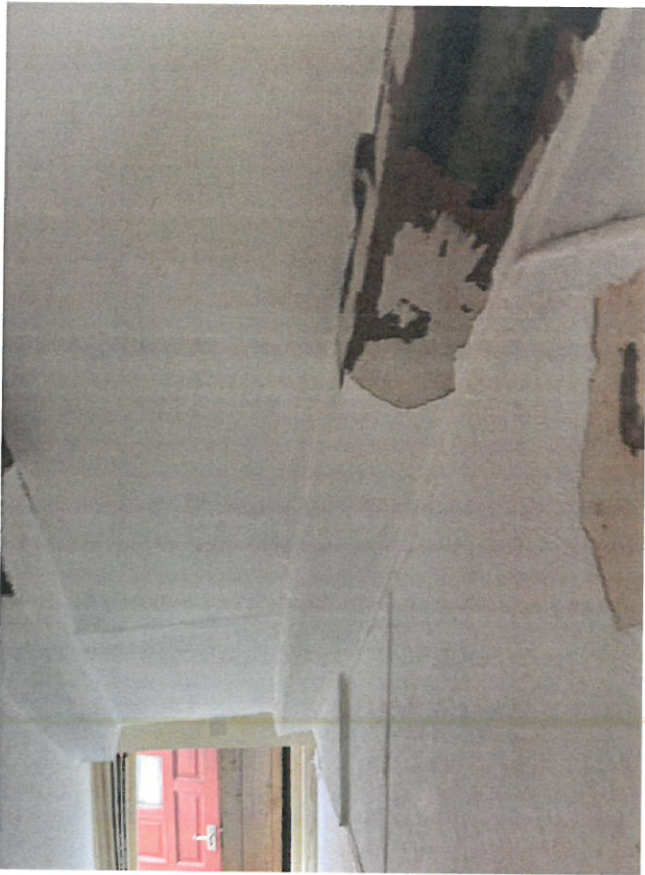
Photograph 21

The stair to second floor is in a poor condition. The timbers including the stringers, are severely affected by woodworm. Photographs 2 & 21.

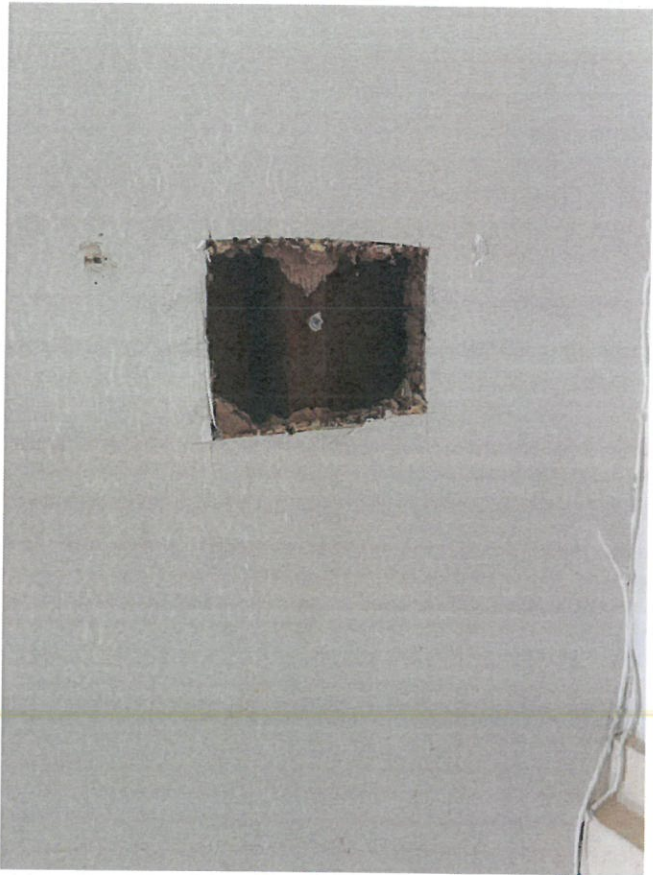
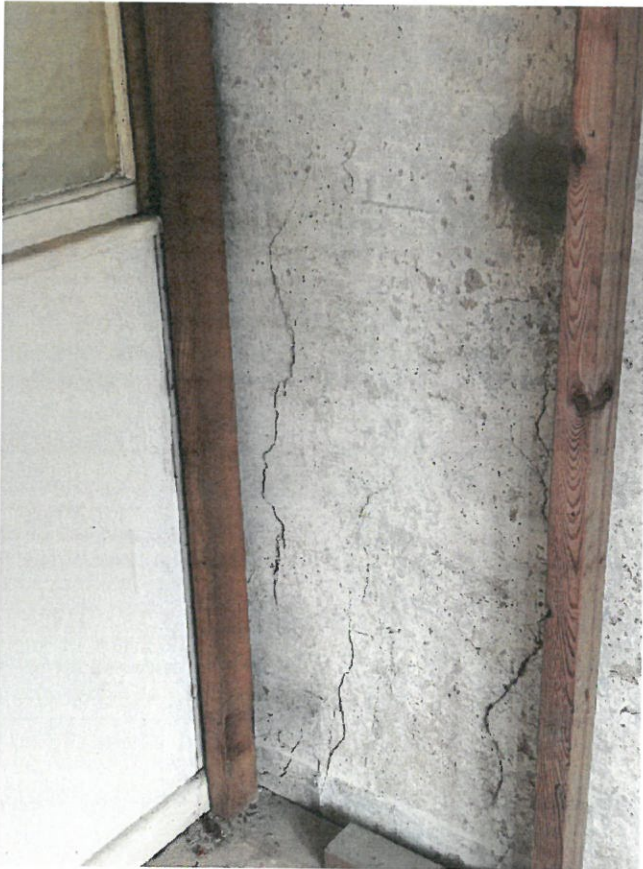
The first floor is divided into a number of rooms by traditional stud and plasterboard partitions. These are clearly not original. Photographs 22 & 23.

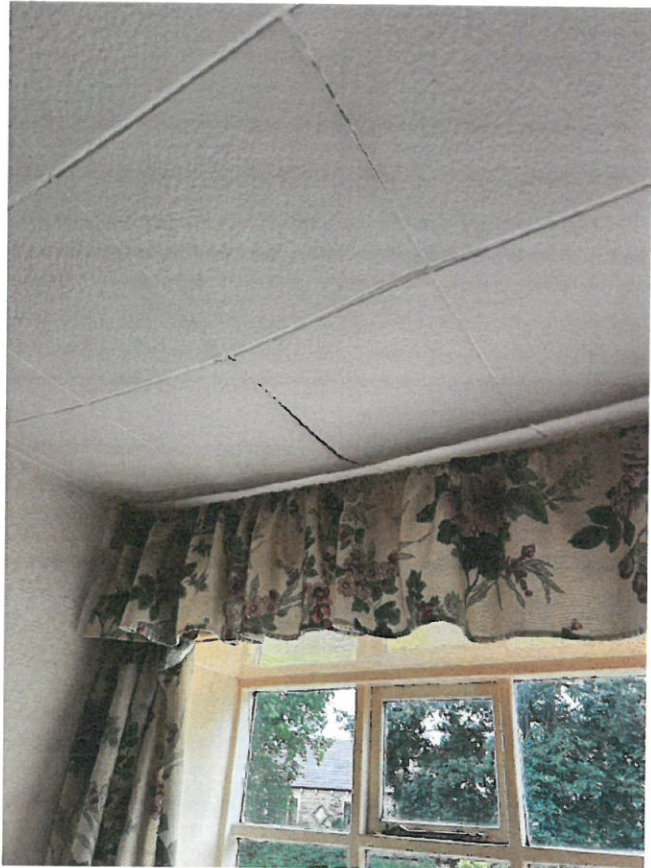
Photograph 24

Ceilings at first floor are poor and will need replacement, photograph 24.

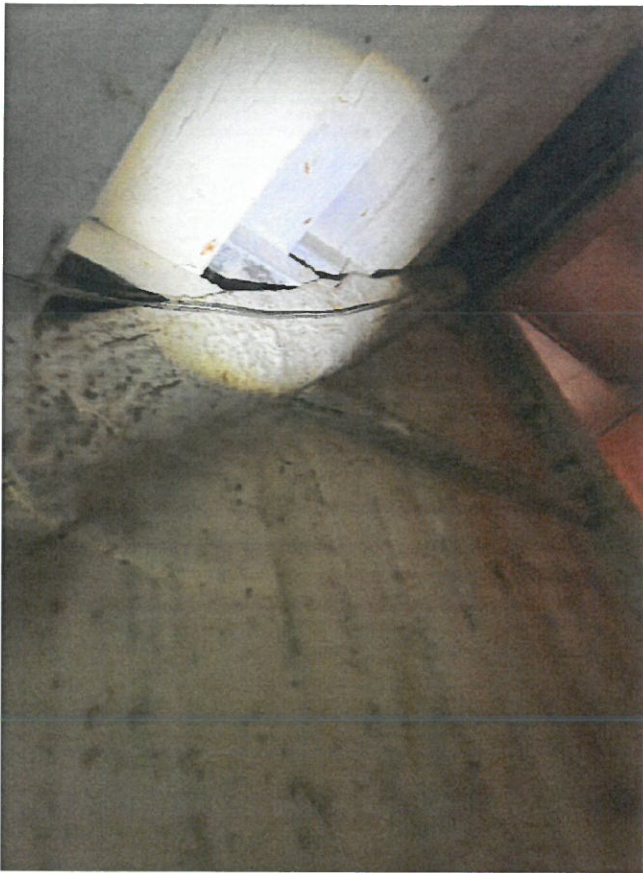
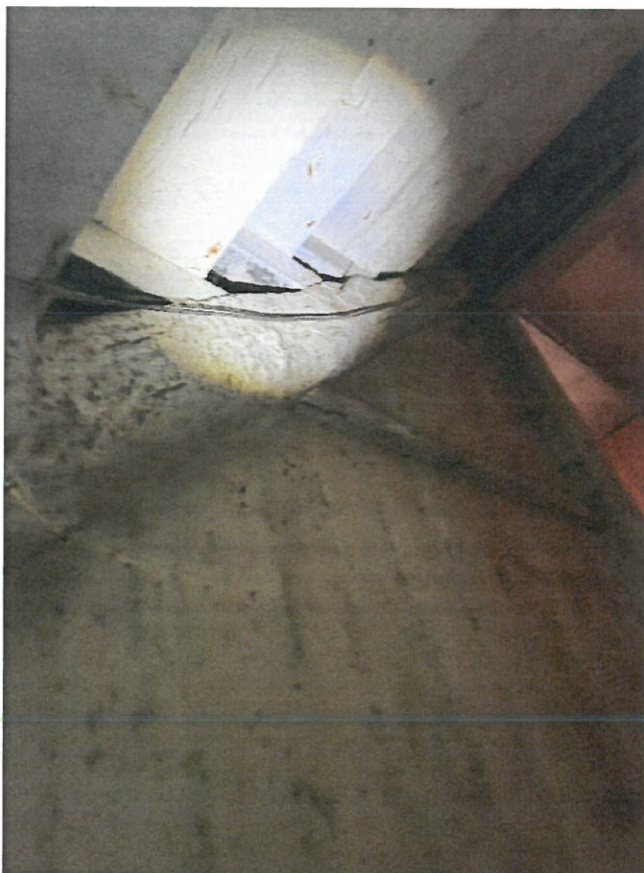
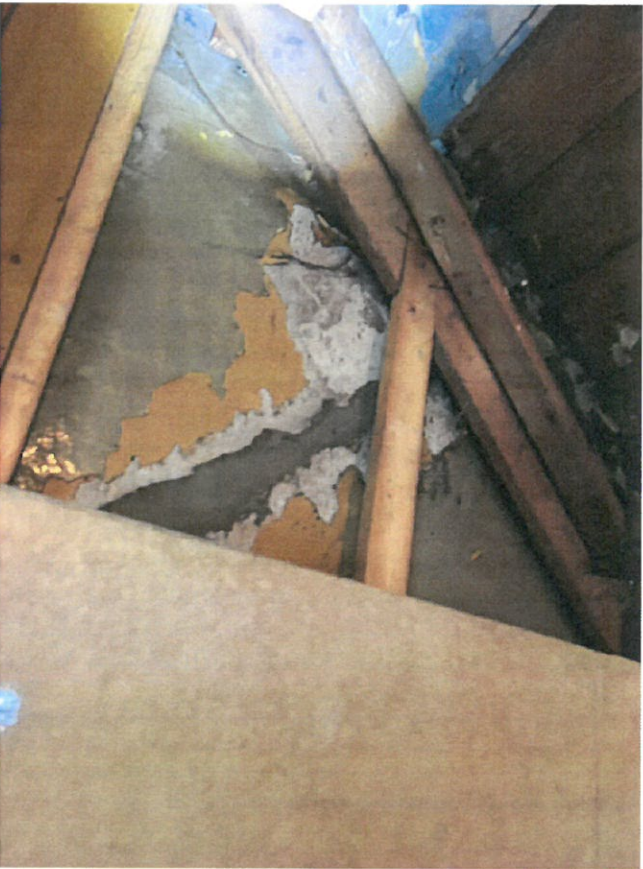
The stair between ground and first floor is similarly affected by woodworm. Photographs 25, 26 & 27.
