MILNROW LIBRARY  
SPECIALIST INVESTIGATIONS  
January 2022

**Bradshaw Gass & Hope LLP**  
**Architects Consulting Engineers Quantity Surveyors**  
**21 Silverwell Street Bolton BL1 1PR**

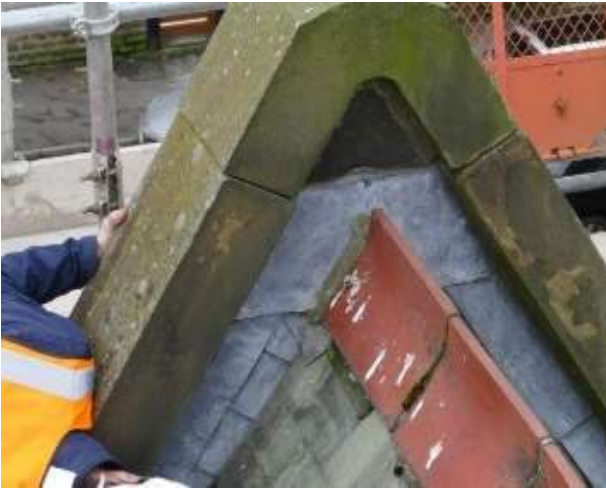
Displaced gable evident in the mis-alignment of the flashings and in the open displaced joint of the coping..

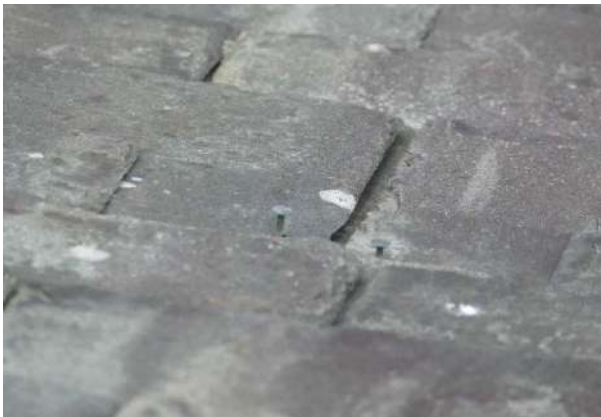
Missing slate from the east slope exposing the joint and nail fixings below. Repair is required..

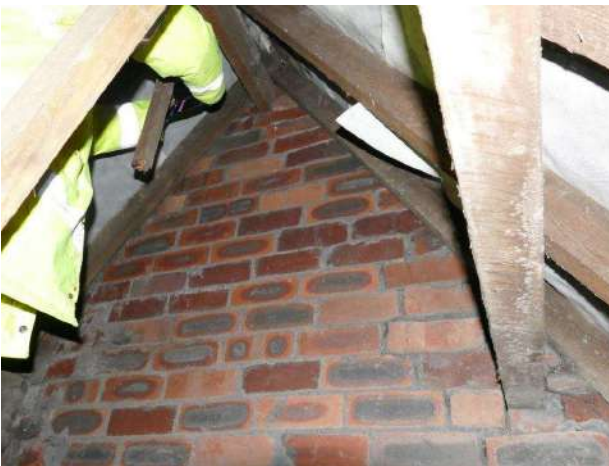
There was no evidence of movement in the internal stretcher bond brickwork. It is possible that ferrous fixings for the stonework have corroded to release the outer panel.

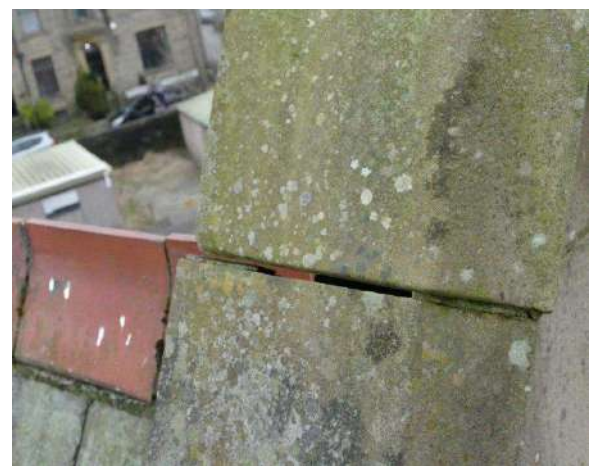
The head coping above the entrance is completely de-bonded and can be lifted. This should be secured as a matter of urgency.

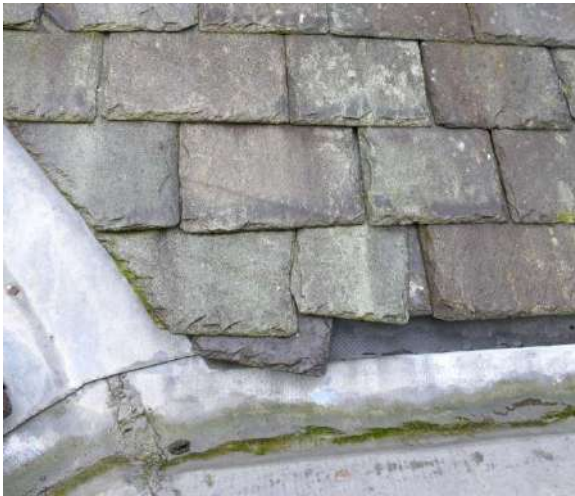
Slipped slates to the foot of the oriel roof/west meeting room roof.

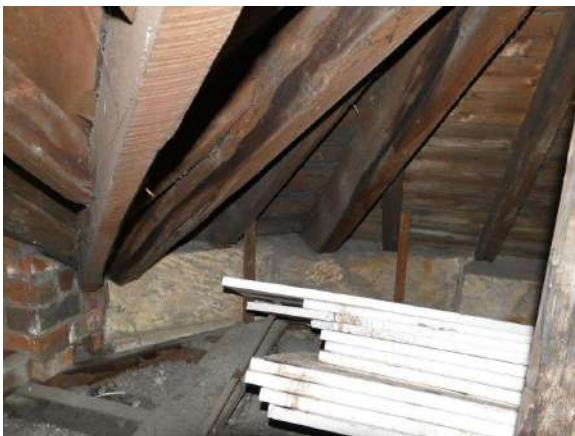
Base of Oriel window north valley. Some water staining to the mitred hip adjacent..

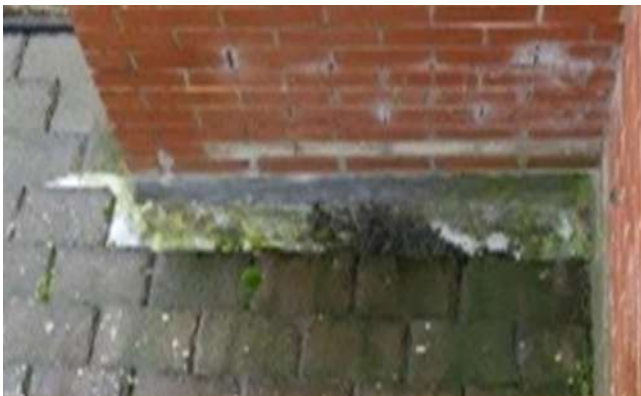
Narrow back gutter flashings to adjacent roof and limited outfall. Lack of fall and debris leading to standing water and potential rot of timbers below.

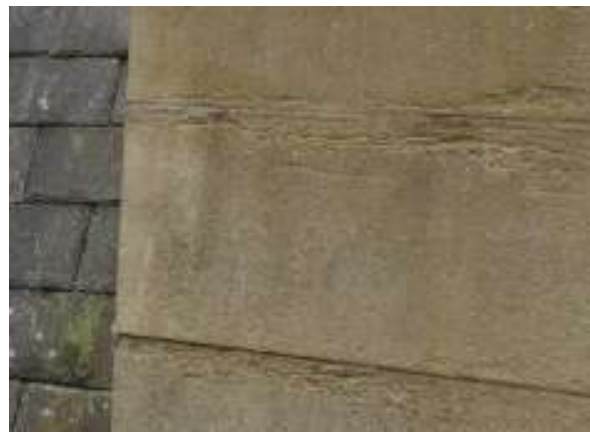
Deterioration of the stonework adjacent to the cement pointing shows where water has remained trapped in the stonework and has frozen. These require very careful raking out.

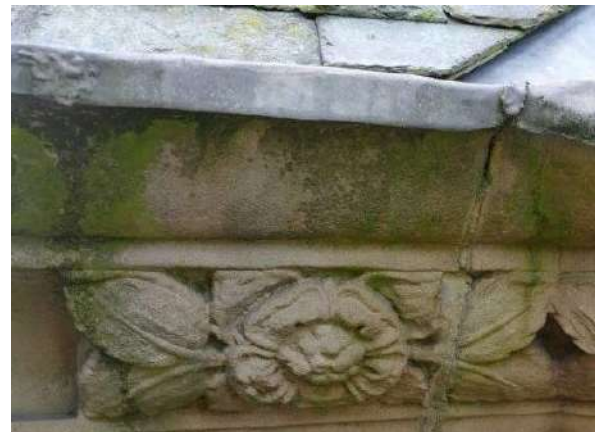
Staining where water has accessed split welds in the lead gutter lining above.

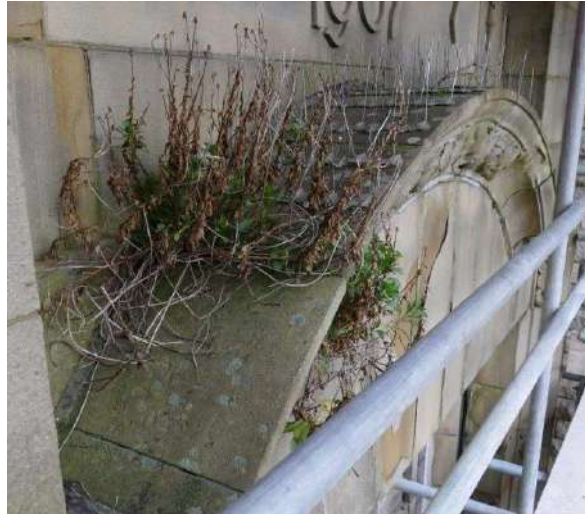
Open joints have been inundated with vegetation which is now causing real damage to the stonework.

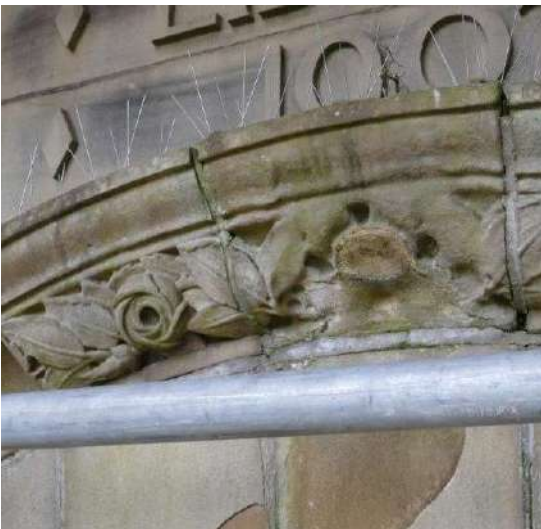
Addressing spalling facings will result in further loss of detail from carved details. New indents to be considered to retain definition.

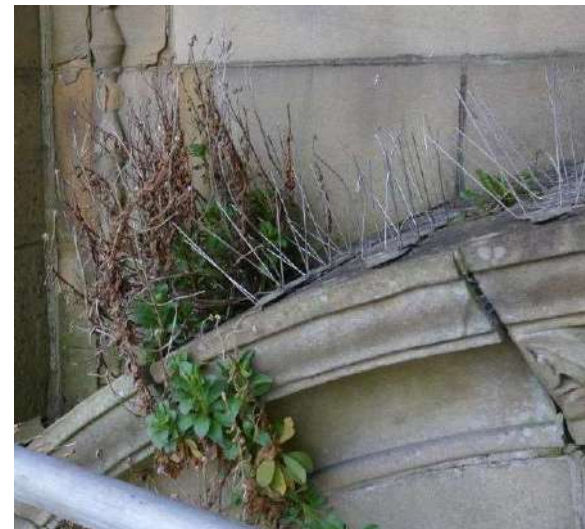
Vegetation and exposed, open joints have led to the local displacement of stonework.

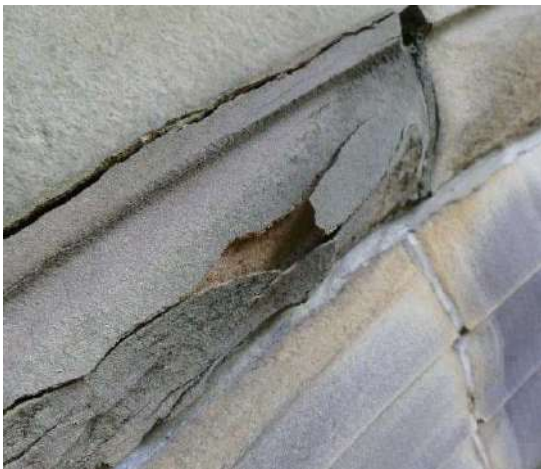
Spalling of stonework adjacent to cement pointing. Raking out strongly recommended.

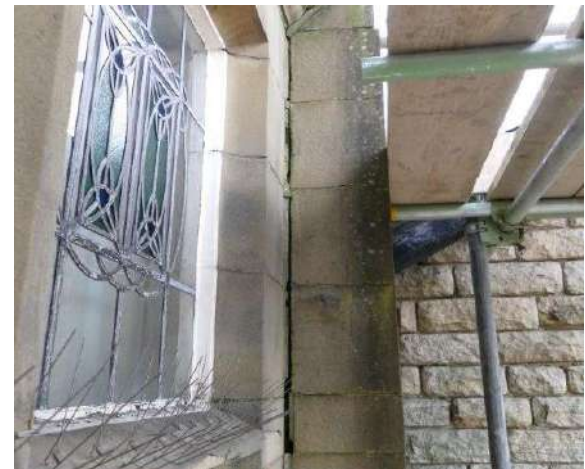
Displaced pier stonework to side of entrance gable. Visible displacement from window head

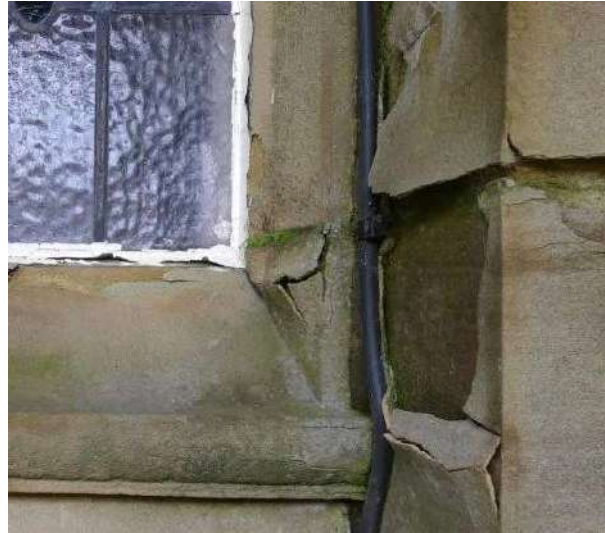
Spalling facings to the pier, stooling, cill and window surround.

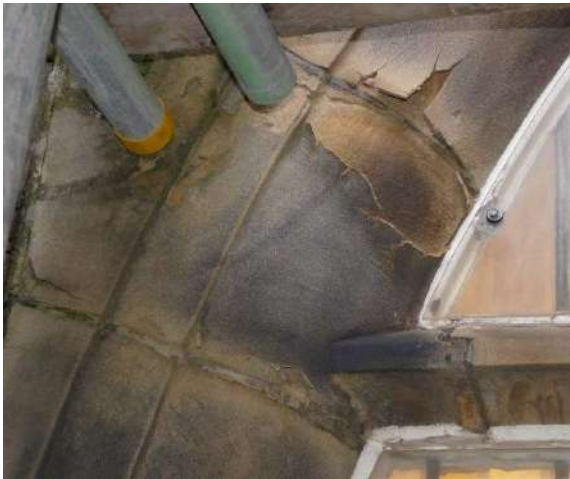
Spalled facing and split to voussoire and past transom repair. Investigation required to assess if full replacement is required.

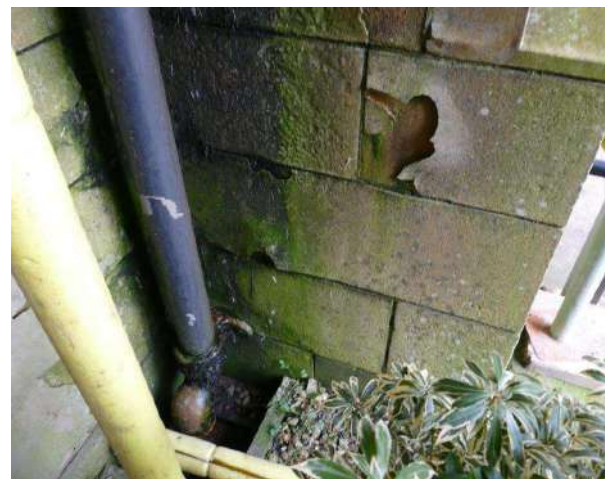
Impact of long term saturation. Rainwater pipe, gully and vegetation all require to be addressed as part of the repair.

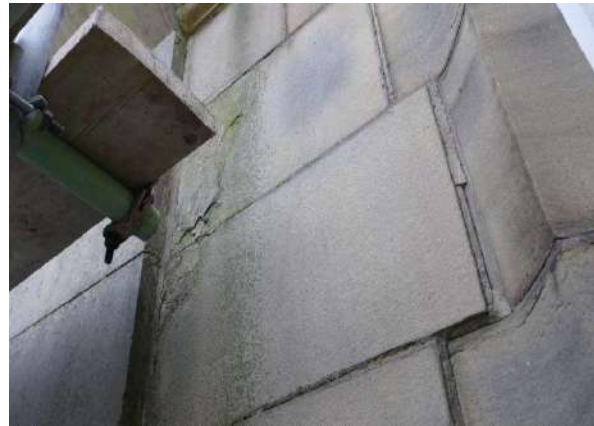
Line of displacement of masonry by the oriel window..

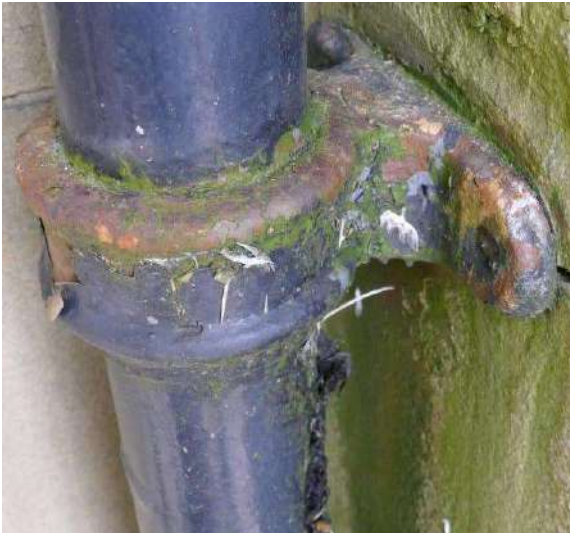
Fractured ear band, corroding fixings and spalling finishes. Repeated saturation of the adjacent masonry has led to extensive spalling and algae growth. The gully was blocked when surveyed.

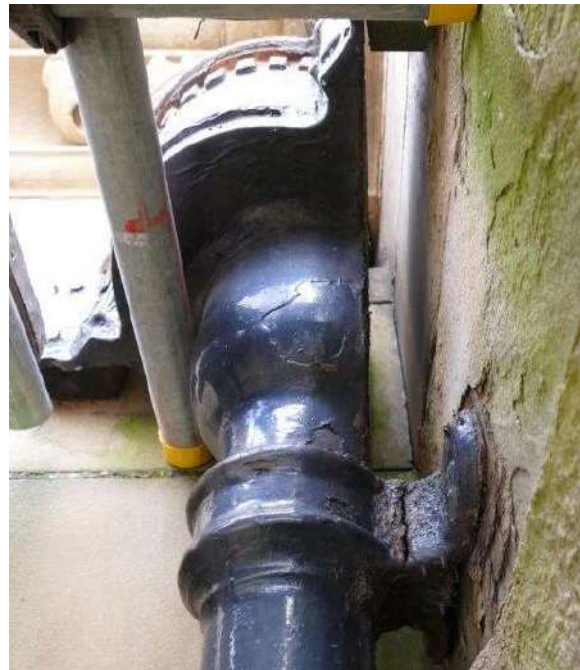
Weathered decoration and rusting of the original cast iron hopper heads. Narrow

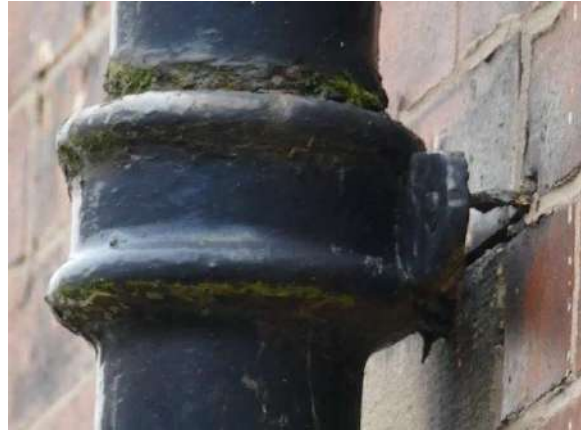
The fall pipe adjacent to the library staff room entrance, has a number of fixings and spacer blocks missing. Repair is urgently recommended.

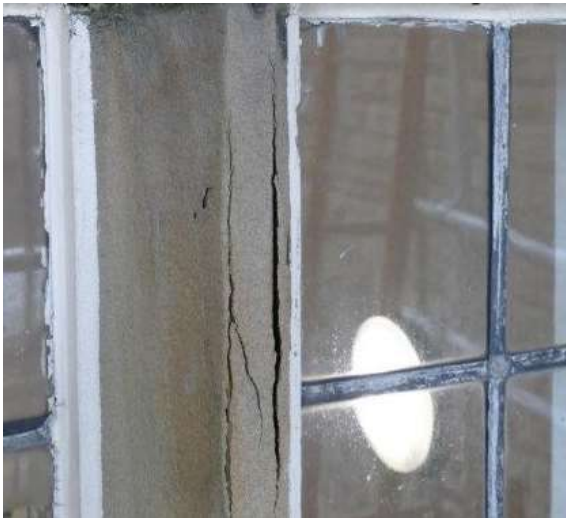
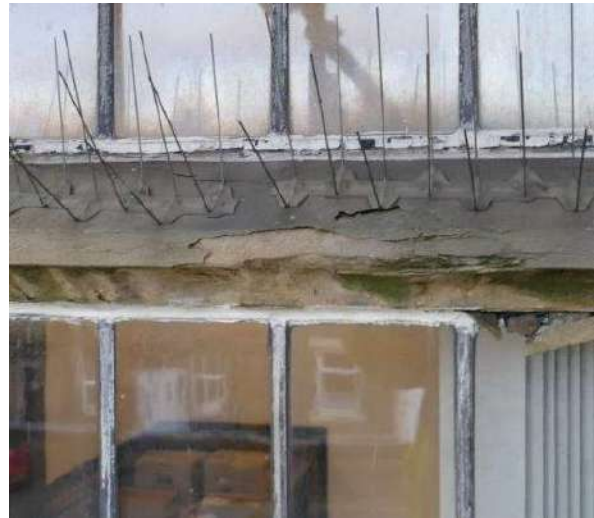
Spalling of exposed transoms and mullions. Re-dressing possible but at loss of some definition of the detailing of the stonework.

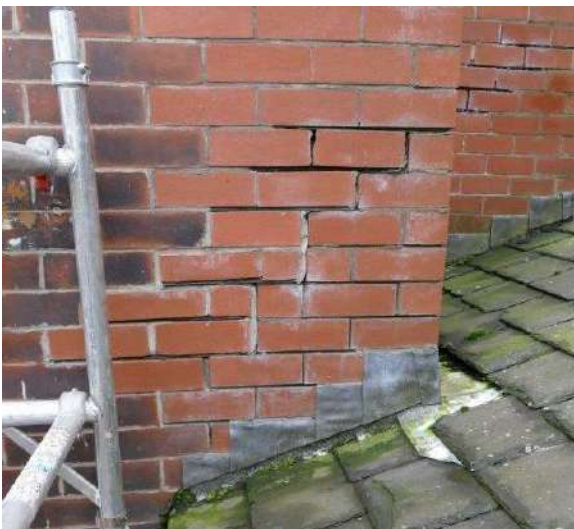
Open joints on stepped cavity tray. Possible settlement of new wall/foundation but requires to be re-packed and pointed.

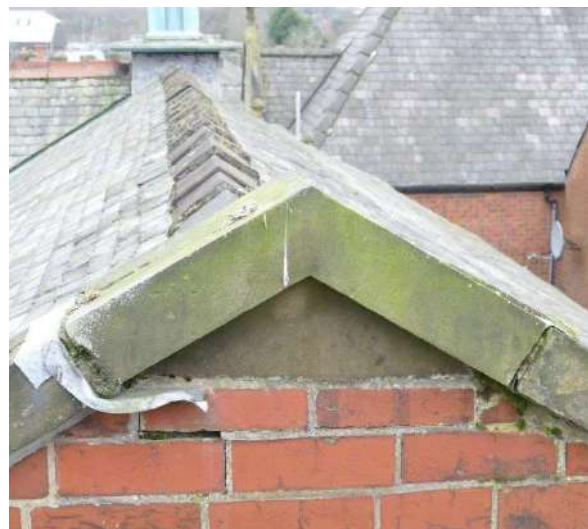
Open joints and partial flashings allow water to penetrate below the copings and damage the mortar.

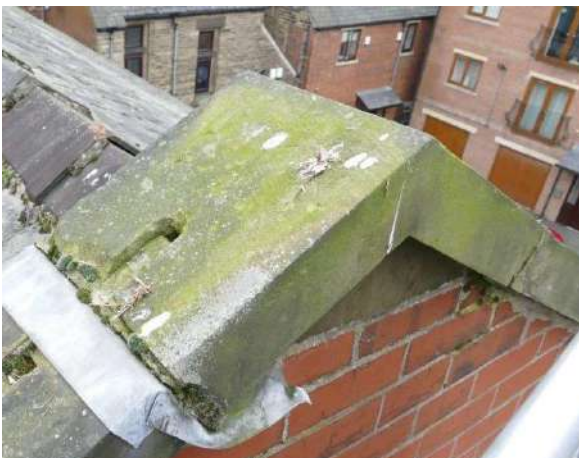
Dog cramps that secured the copings have been removed and the line of the copings appeared to have become a little displaced.

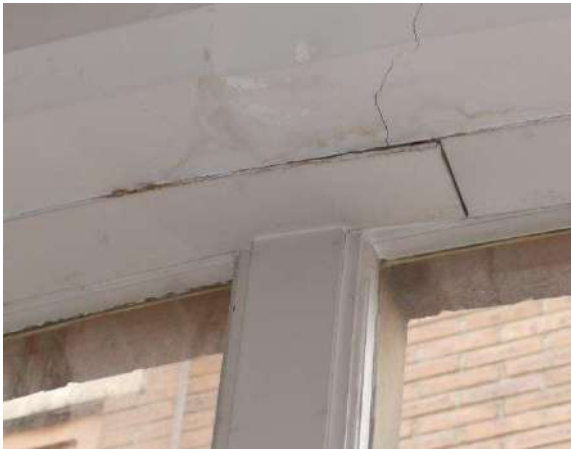
Displaced boarded surround to the east windows and moisture staining of the plaster above. Likely ingress from open joints and copings externally

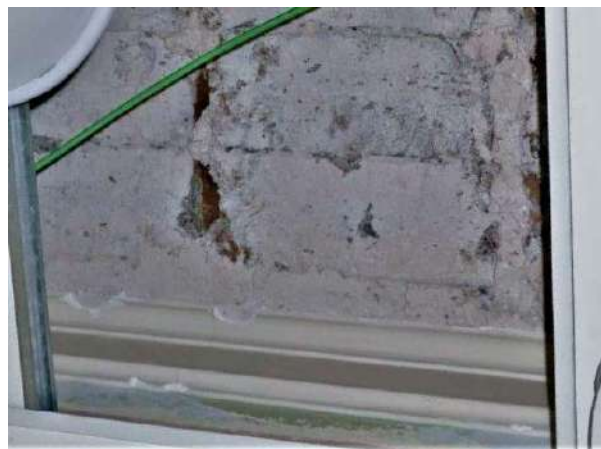
Spalled facing and corroded filler joists. The original coving remains above a recent suspended ceiling. Repair is recommended.

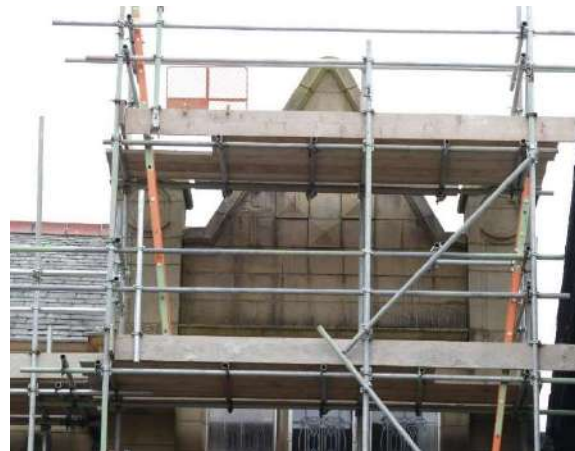
The upper section of the gable is loose and is flanked by two piers with raised heads. The central panel appears to be un-bonded and the right hand pier has displaced to the south. The stonework of the pier is also displaced below.

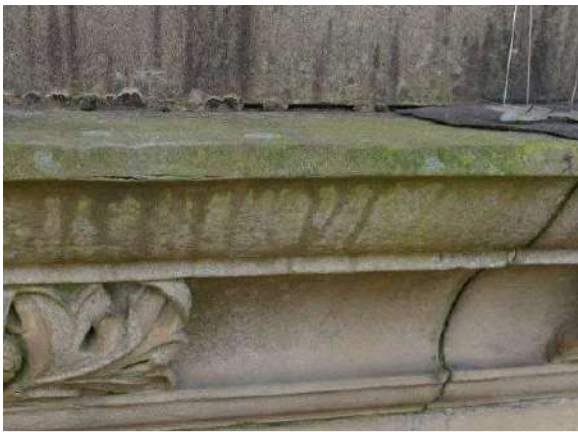
External open joint to the stair window head at the base of the loose section of gable panel,. There are also open joints in stonework below where there is extensive water staining internally.

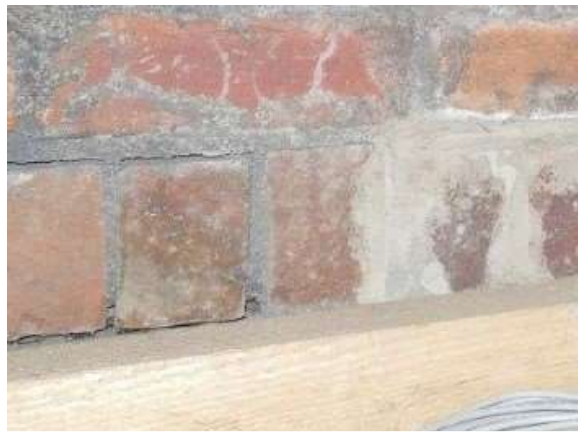
Within the roof void behind the compromised gable there is visible cracking at the base of the compromised panel that appears to coincide with the plane of the fracture externally.

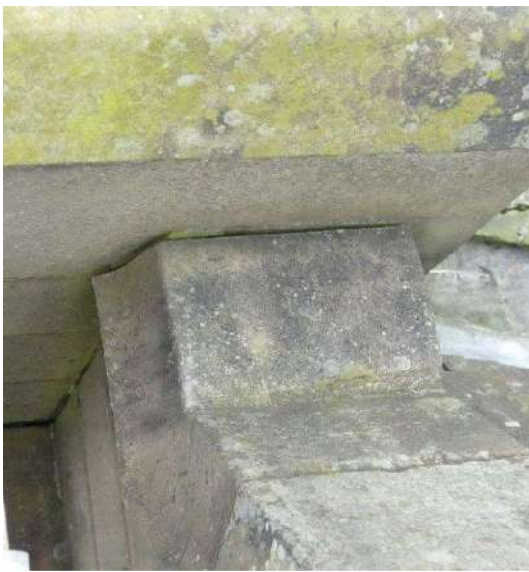
Open joint where the gable panel meets the corner finial. Water can freely run into the joint and into the core of the stone wall.

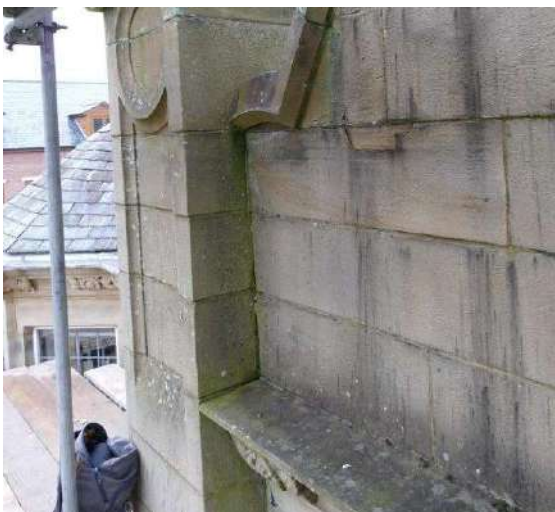
A crack has developed along the junction of the left hand pier and the wall and a significant open joint and displacement to the right hand side.

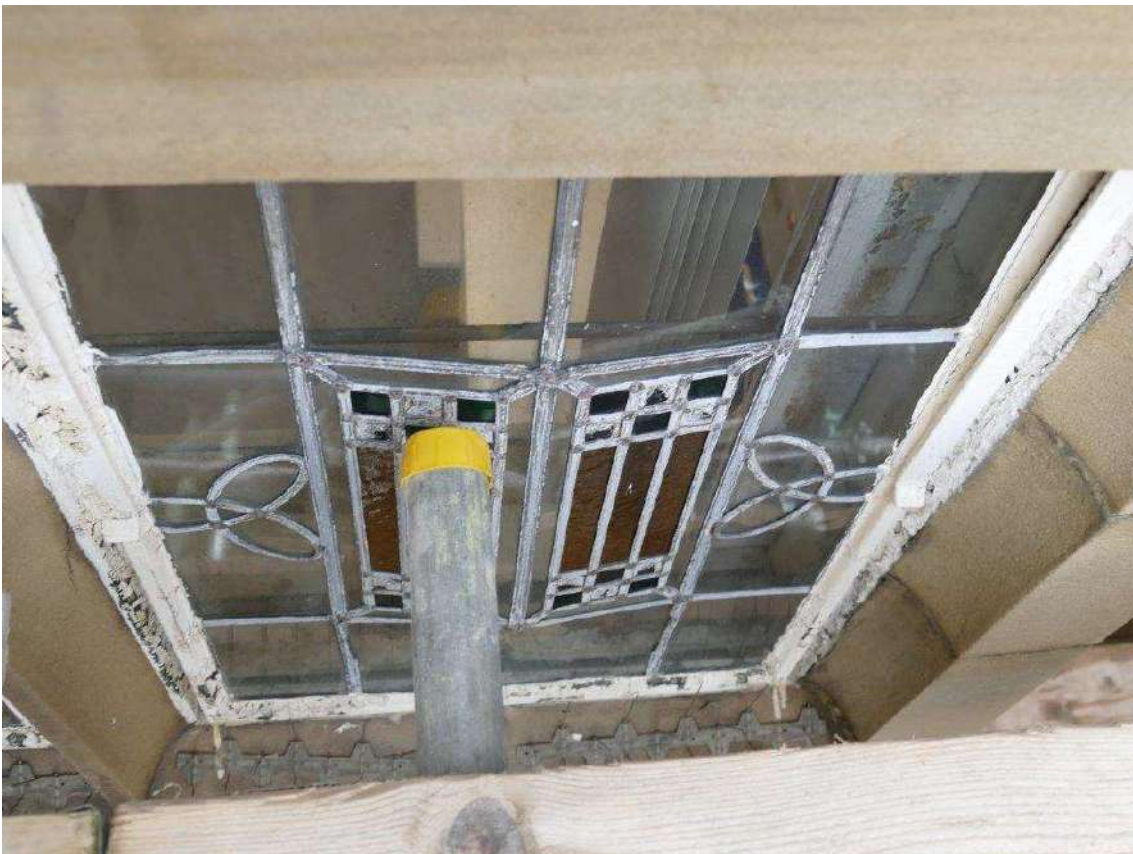
Two central panels to WF3, the two panels of the central section of the Oriel window, are buckled within the surrounding leaded lights and are at risk of falling. The panels appear to be original art nouveau panels and require to be completely re-lead, along with the whole light, to ensure their longevity and survival.

The central 2 panels of the original light have buckled outwards and are only supported by the lead comes. These are vulnerable to wind damage, to further distortion during hot weather or to any impact from the interior of the building.

It is proposed that, while the scaffolding is in place, the opportunity is taken to secure these two lights to prevent them from failing and the glass being damaged. It is proposed that the glass is secured in its current location until a full scale of repair works can be submitted for Listed Building Approval. If, on closer inspection, it is found the at the lights cannot be satisfactorily be secured on site, it is proposed that they are removed by a conservation leaded glass specialist and are re-lead in readiness for when the window and its adjacent stonework are repaired.

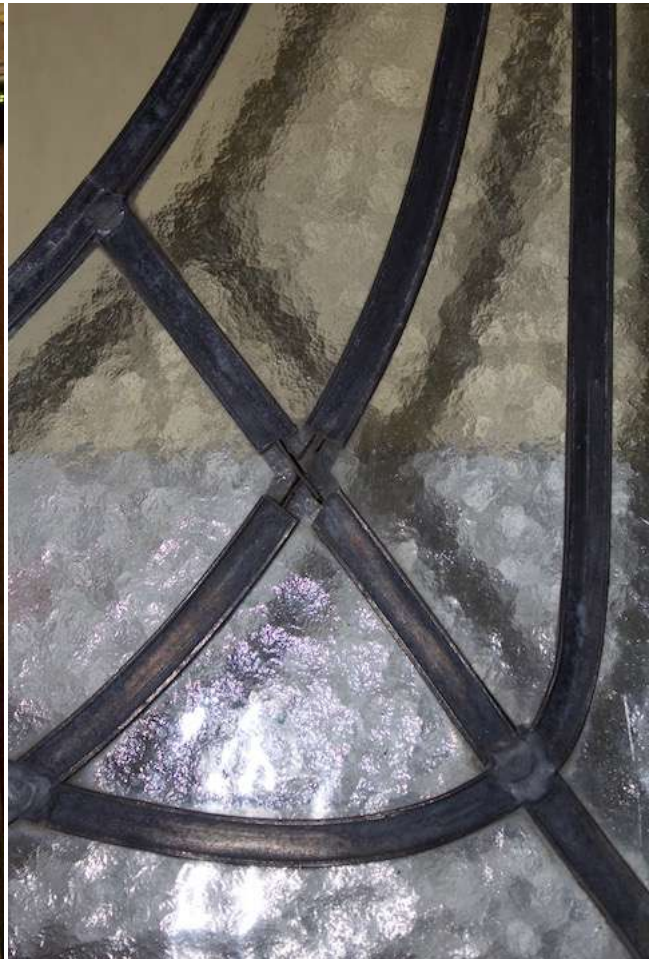
**Example of broken solder**

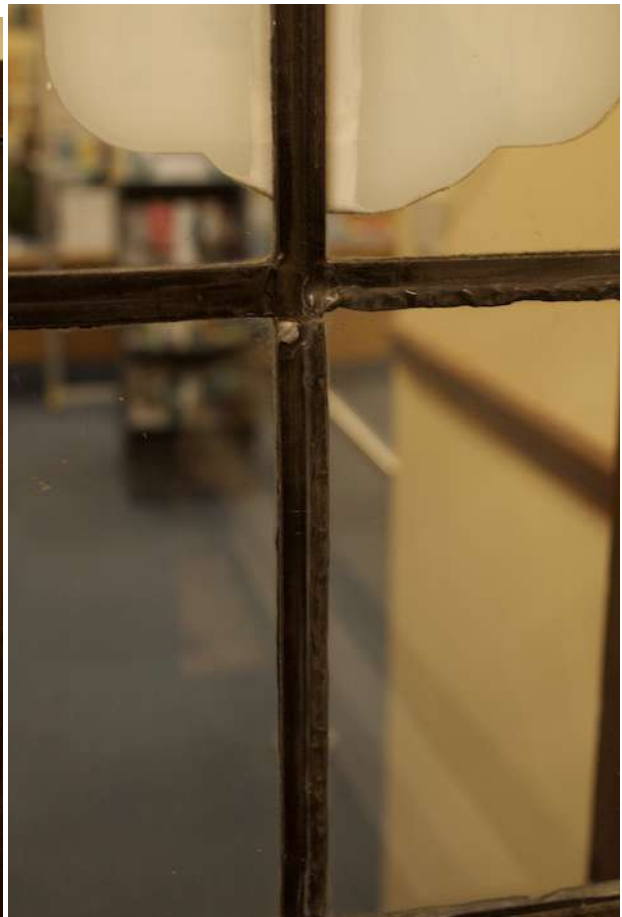
**Loose lead in door panel**

**Recommendation** – Remove, re-lead and re-fit

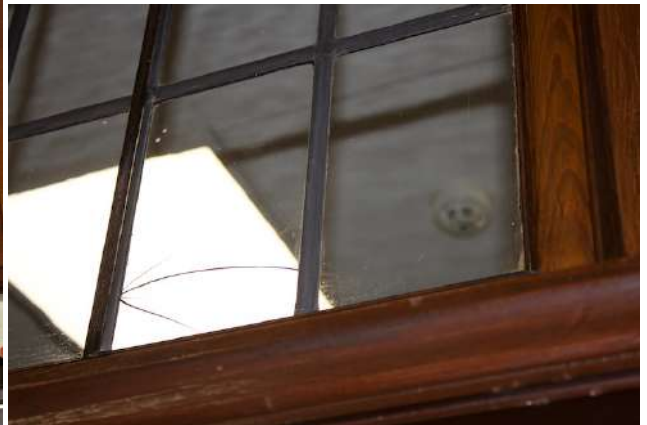
**Damaged pane to internal window**

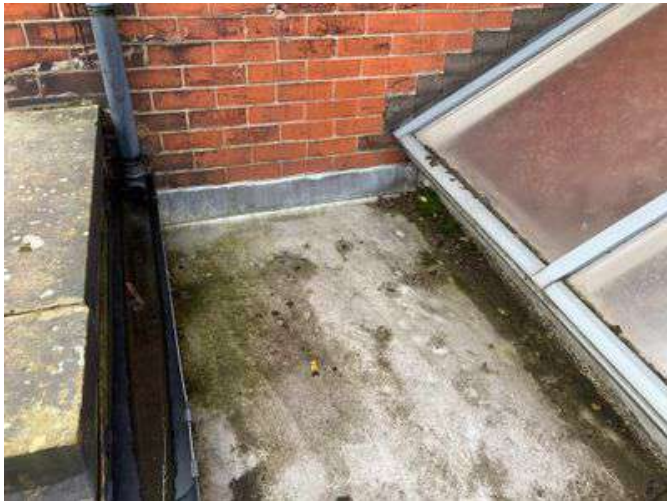
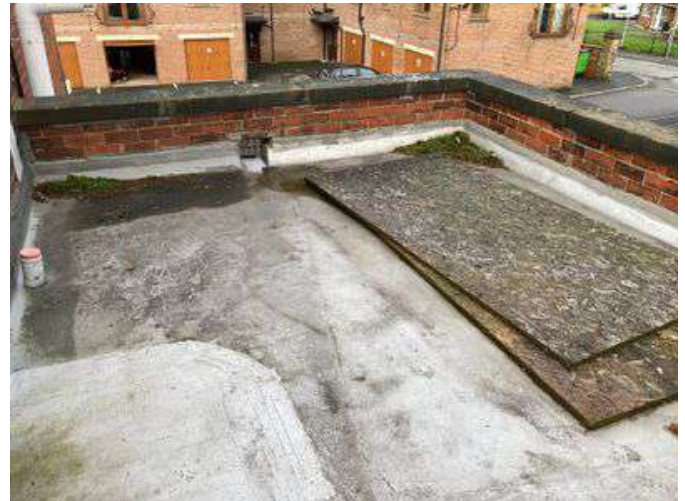
**General Overview:** Asphalt roof with solar paint that has been patch repaired and now needs a new system overlay.

**Roof Surfaces & Internal Gutter Runs:** The proposed Sika system is to be installed utilizing the existing falls.
