## Rochdale Corner Plot

14834-BKP-V1-XX-RP-S-010

Existing Bulding Condition Report

29-31 Maclure Road, Rochdale

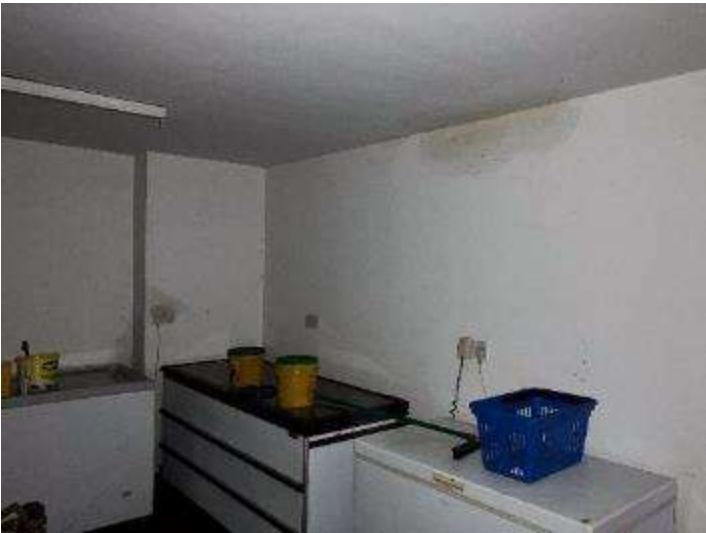
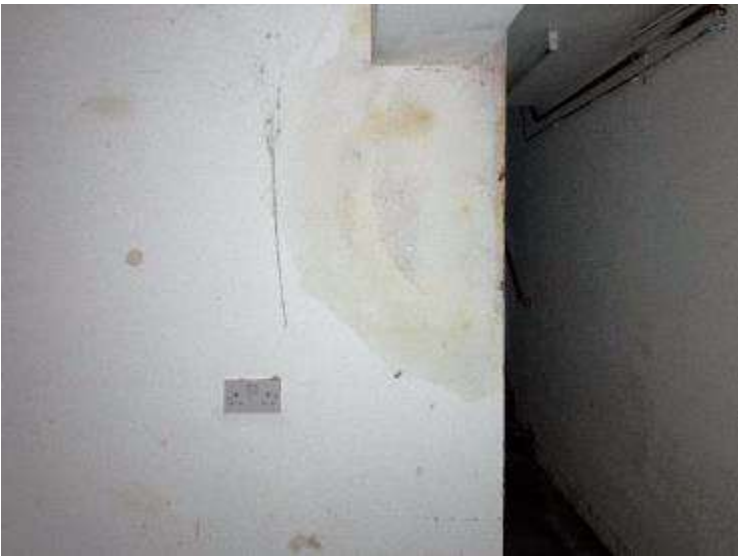
- Possible localised minor damp / water ingress witnessed to north-east wall of smaller basement room (see below Figure 6); localise removal of plaster finish and inspection is recommended.
- Possible localised minor damp / water ingress witnessed to north-east wall of smaller basement room under assumed steel beam bearing (see below Figure 7); localise removal of plaster finish and inspection is recommended.

Figure 6 – Possible Damp Staining to Basement Wall

Figure 7 – Possible Damp Staining to Basement Wall

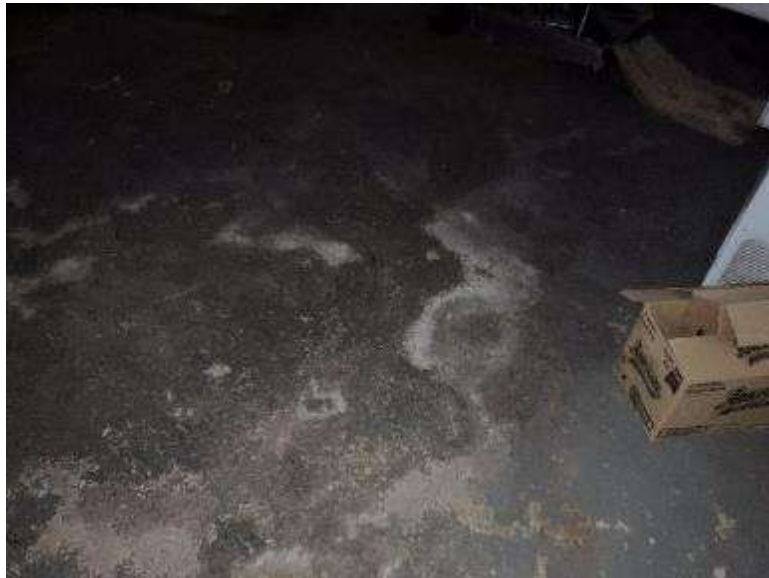
- Possible evidence of damp was noted to the ground floor slab to basement room to the north of the building (see below Figure 8); this was dry at the time of inspection and may represent localised staining, as opposed to a water ingress issue. It is recommended that this area is monitored during any further inspections / works on site and any water ingress reported to the engineer.

*Figure 8 – Possible Damp Staining to Basement Floor*

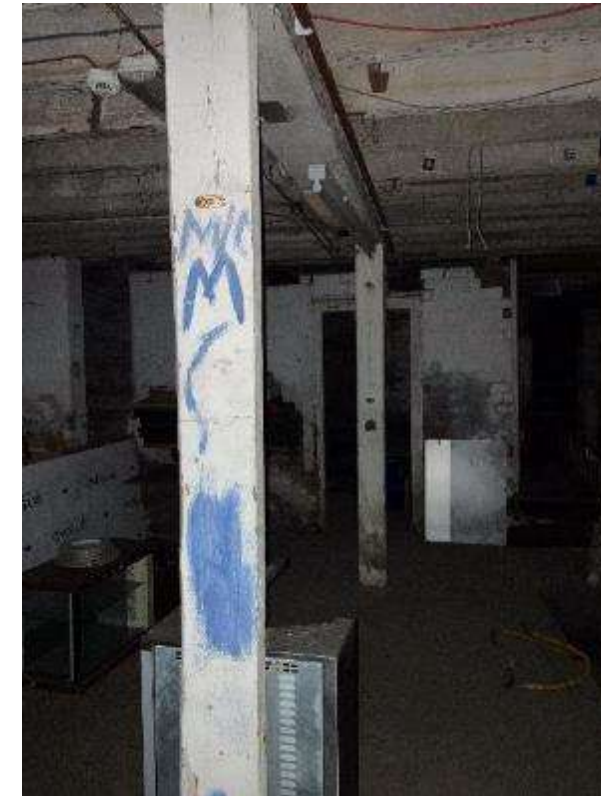
- Additional mid-span support is provided to timber joisted floor to the larger basement room in the form of timber transfer beam member and timber posts members onto the basement slab (refer to below Figure 9). It is suspected that this may be as a result of historic floor strengthening works. Additional strengthening timbers appear to be in reasonable condition, however it is recommended that the bottom of timber posts is further inspected for any signs of damp / softening of the timber in direct contact with the basement slab

*Figure 9 – Possible Historic Floor Strengthening Members*

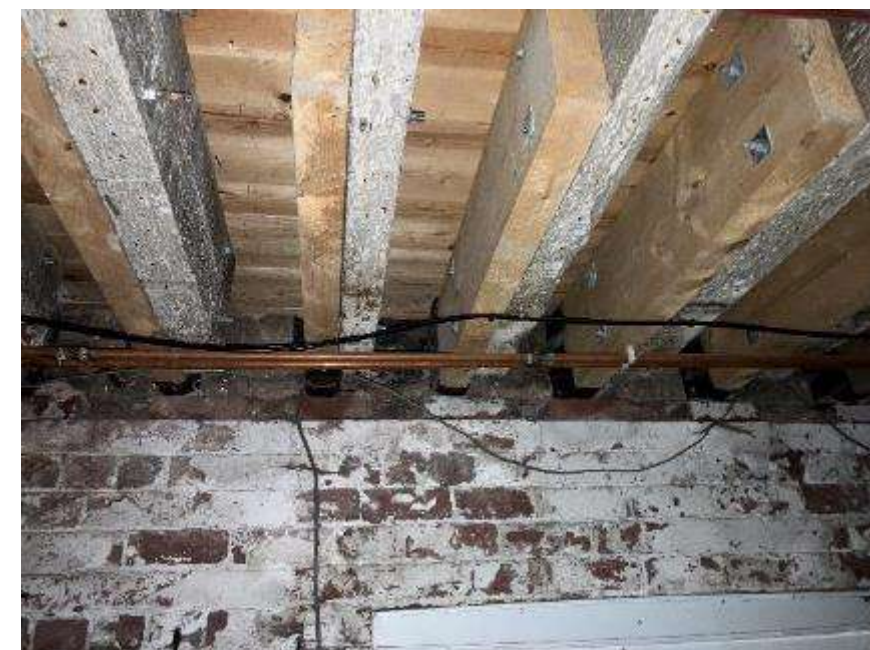
- Historic timber joist end repairs were witnessed to the south gable wall; consisting of joist ends cut back and spliced to new sections following assumed water ingress / timber rot (refer to below Figure 10). Repairs appear to be of reasonable quality, however it is unclear if any rot treatment has been applied locally to masonry wall. No signs of further water ingress were witnessed, however it is unclear if the root cause of ingress has been addressed (likely via interface between gable wall and adjacent single storey building roof). It is suggest that area wall where joist repairs have been carried out is locally cleared of any loose debris, treated with suitable rot treatment and joist ends are mortared into the wall. Root cause of water ingress will be addressed following demolition of existing single storey and construction of new build elements.

*Figure 10 – Historic Timber Repairs to South Gable Wall*

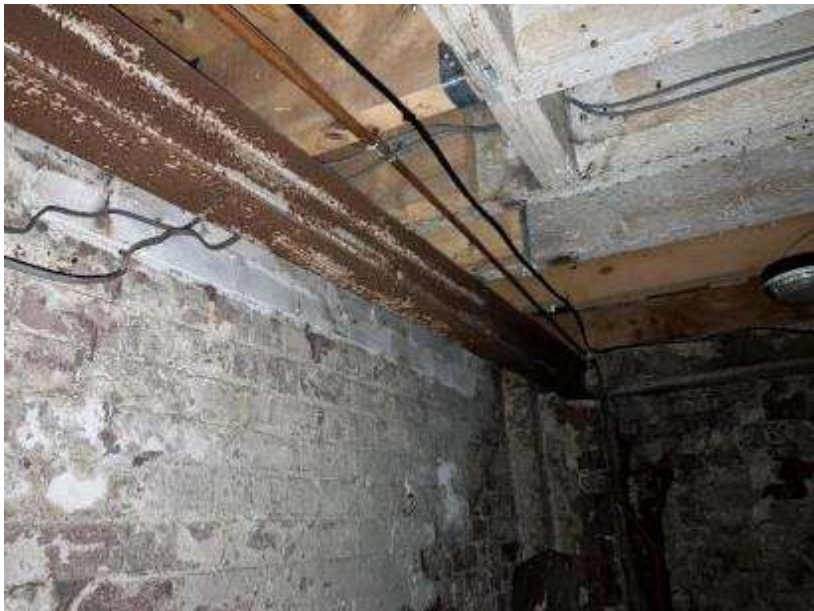
- Existing steel support beam witnessed to south gable wall supporting repaired timber joist ends noted above (see below Figure 11). Beam is showing some signs of surface rusting, but appears to be in good condition and is showing no signs of distress / damage. It is recommended that this beam is cleaned of surface rusting and end bearings onto masonry walls reviewed

Figure 11 – Steel Beam Supporting Joist Ends

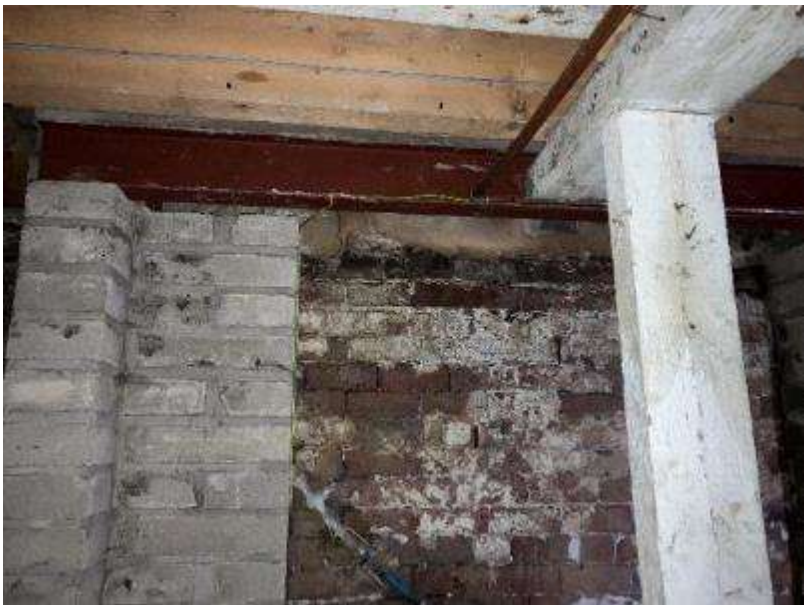
- Relatively new steelwork support members and masonry piers witnessed to front elevation of larger basement room, directly under the main entrance doorways above (refer to Figure 12 below). Steelwork and supporting masonry appeared to be in good condition.

Figure 12 – Steel Support Under Main Entrance Above

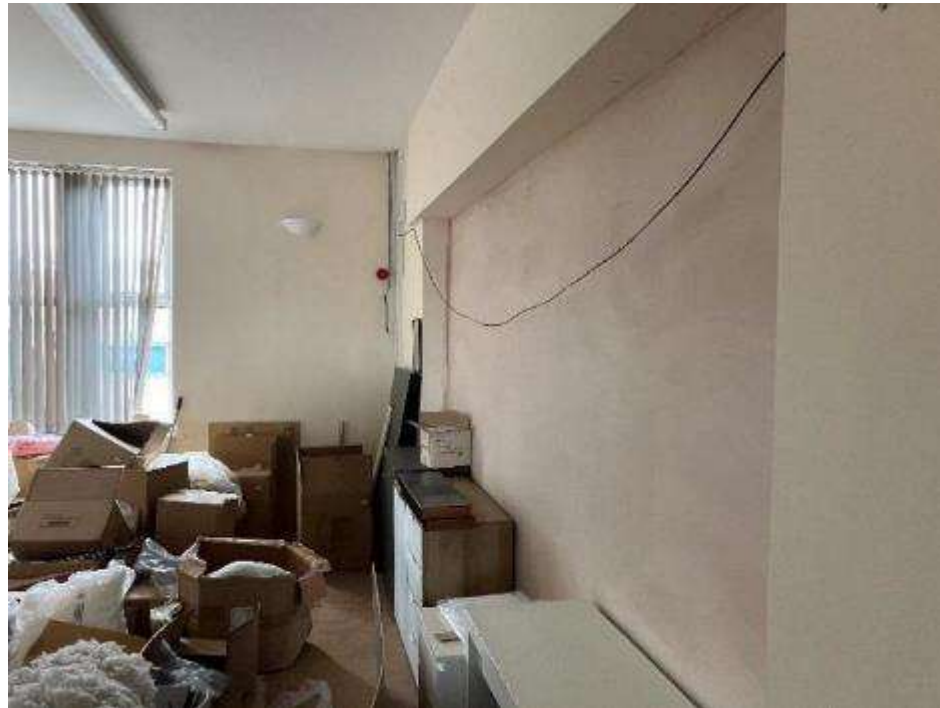
- Evidence of historic structural alterations witnessed to the main spine wall towards the front of the building, appearing to consist of significant opening formed through the load-bearing masonry wall and apparent steelwork support over (refer to Figure 16 below). This opening has since been infilled with non-load bearing studwork. Intrusive investigation works are to be carried out to determine details of this structural alterations, including steel beam details, review of end bearing arrangements, etc.
- Minor cracking of finishes and possible staining witnessed to top-left hand corner of existing front window (refer to Figure 17 below); further investigation and possible repairs to be carried out to prevent further water ingress

*Figure 16 – View on Historic Spine Wall Structural Alterations*

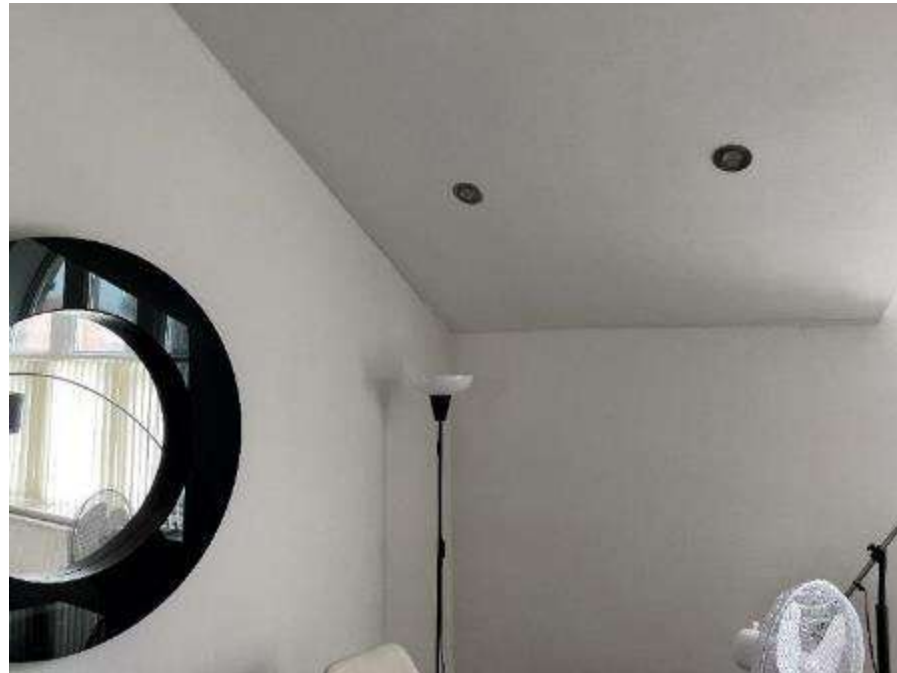
- Minor cracking witnessed at junction between wall and ceiling to south gable (refer to Figure 19 below); given location of this cracking, this is anticipated to be minor shrinkage cracking of plaster finishes only

*Figure 19 – Minor Cracking at Junction Between Wall and Ceiling (Non-Structural Shrinkage Cracking)*

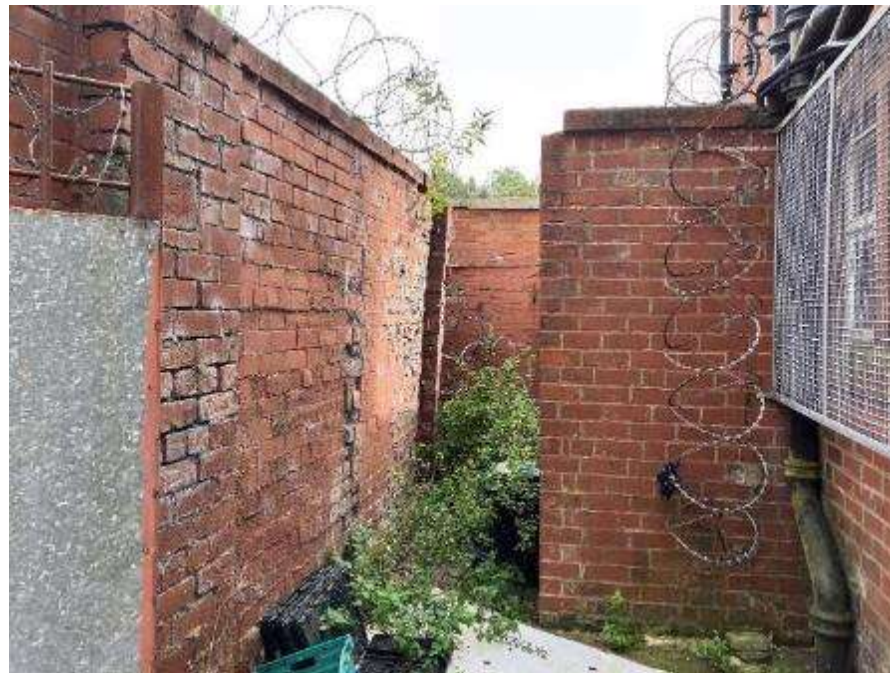
Full access to the rear courtyard (including external access to basement) was not available during this inspection due to presence of significantly leaning / potentially dangerous existing yard wall. This was witnessed as leaning significantly into the yard area and removal of this section of wall should be considered prior to any further inspection works.

*Figure 22 – View on Leaning Section of Yard Wall*

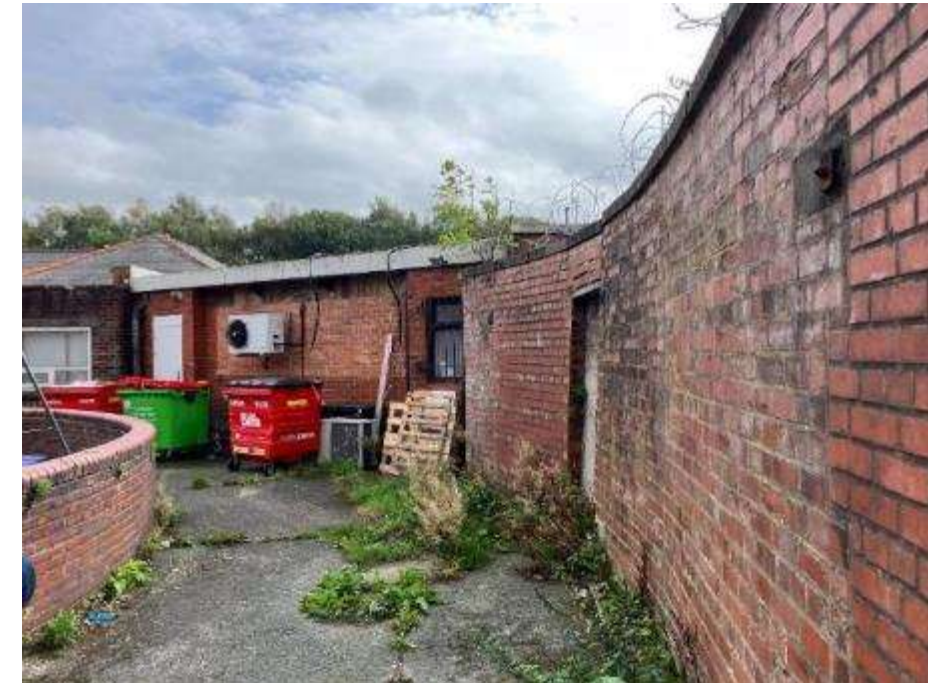
Inspection of the unnamed access road to the rear of the building was carried out, consisting of poor quality concrete paving with significant weed growth, spalling / cracking of concrete surfaces, etc. As noted above, existing masonry wall between the building yard and this unnamed access road was witnessed to be in poor condition, with significant leaning into the yard area observed.

*Figure 23 – View on Unnamed Access Road to Rear*

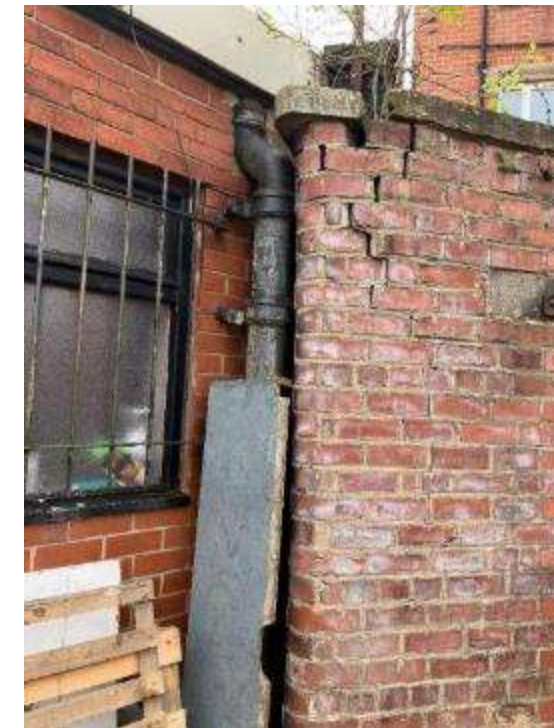
Interface between the existing 3-storey building rear wall and the adjacent single storey commercial unit was observed to be in relatively poor condition.

*Figure 24 – View on Junction with Adjacent Singlet Storey Building*

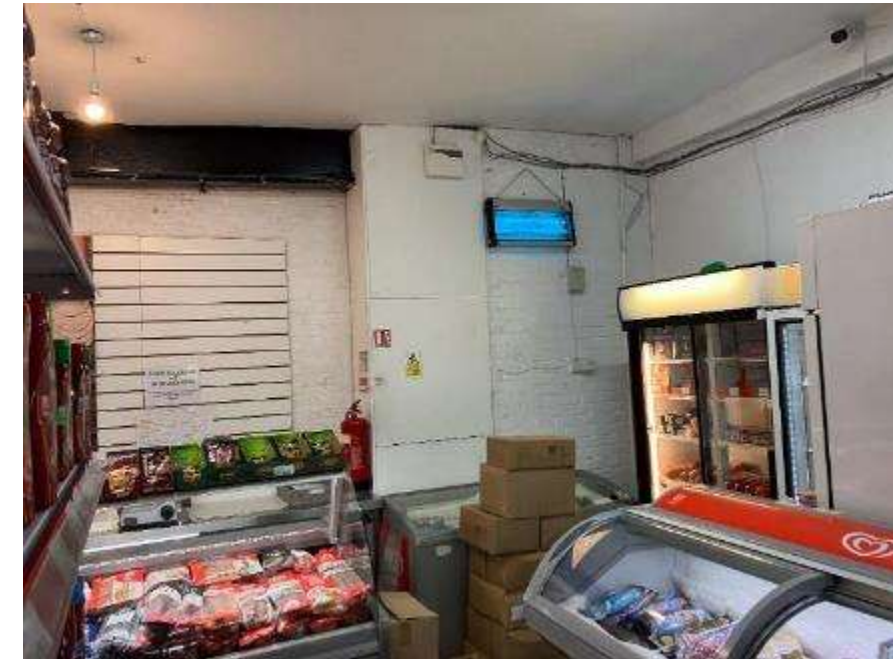
Inspection of the interface between this unit and the adjacent Deen House noted that the single storey building steel frame appears to have been built tight to the existing, with no formal party wall formed between the two properties.

*Figure 26 – View on Single Storey Building Interface with Deen House*
