KE/45466-001

11 July 2021

**Former Akzo Nobel Site, Hollingworth Road, Littleborough**

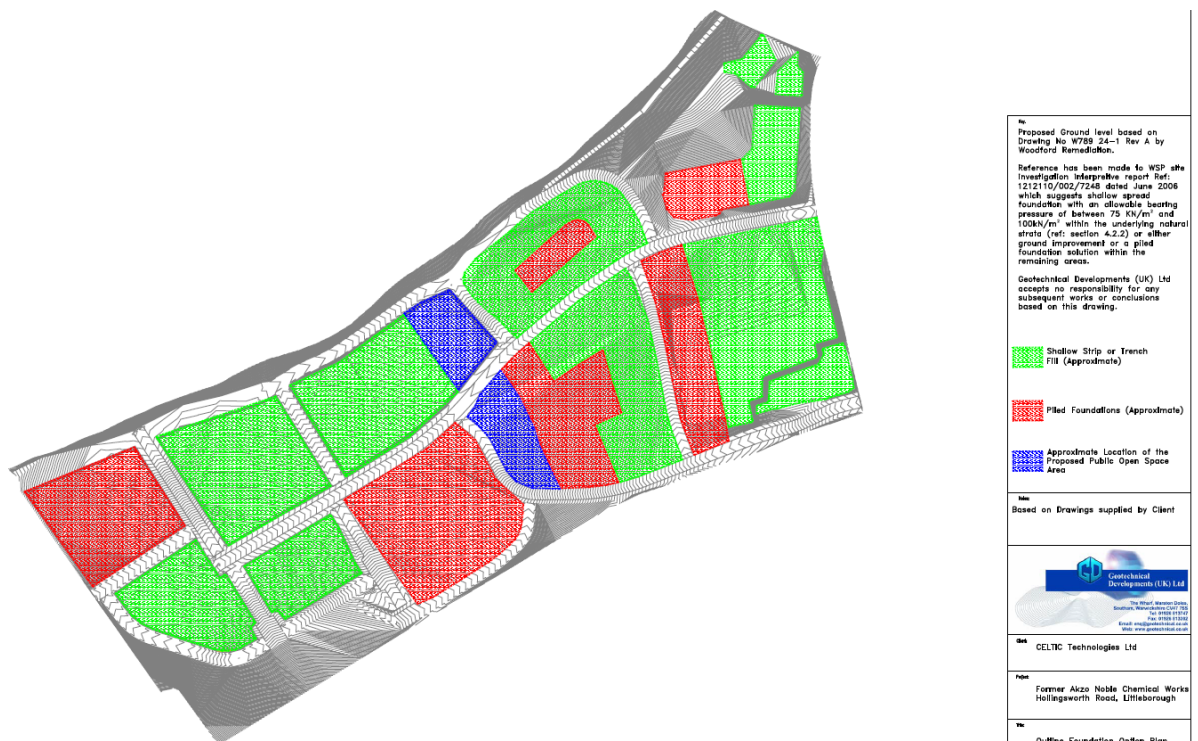
The plan notes the 2006 WSP allows for a safe bearing pressure of 75 to 100 kPa in natural strata. The areas where 'shallow strip and trench fill' footings are expected to be appropriate are shaded in green, whilst piled foundations are in red. Blue is POS area (designated at that time):

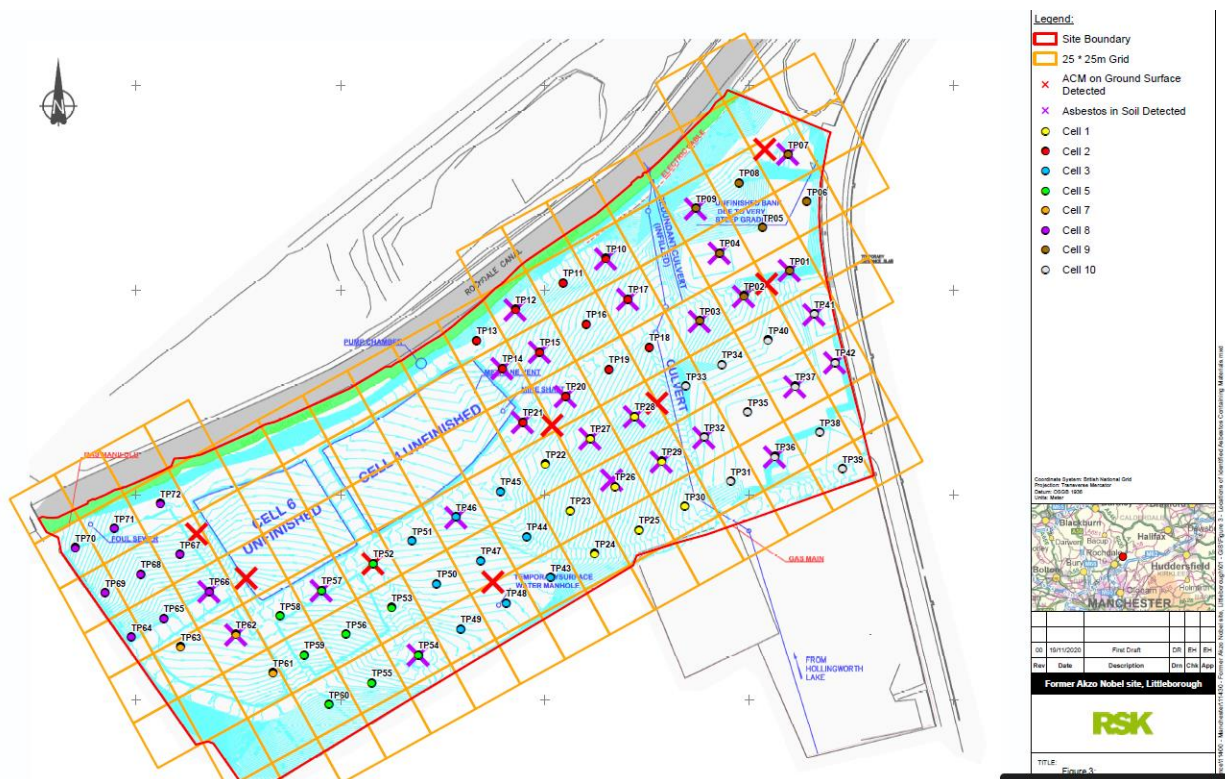
Visible ACM was noted in four surface locations, and 27 of 55 samples recorded up to 0.019%. Of the 8 bulk bags, 4 contained ACM.

The report concludes the material is ingrained with asbestos, and that mitigation measures are required during future disturbance of the ground including notifying future works to the HSE and 'employing the specialisms of a licensed asbestos contractor to manage such future works appropriately'. Air monitoring around the site's perimeter may also be required during drier times of the year. The hard to dig layer could be considered 'hazardous waste' if removed from site in its current state. If it remains in place, it should be capped with 600 mm of clean cover and a visible marker layer. Where services are to be installed, the surrounding soils should also be 'clean'.
