Phase II Geoenvironmental Site Assessment  
Land at Greenbooth Road and Edenfield Road, Norden

Reference: 16-465-R2-2  
Date: June 2023

## **PHASE II GEOENVIRONMENTAL SITE ASSESSMENT**

Land at Greenbooth Road and Edenfield Road  
Norden  
Rochdale  
OL12 7TD

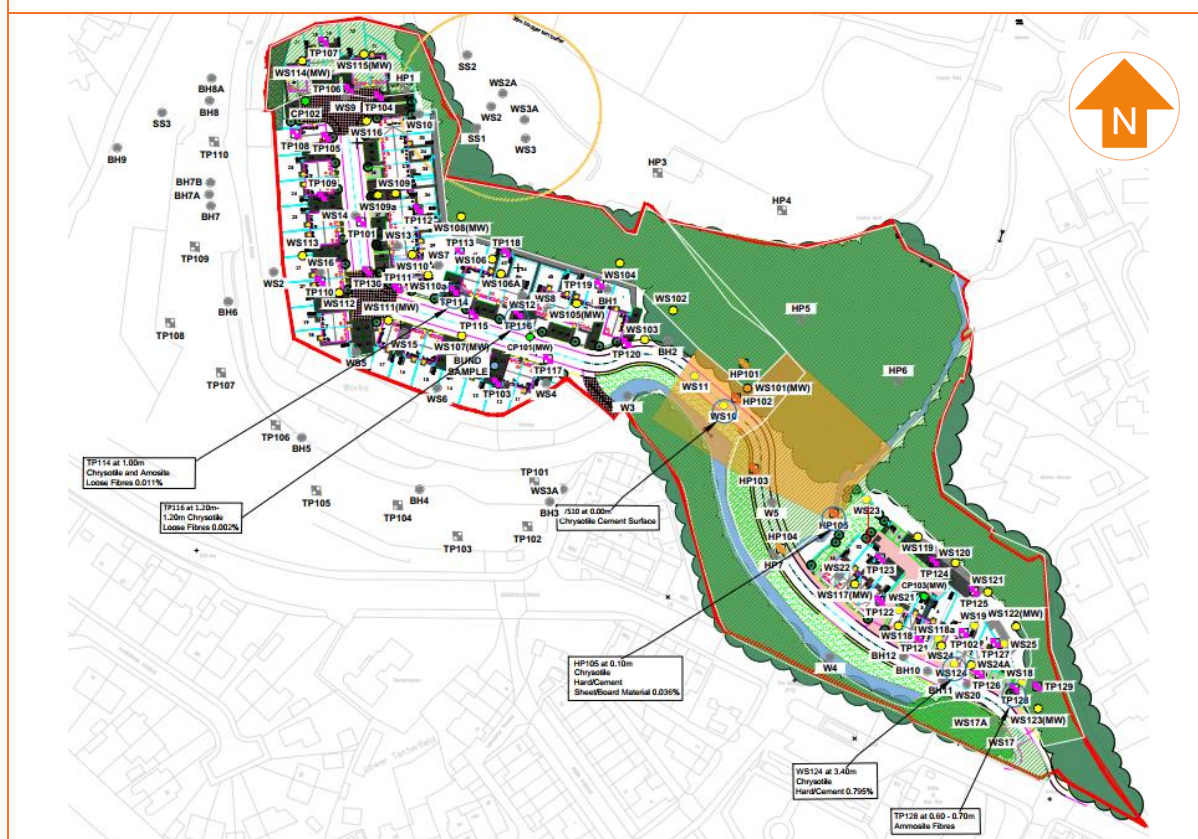
FIGURE 4.2 CONTAMINATION ISSUES PLAN – ASBESTOS

Potential visible asbestos was noted in WS10 as likely chrysotile cement.

Asbestos bulk fragments, in the form of hard cement were also identified in WS124, HP05 and WS10; and asbestos sheeting/board debris within HP05. Visual signs of ACM were encountered during the ground investigations in HP05.

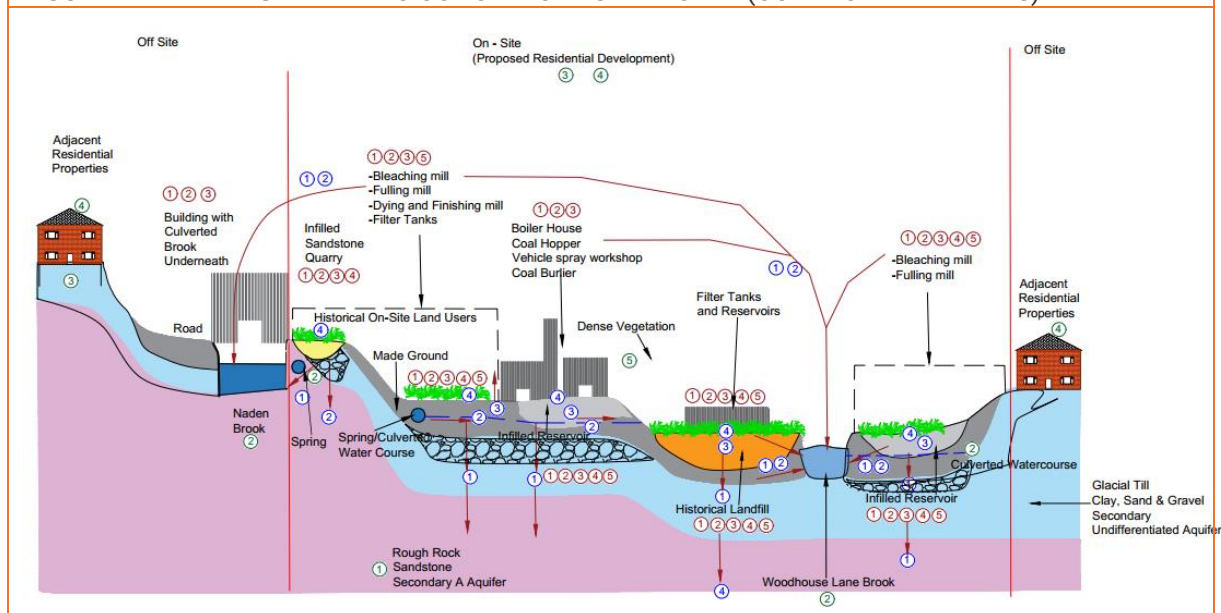
FIGURE 4.9 DIAGRAMMATIC CONCEPTUAL SITE MODEL (CONTROLLED WATERS)

It is noted that mobile contaminants identified within the soils and groundwater (non-volatile PAHs, naphthalene and TPHs) have the potential to migrate laterally towards the surface water receptors as a result of the high permeability strata present beneath the site. The cohesive strata that is present beneath the site may also act as an impermeable barrier and channel mobile contaminants towards the surface water receptors. As such, the surface water receptors are deemed to be at a high risk from on-site contamination.

In addition to above, E3P has developed a diagrammatic conceptual model which considers the factors in Table 4.3. This is available as Drawing 16-465-037 and a snapshot is included in Figure 4.9.
