**VISUAL INSPECTION  
TAME BARN FARM**

**GSL2922**

**25 MAY 2023**

GroundSolve Ltd

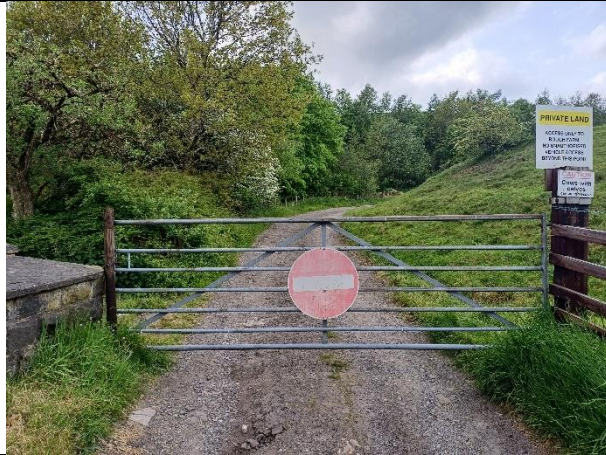
**Photograph 1:** Track up to the site off Woodside / Huddersfield Road.

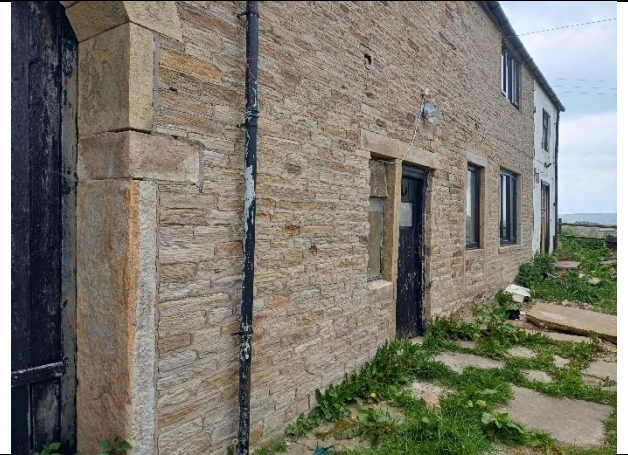
**Photograph 2:** Sandstone Farmhouse building with flagged small courtyard area.

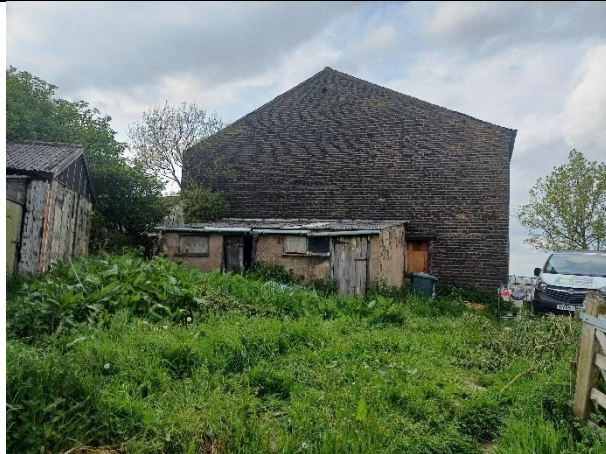
**Photograph 3:** Outbuildings in poor repair and vegetation with no sign of stress.

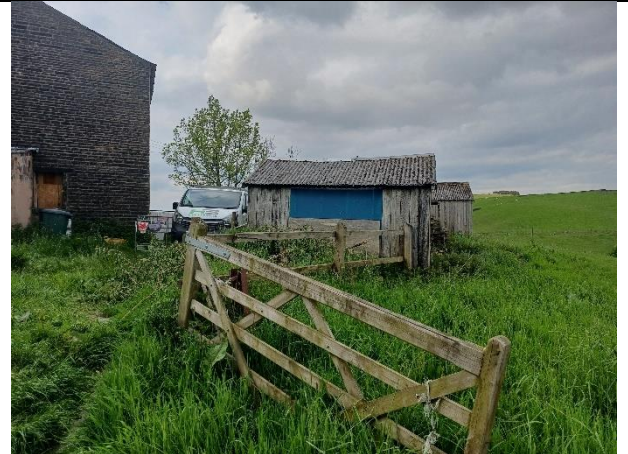
Several of the small outbuildings were noted to have cement bound asbestos roofs and guttering. The client is already aware of this and has made arrangements for their safe removal disposal.

**Photograph 4:** The majority of the outbuildings had what appeared to be corrugated asbestos cement roofs.

Potential asbestos containing materials were noted on several of the outbuildings.

The client is aware of the presence of potential ACMs onsite and it is understood that these are to be safely contained and removed by others.

The works should be undertaken in compliance with all relevant regulations, guidance and legislation. As outlined within the HSE publication "Successful Health and Safety Management - HSG65" this report should inform your development of safe systems of work and information as an input into the safety management system. The risk posed by ACMs can be managed by careful procedures and dampening down to reduce the risk of airborne fibres, and it is recommended that an appropriate 'Asbestos Management Strategy' is developed and adopted for the works.

Care must be taken to ensure that the removal does not lead to the contamination of ground in the surrounding area with dust and fibres.

Details of the removal should be provided to the Local Authority, including provision of waste transfer documents.

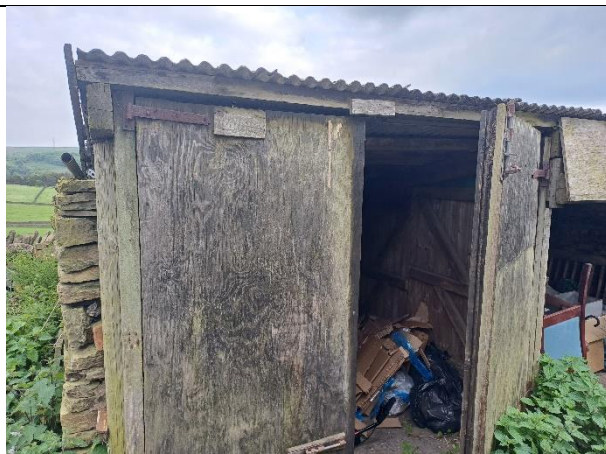
**Photograph 5:** The outbuildings appear to have been used to store household waste in the east of the site.

The site appeared to have predominantly been used for the storage of limited amounts of household waste (predominantly cardboard) and for shelter for animals. No fuel tanks were noted onsite.

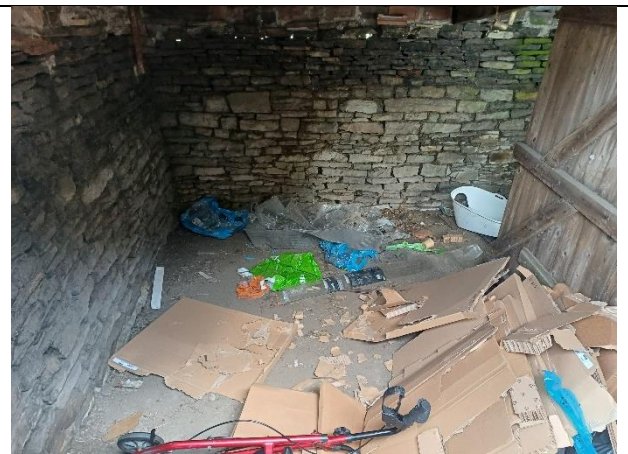
**Photograph 6:** Interior of one of the outbuildings showing packed earth floor.

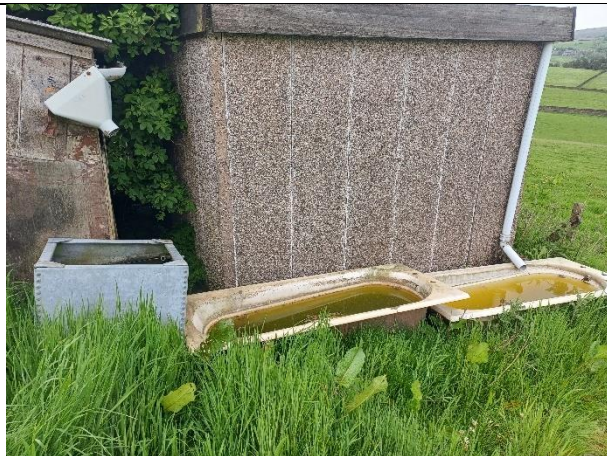
**Photograph 7:** A number of containers were noted around the site. These appear to be for storing water for livestock.

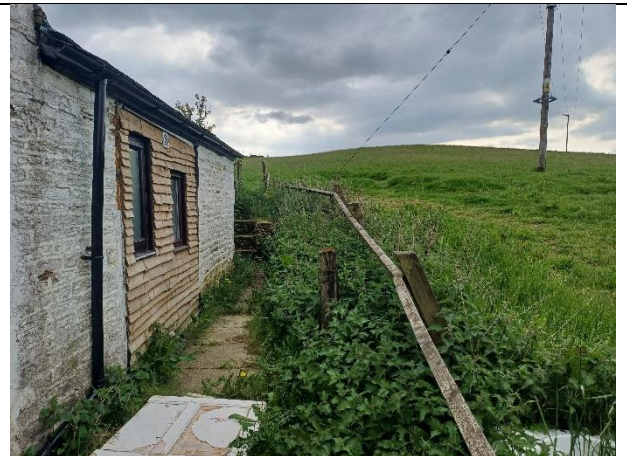
**Photograph 8:** Path to the rear of the farmhouse building. Building shows no evidence of a gas grid connection or presence of any oil tank(s).

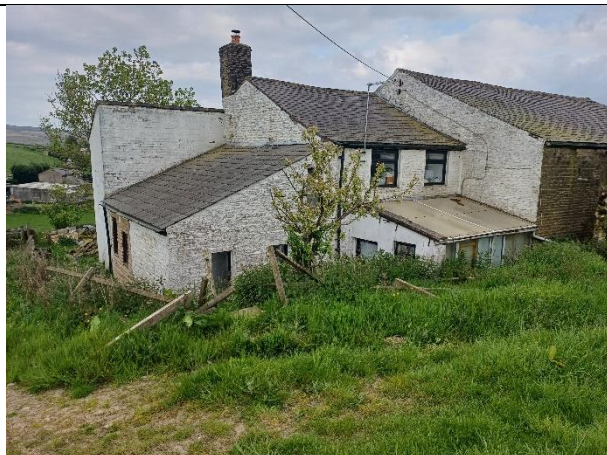
**Photograph 9:** Rear of the farmhouse.

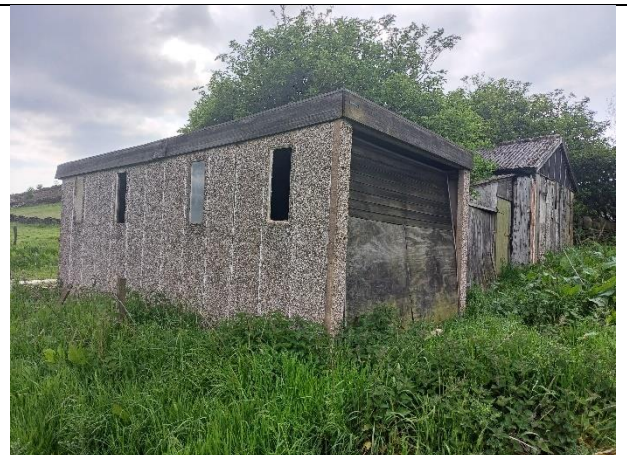
**Photograph 10:** Outbuildings present in the south of the site appear to have been used to shelter livestock.

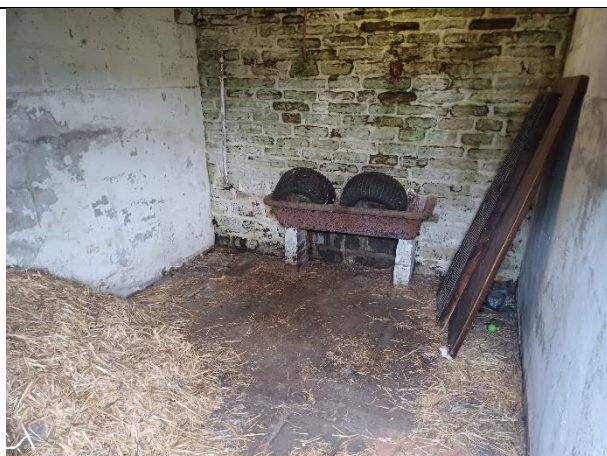
**Photograph 11:** Packed earth floor beneath the hay within the outbuilding. Mossy stonework but no sign of efflorescence or chemical attack.

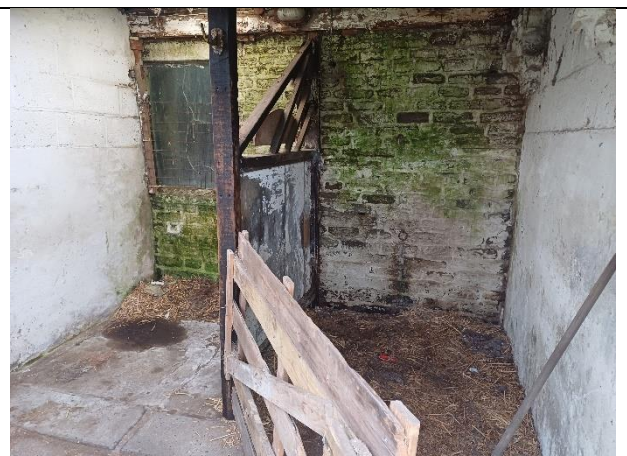
**Photograph 12:** Stains on flagged floor not of hydrocarbon origin.
