# **Contaminated Land Site Assessment**

Ceylon Service Station  
Yorkshire Street,  
Rochdale,  
OL16 2DR

18 September 2023  
Report ref. 23/1326.2.1

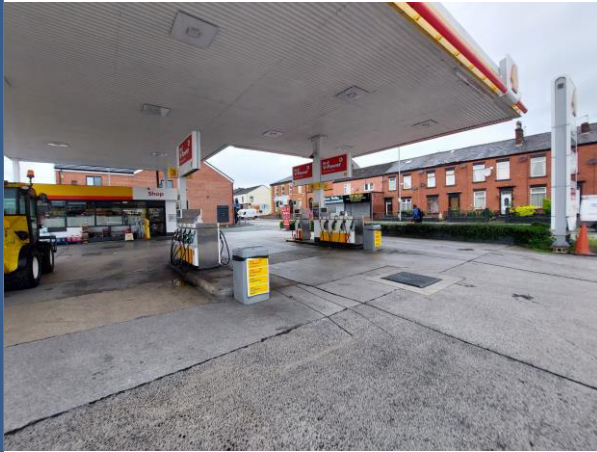
The site is surfaced with concrete slabs, judged to be in fair to poor condition (Images 1-6, Appendix B). Gullies follow the line of the site boundaries.

Five UTS are present in the eastern side of the forecourt area (Image 1). Upon opening the manholes, no information regarding the tank volumes could be found, and this information was not disclosed by the site manager. The offset fills of the five tanks are located by the pump aisle next to pumps 3 and 4, and their vents are located on the disused car wash (Image 6).

**Image 1:** PFS forecourt with Yorkshire St in the background and shop to the left. Facing northwest.

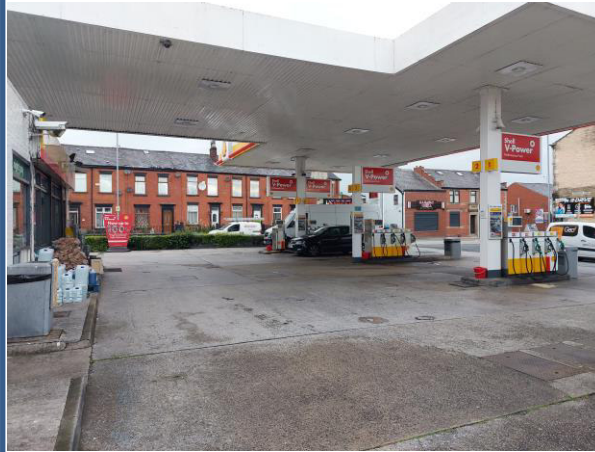
**Image 2:** PFS forecourt with Yorkshire St in the background. Facing north.

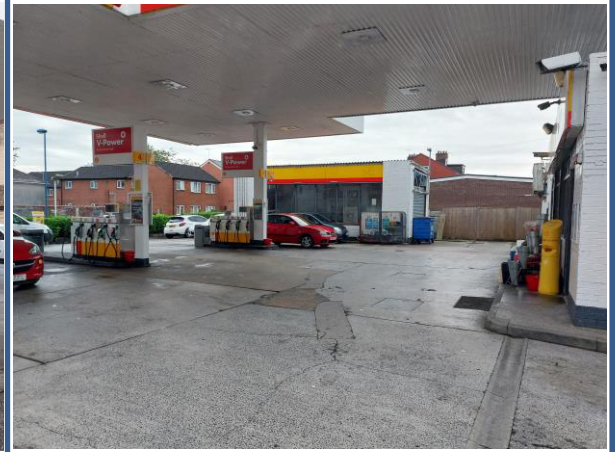
**Image 3:** PFS forecourt with disused car wash facility in the background. Facing southeast.

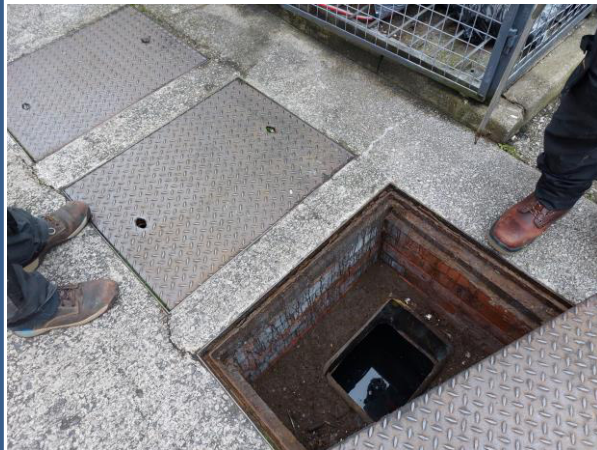
The three-stage interceptor is located on the southern area of the site, next to the disused car wash building. Its first stage shows a visible layer of unidentified hydrocarbon (Image4).

**Image 4:** Three stage interceptor, near car wash building. First stage shown.

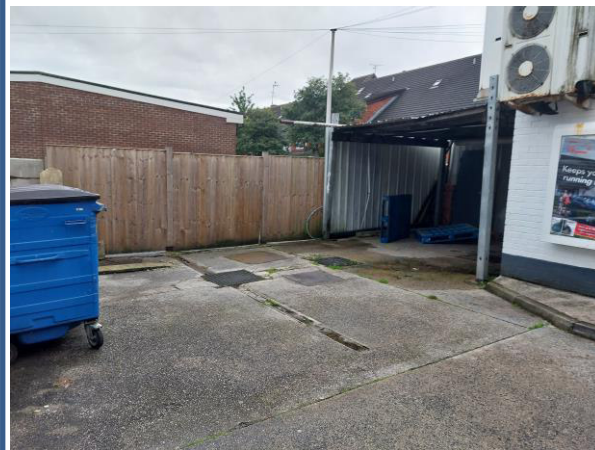
Surface drainage is found by the ingress and egress of the PFS; a gully is located by its eastern border, and another is found in the southern area (Image 5). The drainage by the egress appears to be mostly silted.

**Image 5:** Southern corner of the site, used as general deposit.

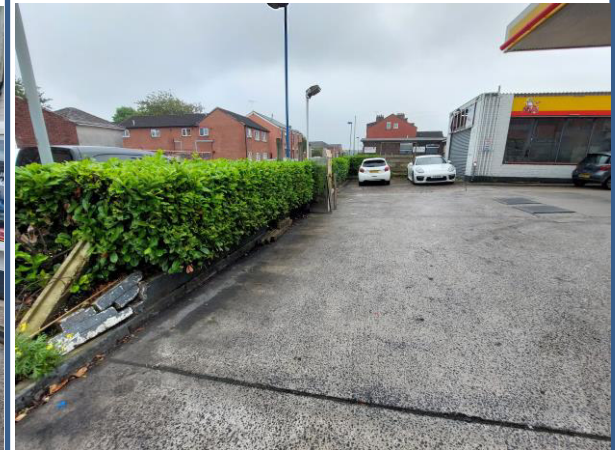
**Image 6:** Air pump near the eastern hedge and car wash in the back. Tank vents in the building's corner. Facing southeast.
