# TREE SURVEY & REPORT

For A Prince  
24 Reddyshore Brow,  
Littleborough  
Rochdale  
OL15 9PF

## TREE SURVEY / SCHEDULE AND REPORT

TPO Grove Works 1990, G4 6x Birch, ID G4TPO097. Local Authority:  
Rochdale

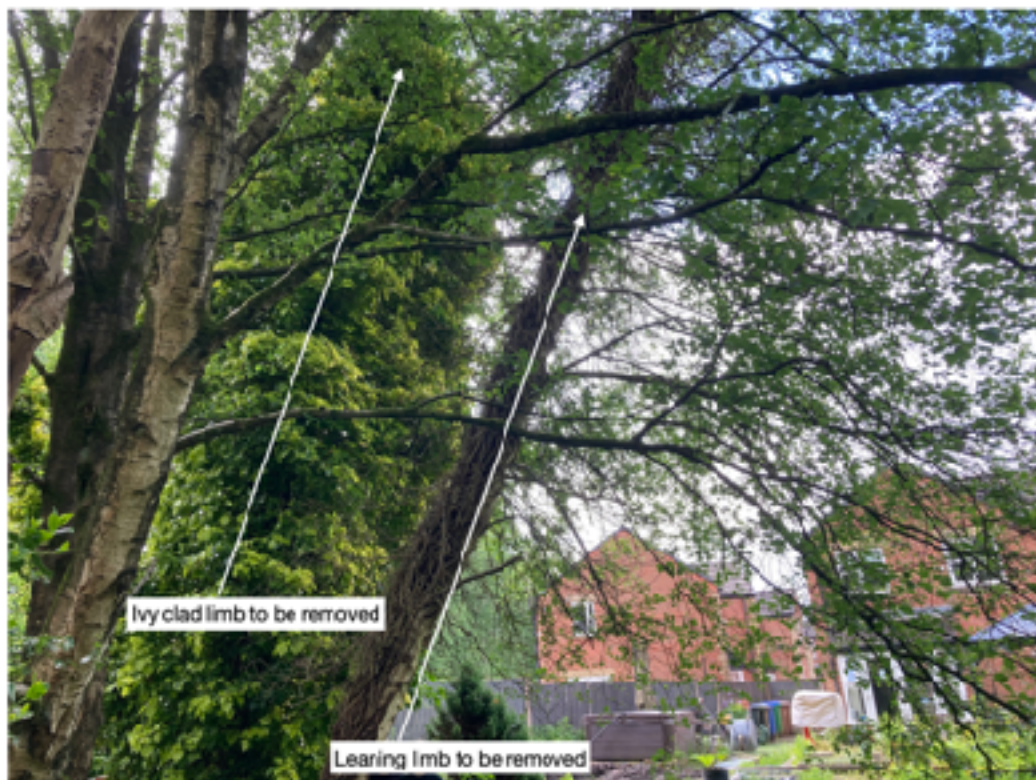
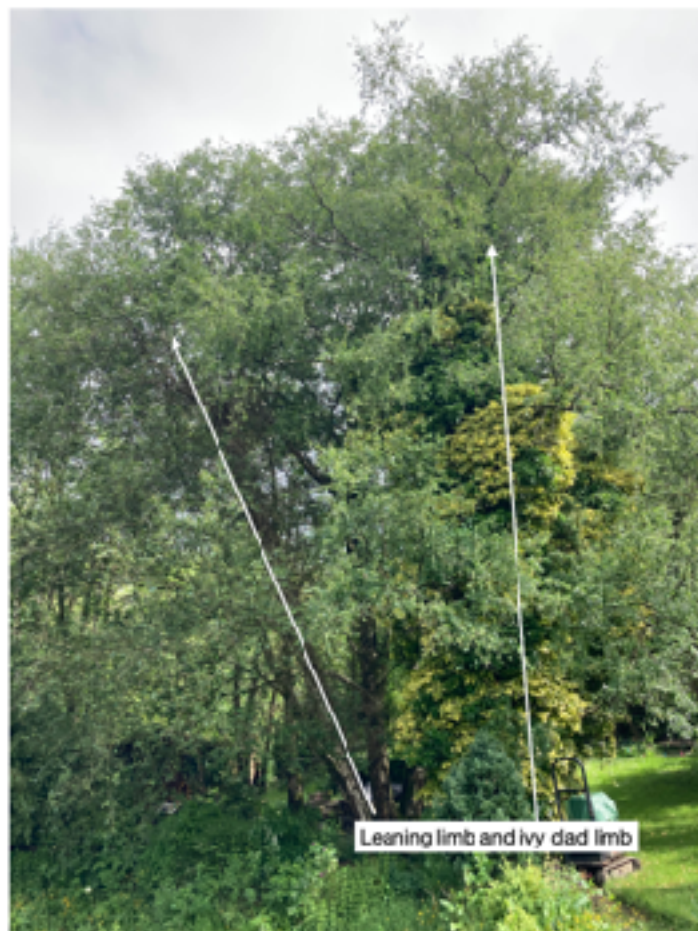
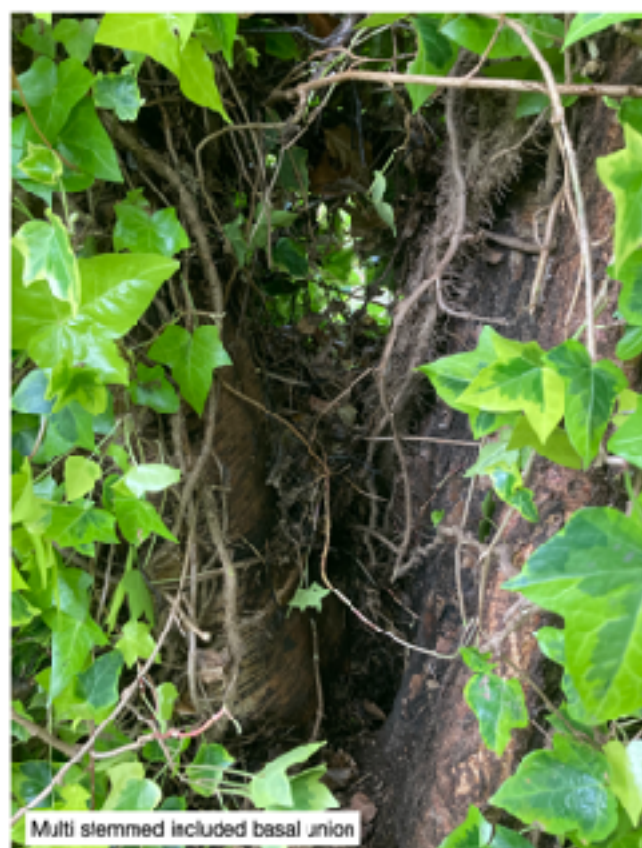
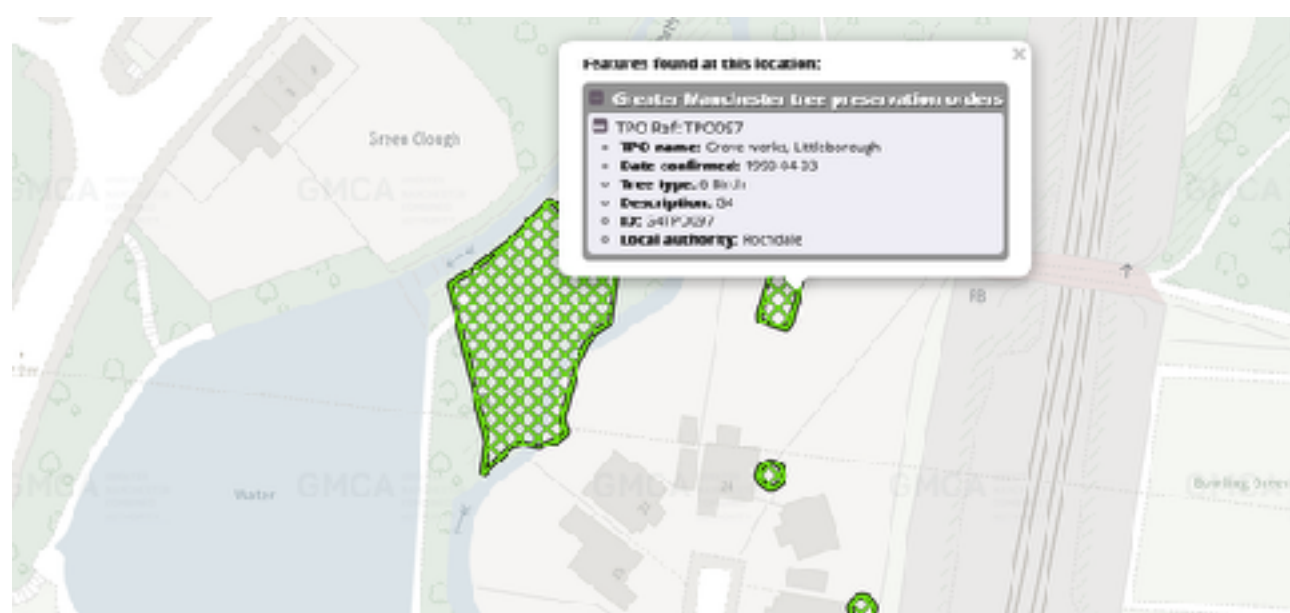
**T1** of the G4 is a mature group of Birch which has seen no maintenance and left to grow naturally. The work proposed is to remove two stems of the multi stemmed tree at the included bark basal union, the union appears to be sound.

The first stem is heavily clad in ivy and has led to the second stem being shaded out and which has a prominent lean which will fail in due course. The removal will improve the aesthetics of the immediate back garden and add a semi formal area which will lead through to a wooded stand of predominately Ash trees.

| TREE NO. | SPECIES | D.B.H (CM) | HEIGHT (M) | AGE | CATEGORY BS 5837 | Work RECOMMENDATION |
|---|---|---|---|---|---|---|
| T1 | Betula (Birch) multi stemmed | 40 | 10 | MA | MS RRR B2 | Remove densely clad Ivy stem<br>Remove prominent shaded out leaning stem |

The owners are passionate about their trees and understand the need to replace trees which have been removed. In this case they would replace with the same species of a heavy standard should permission be granted.
