BRANCH ROAD FARM, BRANCH ROAD  
LITTLEBOROUGH – OL15 0AB

May 2021

Revised: 24<sup>th</sup> June 2022

# REPORT ON STRUCTURE

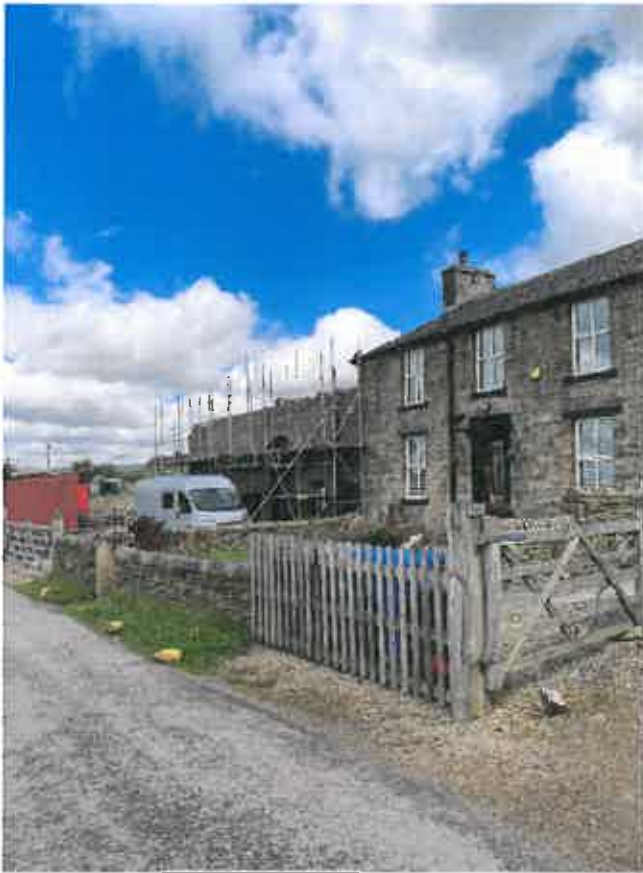
Photograph 1

- 1.01** We were requested by Mr Wildman to carry out a survey and to provide a report on the structure of the property known as The Barn, Branch Road Farm, Littleborough. See photograph 1.

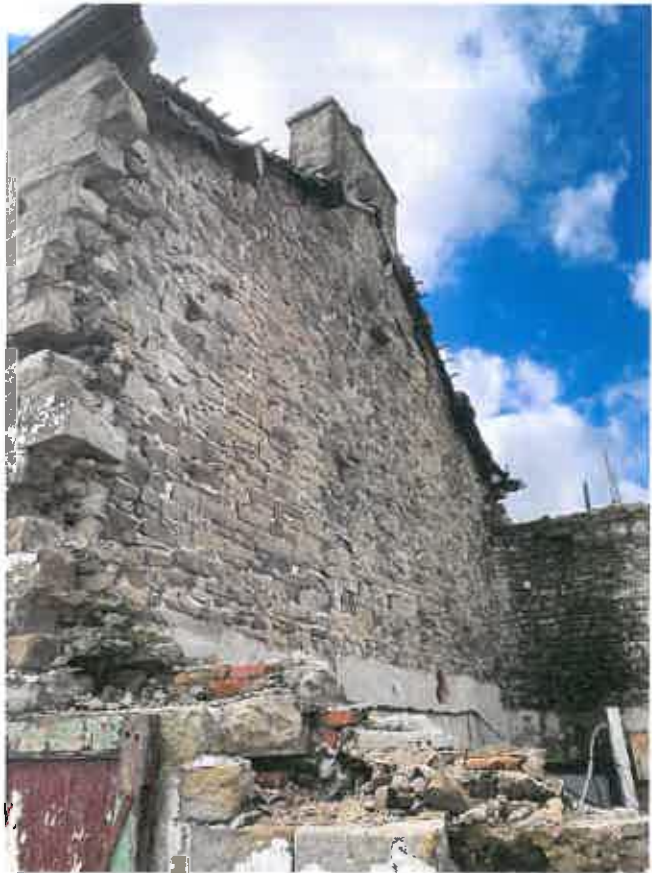
Photograph 2

The party wall, with the farmhouse, is to remain as a party wall in the new development. See photograph 2.

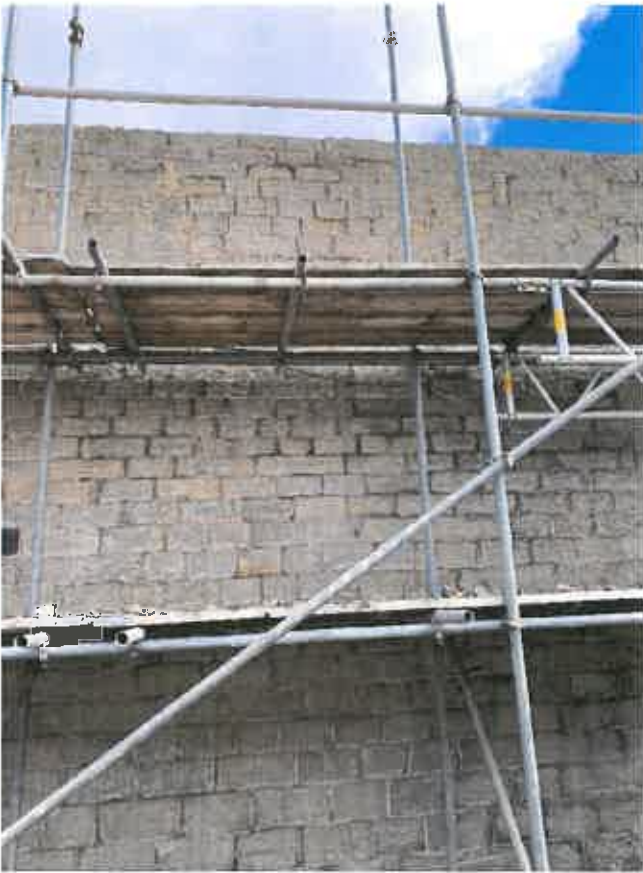
Photograph 3

**2.04** The remaining barn walls are faced with a coursed local stone with narrow beds joints. See photograph 3. The inner leaf is of random stone and there is a poor, loose rubble fill. See photograph 4.

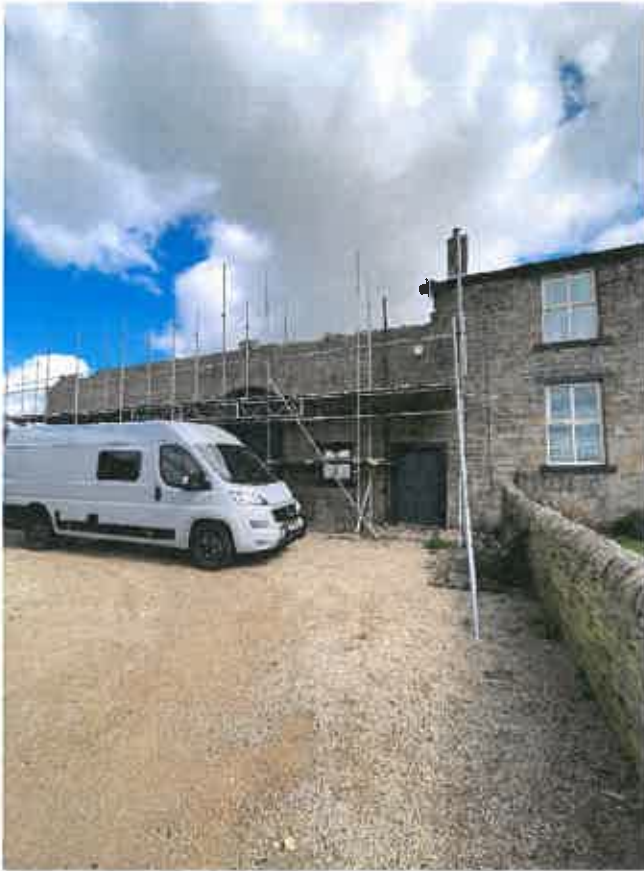
Photograph 5

**2.05** On the front elevation there is an existing large cart arch, two nominal window openings and a personnel door. See photograph 5.

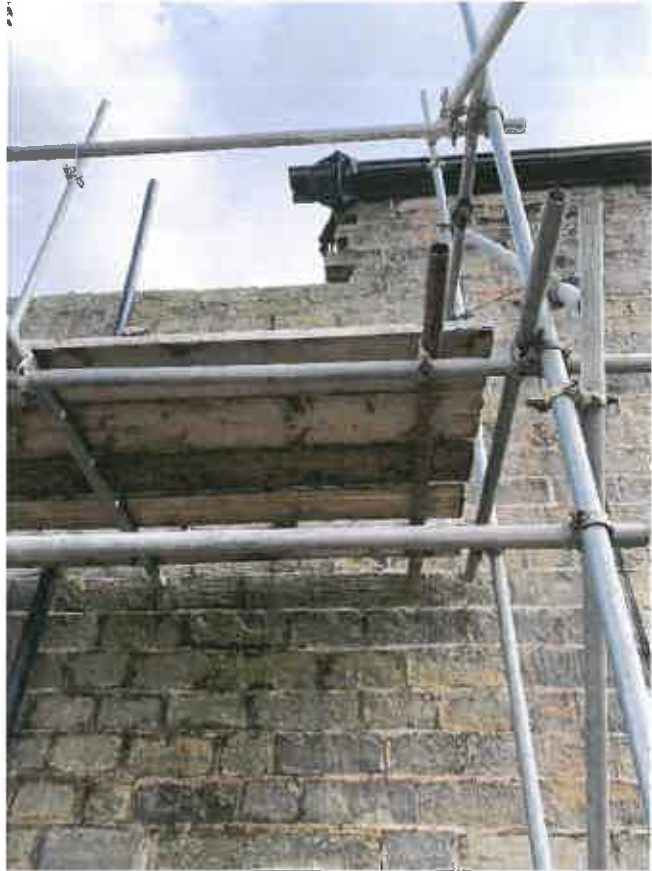
Photograph 6

**2.06** The existing front elevation is complete up to within a few stone courses below eaves level. See photograph 6.

The wall will be extended to eaves level, faced with the original coursed stone. The remaining partial elevations on the left and rear will be stabilised in a similar manner.

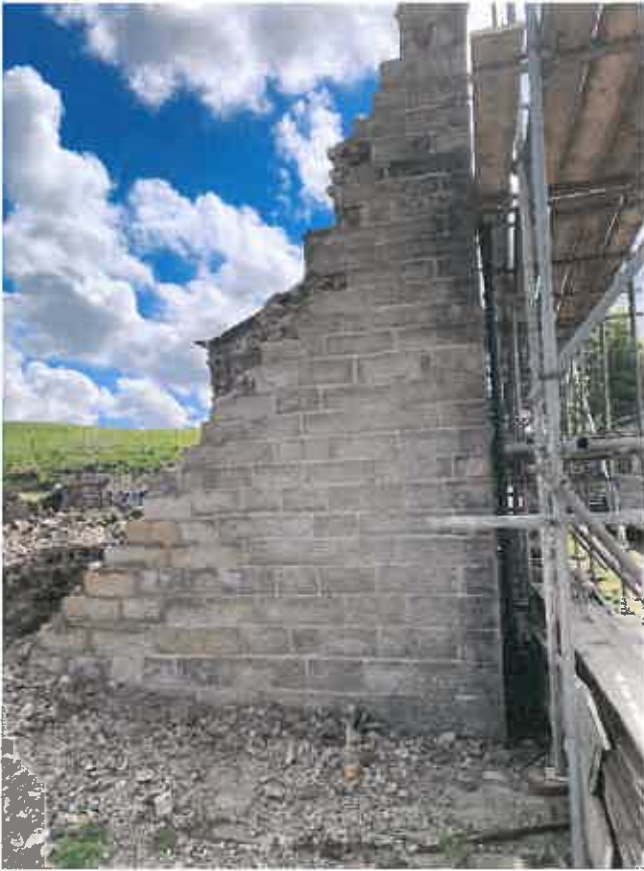
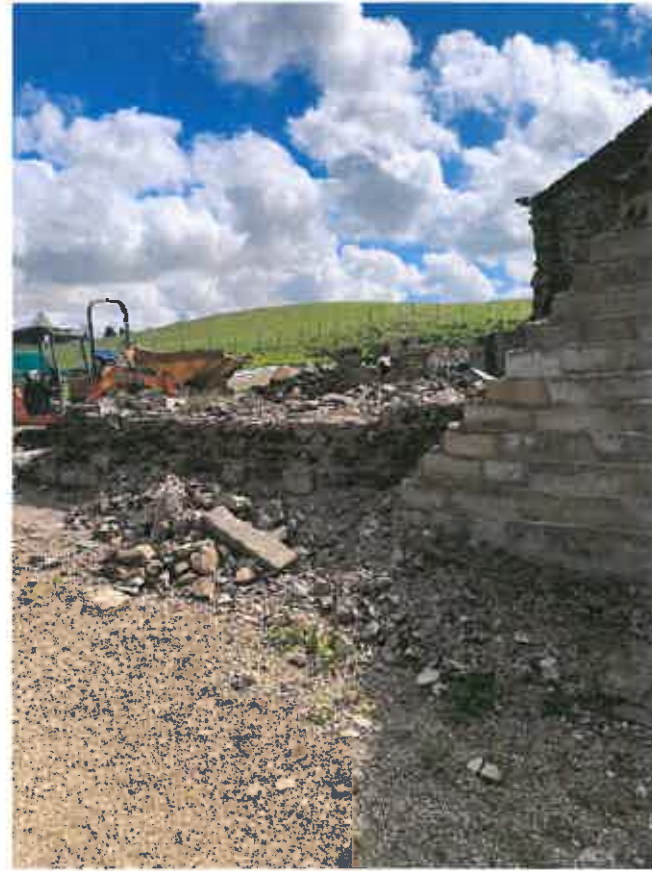
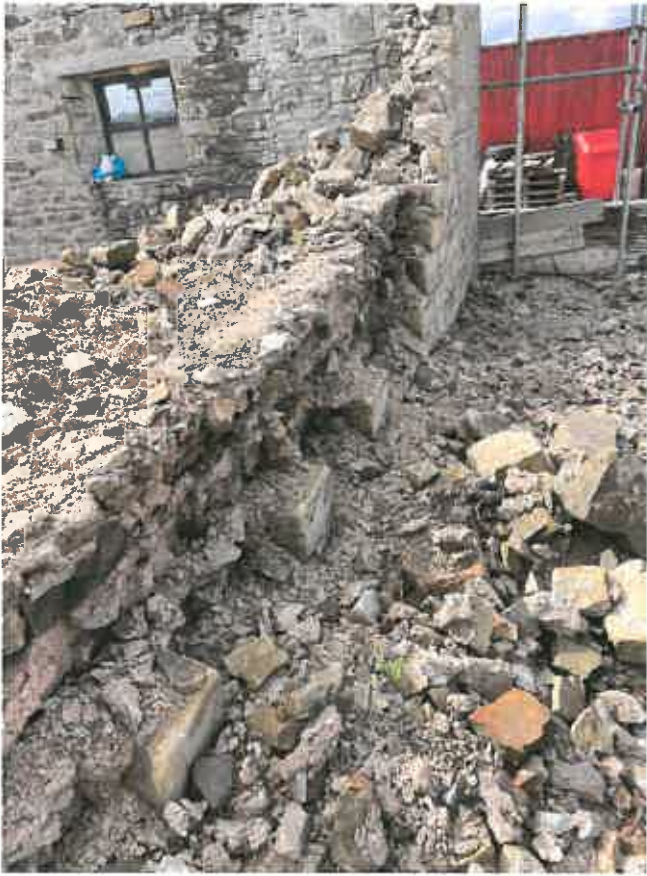
**2.07** The left-hand side and rear elevations became unstable during demolitions and now only remain in part. See photographs 7, 8 & 9 - side elevation and photographs 10, 11 & 12 – rear elevation.

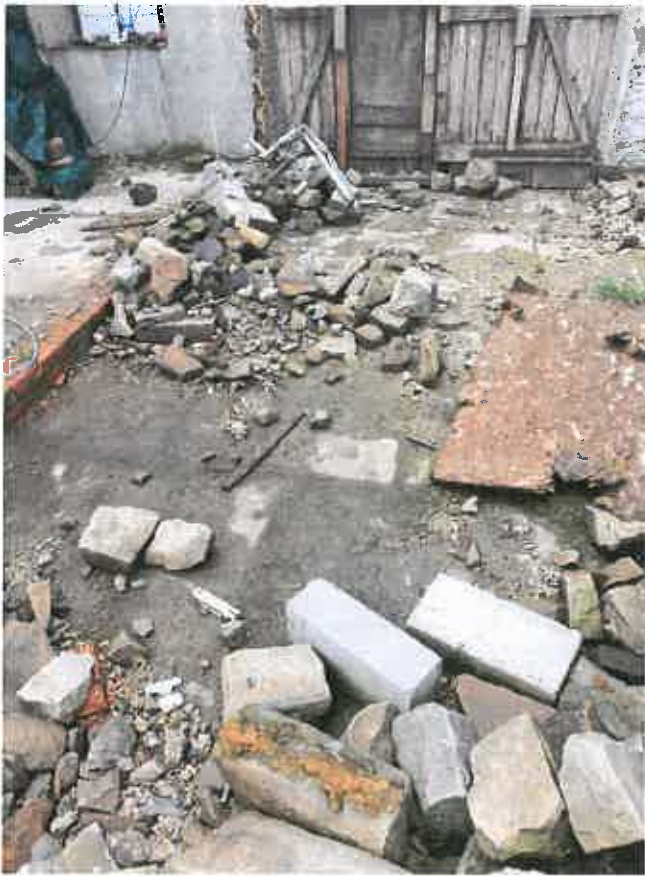
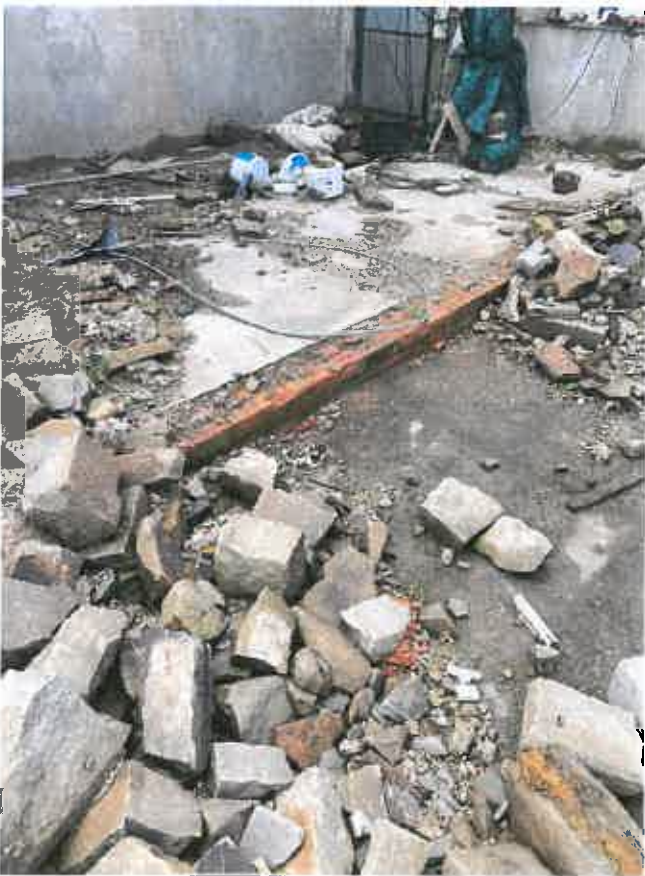
**2.10** The existing floor slab currently remains. This is a mixture of different surfaces set at varying levels. See photographs 13 & 14.

Prior to any further reconstruction, the existing floor slab will be removed and replaced with a new reinforced concrete raft. A typical detail is shown in Appendix D.

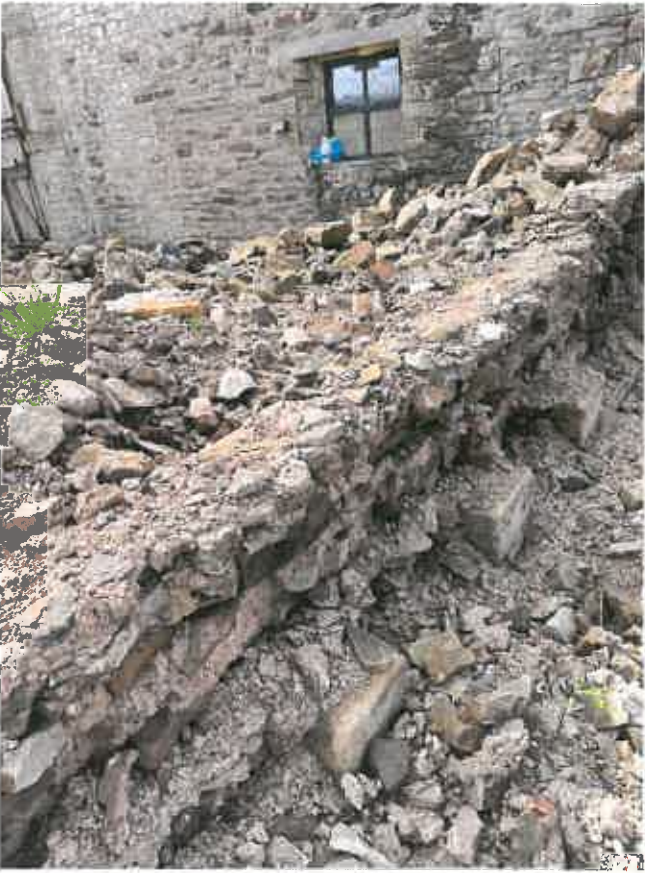
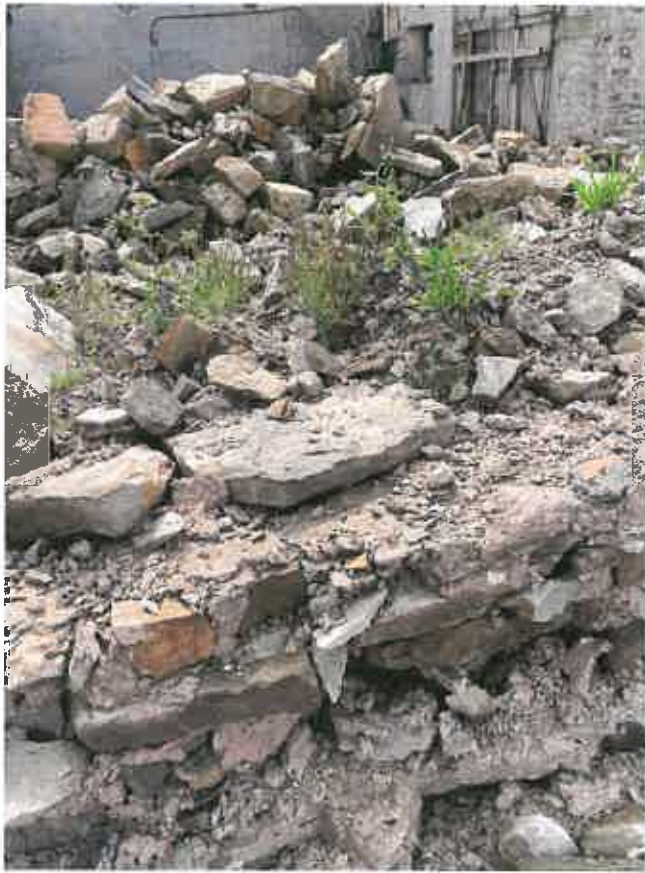
- 4.01** We believe the collapse of the left-hand side and the rear elevation was inevitable given the condition of the walls and the poor quality of the inner leaf matrix and the loose rubble fill. See photographs 15 & 16. The loss of lateral restraint due to the removal of the roof was also a contributing factor.
