## **Application to undertake works to trees subject to Tree Preservation Order and notification of tree work to be undertaken in a designated Conservation Area**

Ref 1 – The Ormrods, Birtle Road, BL9 6TX

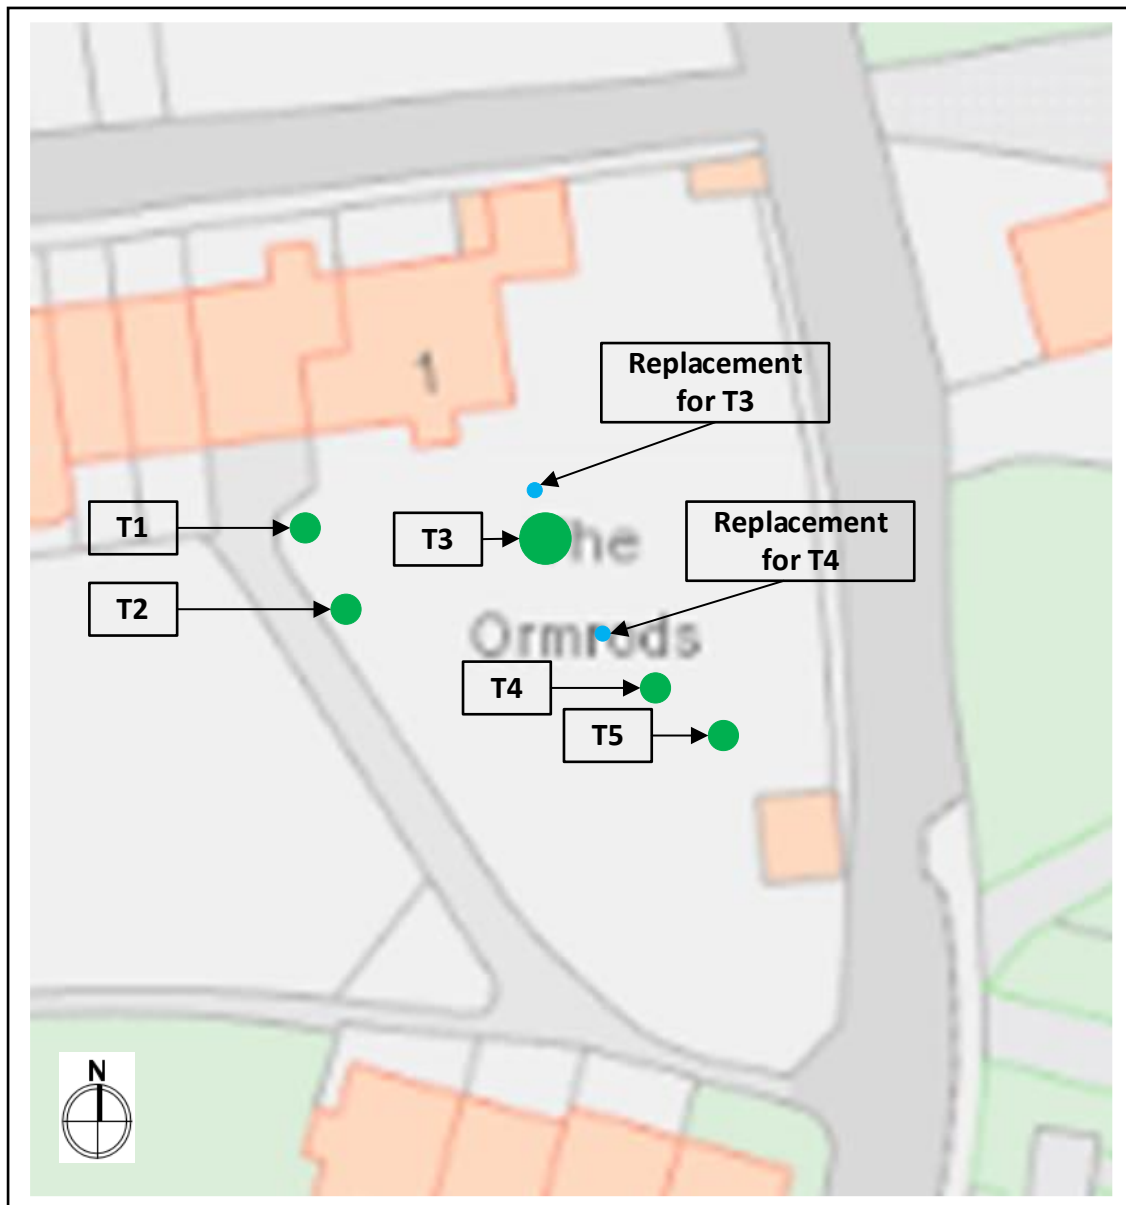
Sketch map to indicate location of trees and replacement trees

Appendix 1 provides the sketch plan of the location of the trees which have been numbered from T1 to T5 for ease of identification. Two of the trees, T3 and T4, are in poor physical condition and are structurally compromised and are therefore recommended for removal, and the location for the replacement trees is indicated on the sketch plan Appendix 1. Appendix 2 provides images of all the trees included within this application.

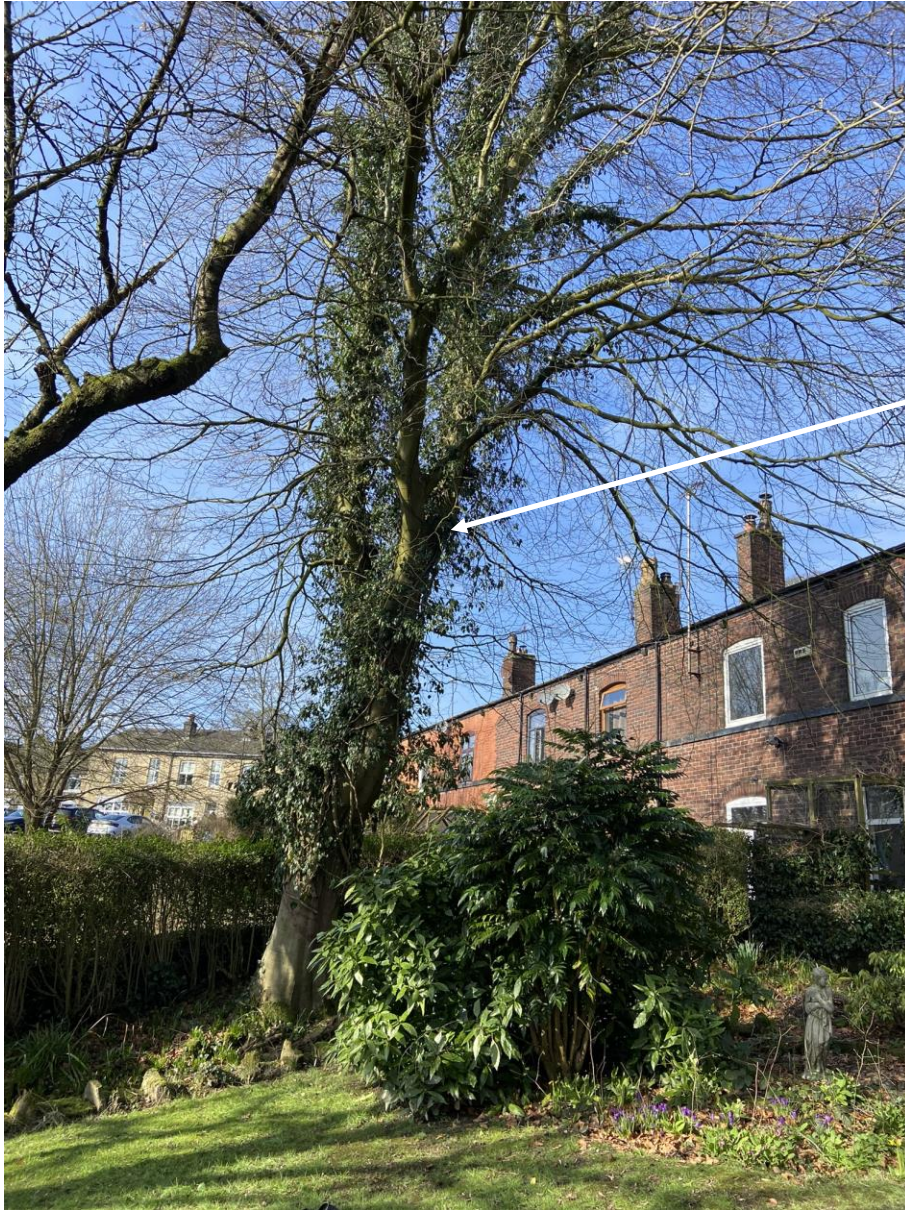
Image 1 - T1

T1 is a mature Beech (*Fagus*) which is subject to TPO and is located approximately 8.3m to the south of the residential property. The lower branches are beginning to encroach onto the building and roof space. The lower branches to the north of the tree are also encroaching onto the telephone cables. In order to mitigate the potential for damage to the property, a 30% crown reduction is recommended to provide sufficient clearance from the property and a crown lift to provide sufficient clearance from the telephone cable. The crown is unbalanced and suppressed to the south by T2, and T1 has a slight lean (10°) towards the property which should be monitored over time. There is no evidence of root plate movement.

| Tree Reference, species and observations | Specification of Work Requested | Reasons for work |
|---|---|---|
| <p>T1<br/>Beech<br/>(<i>Fagus</i>)</p> <p><i>T1 is supressed to the south by T2 resulting in an unbalanced crown and has a slight lean towards the house to the north of the tree of approximately 10°</i></p> | <p>a. 30% Crown reduction<br/>b. Crown lift to above telephone cables at approximately 5m<br/>c. Remove deadwood from canopy and pegs left from naturally shed branches</p> | <p>a. The work is recommended because the branches are beginning to encroach onto the property and roof space creating a potential nuisance and risking damage to both the property and the tree<br/>b. The work is recommended as the lower branches are encroaching onto the telephone cables – this will provide sufficient clearance from the cables<br/>c. Good arboricultural management to prevent decay entering the heartwood of the scaffold branches and main stem</p> |

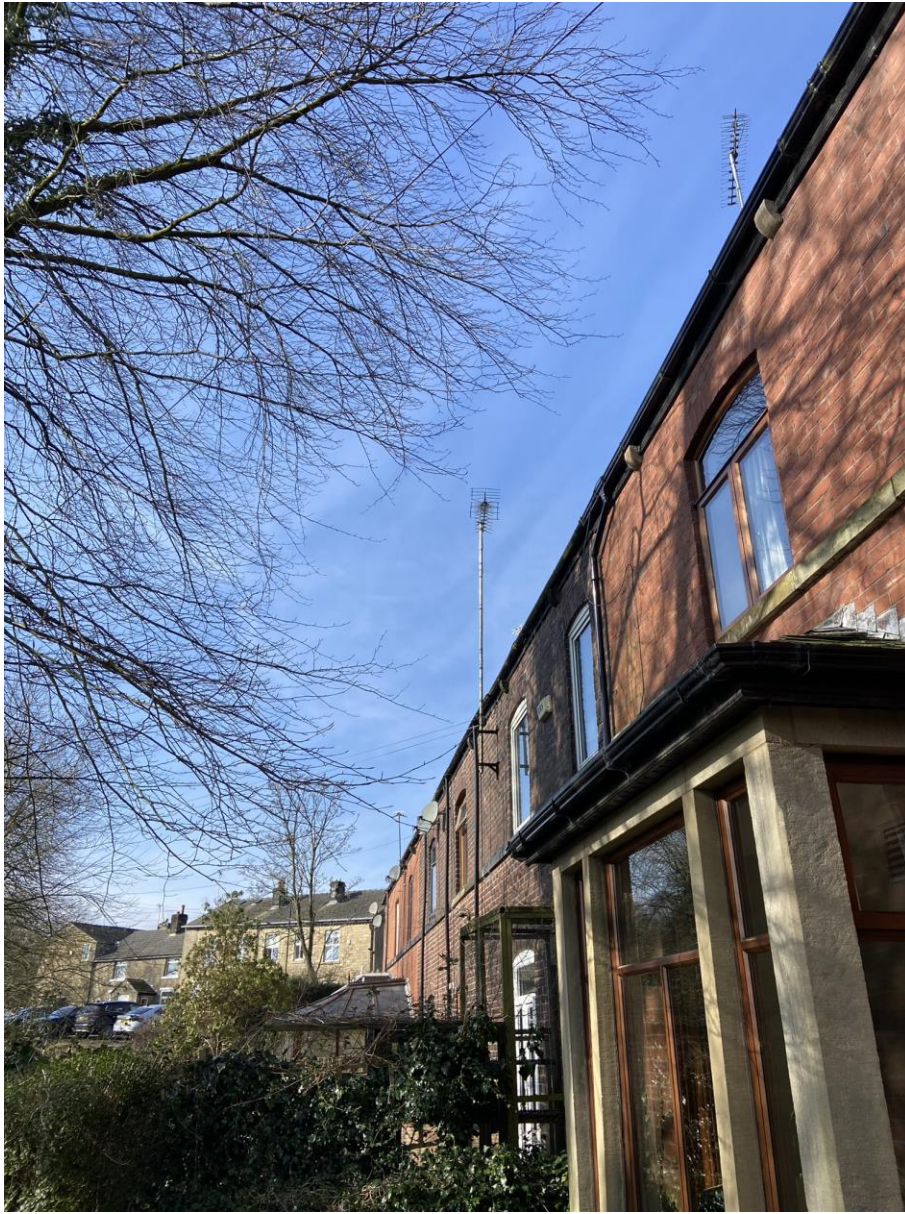
Image 2 – T1 proximity to house

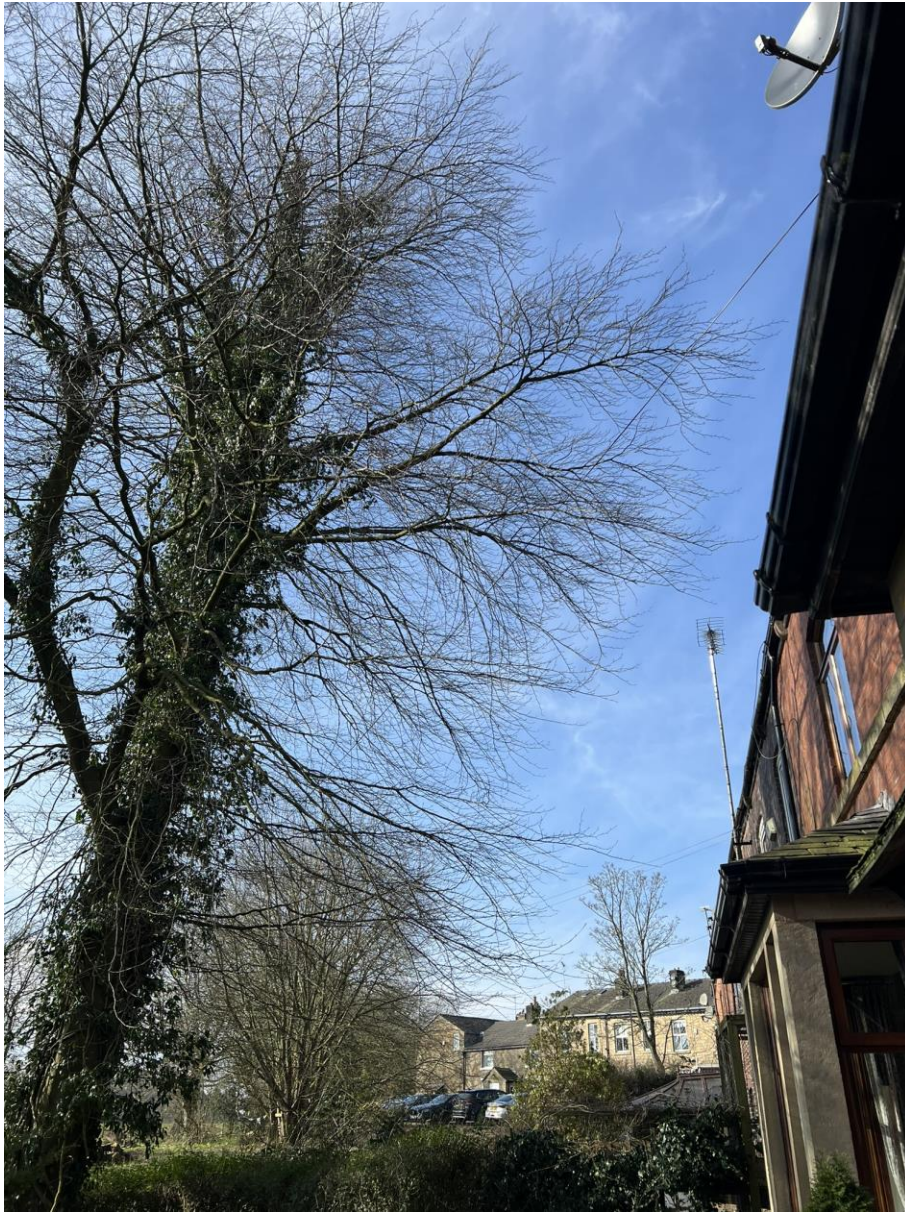
**Image 3 – T1 proximity to telephone cables**

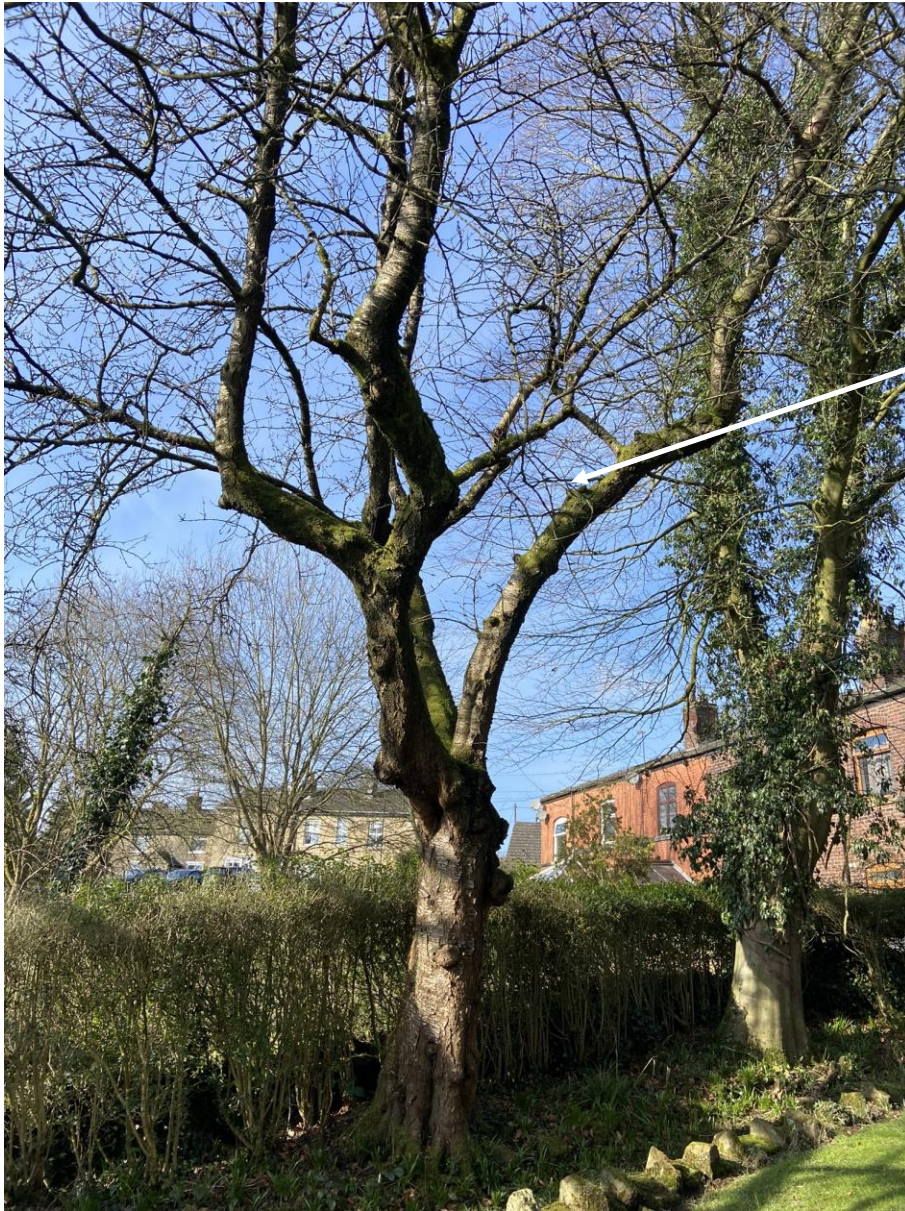
Image 4 - T2

T2 is an over mature Flowering Cherry (*Prunus serrulata*) and whilst there is some deadwood present within the canopy it is budding well and appears to be in good health. The canopy is wide and creating a significant number of crossing limbs with T1 to the north and the neighbouring tree to the south (not surveyed), T2 also creates a lot of shade across the garden of the Ormrods to the east of the tree and the neighbouring garden to the west of the tree. A 30% crown reduction will enhance the natural light levels to the gardens and encourage biodiversity and will also help to mitigate the crossing branches from causing damage to the other trees and to itself. T2 is located within the designated Conservation Area but desk research has indicated that it is unlikely to be subject to TPO.

| Tree Reference, species and observations | Specification of Work Requested | Reasons for work |
|---|---|---|
| <p>T2<br/>Flowering Cherry<br/>(<i>Prunus serrulata</i>)</p> <p><i>T2 is in close proximity to T1 and the tree to the south (not surveyed) and there are a significant number of crossing branches. T2 is creating significant shade across the gardens</i></p> | <p>a. 30% crown reduction<br/>b. Remove deadwood from canopy and pegs left from naturally shed branches</p> | <p>a. To increase natural light into the garden to enhance biodiversity and to reduce the potential for the crossing branches to cause damage to the neighbouring trees.<br/>b. Good arboricultural management to prevent decay entering the heartwood of the scaffold branches and main stem</p> |

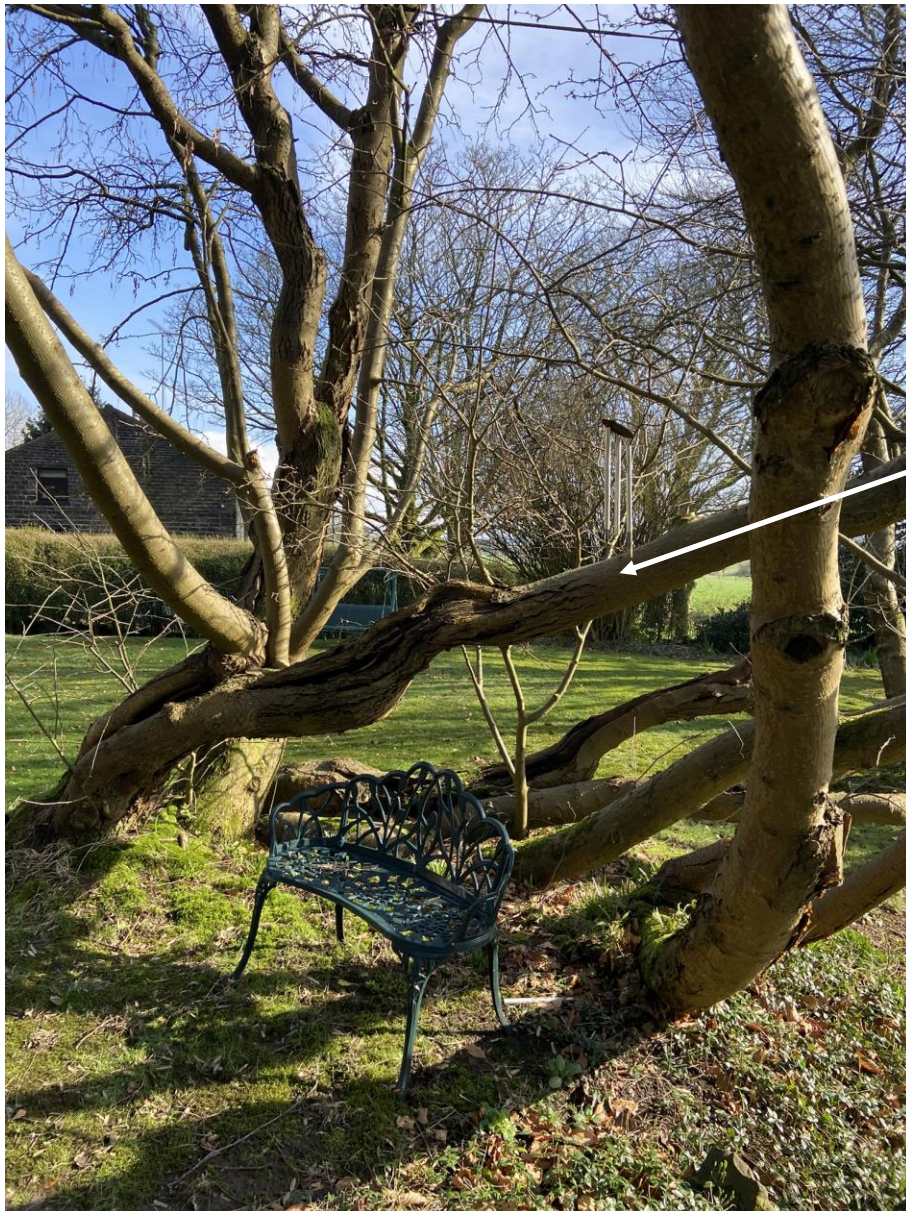
T3 is an over mature Laburnum (*Laburnum anagyroides*) which is multi-stemmed from ground level with 5 stems all of which are structurally unsound and are decaying with rot present throughout. The tree is shedding large branches and to mitigate the risk of harm to users of the garden removal of the tree, which is a species with a recognised short life expectancy, is recommended. The tree would be replaced with one standard sized laburnum to be located as indicated in appendix 1. T3 is located within the designated Conservation Area but desk research has indicated that it is unlikely to be subject to TPO.

| Tree Reference, species and observations | Specification of Work Requested | Reasons for work |
|---|---|---|
| <p>T3<br/>Laburnum<br/>(<i>Laburnum anagyroides</i>)</p> <p><i>T3 has a split stem (n=5) from the base and visual inspection together with sound and probe testing indicates that the tree has significant decay throughout and the tree is dead in parts and dying in the remaining stems.</i></p> | <p>a. Remove and replace</p> | <p>a. T3 is in a very poor physical and structural condition and at risk of failure. It is recommended for removal to avoid harm to people using the garden area</p> <p>The tree is to be replaced by one of the same species at standard size in the location indicated in Appendix 1</p> |

Image 5 - T3 (to be removed)

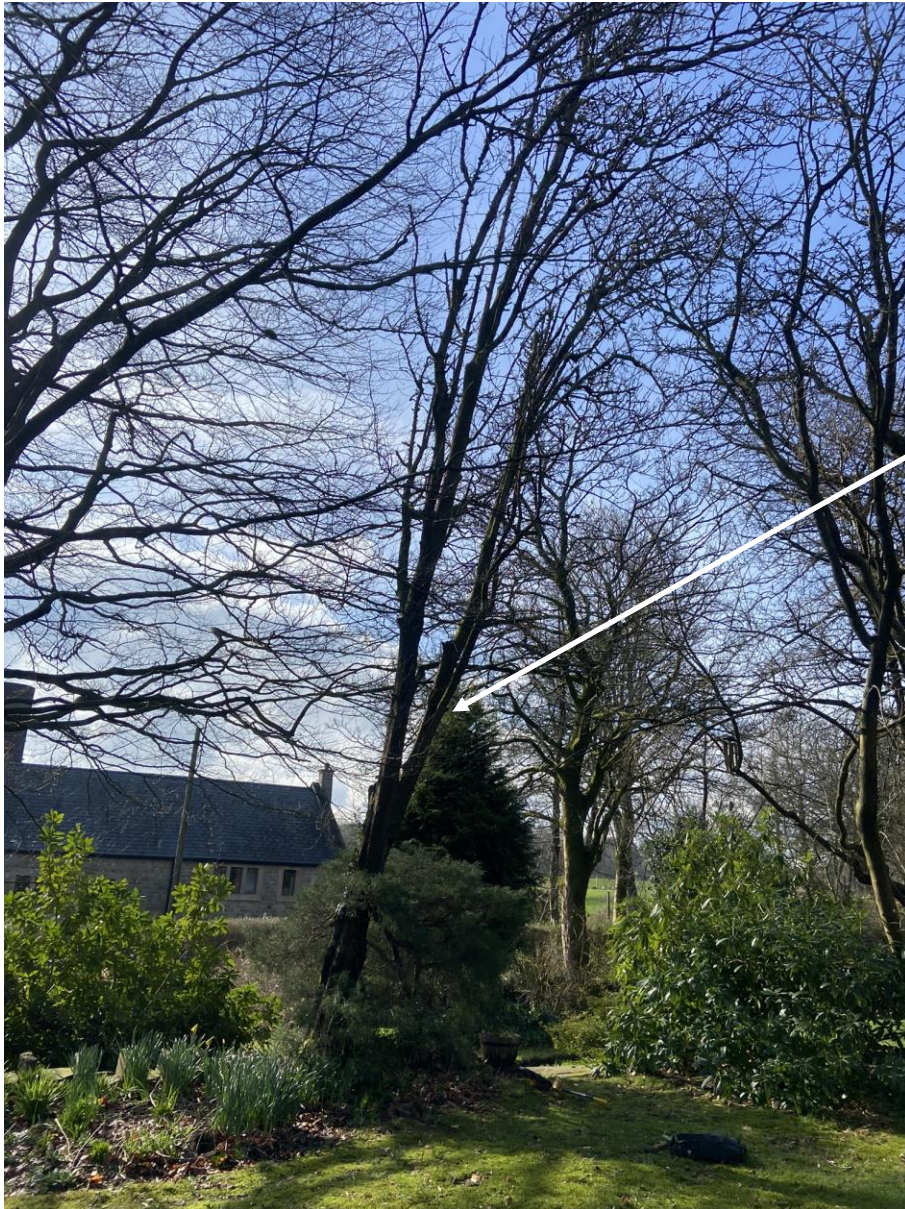
T4 is a mature Pear tree (*Pyrus communis*) which is in poor condition with evidence of the large scaffold branches being dead and compromised vigour evidenced by poor budding. The tree has a 20° lean towards the north and the lateral anchor root appears to be compromised and it is suspected to

have root rot beneath ground level. The tree has been in decline for some time and has not fruited for many years. This species has a recognised short life expectancy and it is recommended for removal with replacement being one standard sized Pear tree to be located as indicated in appendix 1. T4 is located within the designated Conservation Area but desk research has indicated that it is unlikely to be subject to TPO.

| Tree Reference, species and observations | Specification of Work Requested | Reasons for work |
|---|---|---|
| <p>T4<br/>Pear<br/>(<i>Pyrus communis</i>)</p> <p><i>Sound test indicates root rot in the lateral root to the south east of the tree which appears to not be sufficiently anchoring the tree. T4 has a lean of approximately 200 to the north. Budding is limited throughout the tree and this short lived species is recommended for replacement</i></p> | <p>a. Remove and replace</p> | <p>a. The tree is highly likely to fail and in doing so will damage other neighbouring trees.</p> <p>The tree is to be replaced by one of the same species at standard size in the location indicated in Appendix 1</p> |

Image 6 – T4 (to be removed)

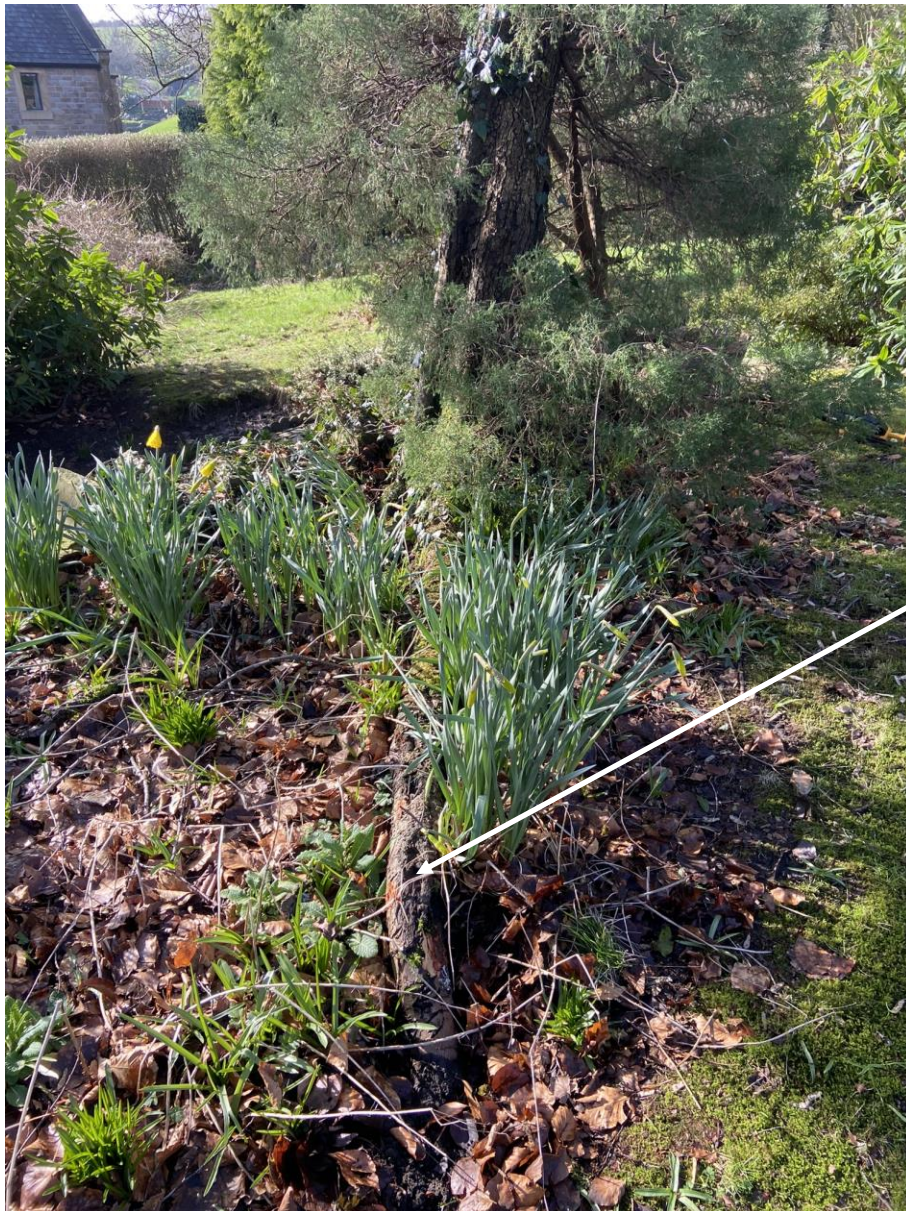
Image 7 – T4 ineffective lateral root

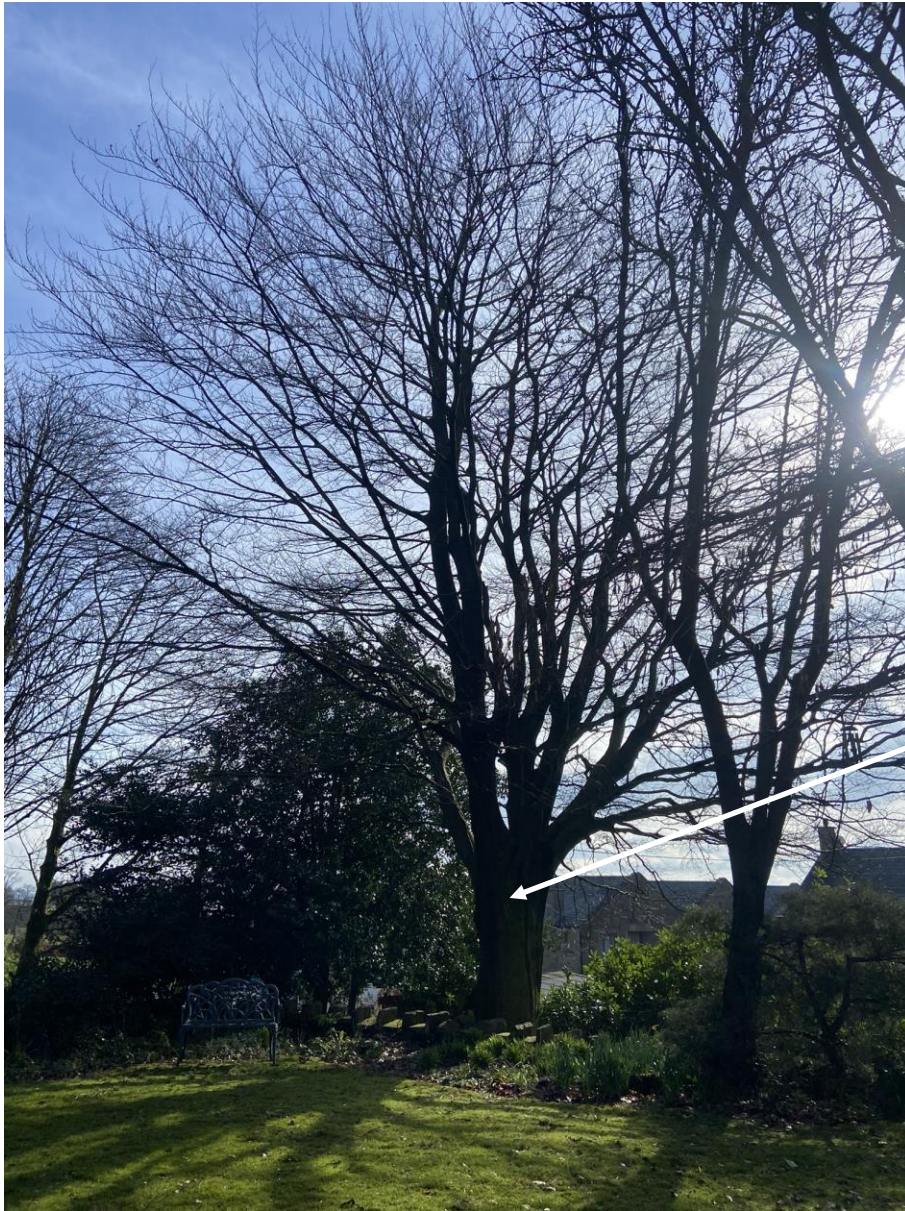
Image 8 – T5

T5 is a mature Beech (*Fagus*) which is subject to TPO and is in excellent structural and physical condition. It's very large canopy is casting significant shadow across the garden of the Ormrod to the north of the tree and a 30% crown lift and thin is recommended to increase natural light levels into the garden and surrounding area to enhance biodiversity.

| <p>T5<br/>Beech<br/>(<i>Fagus</i>)</p> <p><i>T5 is approximately 8m from the public highway and the spread to the east is over the road however there is sufficient clearance for this not to cause a nuisance. The canopy which is however causing significant shade within the garden</i></p> | <p>a. 30% crown lift and thin<br/>b. Remove deadwood from canopy and pegs left from naturally shed branches</p> | <p>a. The recommended work will allow increased natural light levels into the garden and enhance biodiversity<br/>b. Good arboricultural management to prevent decay entering the heartwood of the scaffold branches and main stem</p> |
