## Phase 1 GeoEnvironmental Desk Study

Former Waterfold Mill

Waterfold Lane

Report No. A4301/21

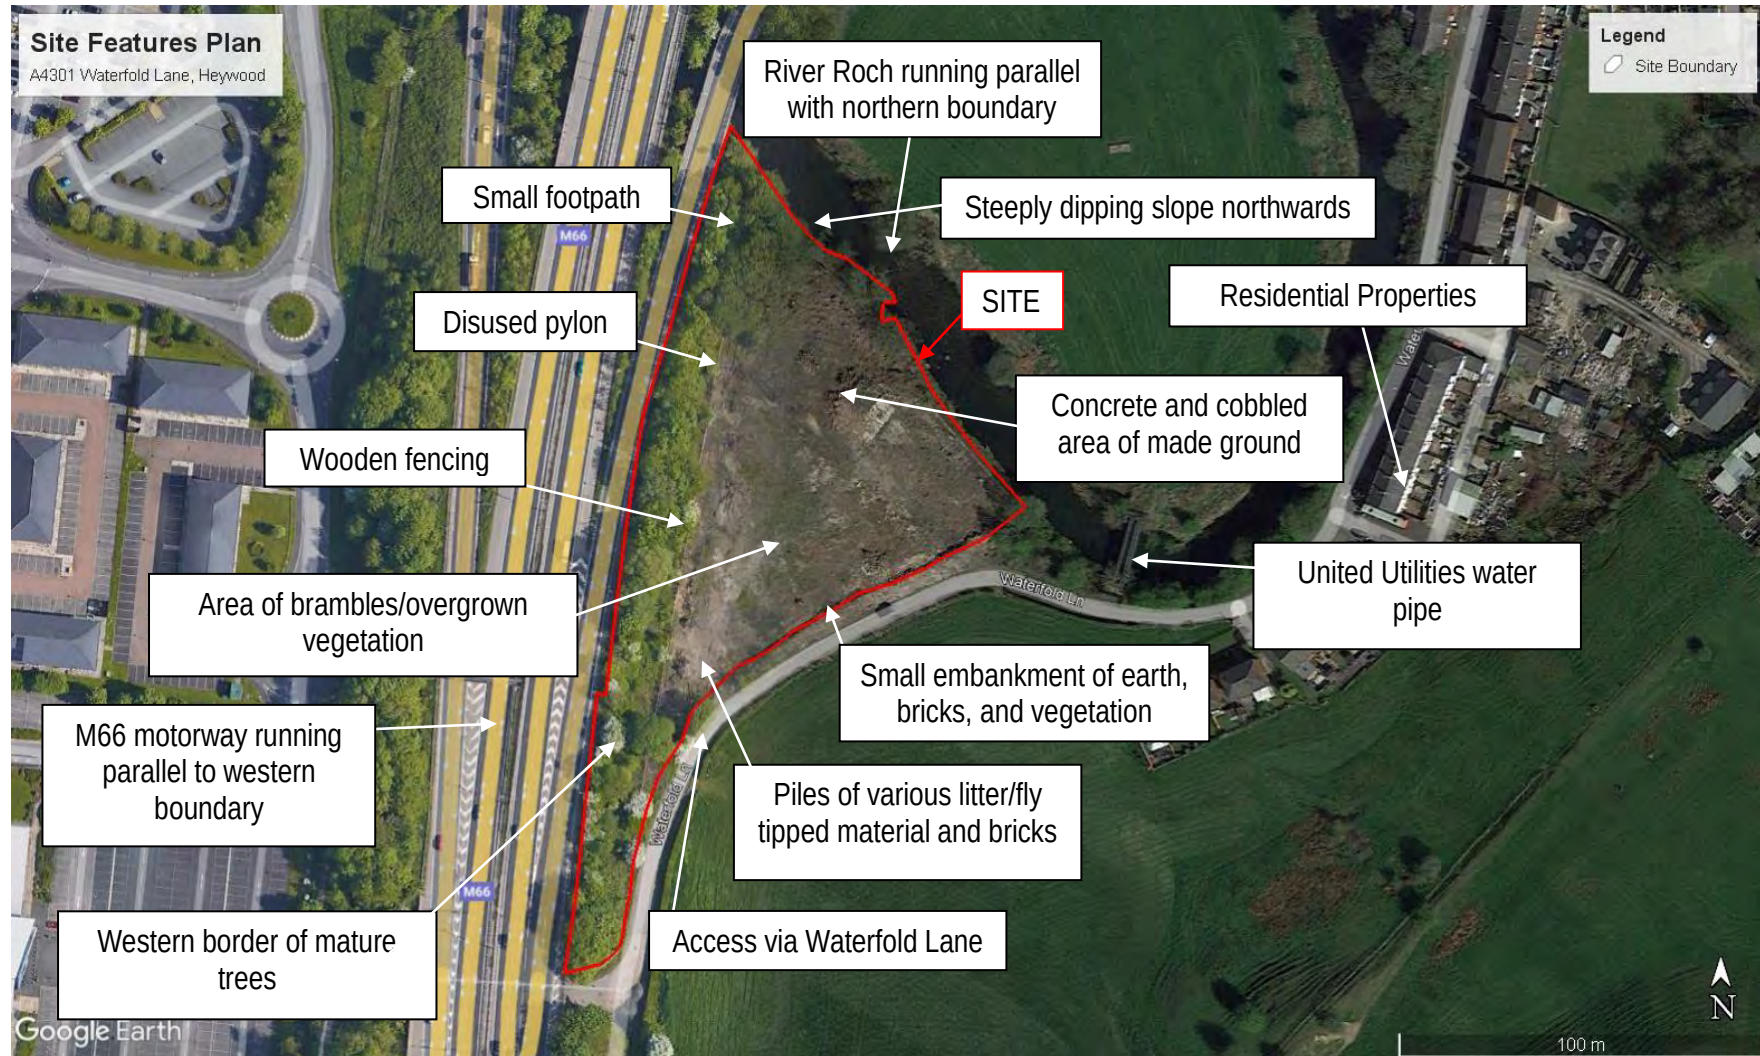
Figure 9 Site Features Plan

- 5.1 A walkover survey was completed on 25<sup>th</sup> October 2021. The photographs and notes from this survey are appended to this report as Appendix 2 and Appendix 3, respectively.
- 5.2 The site is currently accessed via Waterfold Lane to the south of the site.
- 5.3 The site is currently vacant land with minimal vegetation and areas of made ground present on the northern boundary.
- 5.4 The site is generally flat lying with small uneven areas, however the northern boundary has a steep gradient northward towards the River Roch.
- 5.5 There are no overhead cables on the site, although a disused pylon is present on the western boundary.
- 5.6 The site is surrounded by agricultural fields, with the M66 motorway running parallel with the western boundary. There are also residential properties located 100m east of the site.
- 5.7 A site features plan is presented as Figure 9 overleaf.

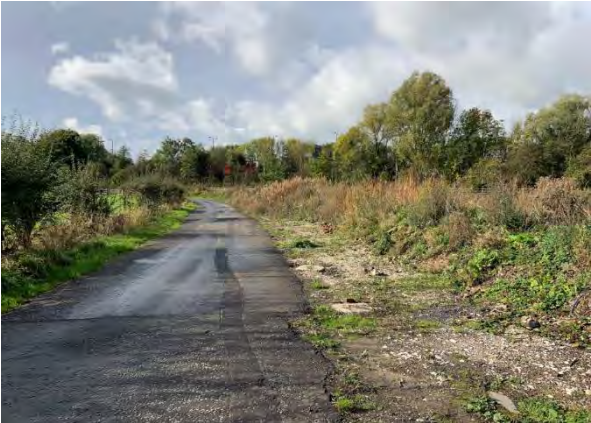
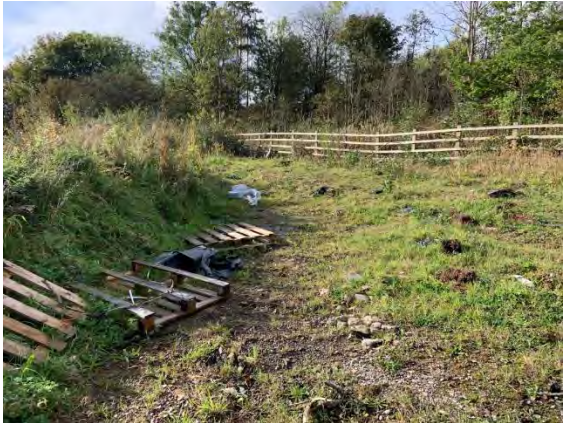
| <p><b>Plate 1</b> Viewing south, showing site access via Waterfold Lane. Note scar in the road may be a potential water supply.</p> | <p><b>Plate 2</b> Viewing south, showing areas of fly tipped material and litter on site.</p> |

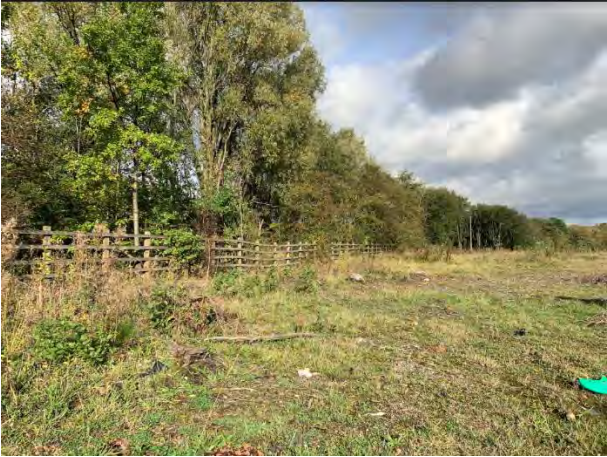
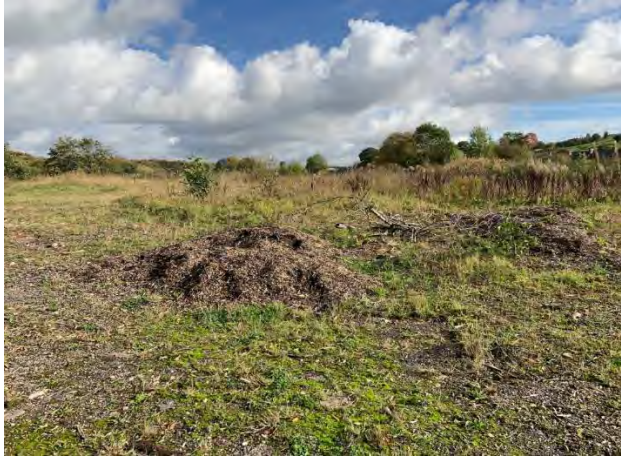
| <p><b>Plate 3</b> Viewing northwest, showing western boundary. Note wooden fencing and mature trees running alongside the boundary.</p> | <p><b>Plate 4</b> Viewing north, showing an overview of the site. Note large areas of brambles and overgrown vegetation.</p> |

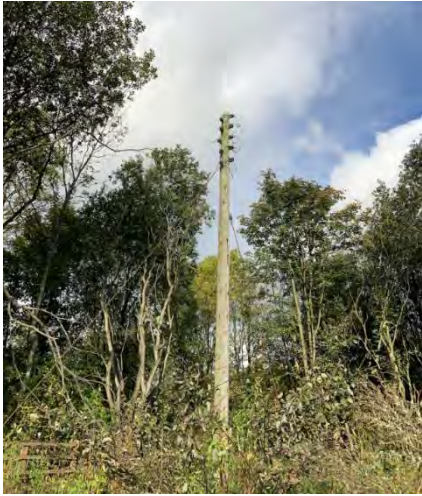
| <p><b>Plate 5 Viewing northwest showing a disused pylon located onsite.</b></p> | <p><b>Plate 6 Viewing east showing area of cobbled made ground located in the northwest corner of the site.</b></p> |

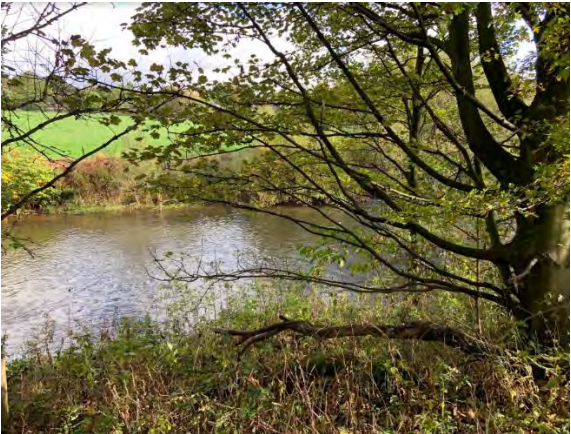
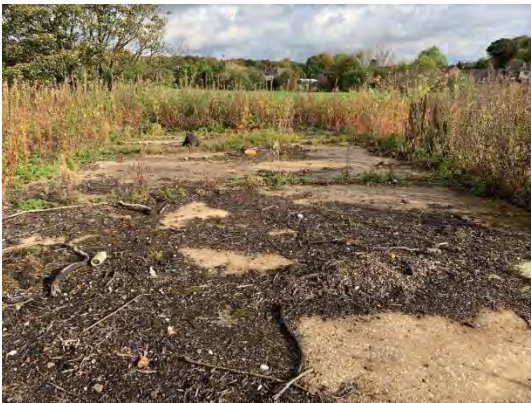
| <p><b>Plate 7 Viewing north, showing River Roch located on the northern boundary. Note the steeply dipping slope towards the river.</b></p> | <p><b>Plate 8 Viewing north showing large concrete slabs in the north of the site.</b></p> |

| Desk Study features checked during site visit | Feature and Information required | Present | Description / Comments |
|---|---|---|---|
| Ground Conditions | Is there any evidence of:<br><br>Mining, Mine entries<br><br>Subsidence<br><br>Landslip/slope erosion<br><br>Former investigation works | Yes/No<br><br>Yes/No<br><br>Yes/No<br><br>Yes/No | Slope erosion is observed on the northern boundary due to the River Roch. |
