Touchstones Gallery, Rochdale  
Design, Access and Heritage Statement

For Alterations and Repairs to Roof Zone 1

For Rochdale Development Agency  
December 2024

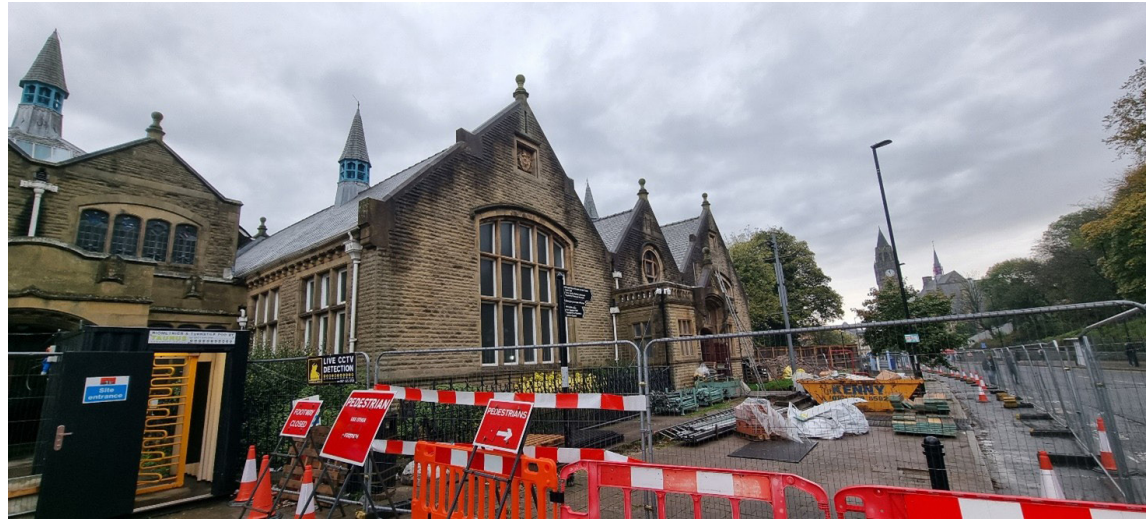
Photo 1. South elevation showing the gabled bays making up, from left to right, RF03, RF02 and RF01.

The parapets have no dpc and lack any overhang or drip - dark staining relating to damp at the top of the walls can be clearly seen in photograph 1. Parapet copings and stone finials have moved in places (photo 14), and there is cracking to mortar joints between coping units and between copings and masonry wall beneath. Fixings are visible to the top surface of the copings (eroded and forming a water trap), and extra fixings have been added to some of the copings.

Due to the movement noted it is recommended that all parapet copings and finials are carefully lifted and re-bedded on a lead dpc, integrated with the flashings and soakers, to make the back of the upstand fully weather proof. Nothing can be done about the lack of a drip to the outer visible edge, and as the walls are solid, there is still a risk of damp tracking of the parapet gable copings from the outer face into the plaster wall beneath the sloping ceilings. The porch parapet is ideally to be reset on lead dpc, with lead taken down the front of the blocking course and over the top of the cornice.

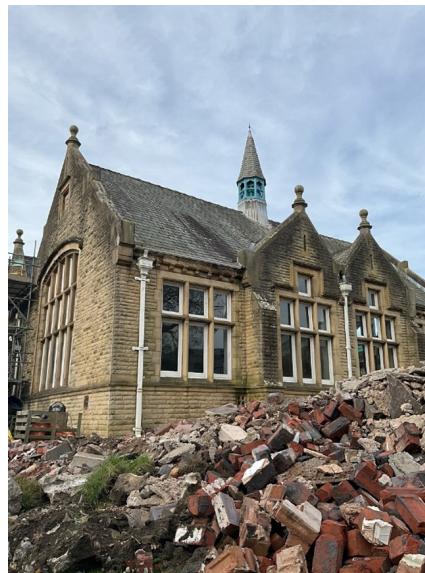
Photo 2. East elevation.

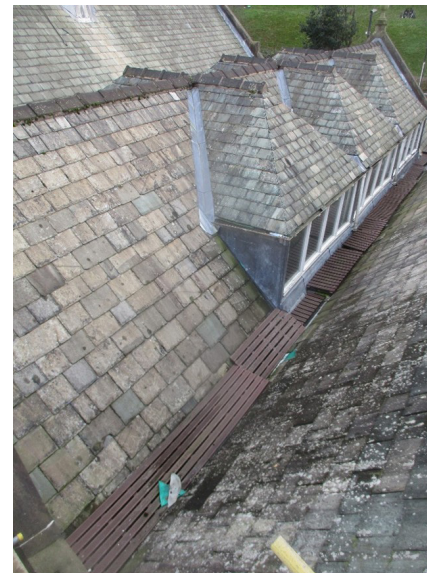
Photo 3. Dormers to roofs RF02.

The lowest purlins to the north wall of RF01, RF02 and RF03 are soft and suffering from decay (photos 03, 04 and 25). A closer inspection is required but the application includes for cutting back of decayed timber and provision of steel plate repairs to improve bearing of these purlins – steel to be painted where visible. It is presumed there are similar instances within the roof space, which require the same repair. The purlins built into the south walls all appear to have had steel plate repairs carried out in the past.

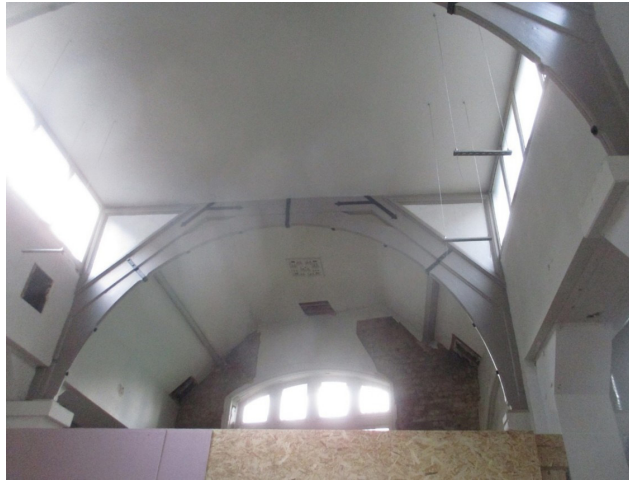
Water ingress was reported along the north walls of roof area RF01, RF02 and RF03, with deterioration of the wall plaster following water ingress over a period of time (photographs 4 and 5). On closer inspection the ends of the purlins built into the north walls were found to be soft as a result of decay. Water ingress was also visible to the north end of east wall of RF1 and to the north end of the west wall to RF3. The rafter ends abutting these walls were found to be wet. A condition survey was carried out to assess the condition of the roof.

Photo 4. North wall below RF02.

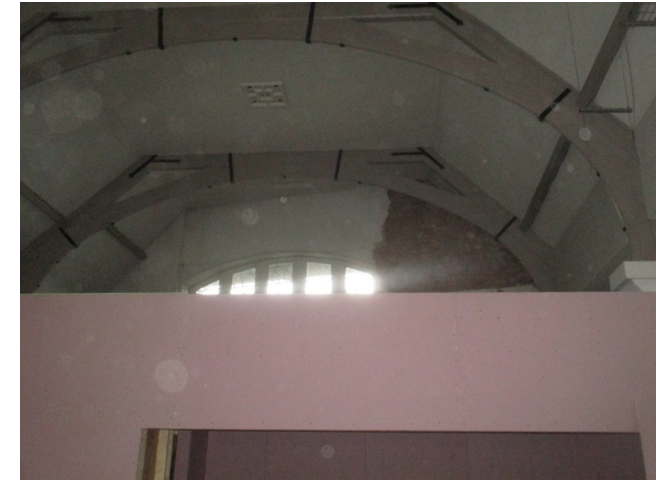
Photo 5. North wall below RF03.

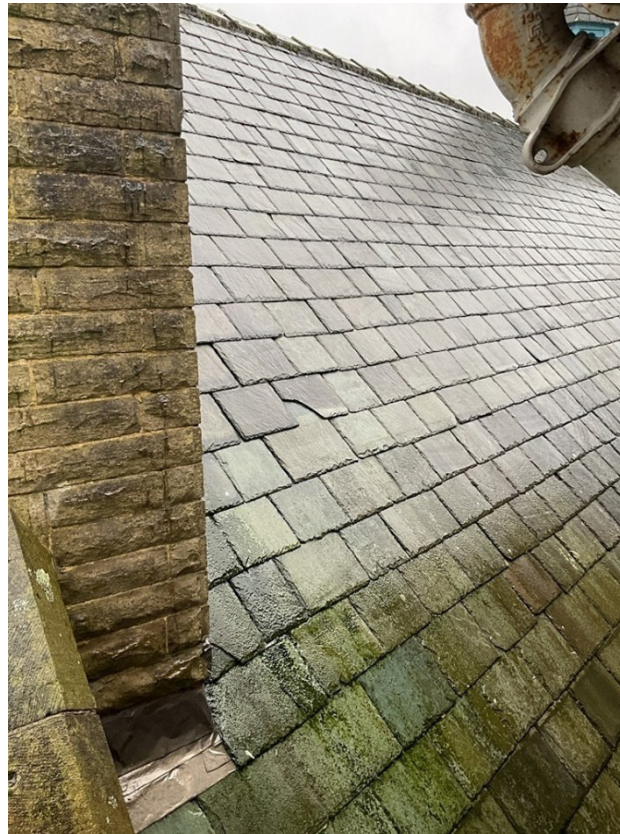
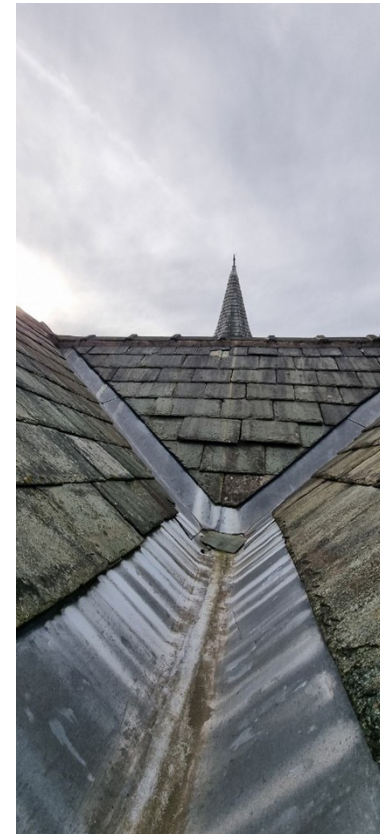
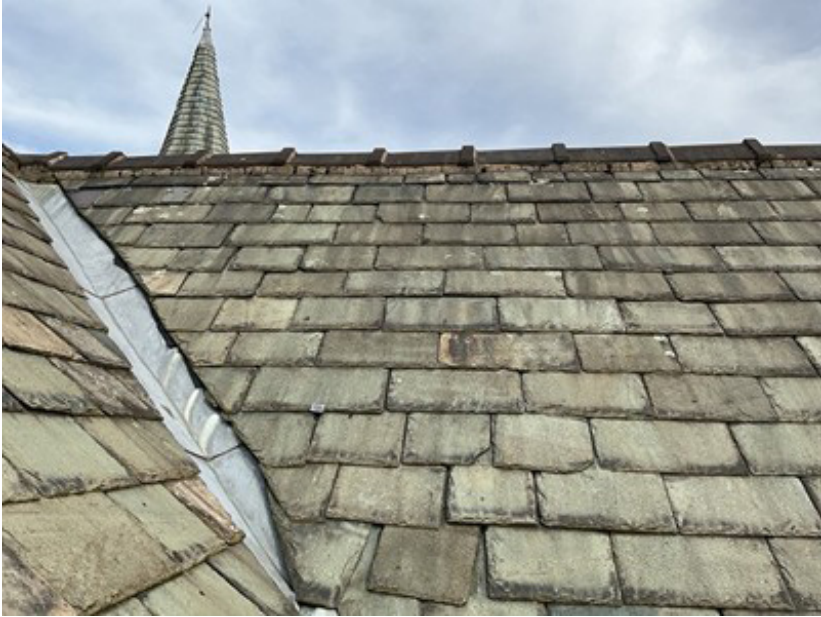
- Slipped and broken slates (Photos 6, 7 and 8).
- Inadequate head lap to slates.
- Use of half slates on roof slopes and especially at abutments.
- Slates laid on plastic sheet underlay (photo 9).
- Insulation infilled between rafters in some instances, but no ventilation provided.
- Deterioration found to underside of slates, possibly caused by condensation due to lack of ventilation (photo 10).
- Selected slates removed all found to be delaminated.
- Selected slates removed all found to have been re-nailed (photos 10 and 11).

It is assessed that only 25% of the existing slates may be re-usable for re-roofing.

The roof requires stripping and sound slates set aside for re-use. As detailed above, optimistically only about 25% of slates are thought to be re-usable. Matching Westmorland green slate is on long order and a like for like replacement imported slate may be necessary, dependant on programme and lead in times. As the roof is being re-slatted an upgrade in the insulation will be required. The existing plaster ceiling will be retained, and so nominal insulation only may be added between the rafters from above. Ventilation to cold roof voids and between rafters will be provided at valleys, abutment and ridges using proprietary ventilation packs.

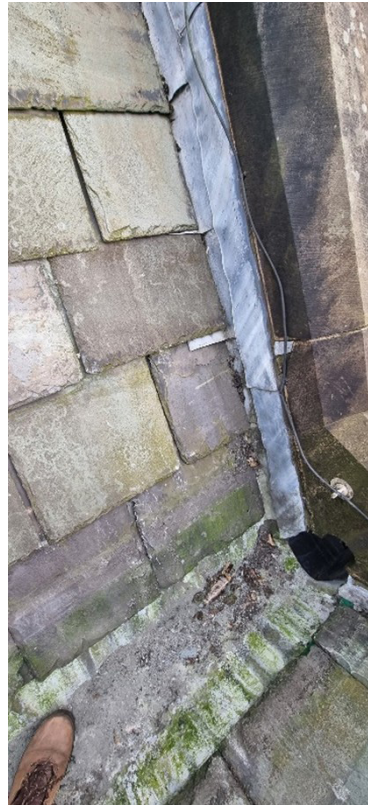
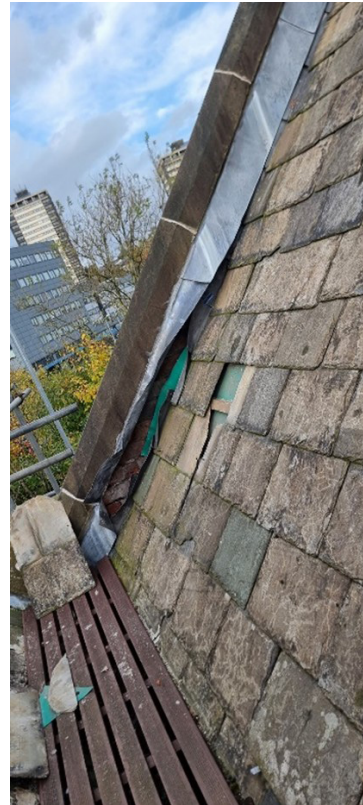
Inadequate laps were found at the junctions between soakers and cover flashings at the roof abutment with the back of the stone parapets (photo 13). Some of the roof slopes have inadequate height between the slates and current top of flashing to meet recommended lap requirements (photo 12).

These need to be renewed in lead to latest Lead Sheet Training Academy details and recommendations. A 'secret' lead lined abutment gutter is recommended to mitigate where recommended upstands and laps are not achievable.

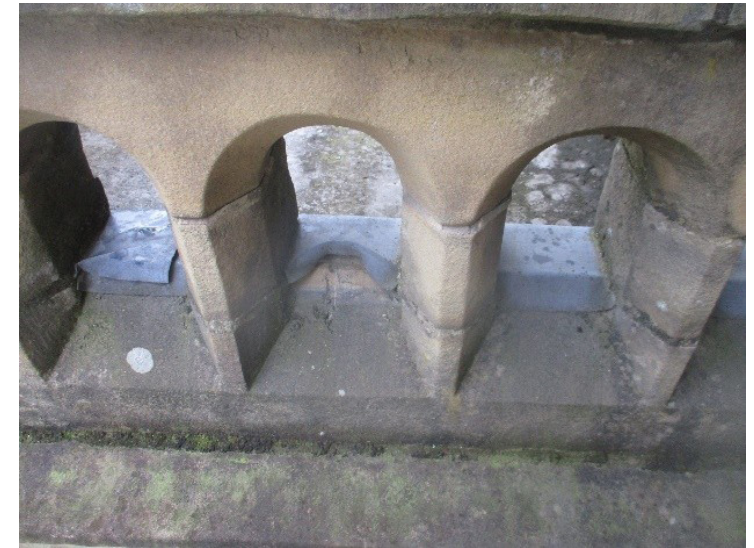
Photo 15.

The entrance porch has a flat roof (FR01) concealed behind a stone balustrade. The roof coverings appear to be originally lead with more recent asphalt but both covered over using a liquid applied membrane. Lead flashings appear retrofitted between the stone balusters, and these are lifting in places (photo 15). The roof is reported to be leaking. Ideally the existing roof coverings are to be stripped, and new lead lined gutters and roofs formed. The stone balusters are ideally to be lifted, and leadwork taken beneath the balusters to LSTA details, with the lead dressed over the front of the blocking courses and cornice.

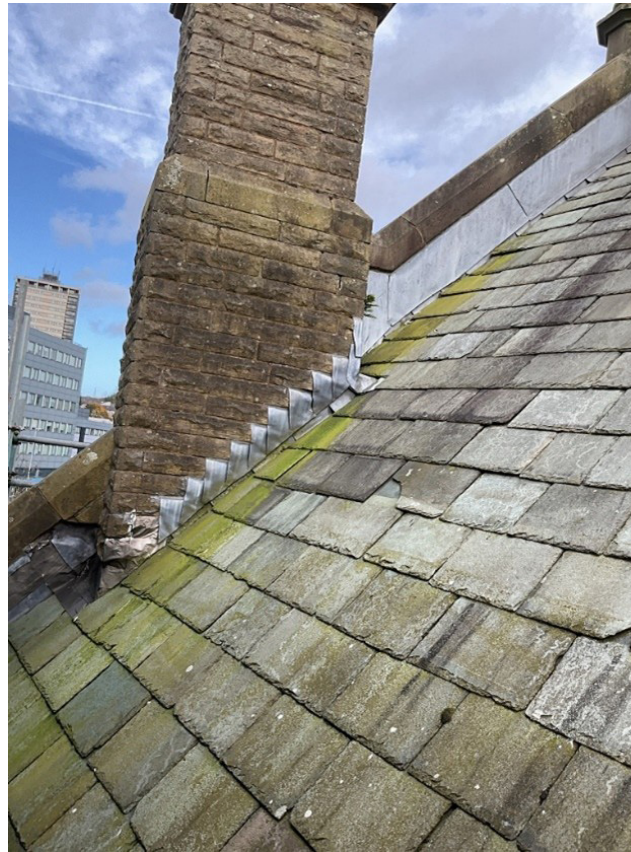
Photo 16.

Chimney flashings and back gutter are in poor condition (photo 16), with slipped lead and patch repairs in flash-band. Roof is leaking around the stack. The chimney appears to have been capped off using concrete, and it is recommended that this is unblocked and vented using a proprietary metal vented capping.

Flashings and back gutter to be reformed in lead to LSTA recommendations. As the chimney is located adjacent to the sloping ceiling area, the installation of a lead dpc might be considered. This will involve taking down and rebuilding the top part of the stack, on lead dpc. The back and two sides of the stack would be clad using lead to integrate the dpc with the cover flashings.

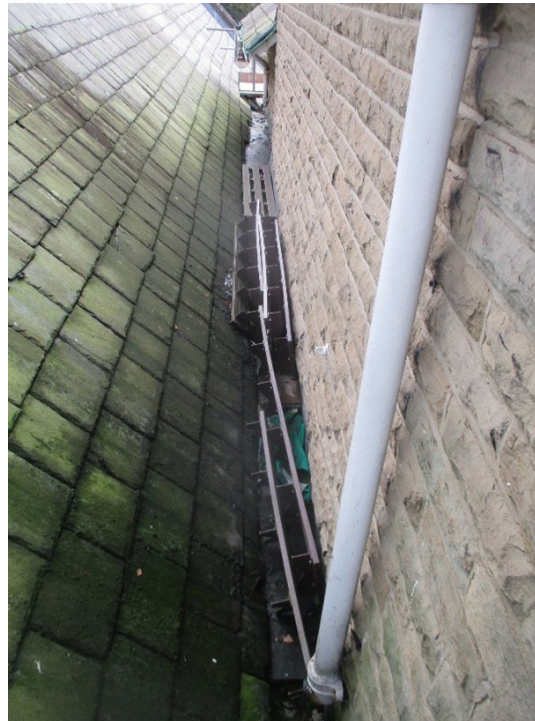
Photo 18.

The abutment gutter to RF03 at the north west is blocked and leaking and there is ladder damage to one of the bays (photo 18) and drips are undersized – this gutter should be reformed and re- leaded. The tapered gutters between roofs RF02 and RF03, while obscured by plastic walkways, appear to be in fair condition.

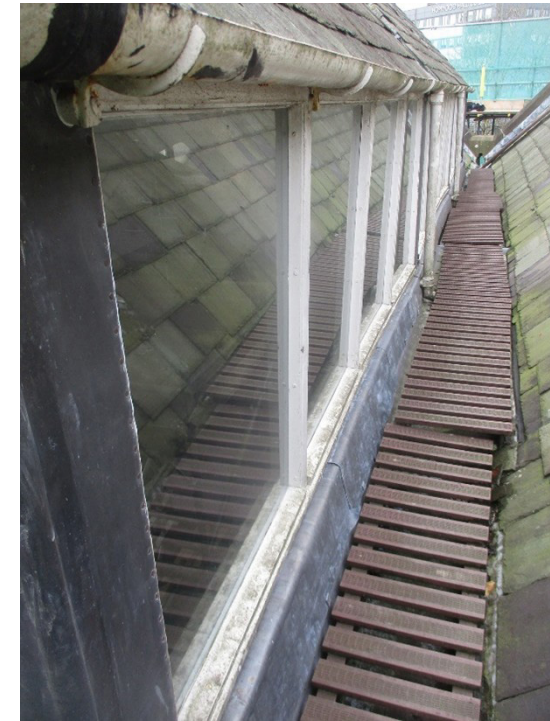
Photo 19.

The dormer windows are leaning outwards and the sills deflecting inwards (photo 19). The roof appears to be straight, but the windows themselves may be carrying some of the roof loads, deflection exacerbated by the decay present to timber members.

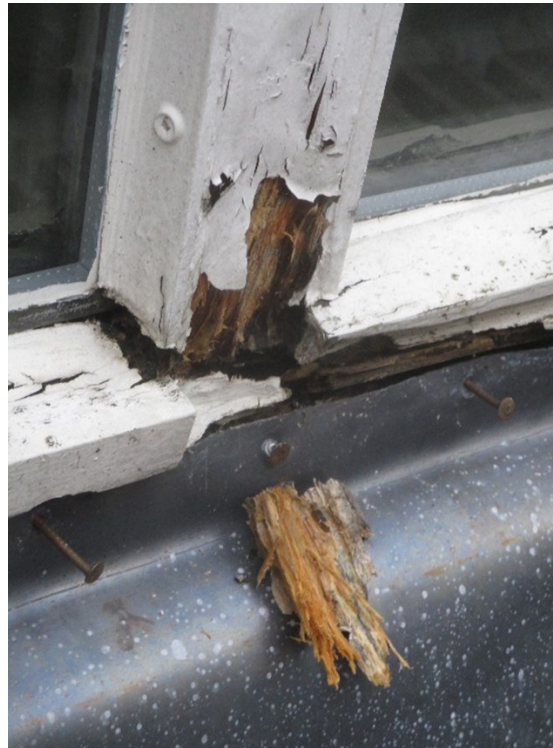
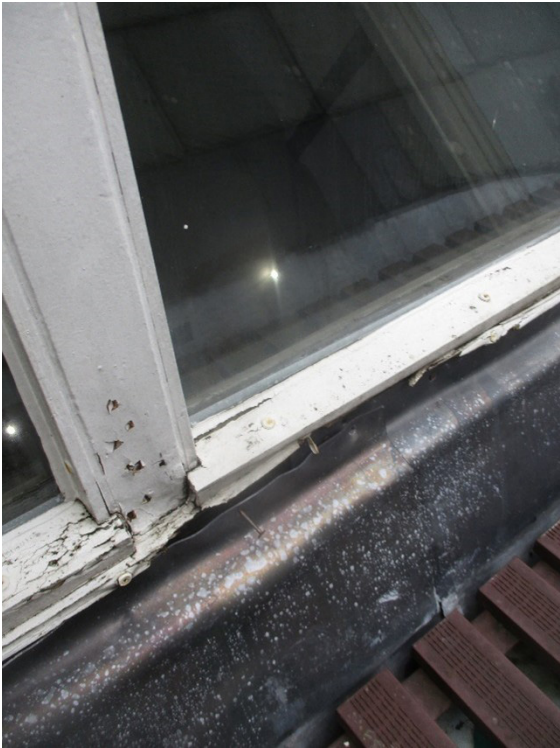
The existing windows are modern, of plain section painted softwood, with fixed lights and double-glazed units. The bottom rail is also the sill and has been affected by decay (photo 20, 21 and 22). Cover beads have been planted over the sill, and these beads are also now decaying. The base of the mullions is decayed (photos 20, 21 and 22). Patch repair might be attempted due to the advanced nature of the interior fit out, but due to the lean of the windows they are better replaced, with increased section mullions, if necessary, to improve strength. The windows are not visible externally but are visible at high level internally (photo 23). Replacement is included with this application. The mechanical fixing of the flashings below the sills have failed due to decay of the timber substrate and need reforming as part of the window replacement (or repair).

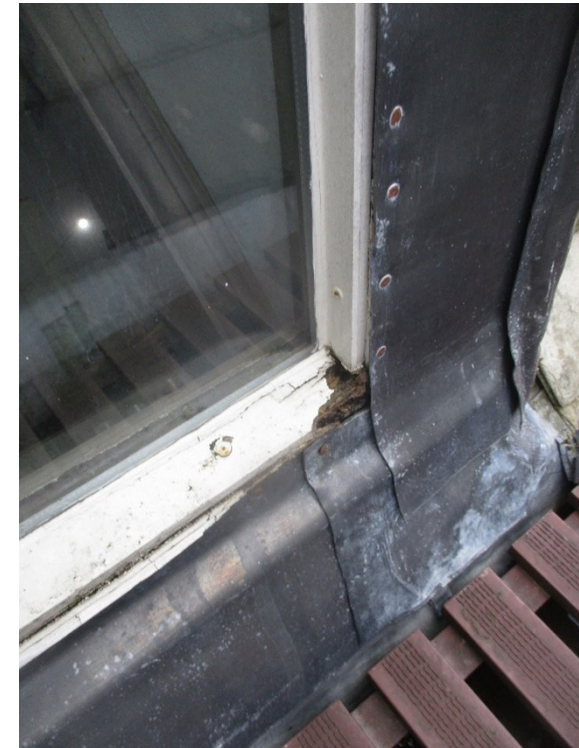
Photo 21.

The dormer lead cheeks are crudely detailed (photo 21) and not in compliance with LSTA recommendations. Lead to the side cheeks appear to be laid over a plastic membrane.

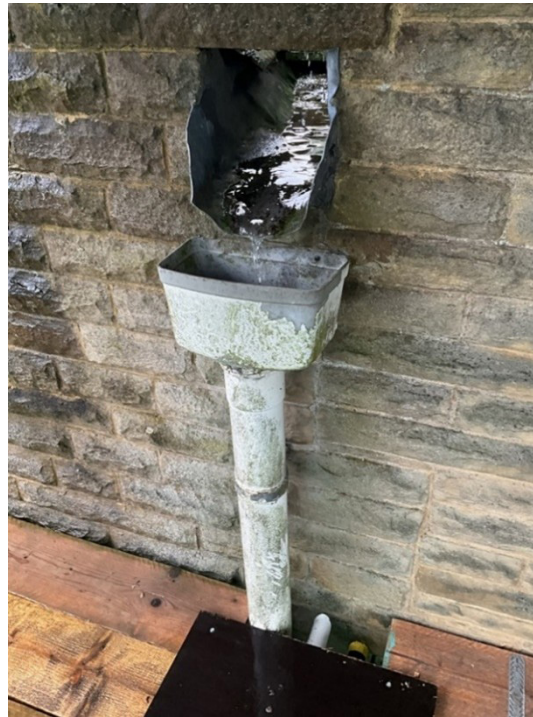
Photo 24.

Generally, in fair condition. Blockages and paint loss, and hopper fixings becoming loose being identified in the condition survey. All cast iron fittings are to be retained, cleaned back, repainted and reinstated. Plastic hoppers and downpipes fitted to the north elevation (photo 24) are unsuitable modern replacements and it is proposed to replace these using cast iron fittings.

The plastic hoppers and downpipes fitted to the north elevation are unsuitable modern replacements and it is proposed to replace these using cast iron fittings.

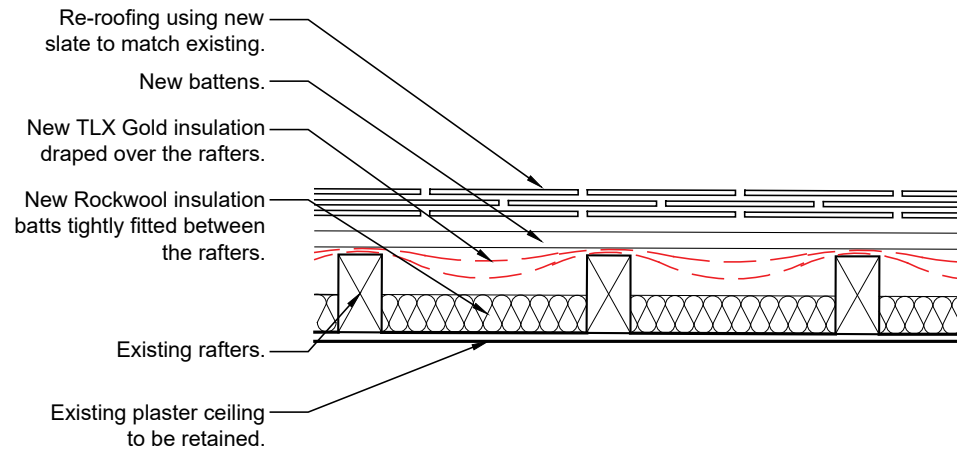
The existing ceiling finishes are to be retained and there is limited scope to increase the height of the roof build up to significantly increase the amount of insulation. All the slates are to be lifted and the roof re-slatted, as such there will be a requirement to improve the insulation standard of the roof. The existing sloping ceiling plaster is being retained as such the insulation strategy proposed is to lay draped TLX Gold over the existing rafters, with additional 50mm Rockwool batt fitted between the rafters. There will be small uplift in the roof covering height due to the TLX gold compressed above the rafters, but this will be mitigated by the proposed lead abutments gutters.

Sketch cross section through roof showing proposed insulation strategy
