### GAS MEMBRANE VALIDATION – BOOTHROYDEN

**Project Name:** Boothroyden Road, Middleton

**Project Number:** 13-500

**Plot Number:** 16

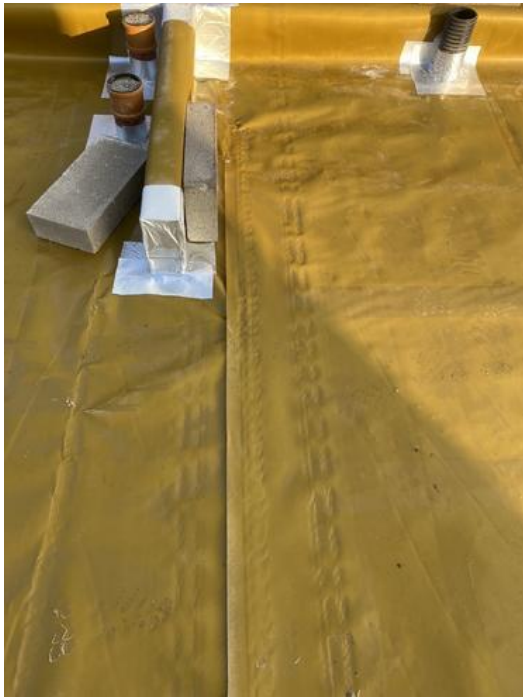
Photo 1

Laps, welds, and joints seals: Joints lapped and sealed in accordance with manufacturer's requirements/ specification? Minimum overlap insured? Sections taped twice? Are welds complete? Appropriate joining/double-sided tape used, Folds running in line with joints? (no joints cutting across folds)

Pass

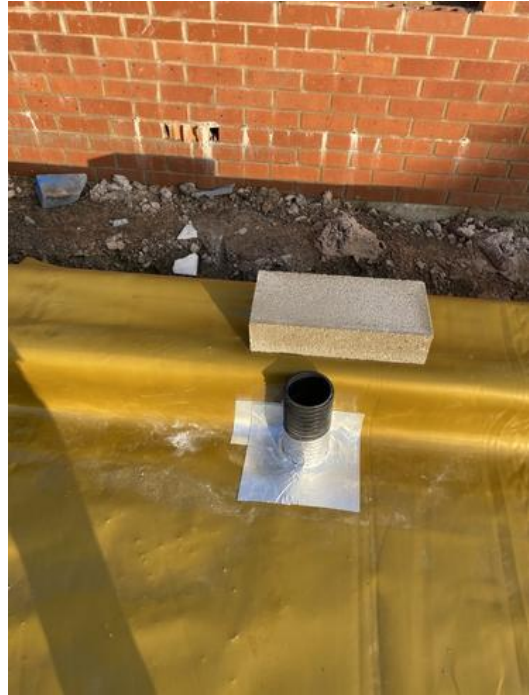
Photo 6

Each unit has a service duct located to the front and outer edge of the property. E3P inspected each one and can confirm that the top-hats have been adequately sealed against the membrane.

Service entries seals: Top hats seal arrangements fixed around service entries? Use of Jubilee clips?

Yes

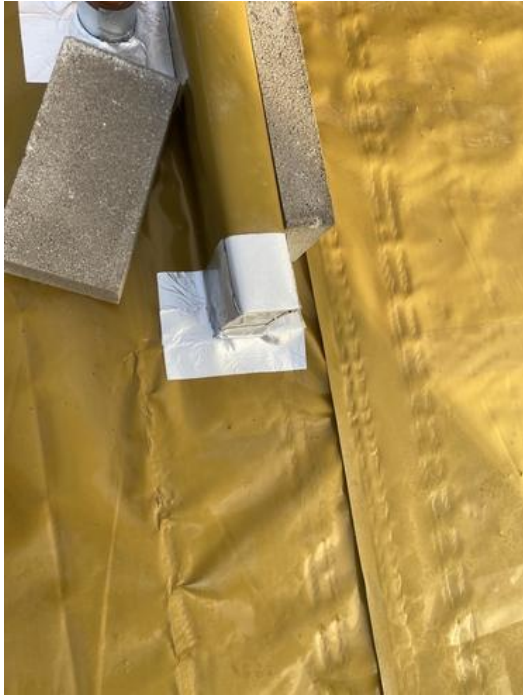
Photo 9

Corners / Internal joints: Check all corners are correctly formed or contractor has used performed corners.

Pass

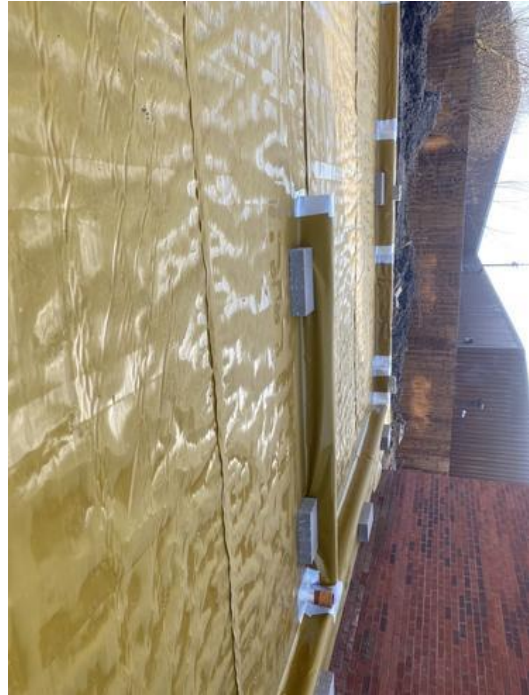
Photo 18

**Extent of Coverage: Is the membrane covering the entire plot? Does membrane span over outside walls?**

Yes

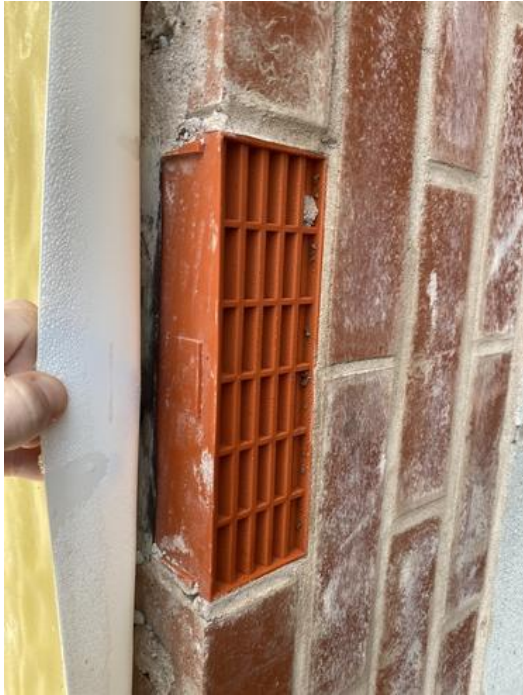
Photo 21

**External Wall Air bricks: Numbers, size. positions as design drawing? (Minimum of 3 walls)**

Pass
