## BUILDING SURVEY REPORT AND REPAIR STATEMENT

### SILVERHILL FARM AND BARN ROCHDALE

Dated Feb 2022

Kevin M Neary Dip Surv, C. Build E FCABE AssocRICS  
Building Surveyor, Chartered Building Engineer,  
15 Litherland Ave  
Ashway Park  
Peel Hall  
Manchester  
M22 5LD  
Tel no 0161 436 4079  
Email [kevin@kevinneary.co.uk](mailto:kevin@kevinneary.co.uk)

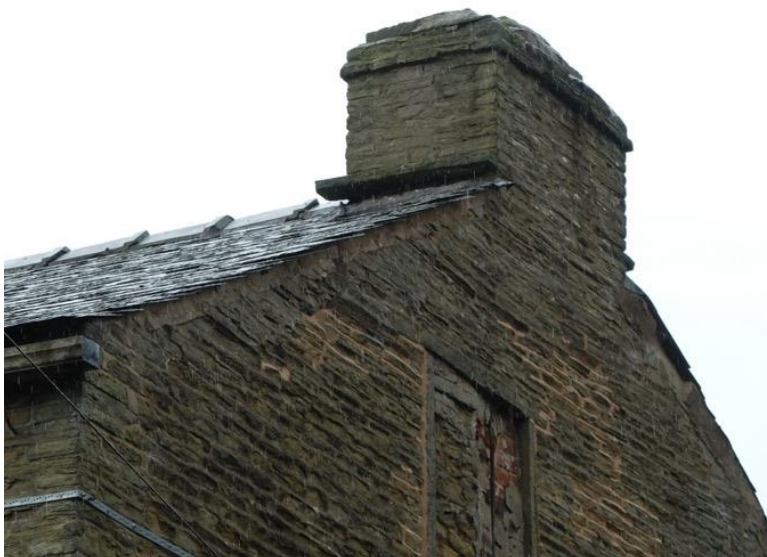
Photo Stone Chimney with weathering course to left gable.

The flaunchings to all three chimneys appears to be poor and will require replacement which will include re-bedding of the pots.

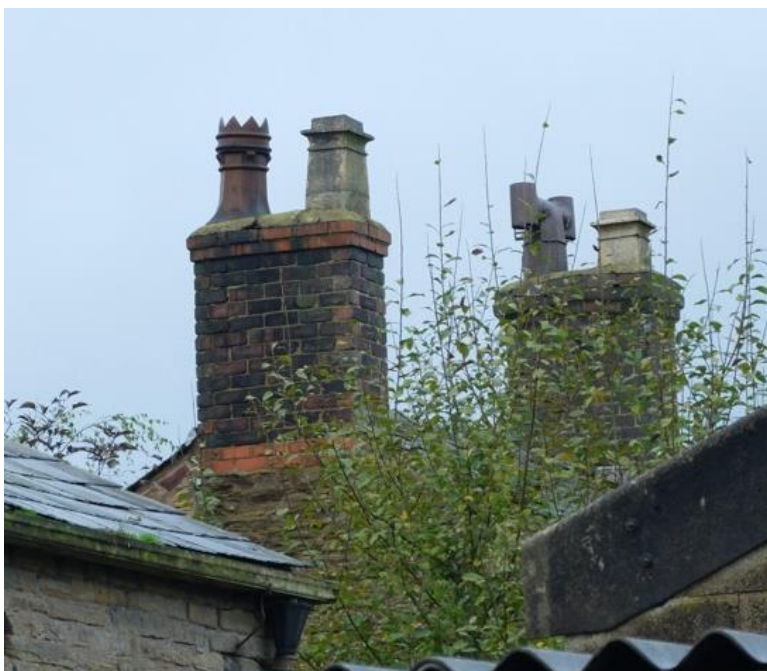
Photo Brick chimneys to farmhouse

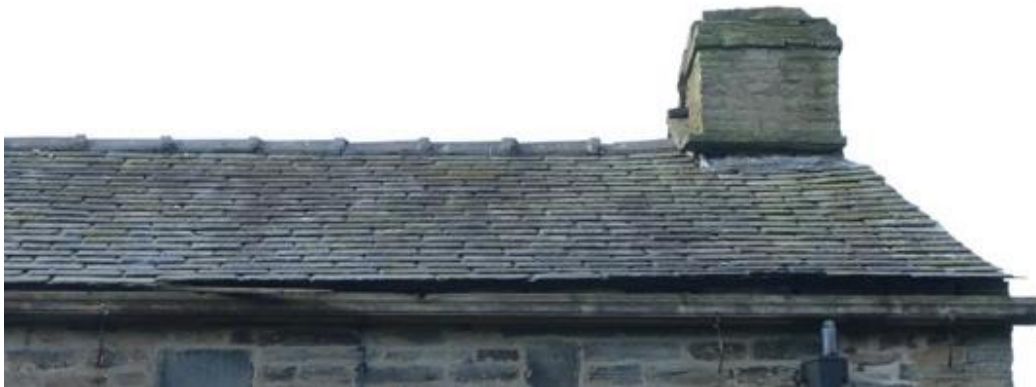
Photo. Diminishing coursed slate roof to farmhouse

At the verges the slates extend over the face of the stonework the infill verge detail is untidy and has been done using a hard cementitious mortar. This has become loose in places and will require complete renewal.

There are several slipped slates noted of the surface of the roof which could be viewed.

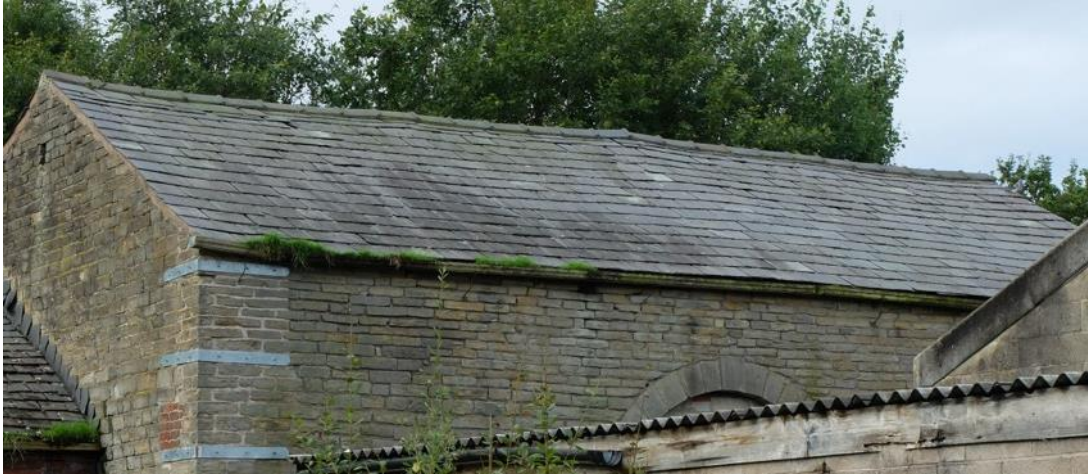
Photo. diminishing coursed slate roof over barn

There are several slipped slates noted.

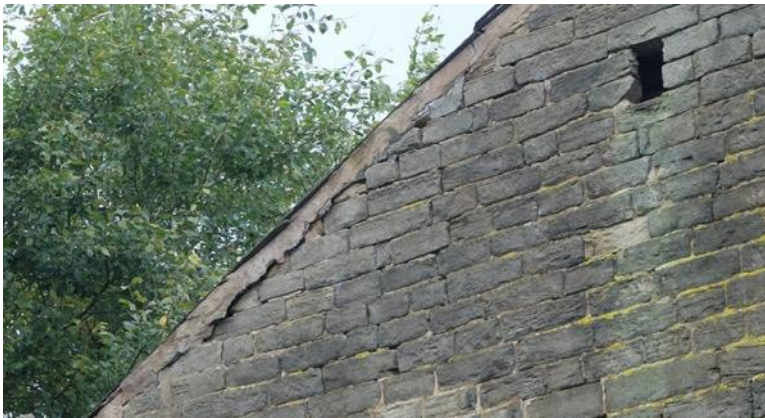
At the verges the slates extend over the face of the stonework the infill verge detail is untidy and has been done using a hard cementitious mortar. This has become loose in places and will require complete renewal.

Photo. Loose cement verge pointing

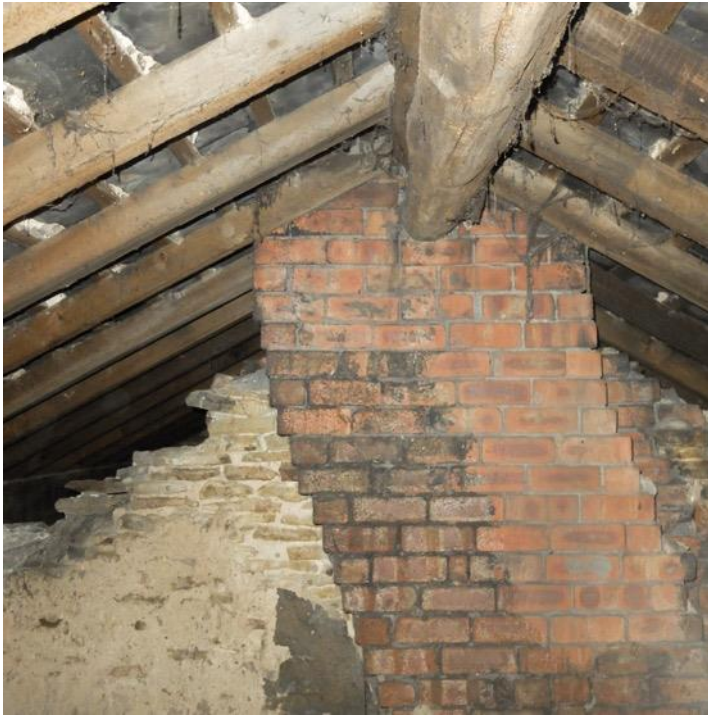
The roof is supported on an original oak log ridge which is the only remaining section of what is considered to be the original roof structure and then a later softwood 350 x 125mm purlin at mid span of each roof slope. There were signs of common furniture beetle emergence holes from the sapwood sections of the timber.

Photo. Newer brick chimney to Space R2, log ridge, which is original roof structure, note old plaster to walls

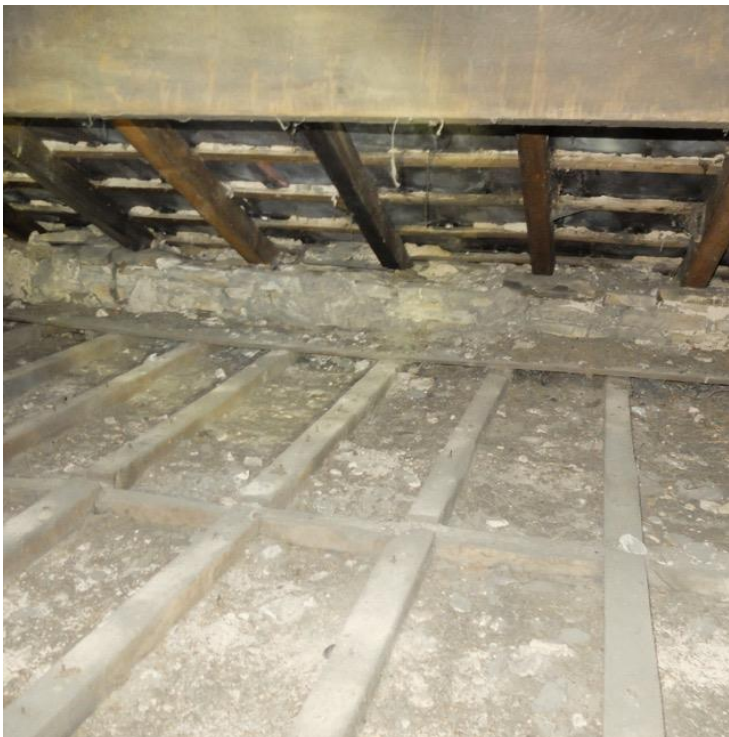
The ceiling joists which enter the front and rear walls are located approximately 400 mm lower than the intersection of the rafters and therefore there is limited triangulation of the roof structure.

Photo. Rafters sit direct on wall head with no fixing down

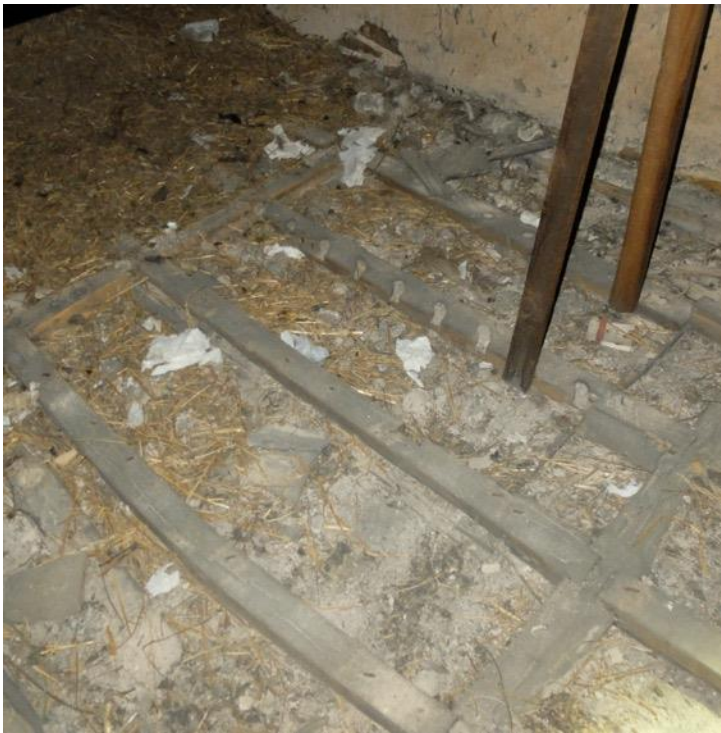
Photo. Old ceiling trap in location of hangers above room F.04

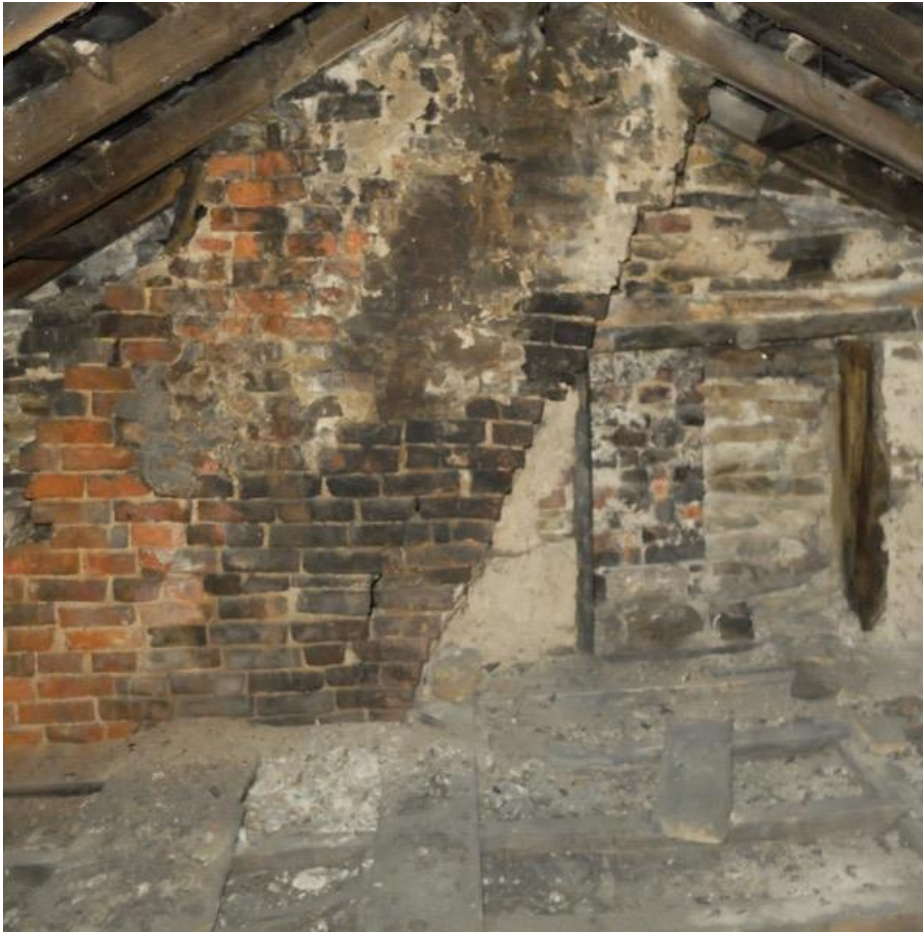
The original stone chimney has a different earlier brick below the stone, however, there is concern regarding the condition of this within the roof space as there is cracking within the chimney brickwork and the angle created by the brick corbelling is too slow and this appears close to collapse. This requires support and repair.

There is concern regarding the stability of the left-hand chimney within the external gable wall and further support is required.

Photo. Crack at base of chimney the angle of build is too steep and urgent support is required, Roof space R1

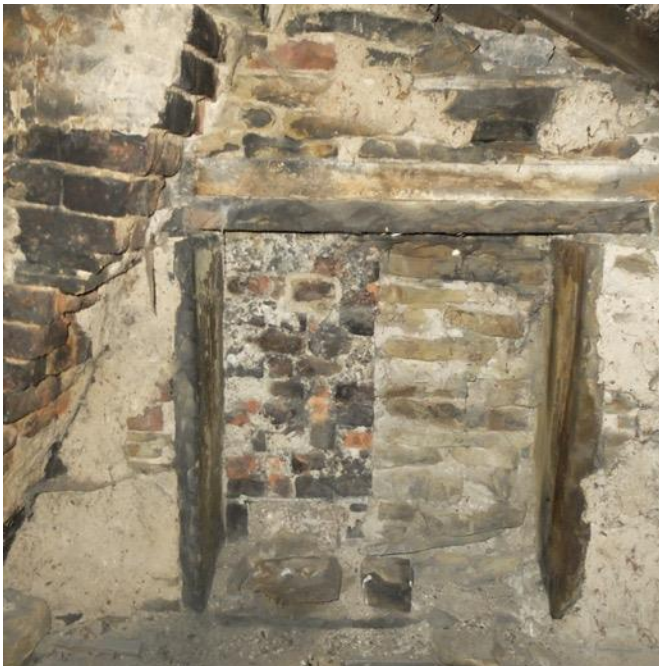
There is a window opening within the west gable which has been blocked up with stone and brick.

Photo. Old window infilled with masonry.

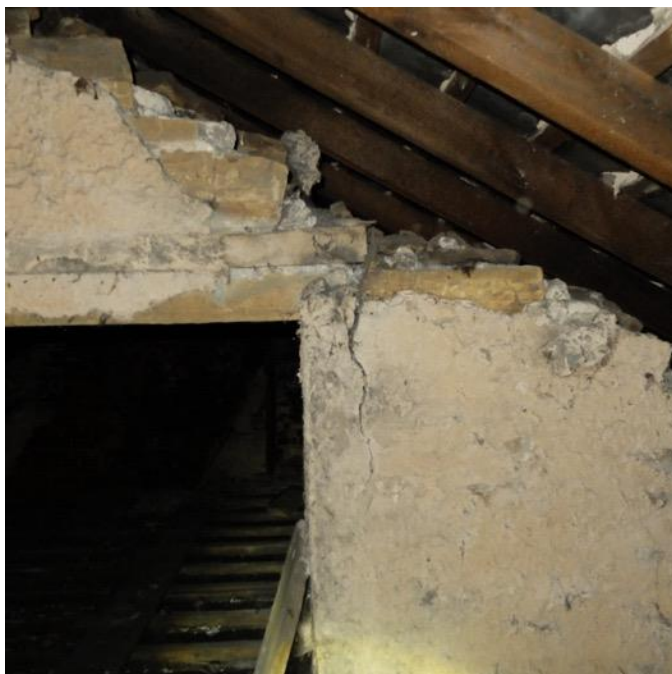
There is cracking around the lintel above the doorway which provides access into the middle roof area and some rebuilding works are required to make this secure.

Photo. Crack around lintel to opening between roof spaces R1 and R2

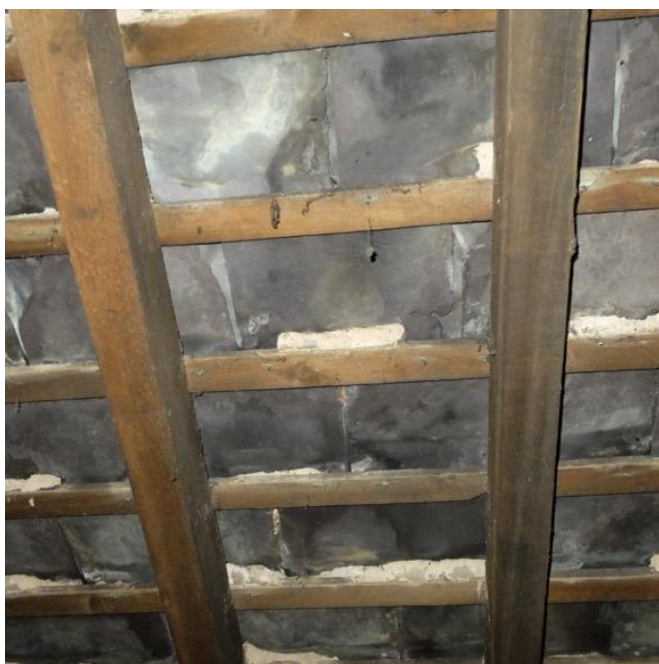
Photo. Slate fixings no underfelt. See original parging which has mostly fallen away.

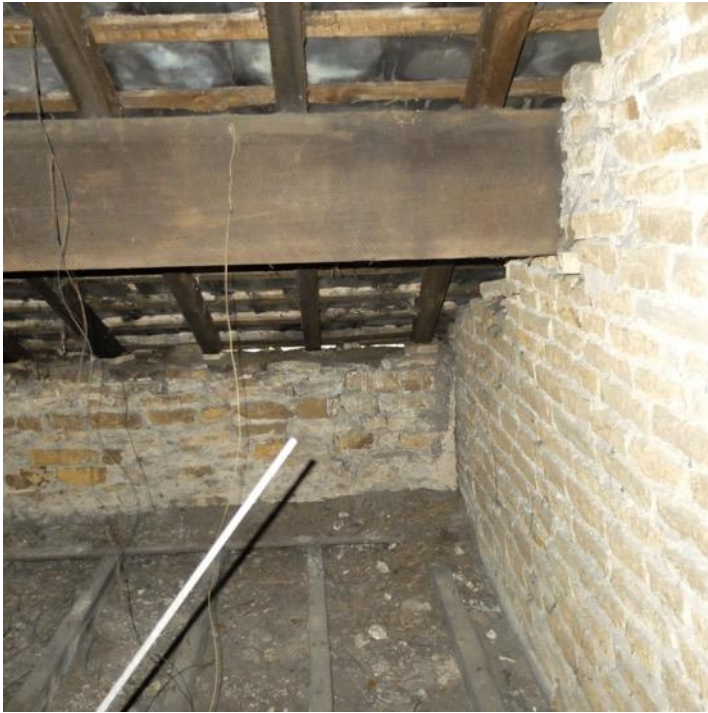
The ceiling joists which enter the front and rear walls are located approximately 600 mm lower than the intersection of the rafters and therefore there is limited triangulation of the roof structure.

Photo. Rafters sit on wall head no fixing.

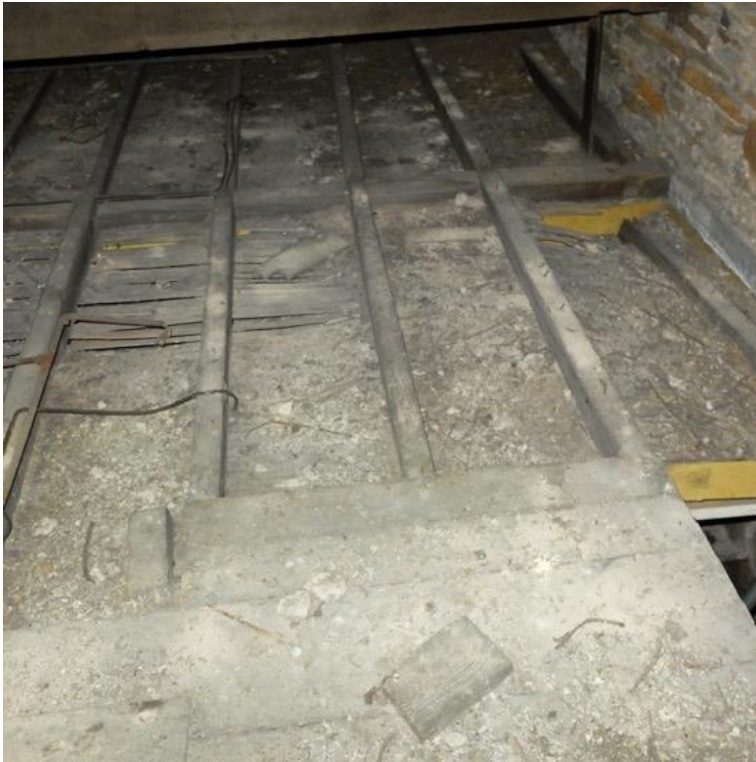
There are nails to the tops of the joists which indicate that the lofts were originally floor boarded and this space may have been used for weaving. This could also be confirmed by remains of old lime and horsehair plaster on the walls.

Photo. Ceiling joists with old nails indicating floor boarding.

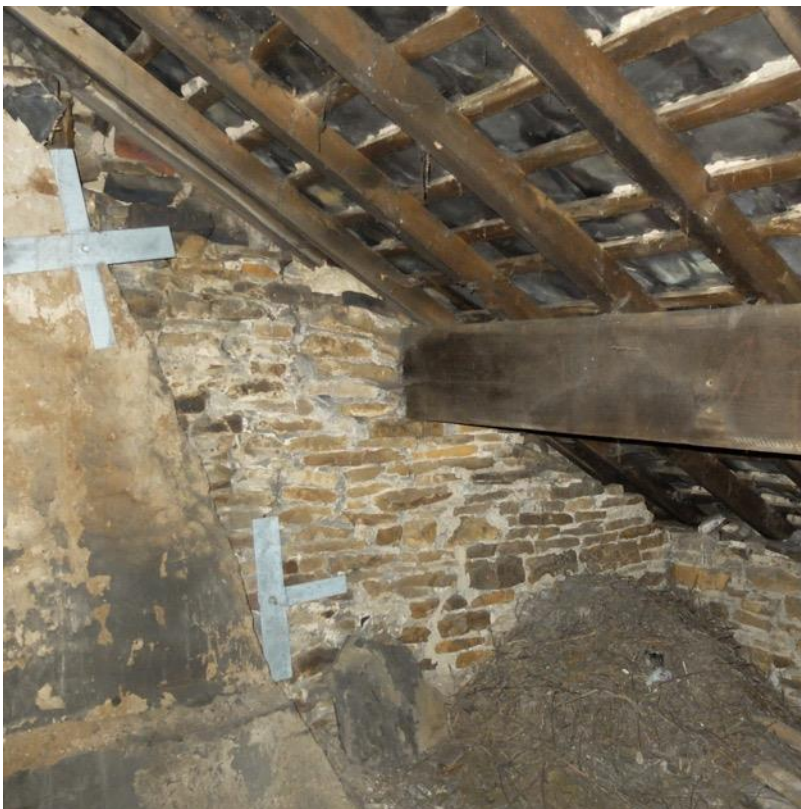
Along the right-hand (East gable) there is a serious bulge around the flue of the chimney within the gable wall. It is evident that the external leaf of stone has become detached from the internal leaf, and this has now formed a significant bulge which has been restrained by tie plates within the gable. The cause of this may have been sulphate attack from the chimney which has caused volume expansion of the mortar and started the bowing of the external brickwork. It should be noted that the masonry thickness on the outside of the chimney is always a single skin and therefore is considerably weaker than the other sections of the wall which will be double skinned.

On the right and gable wall there are tie plates on the gable. However, the internal leaf of masonry appears relatively plumb.

Photo. Tie plates and bulge in outer leaf behind this section.

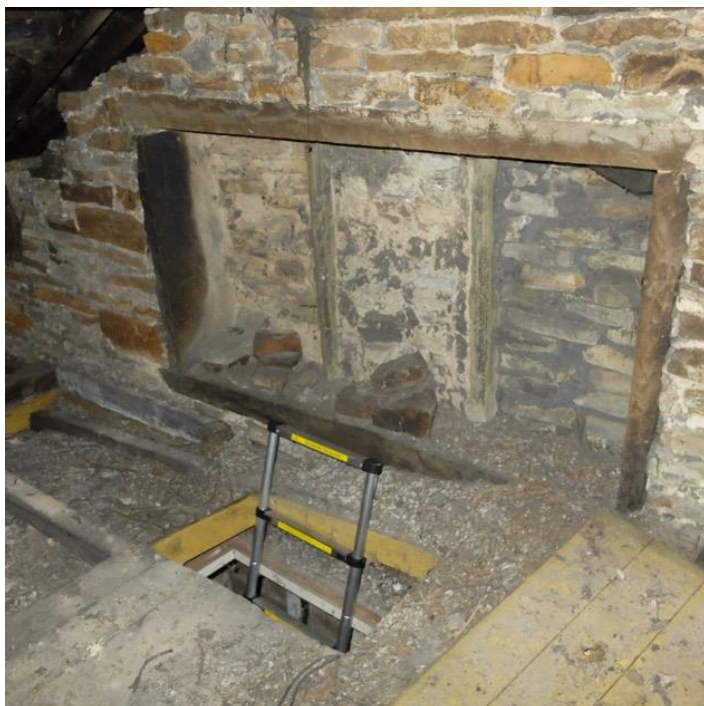
There is a blocked up window to the rear section of the gable.

Photo. Infilled window to east gable.

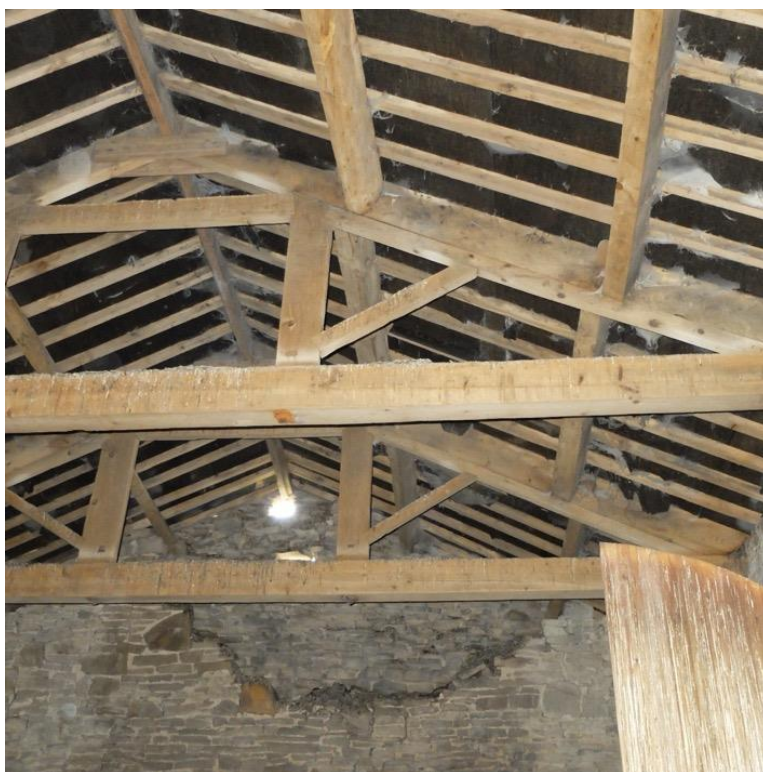
The roof structure of the barn can be viewed from the underside as this is an open construction. The roof is supported on 3 no queen post trusses. These are of a softwood construction and appear to be late Victorian. The trusses support 2 no purlins per slope which appear to be approximately 350 x 125mm in size which is similar to the purlins within the main farmhouse. The purlins are positioned so that the top chord is level with the top chord of the principal rafter which is unusual as the purlins normally sit above the truss. This may have been an oversight by the carpenters to prevent having to build up the walls, it is assumed the original oak construction would have been slenderer than the softwood replacement.

Photo. Queen post roof structure of barn (considered 1900s)

There was evidence of some leaks and staining due to water ingress to the ends of the larger timbers which enter the walls and further investigation would be required.

A full assessment of the roof timbers would be required to determine which sections would be salvageable and could be repaired and reincorporated into the conversion. This exercise cannot be undertaken until the external wall structure and roof support is made safe.

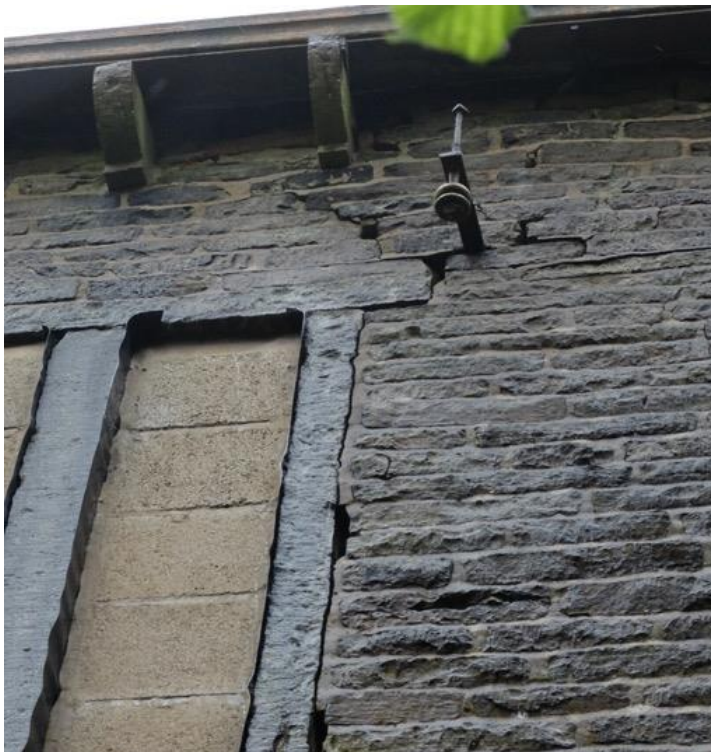
There is a diagonal crack within the mortar joints of stonework which extends from the top of the first floor left hand window down to the living room window below.

Photo. Crack from roof along vertical stone reveal to window.

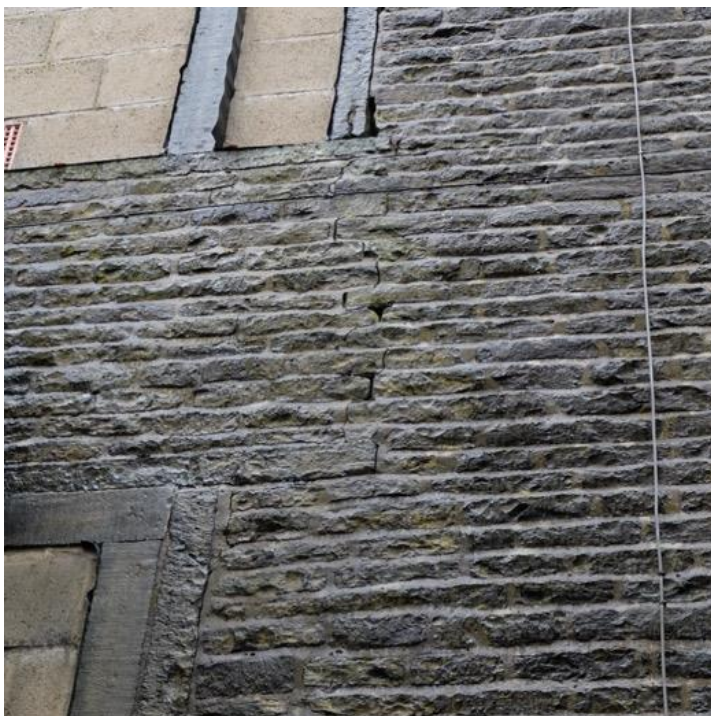
Photo. Crack extends from first floor to ground floor window.

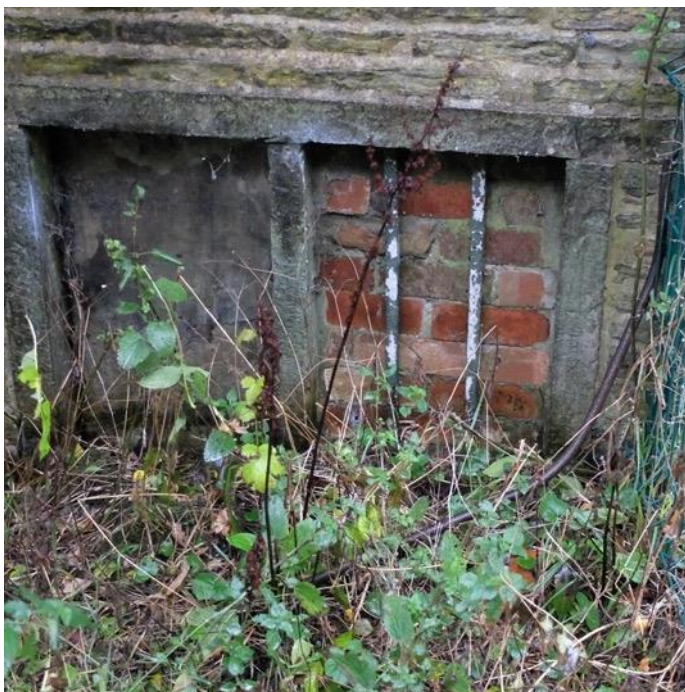
At basement level there are metal bars within the window openings between the stone head and cill and this may have caused rusting and damage to the stone. Further investigation is required.

Photo. Bars to basement window concern regarding corrosion

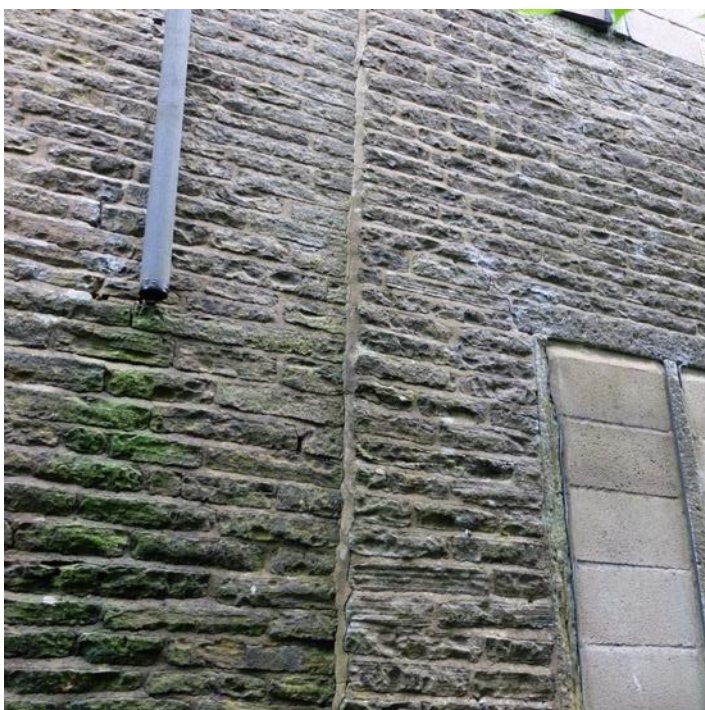
Along the vertical joint between the existing building and the extension there is bowing to the extension wall which now projects out at the centre.

Photo. Outward bowing to extension wall at chamber level.

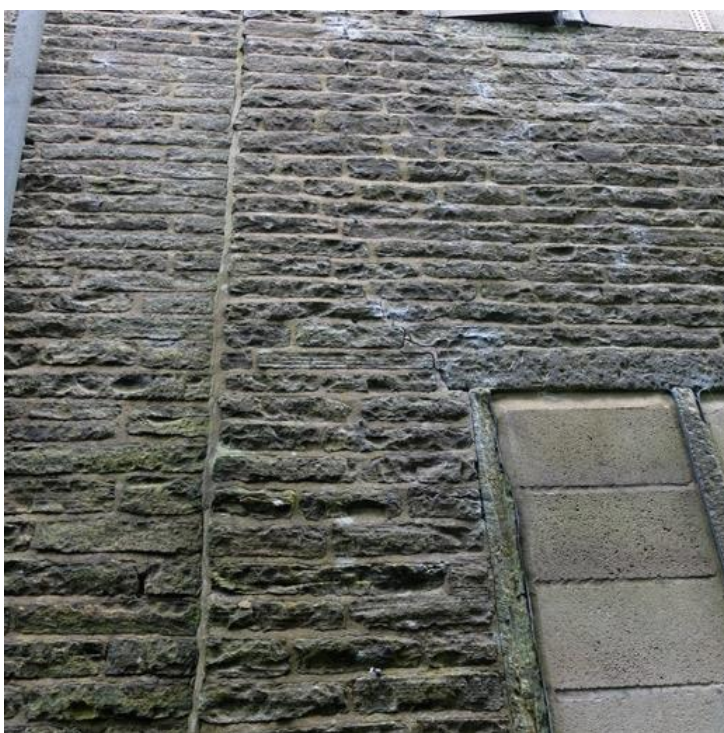
There is diagonal cracking from the top left corner of the ground floor extension window which travels upwards.

Photo. Diagonal crack above ground floor window to extension

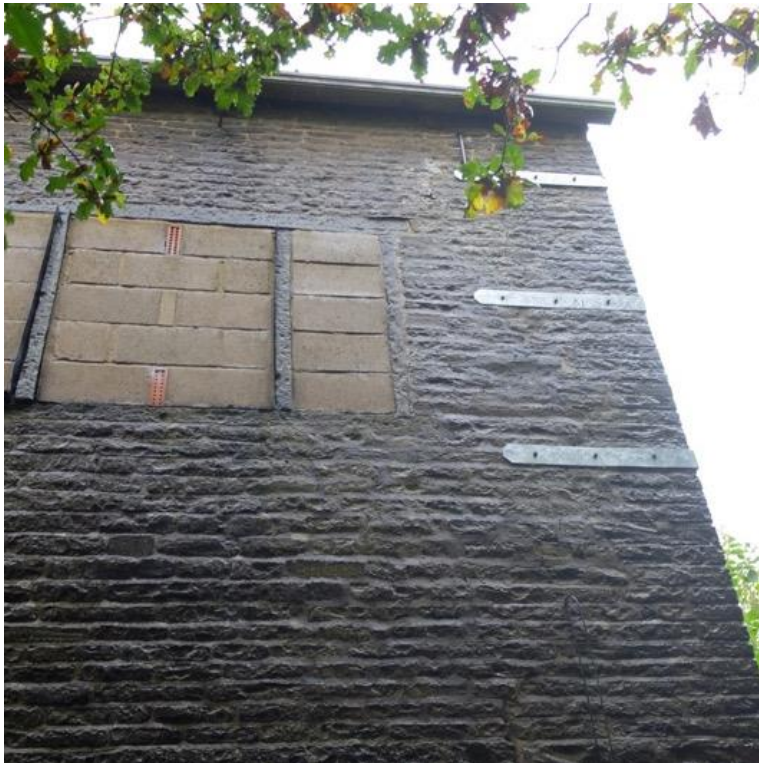
Photo. Corner strapping

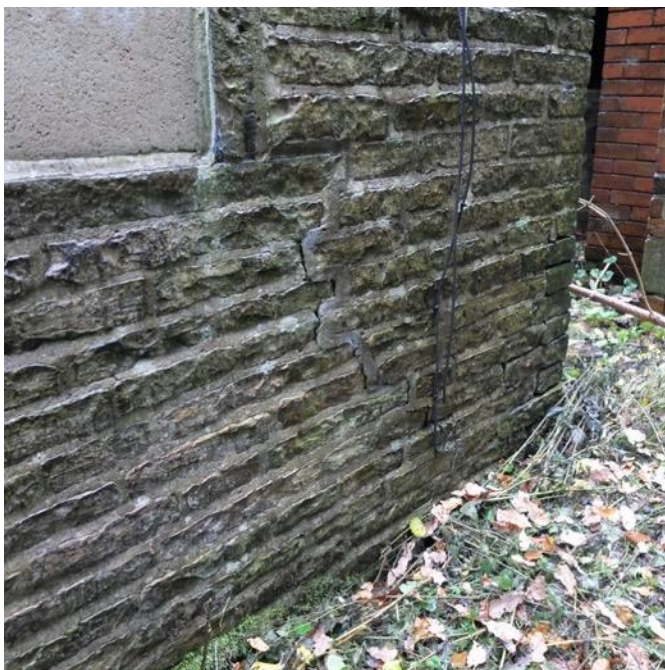
There is a vertical crack which follows the lines of perpendicular joints in the stone and extends from the roof at the top right corner of the first floor extension window down to the right side of the ground floor window and then to ground.

Photo. Diagonal cracking towards front right corner

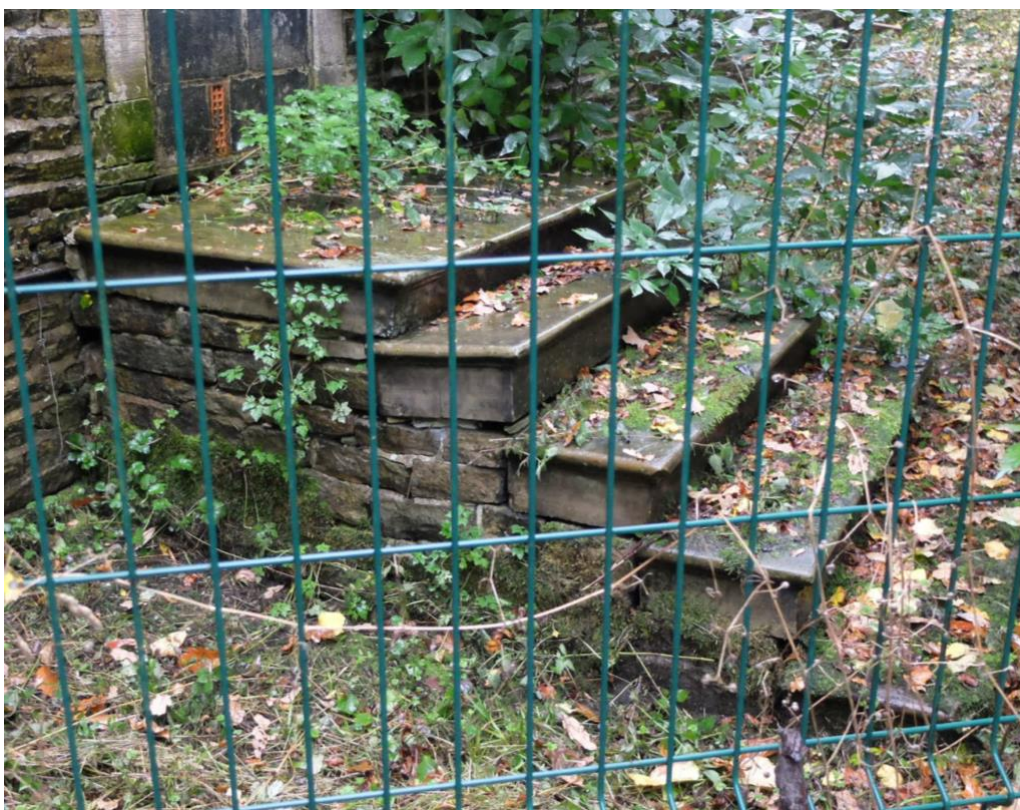
The ashlar stone steps to the front door have moved and will require repair and rebedding.

Photo. Stone steps to front door require repair.

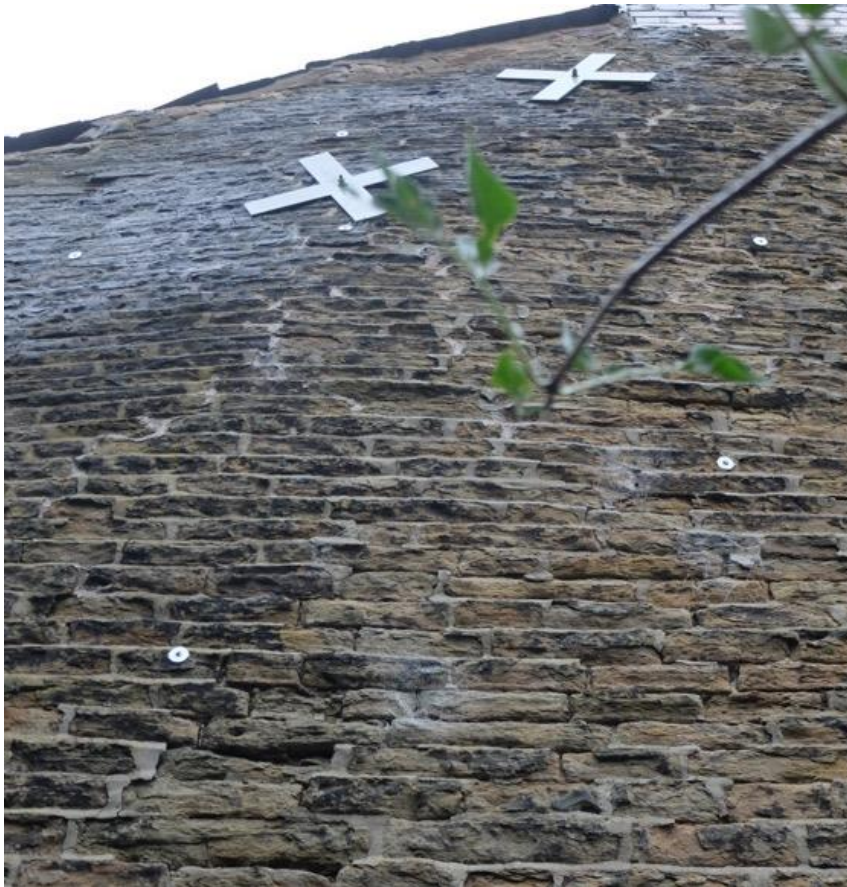
There is a large area of bowing to the gable which extends from the front top corner down to the first floor, floor level and then backup to the underside of the chimney. This is indicative of movement of the outer leaf of stone and may have been caused initially by sulphate attack within the chimney stack which will have caused the volume expansion of the mortar. Horizontal cross ties have been added in the past to try and restrain this movement however rebuilding of the outer leaf is required which would have to incorporate some horizontal ties to tie the two leaves of masonry together.

Photo. Bowed section of gable around flue to chimney.

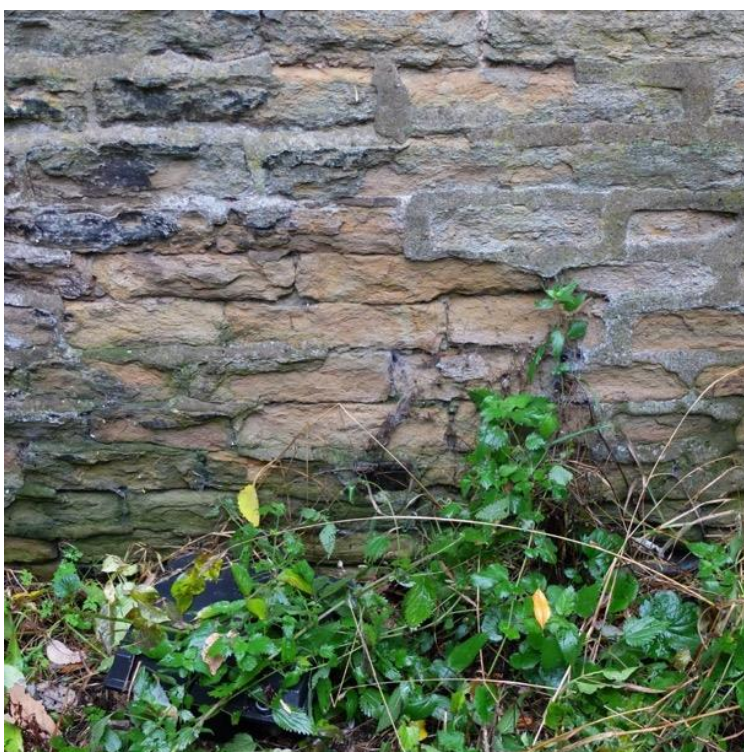
At low level the stonework to the back of the chimney flue is very badly corroded which is indicative of sulphate attack. Some of the stones are corroded to the extent where they will require replacement and cannot be dressed back cosmetically.

Photo. Corroded and frost damaged stone beyond repair.

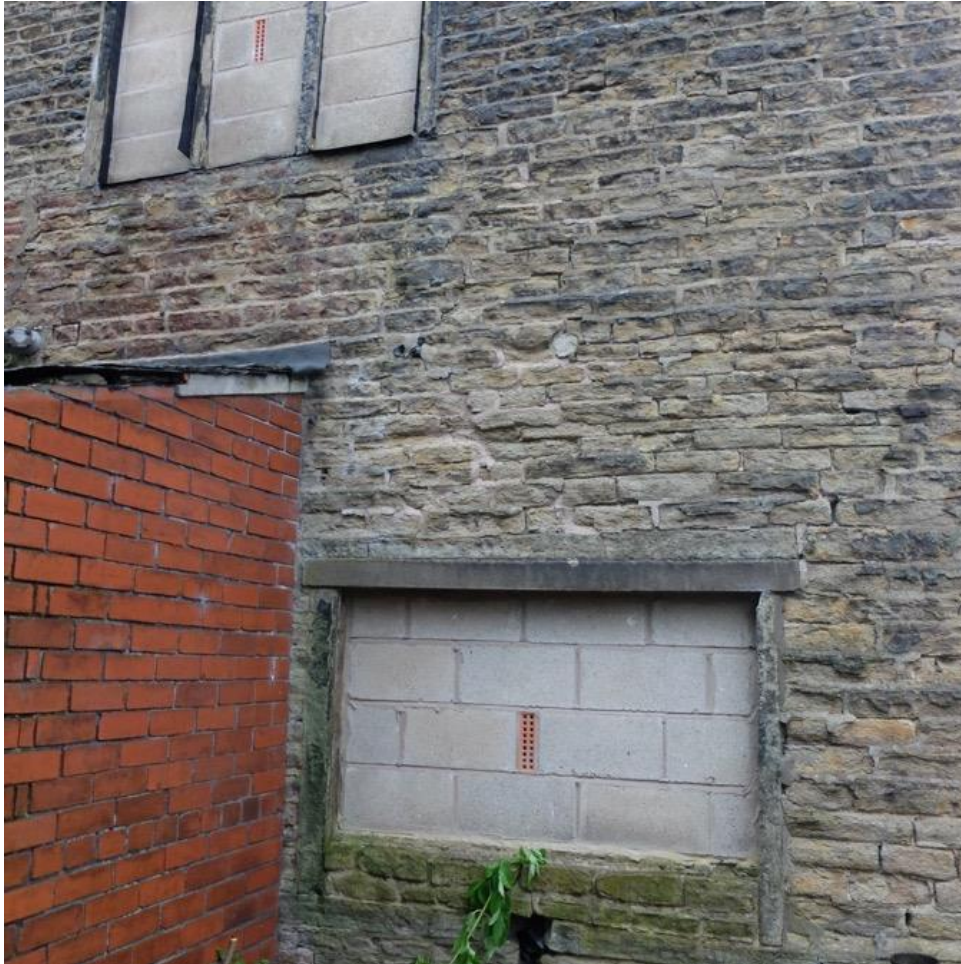
There is diagonal cracking from the front sill area of the first floor bathroom window.

There is diagonal cracking from the head of the kitchen window back up to the bathroom window at first floor.

Photo. Cracking between ground and first floor windows.

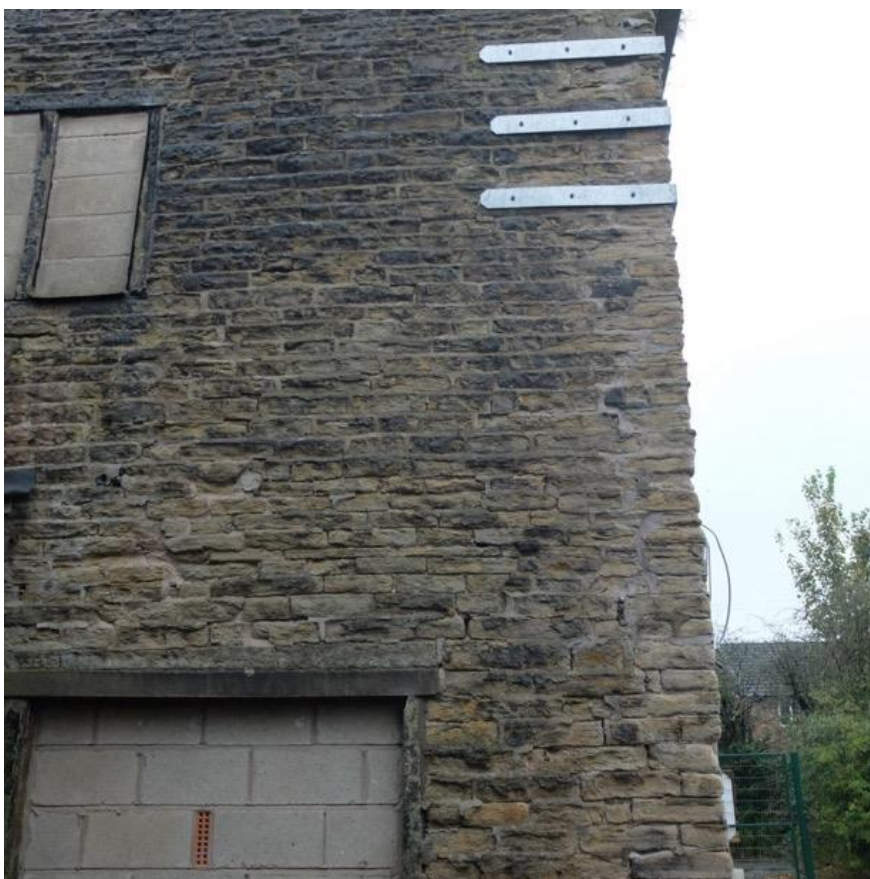
Photo. Frost damaged and eroded stone.

There is an area of badly eroded stone between the ground floor kitchen window and the first floor bathroom window. Some of the stones are corroded to the extent where they will require replacement and could not be dressed back cosmetically.

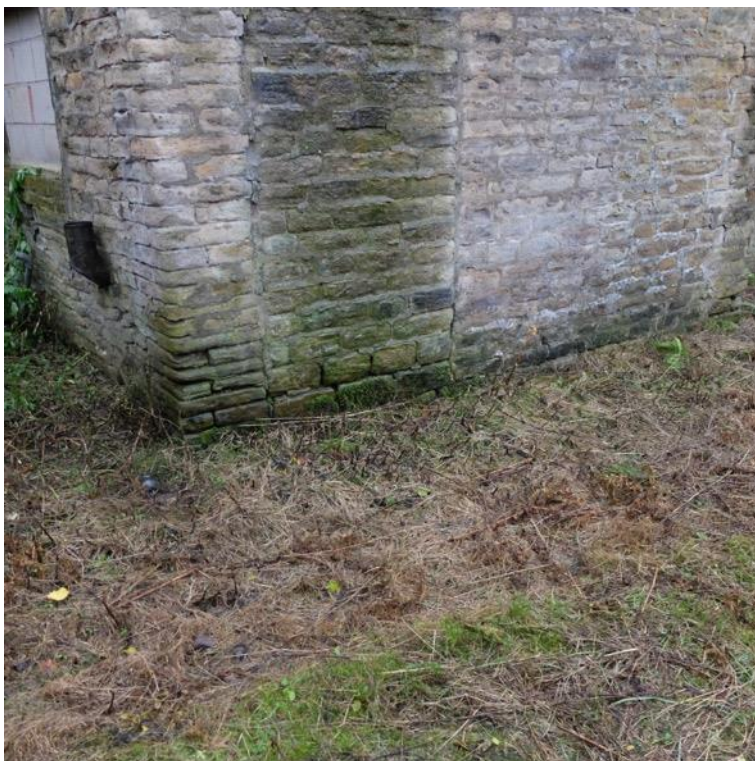
A crack is evident along the vertical joint which has been formed by the blocking up of the door towards the right (east) corner. There is a further blocked up window at first floor level.

Photo. Crack along vertical joints between wall and infill.

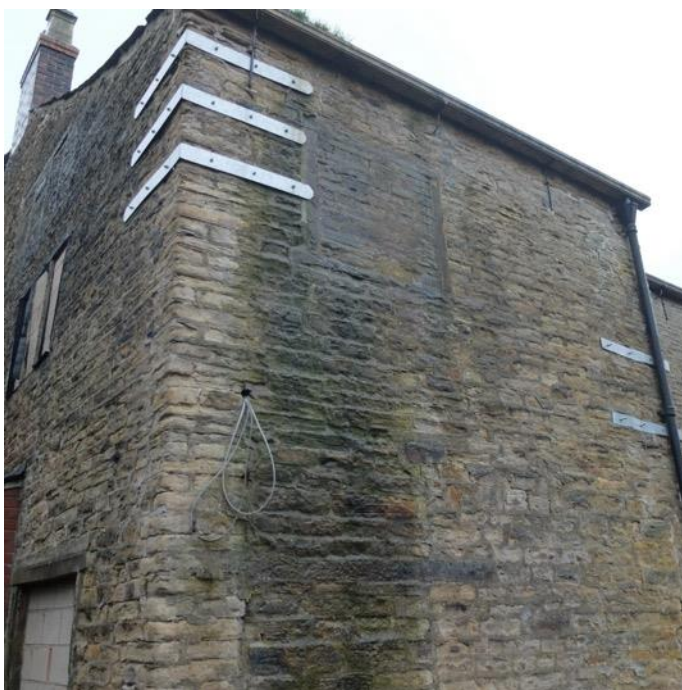
Corner ties been added to the upper corners to both sides of the outrigger to restrict movement between walls.

Photo. Corner straps to high level.

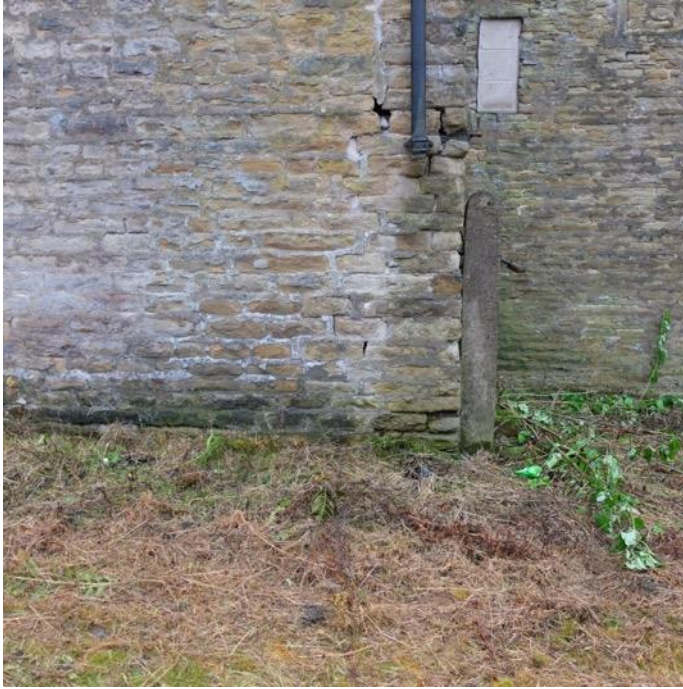
There is badly corroded stone walling at ground level along the length of the elevation.

Photo. Eroded stonework to corner in location of downspout, foundation investigation required

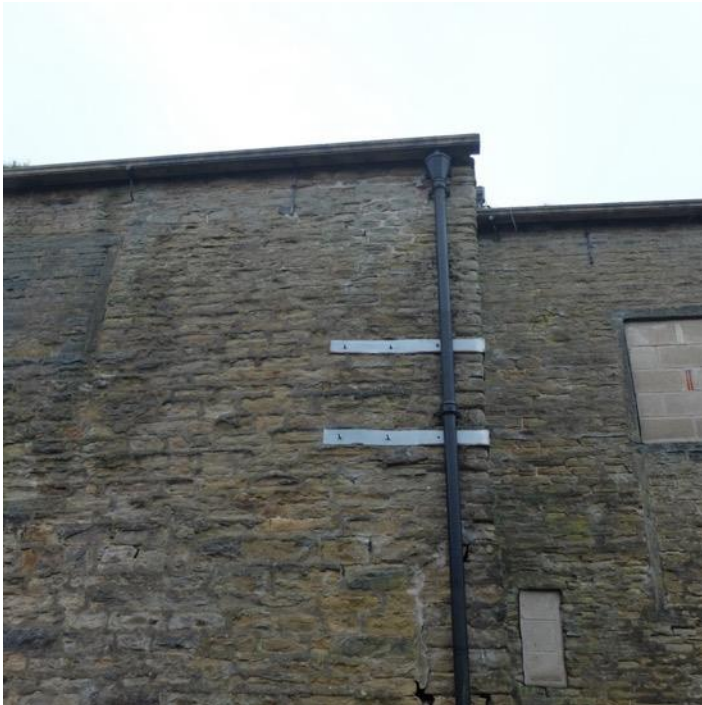
Photo. Corner steps to upper corner

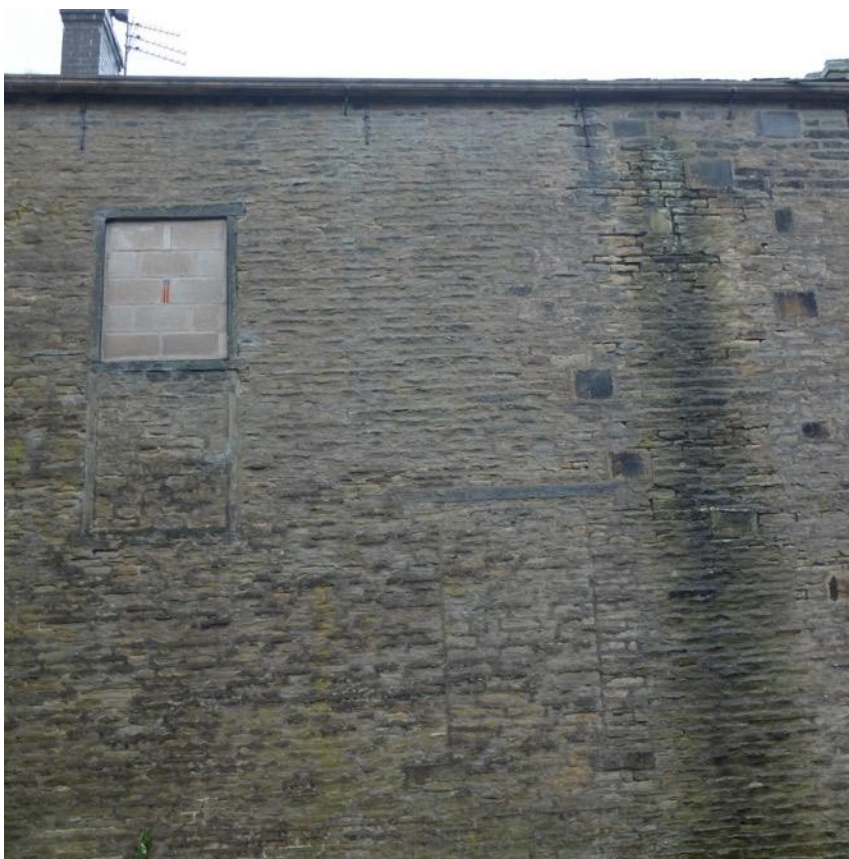
There is evidence of windows which have been blocked up on the rear elevation.

Photo. Infilled windows to rear elevation.

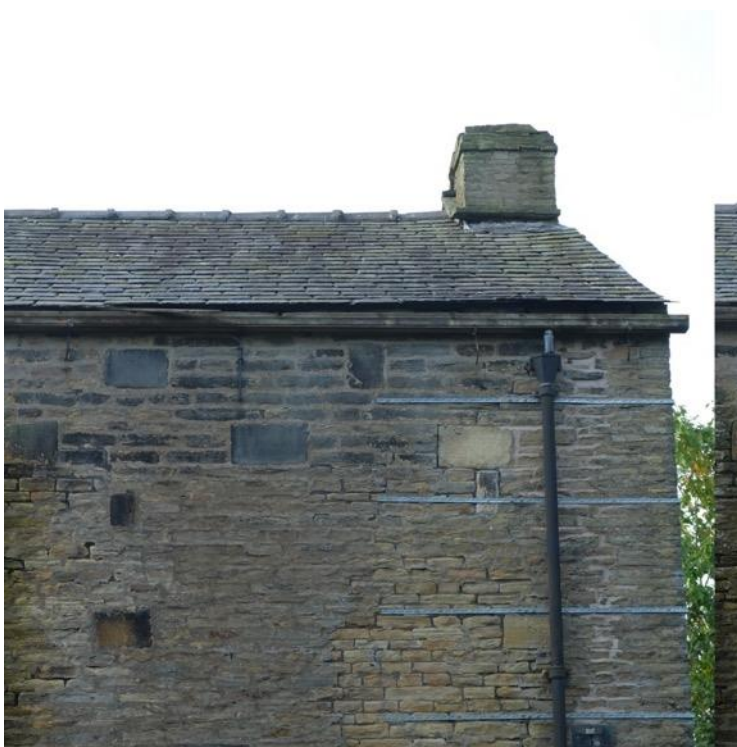
There is a vertical crack which extends from ground floor to the roof which follows the lease line of resistance within the perp joints of the stone this is approximately 600 mm from the west corner.

Large restraint straps have been added to the west corner to restrict movement.

Photo. Corner strapping

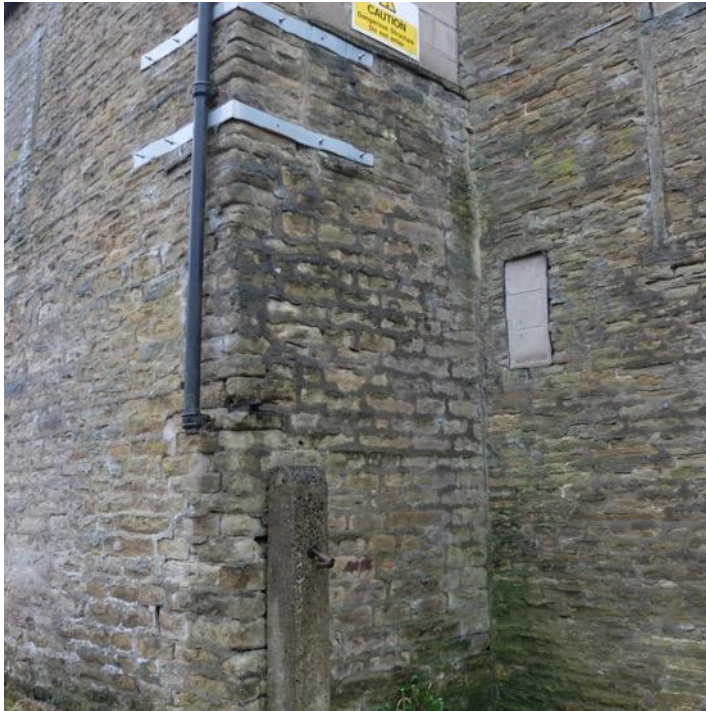
There is a large area of corroded stone to the face of the wall from ground up to the first floor window.

Photo. Eroded stone
