## BUILDING SURVEY REPORT AND REPAIR STATEMENT

### SILVERHILL FARM AND BARN ROCHDALE

Dated Feb 2022

Kevin M Neary Dip Surv, C. Build E FCABE AssocRICS  
Building Surveyor, Chartered Building Engineer,  
15 Litherland Ave  
Ashway Park  
Peel Hall  
Manchester  
M22 5LD  
Tel no 0161 436 4079  
Email [kevin@kevinneary.co.uk](mailto:kevin@kevinneary.co.uk)

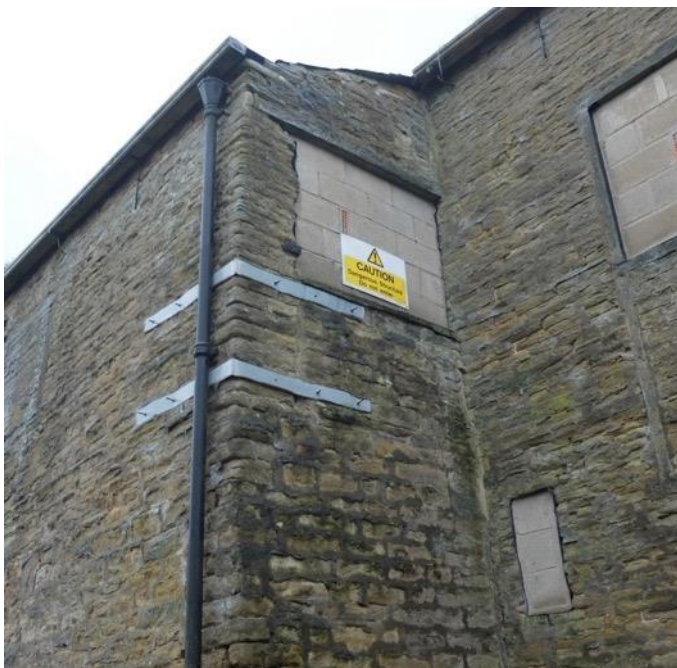
Corner straps have been used to restrict movement with the rear elevation of the outrigger.

Photo. Outward bowing of wall caused by position of window opening.

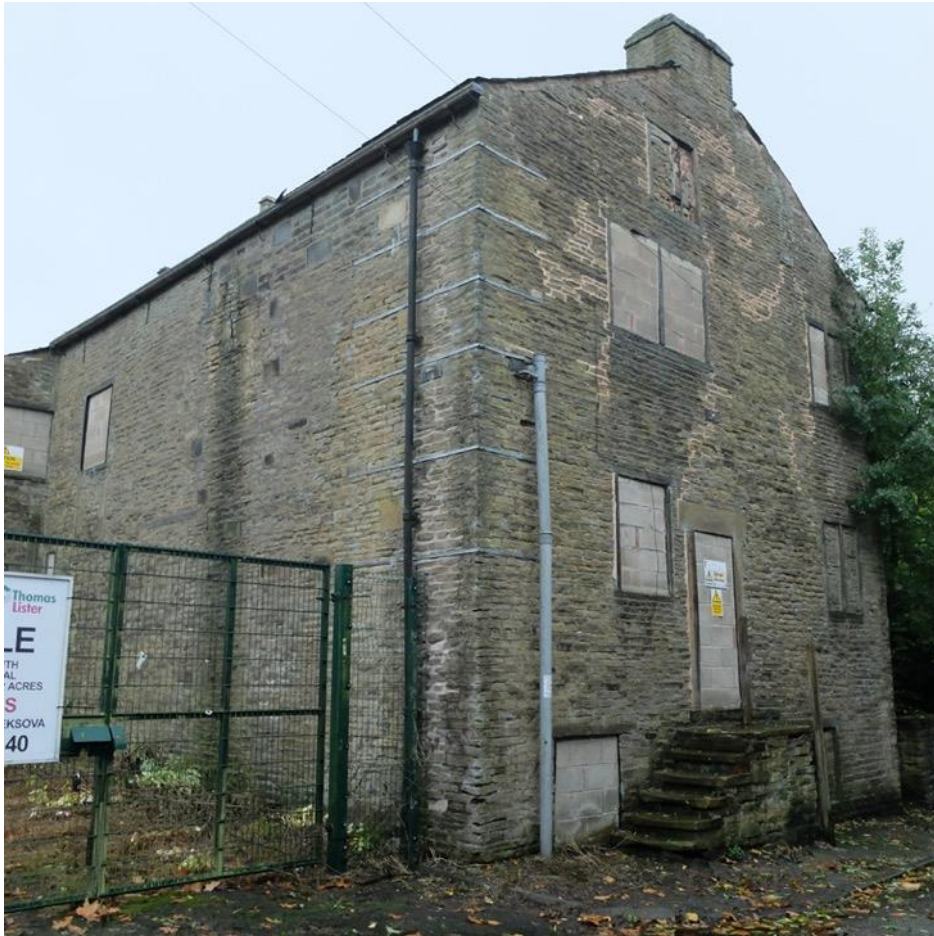
There are approximately 7 areas of cracking which appear to have been patch repointed.

Photo. Full view of gable which overlooks road

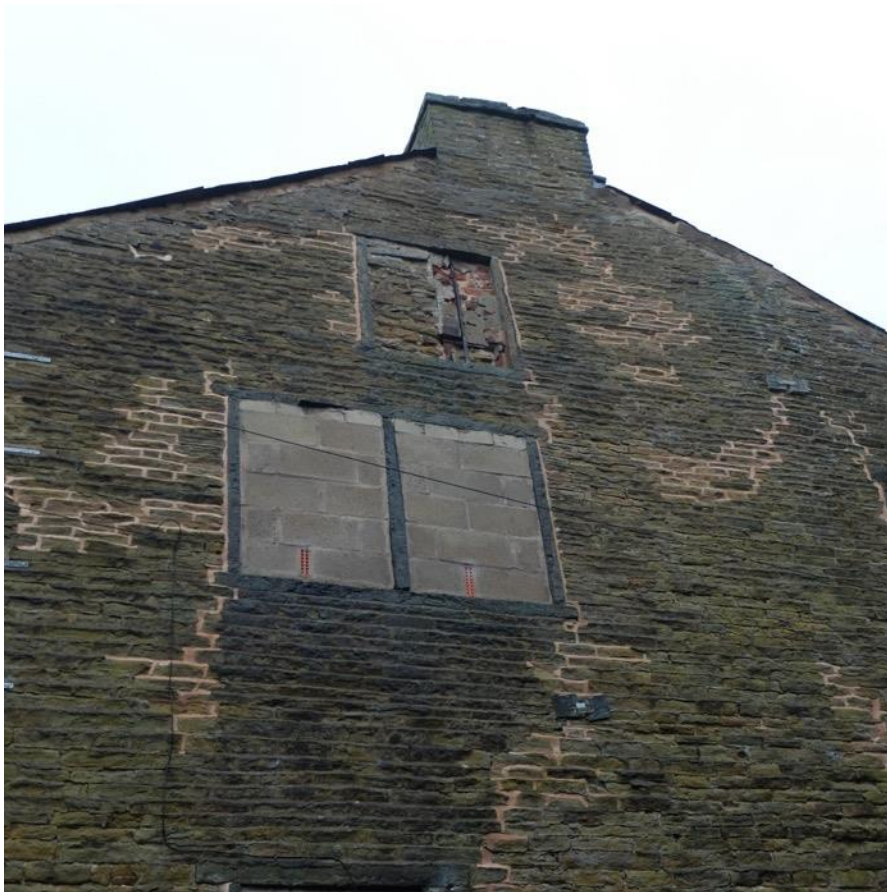
There are old crack indicators evident and large angle straps to the rear corner at high level.

The mortar used for the repair is the wrong colour and appears to not contain sufficient aggregate to prevent future shrinkage and failure. With stonework of this type, it is necessary to use larger particles of aggregate which prevent excessive shrinkage in-service.

Photo. Previous repairs and bowing of masonry below chimney

At the high level gable, the area of walling below the chimney appears to lean inwards creating an inward belly within the wall which may have been caused by expansion of the mortar due to sulphate attack around the flue.

There is considerable corrosion and damage to the walling stone in the location of the chimney flue. The corrosion and damage to the extent where replacement stones would be required.

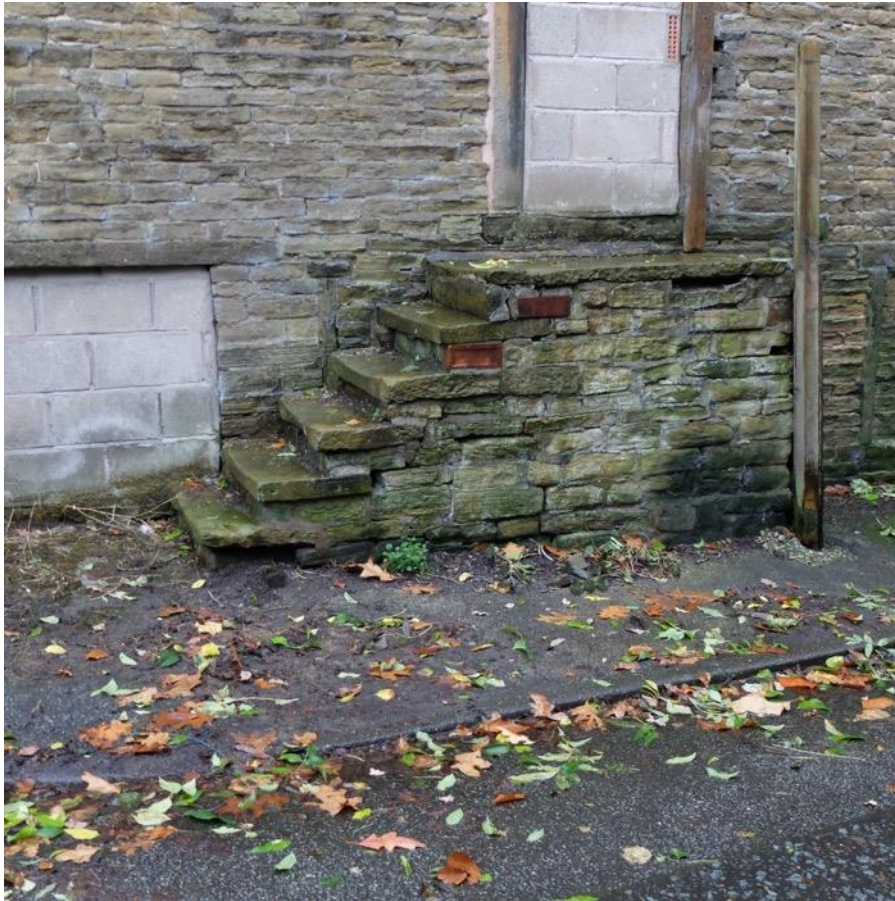
The stone steps to the side door are badly corroded and will require some rebuilding.

Photo. Later stone steps to gable door will require rebuilding

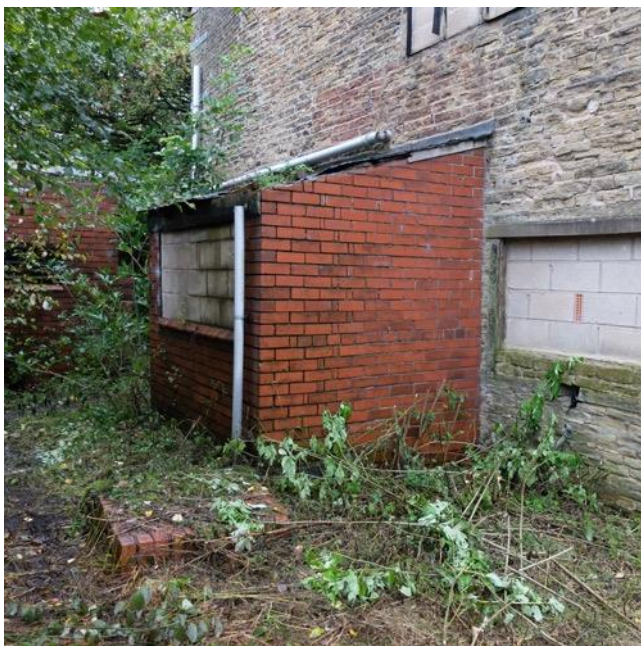
There is a small brick porch which is located on the right-hand gable. This is constructed in redbrick and black ash mortar and appears to have been constructed around the 1900s which is the same time as the other outbuildings on site.

Photo. Brick porch, poor quality

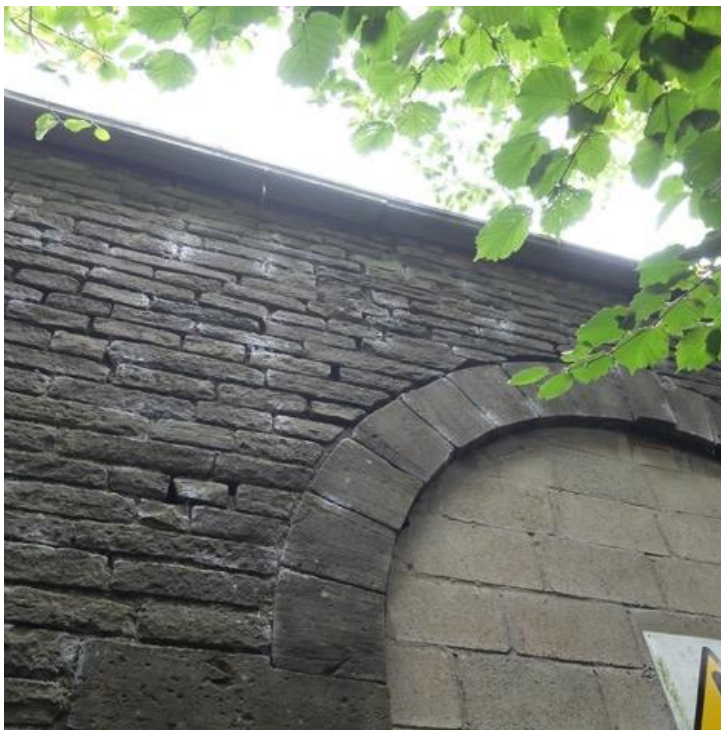
There are areas on the front elevation where leaks from the gutters have promoted the washing out of mortar from the walling stones.

Photo. Mortar was away by leaks

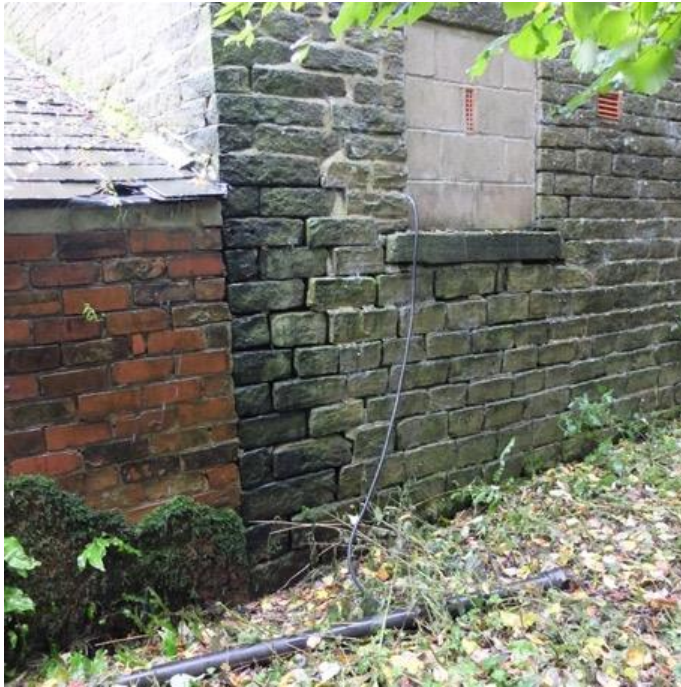
There is some loose stone located to the front left corner at low level.

Photo. Loose brickwork at ground level

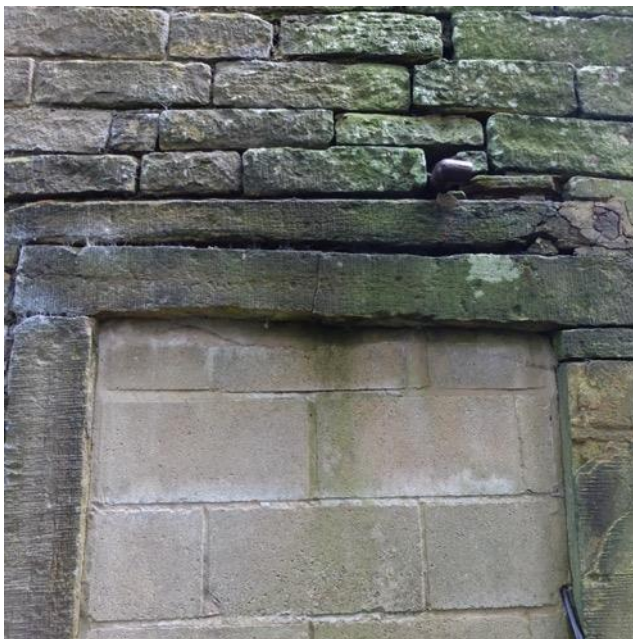
The stone lintel above the window is cracked and there is loose stone above.

Photo. Crack to lintel and movement of masonry above

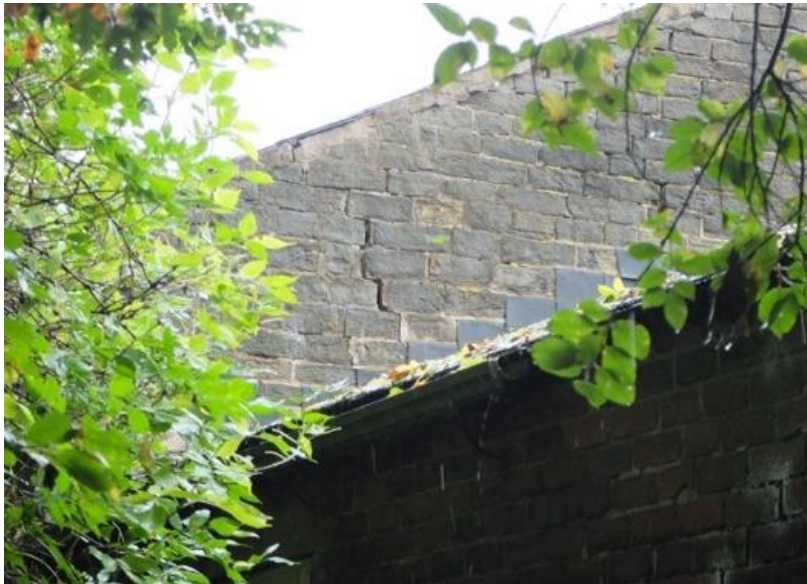
Along the front section of the right-hand gable there is an opening into the barn. This opening coincides with the opening in the front elevation the barn meaning there is only a very small pillar of stone which supports the corner of the barn. There is considerable outward movement in this area and this movement appears to extend up to roof level. The gap which has opened is approximately 50 to 75 mm in places and urgent support and restraint is required in this location.

Photo. Movement extends up to roof level

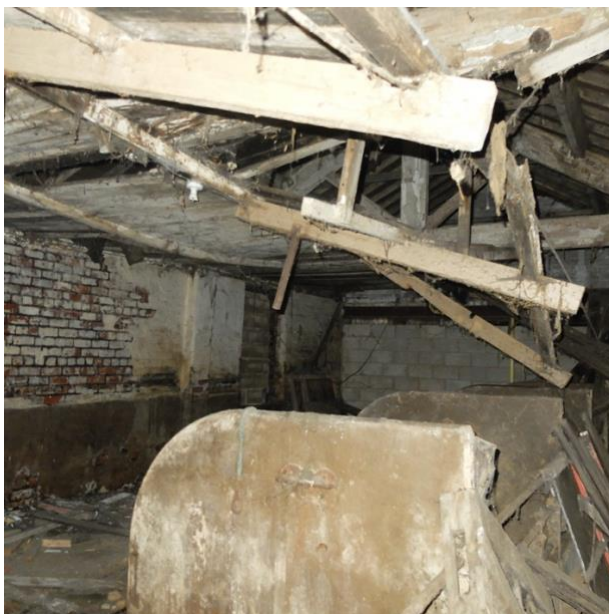
It is considered that the outward movement of the brick front elevation of the single storey building which abuts the front right-hand corner of the barn will have contributed to the movement and cracking to the front right-hand corner of the stone barn. The structural condition of this single storey building is very poor, and failure of the roof has contributed to the movement of the brick walls.

Photo. Collapse of roof structure to single storey building abutting barn

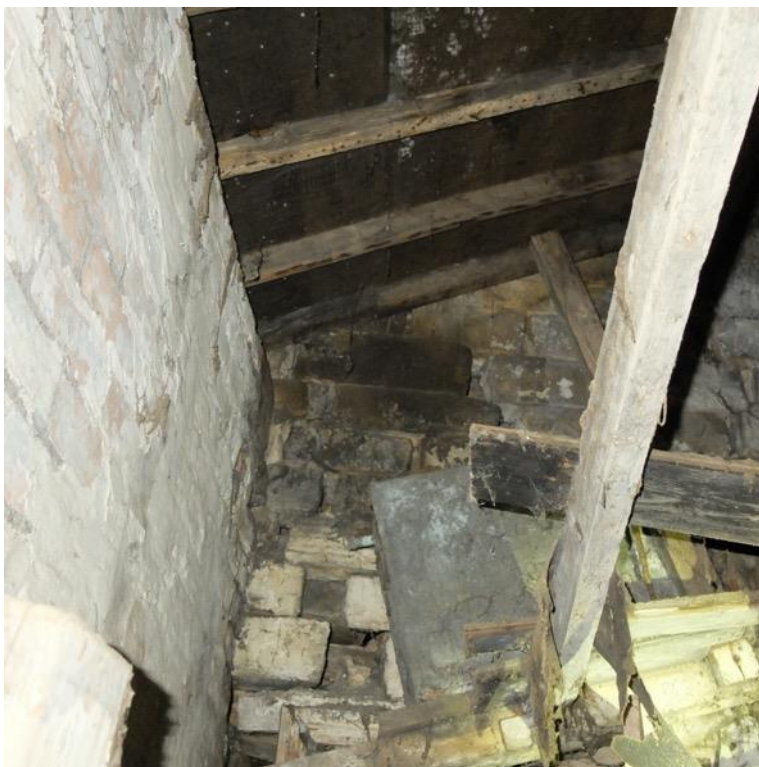
Photo. Movement above doorway which extends up to roof (photo above) outward movement of brick walls

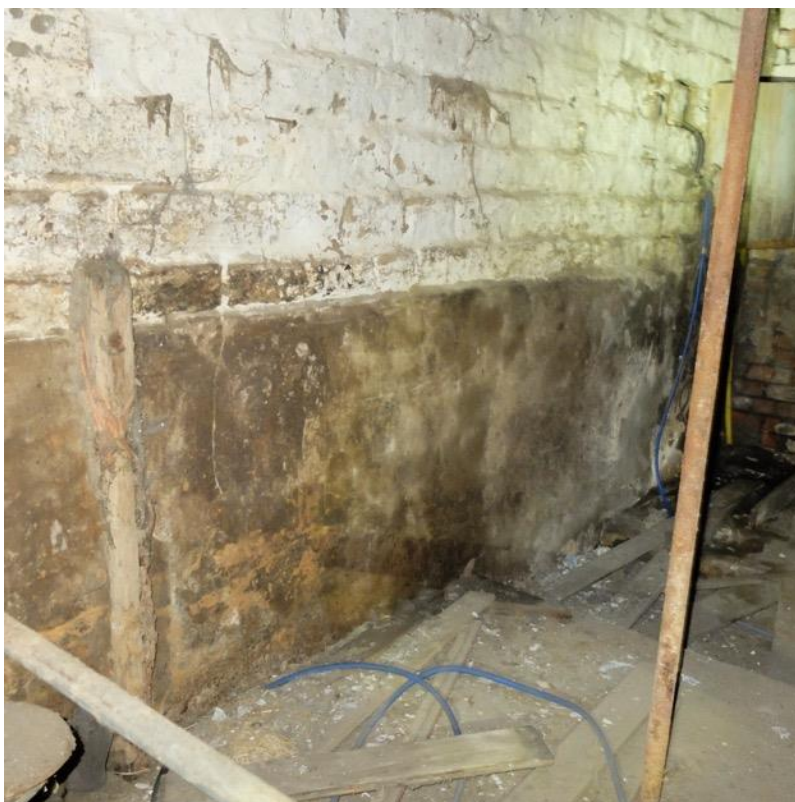
At low level when viewed from the cowshed the wall has been tanked using a hard cementitious render system to support framing activities. When the cowshed is removed, and the full gable is exposed the cementitious render will be difficult to remove without causing serious damage to the face of the stones at low level.

Photo. Tanking to external barn wall will be difficult to remove.

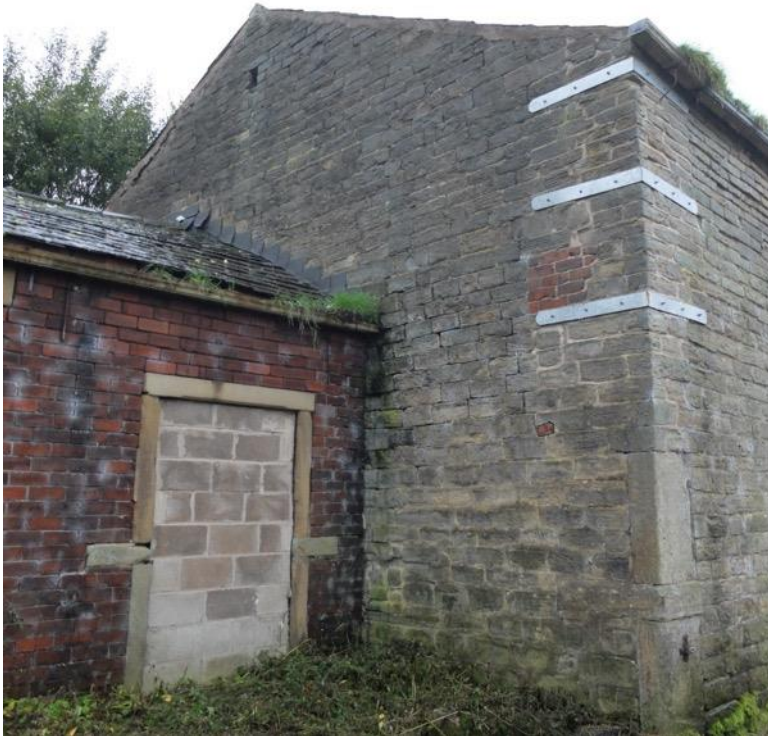
On the rear corner with the rear elevation clay brick has been used to repair a hole which may have been an old metal flue for a heater. The brick does not bond well with the stone and creates a weak point.

Large stones laid vertically have been used on the rear corner. This may have been a striking or hinge point for an old gate to the farmyard the large stones have no bond with the masonry which abuts this and creates a weak point in the construction.

Photo. Old bricked up flue and corner strapping

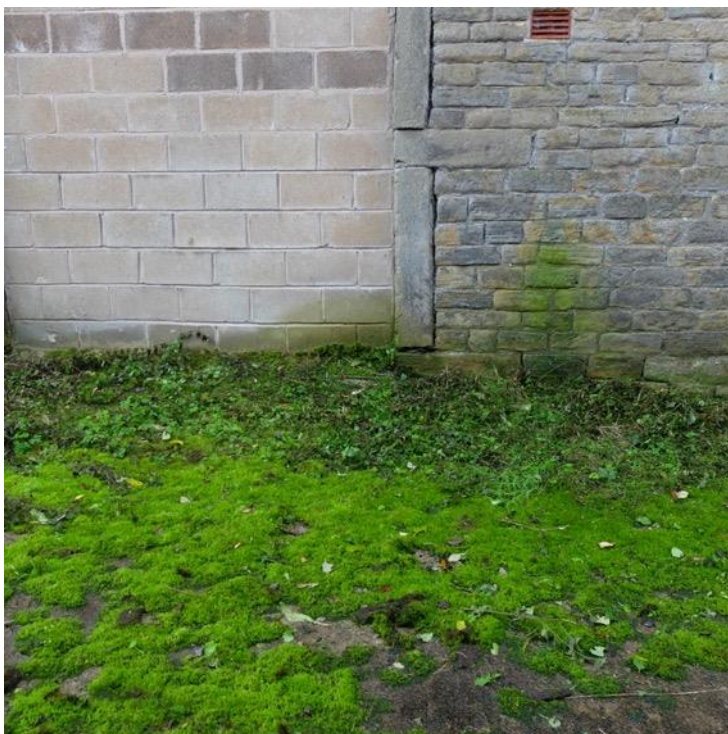
The stone reveals at low level which form the threshing door appear to have been repacked at the base. It is possible that the action of the large doors has caused these to become loose and these have had to be repacked. It is considered that these will need removal and re-bedding incorporating horizontal tie system with the masonry walls.

Photo. Repacking of threshing door reveals

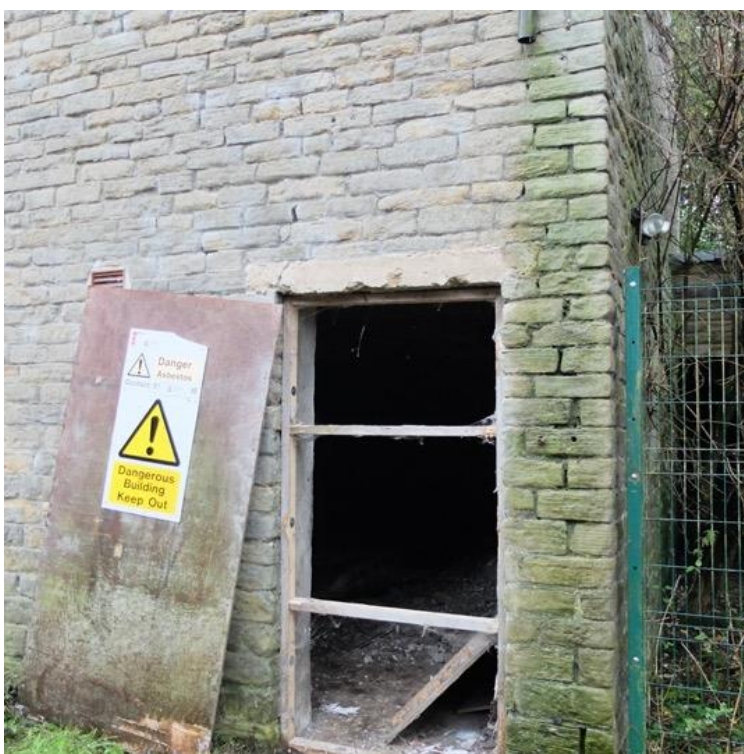
The stone lintel over the door opening has been bashed and damaged by years of carrying items into the barn.

Photo. Damaged stone lintel above door

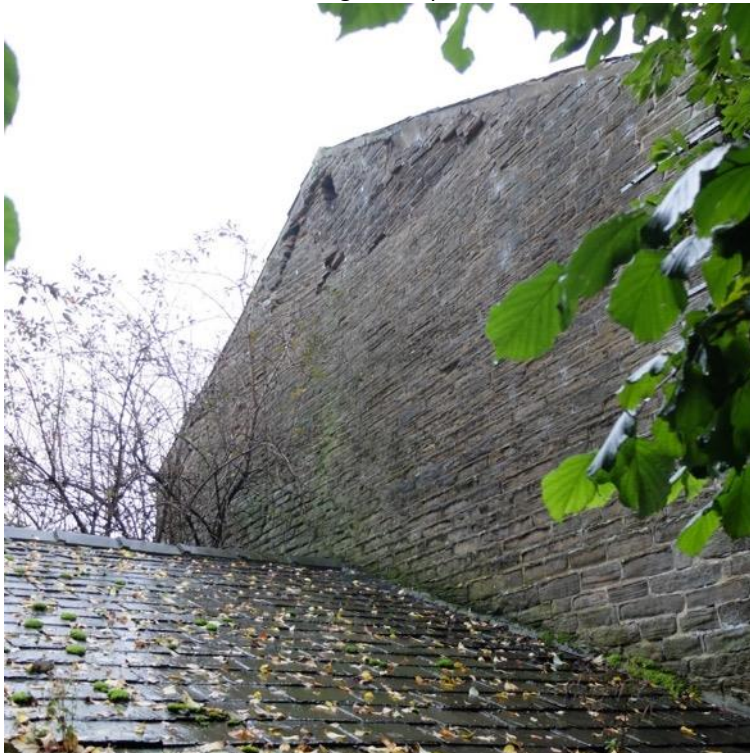
Photo. Inward bulge to high level gable

Cracking from the inward belly extends along the line of the verge towards the rear elevation.

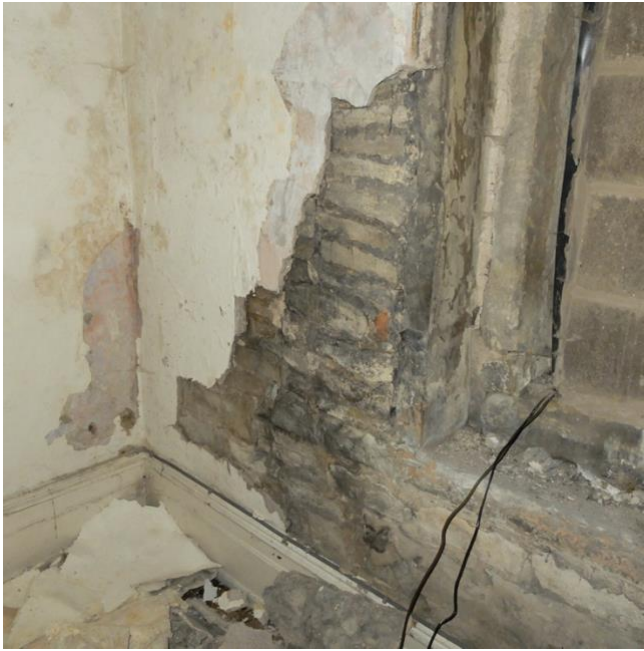
Photo. Added plaster from elevation Room G.03

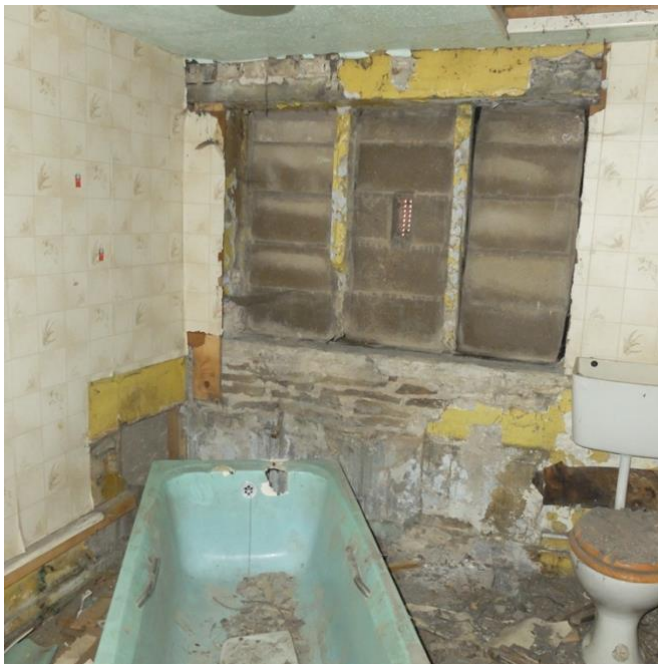
Photo. Added and damaged plaster east gable. Room F.08

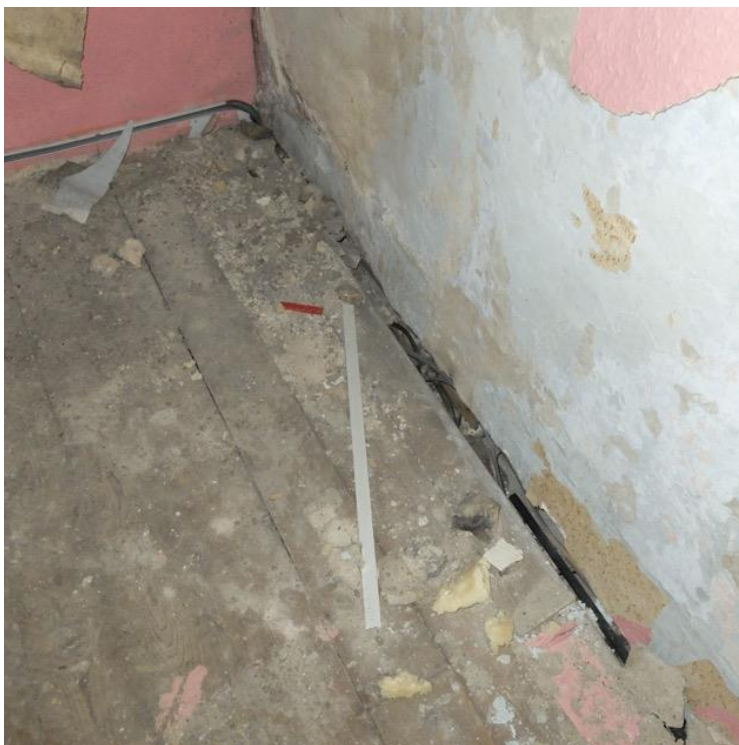
Photo. Gap between floor and wall indicates movement. Room F.07

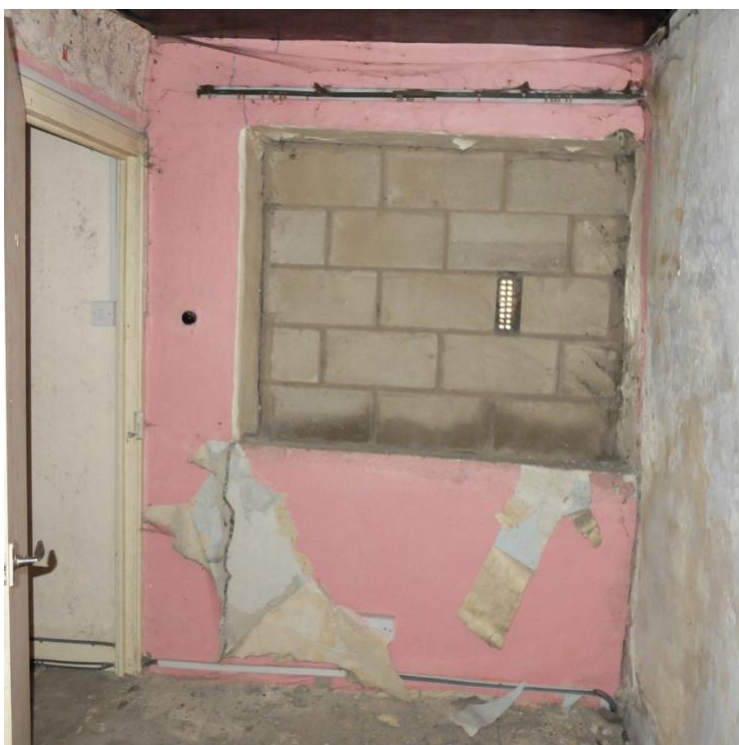
Photo. Cracking to below window west wall of outrigger Room F.07

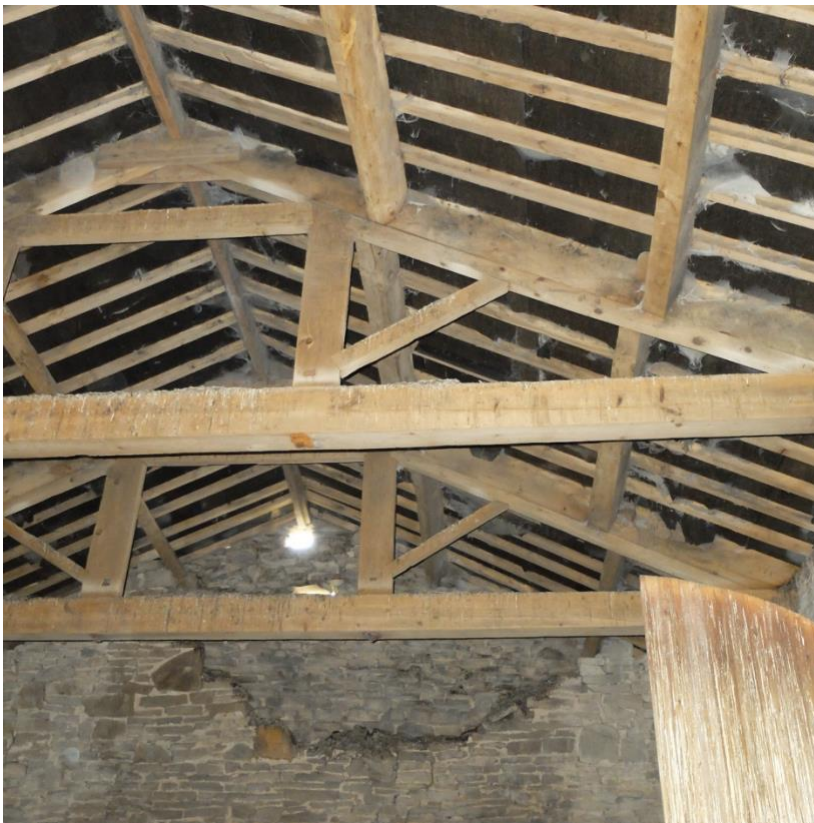
Photo. Collapse of inner leaf to gable.

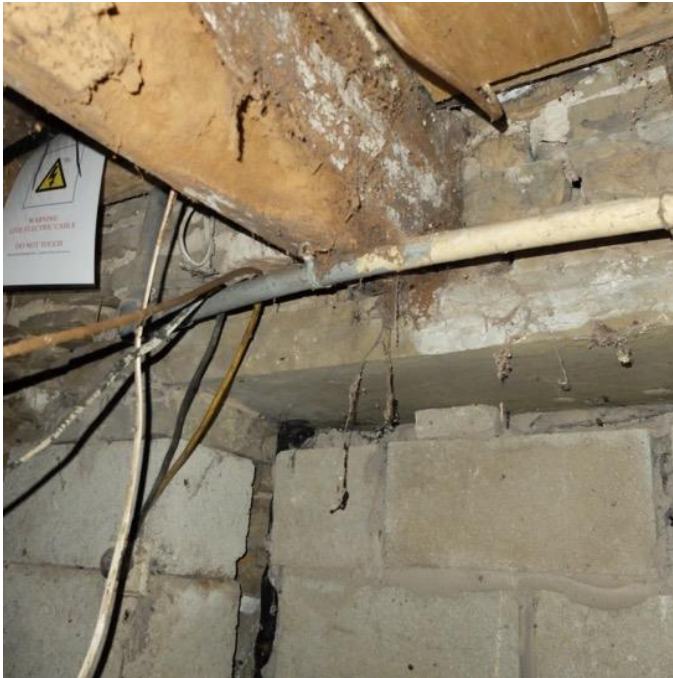
Photo. Decay to timber beam Room B1

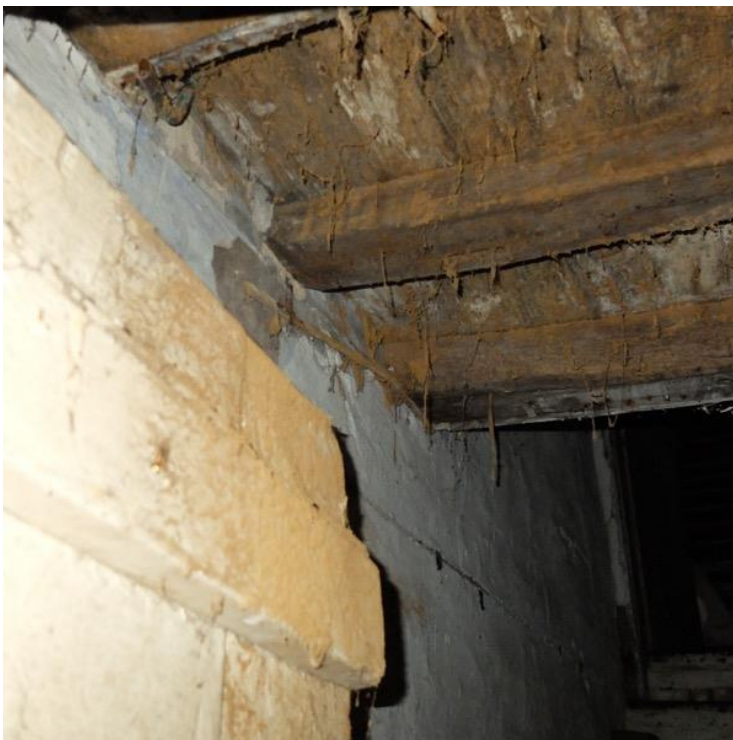
Photo. Decay to joists and boards which support York stone floor above, Room B1

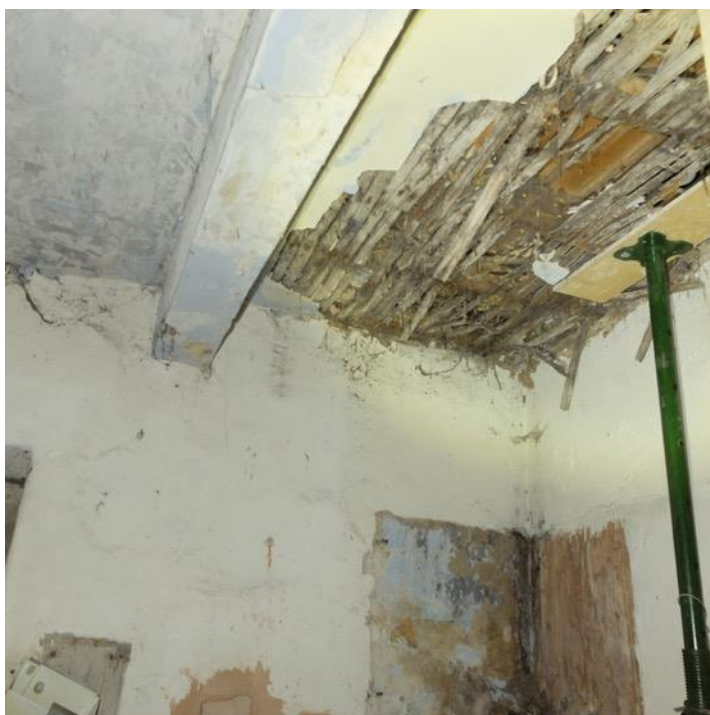
Photo. Example of damage to lath and plaster ceilings and downstand timber beam
