MILNROW LIBRARY  
SPECIALIST INVESTIGATIONS  
EMERGENCY WORKS  
January 2022

**Bradshaw Gass & Hope LLP**  
**Architects Consulting Engineers Quantity Surveyors**  
**21 Silverwell Street Bolton BL1 1PR**

## 1.0 INTRODUCTION

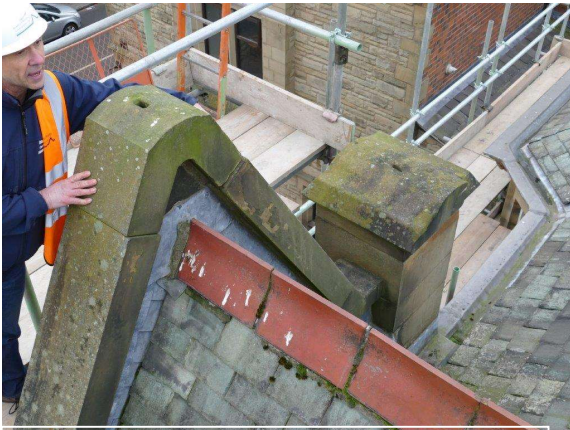
The panel is at a real risk of future collapse and as the level of integrity between the panel and the wall cannot be assessed without dismantling, it is proposed that an intervention is made to provide temporary support for the panel while a full proposal for its future careful dismantling and re-instatement is devised and submitted for listed building approval.

The top panel of the entrance gable can be rocked on its bed joint, three metres below at the head of the stair window.

It is proposed that a temporary restraint and bracing frame is installed within the roof void with the front angle resin bolted into the compromised gable from behind to provide temporary support.

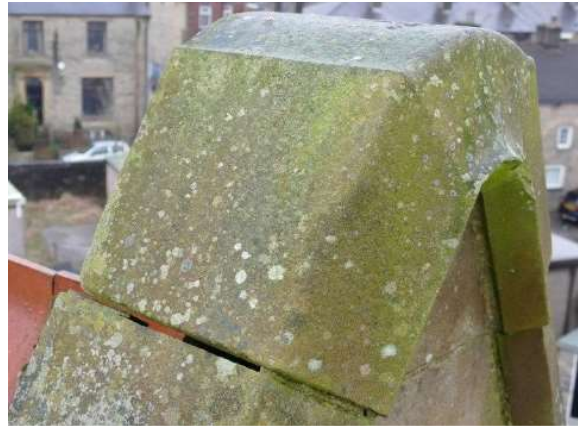
The apex capping stone is de-bonded and remains in position by gravity. It can easily be lifted off the gable. An open joint is visible above.

- The lifting and re-setting of the capping stone at the apex of the entrance gable cornice. (This is to be re-bedded into a lime mortar as a temporary measure with a proposal for it to be restrained with stainless steel dowels under a later Listed Building Application).

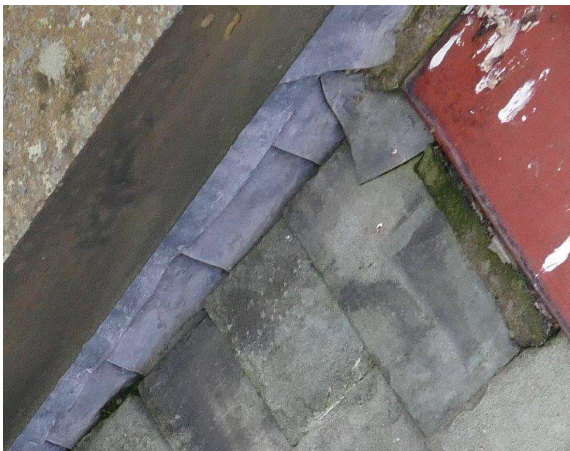
Displacement of the gable appears to have stretched the soakers, reducing their lap with the cover flashings to 30mm in places. This is a likely source of water ingress.

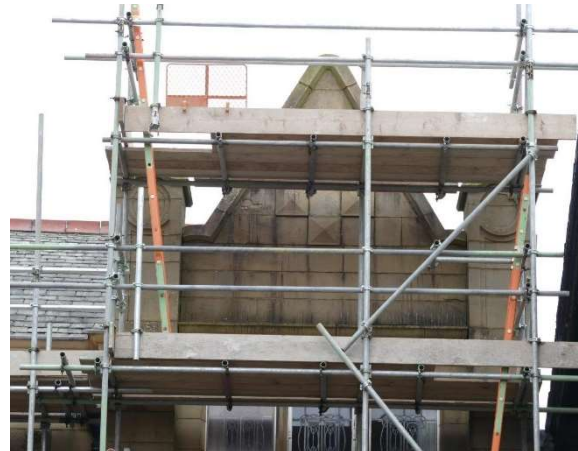
The upper section of the gable is loose and is flanked by two piers with raised heads. The central panel appears to be un-bonded and the right hand pier has displaced to the south. The stonework of the pier is also displaced below.

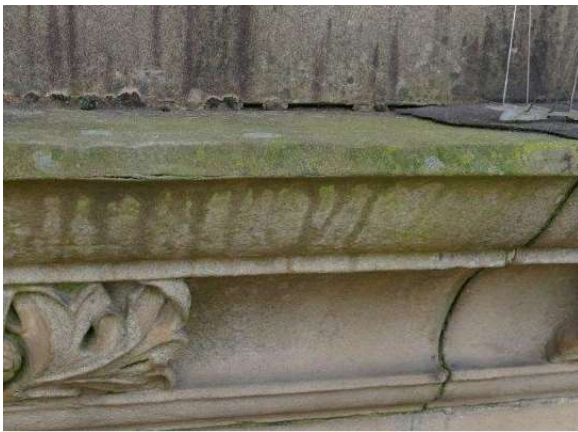
The rear of the loose panel, where it is bedded on to the head of the stair window, shows open cracks internally as well as externally and is likely to be from past water ingress and failure of the bed joint.

External open joint to the stair window head at the base of the loose section of gable panel,. There are also open joints in stonework below where there is extensive water staining internally.

- The carrying out of pointing works to the fractured bedding joint at the base of the panel, that is currently loose, and of the open joints in the window head below (that have been allowing water to enter the fabric and compromise the internal plaster above the window)

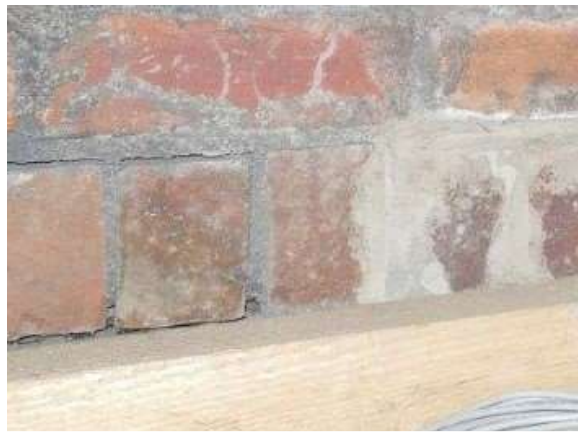
Within the roof void behind the compromised gable there is visible cracking at the base of the compromised panel that appears to coincide with the plane of the fracture externally.

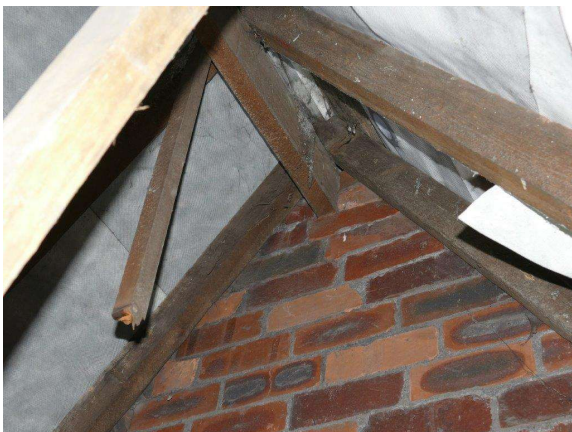
Roof spars offer little real support to the gable and appear not to be strapped or tied to the gable in any way..

The steel frame is to be braced and tied back to the existing roof structure behind. The final detail for this is to be agreed on site to suit the timber alignment and section sizes. Full details of the scheme, proposed by the Care registered Structural Engineer, are given in the appendix C.

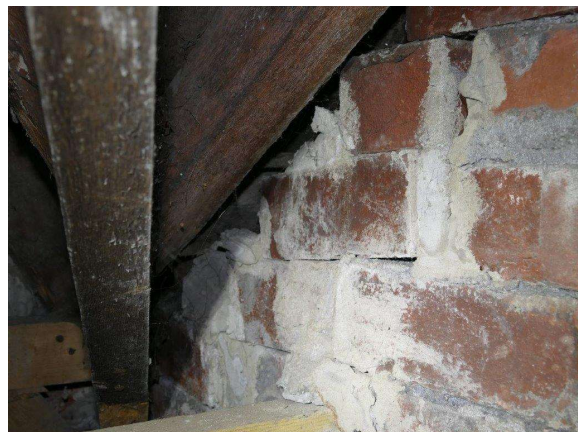
The brickwork to the side of the gable, which coincides with the south east pier and capping, is displaced and lifted. This may have been displaced by the movement in the external pier. This should be assessed during the future dismantling.

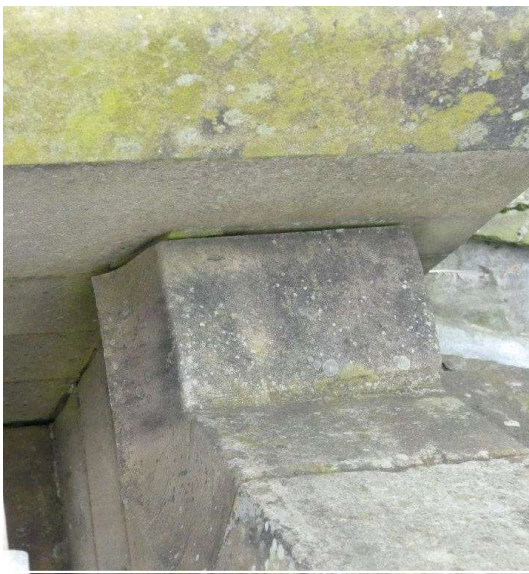
There appears to be little or no tying in of the gable panel with the piers and there is an open joint to both sides that is open to water ingress and may too have contributed to the failure of the gable panel.

Open joint where the gable panel meets the corner finial. Water can freely run into the joint and into the core of the stone wall.

- The carrying out of pointing to the currently open joints between the copings of the gable and between the lower coping and the projecting finial of the side piers.

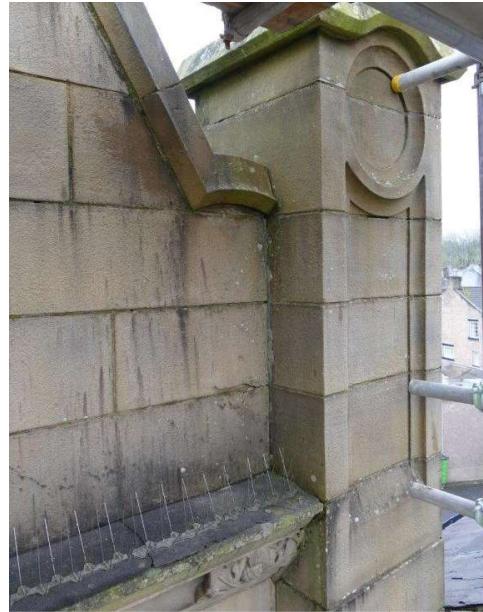
The south pinnacle has a very noticeable rotation to the south. The North pinnacle has a slight rotation to the south east and this is visible in the displaced mortar joint in the photograph below.

The south pier and finial has a distinct lean to the south which has further opened the joint to the gable panel

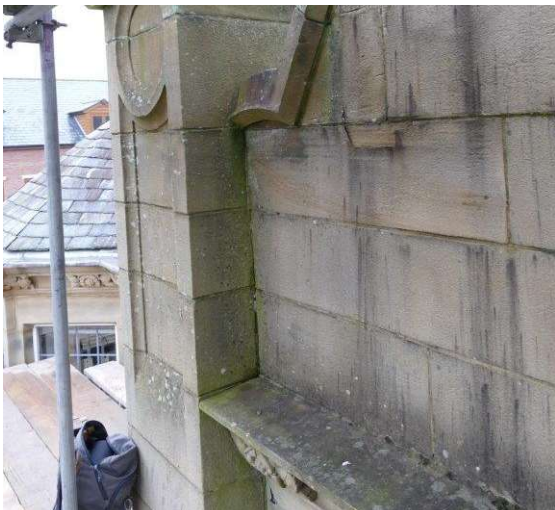
Both open joints show a lateral displacement, suggesting that the piers have already rotated away from the gable panel.

A crack has developed along the junction of the left hand pier and the wall and a significant open joint and displacement to the right hand side.

- the carrying out of pointing to the vertical open joints between the central wall panel and the side piers.
- The fabrication and installation of a steel support framework, as detailed on the Structural Engineer's drawings, to provide lateral support to the compromised gable and to restrain and brace it back to the roof structure behind.

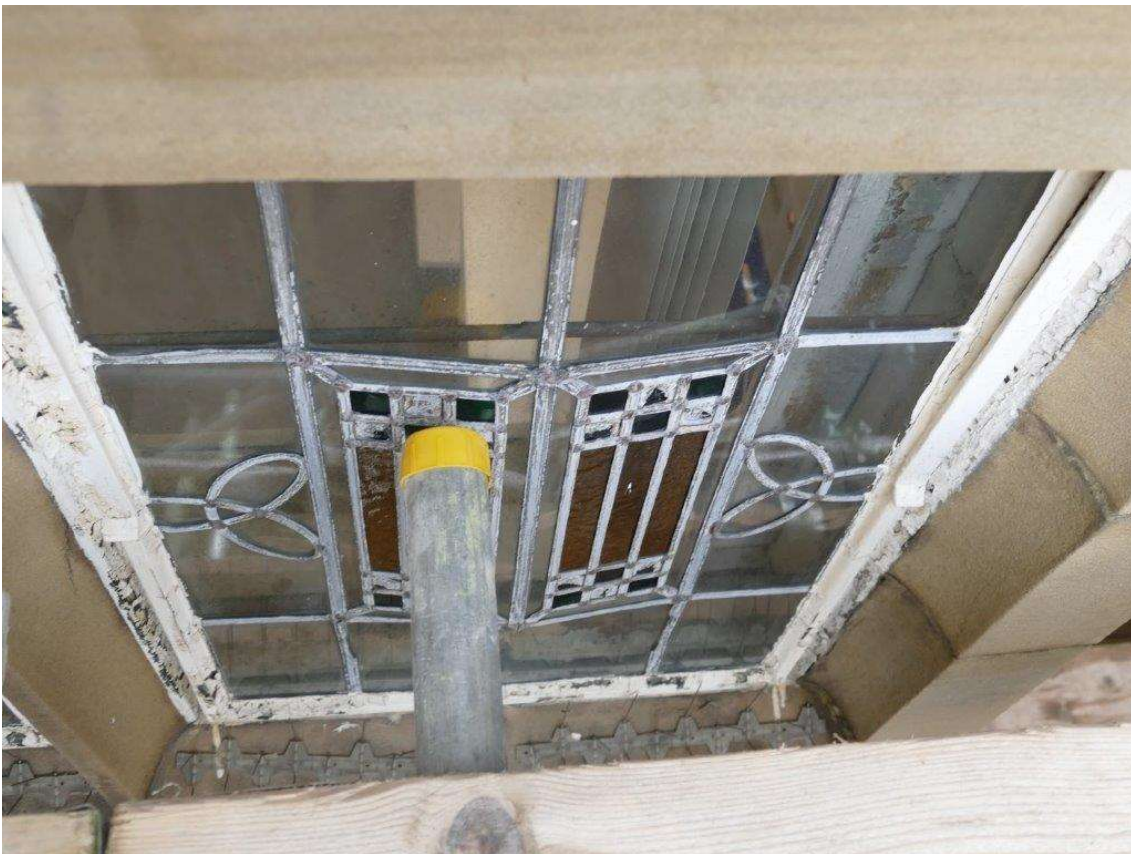
Two central panels to WF3, the two panels of the central section of the Oriel window, are buckled within the surrounding leaded lights and are at risk of falling. The panels appear to be original art nouveau panels and require to be completely re-leaded, along with the whole light, to ensure their longevity and survival.

The central 2 panels of the original light have buckled outwards and are only supported by the lead comes. These are vulnerable to wind damage, to further distortion during hot weather or to any impact from the interior of the building.

It is proposed that, while the scaffolding is in place, the opportunity is taken to secure these two lights to prevent them from failing and the glass being damaged. It is proposed that the glass is secured in its current location until a full scale of repair works can be submitted for Listed Building Approval. If, on closer inspection, it is found the at the lights cannot be satisfactorily be secured on site, it is proposed that they are removed by a conservation leaded glass specialist and are re-leaded in readiness for when the window and its adjacent stonework are repaired.

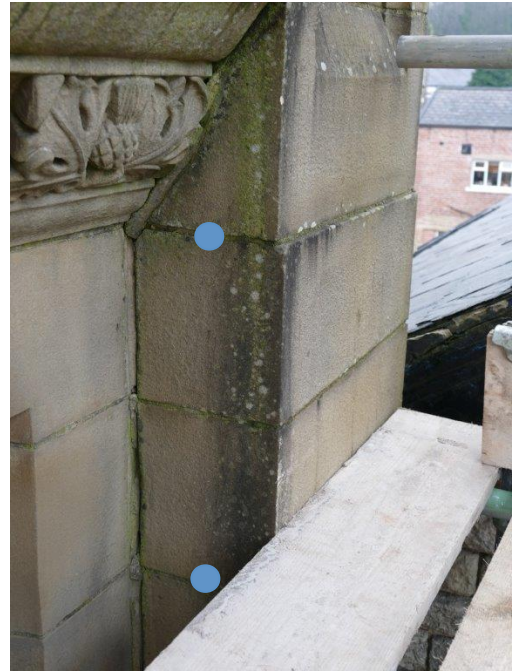
### New restraint to pillars

The existing stone pillars are not bonded to the stone face. There is a vertical mortar joint that has broken down and is allowing water to enter.

Each pillar to have 3 No restraint anchors. Consisting of 6mm dia stainless steel threaded bars, in a 10mm dia hole, anchored full depth with a Hilti resin applied under hand pressure from an application gun.

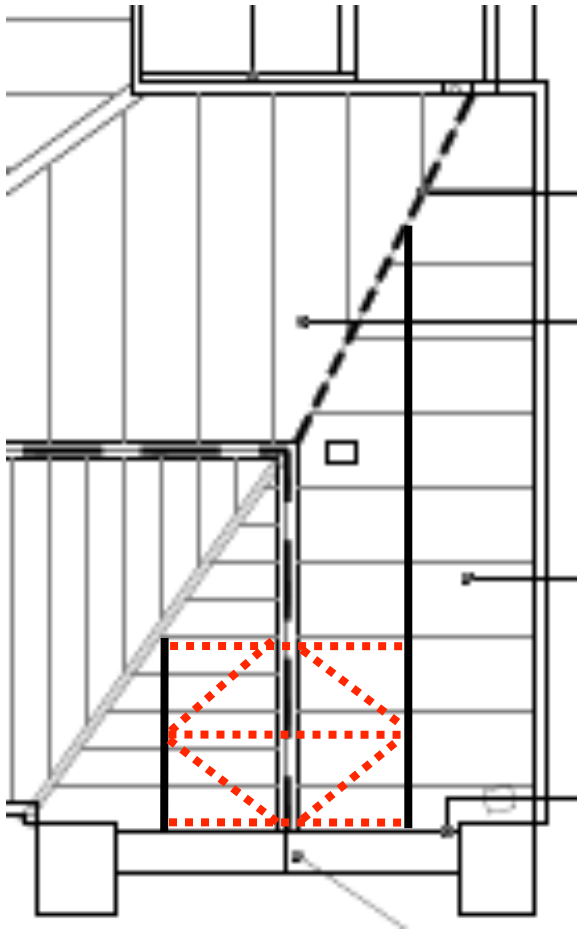
### **New restraint to gable**

The stone face, brick backed existing gable can be rocked and is unstable. There is insufficient lateral restraint from the roof structure and this now needs to be enhanced.

Angle at the face of the brick to be fixed with 6No M10 x 150mm long Hilti HAS-U A4 stainless steel anchor rods, each with a Hilti HVU-TZ capsule resin.

Angle to angle connections to be achieved using M10 grade 4.6 black bolts, 1No per member end.

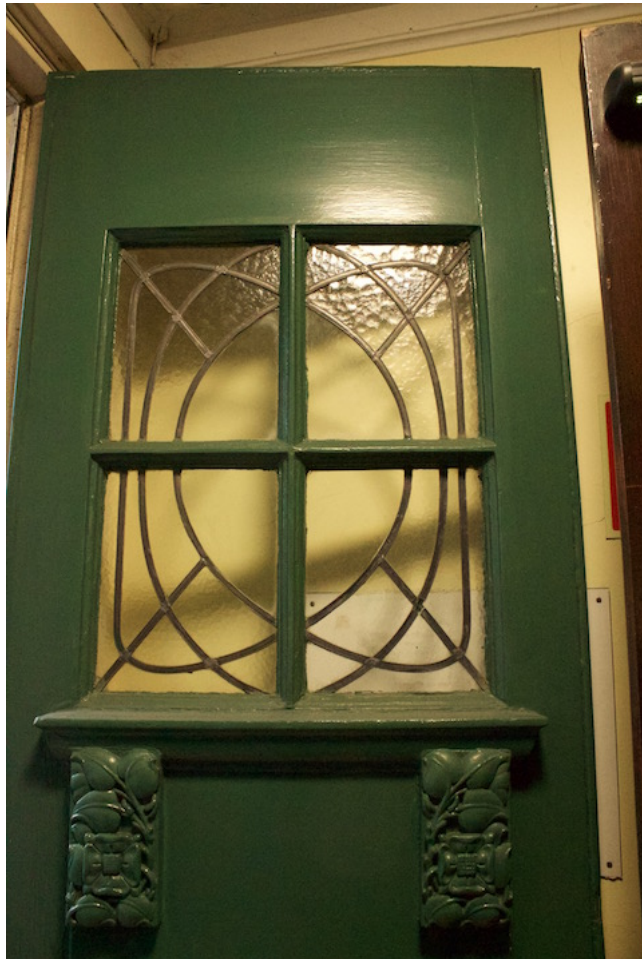
**Right door**

**Condition** – Glass / lead is quite poor

All panels have broken solders

1 cracked pane to inside right door

**Recommendation** – Remove all panels, re-lead and re-fit

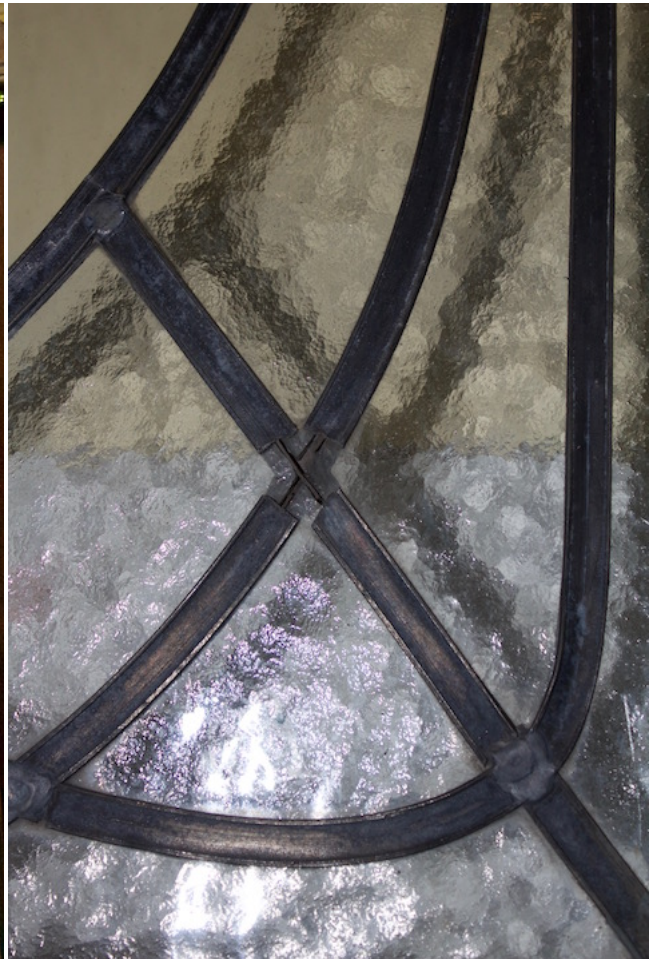
**Example of broken solder**

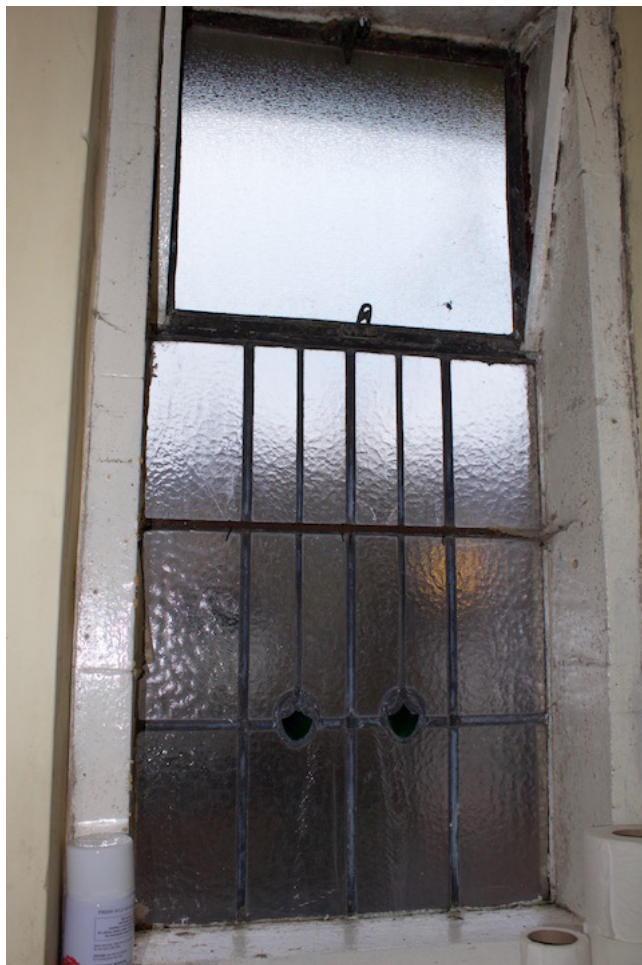
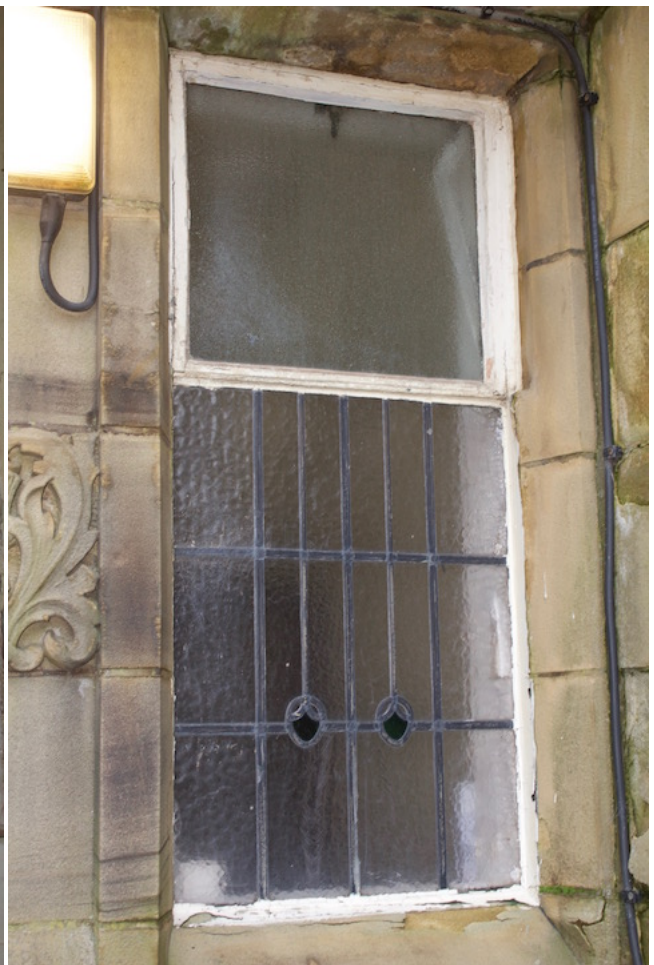
**Toilet window internal**

**Condition** – Glass / lead is in satisfactory condition

Saddle bar is rusting slightly

Hopper is rusting and not working

**Recommendation** – Remove leaded panel, re-lead and re-fit

Refurbish hopper or manufacture new stainless steel

Make new top leaded light in keeping with bottom (as would have been originally)

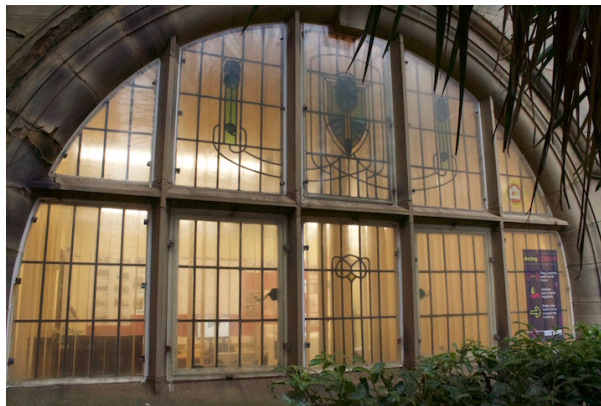
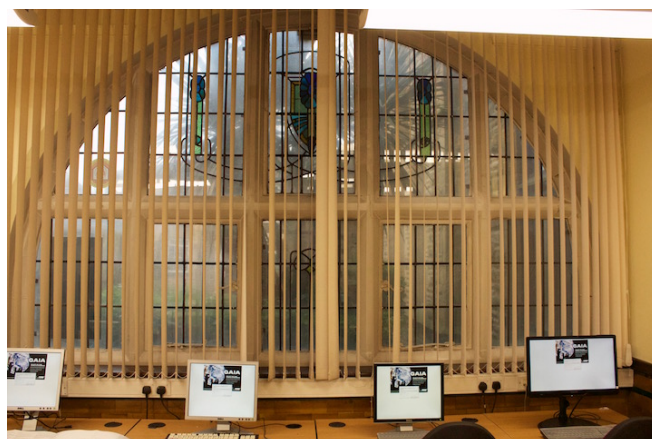
**WG2 external**

**Condition** – Leaded panels have been recently re-leaded and are in good condition

Fitting of windows is poor with bars missing, meaning leaded windows don't have support required

Panel 5 has 2 broken panes

**Recommendation** – Monitor leaded lights for bowing

Repair damaged panes in-situ

Long term, replace stick-on lead panels with leaded lights (as they would have been originally), re-fit leaded lights with new saddle bars

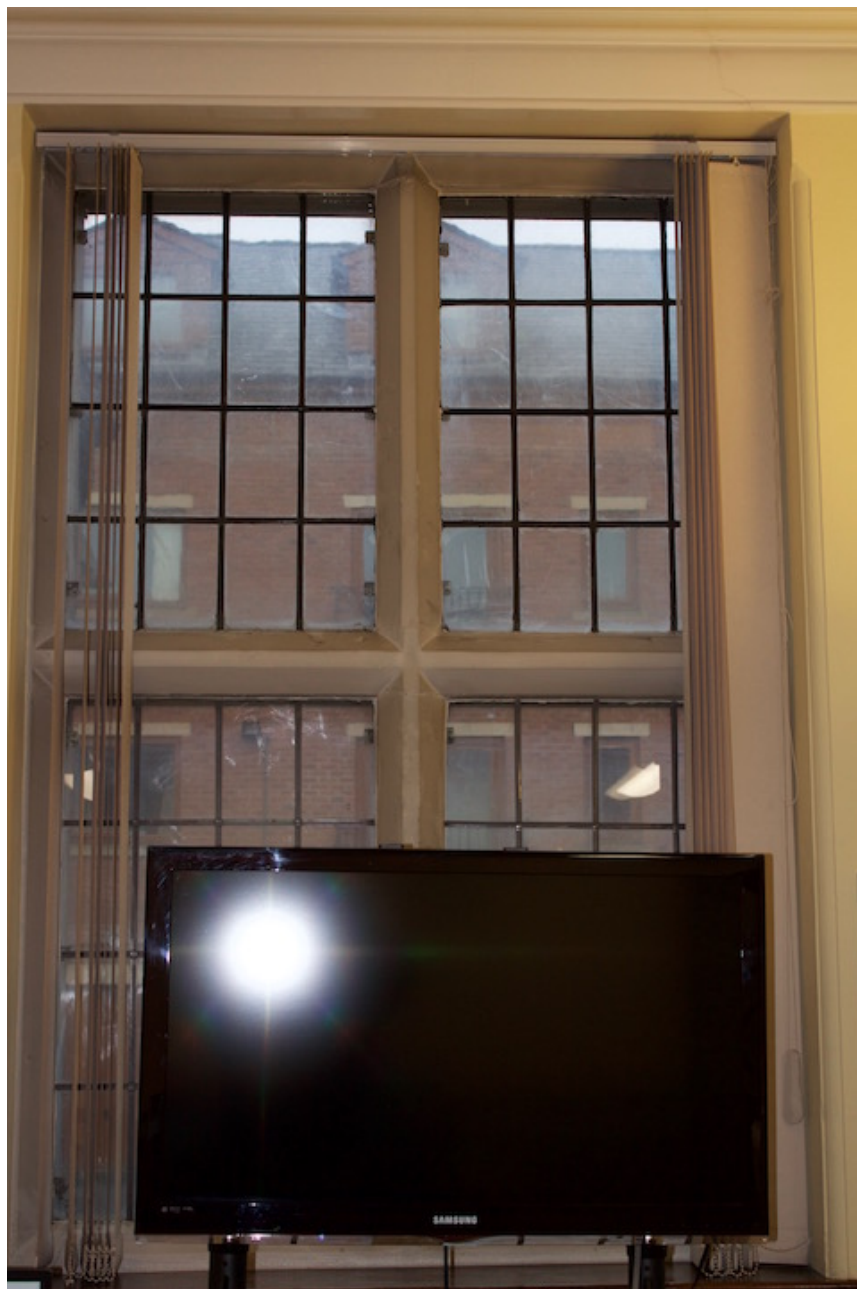
**WG3 in-situ**

**Condition** – Panel 1 has 1 broken pane, panel 2 has 3 broken panes

**Recommendation** – Repair damaged panes in-situ

Long term, replace stick-on lead panels with leaded lights (as they would have been originally)

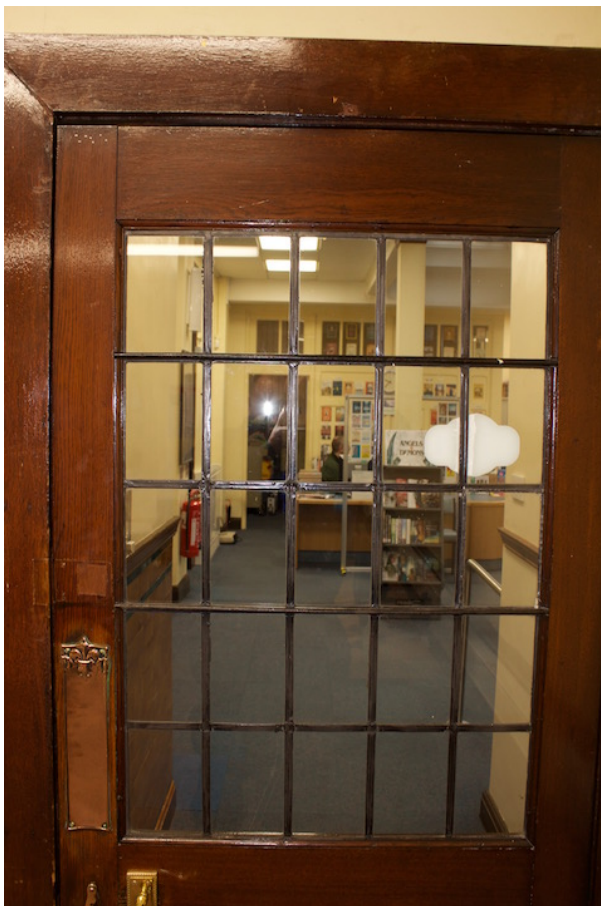
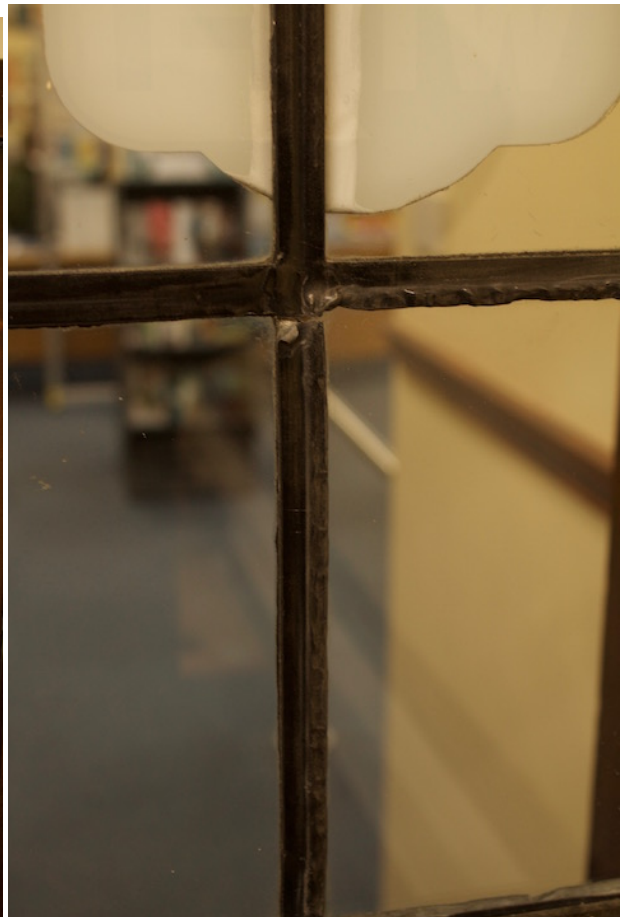
**Computer room door**

**Condition** – 1 piece of lead is loose

Panel has had a lot of previous in-situ repairs

Panel moves / rattles when touched

**Loose lead in door panel**

**Door to computer room** – This window needs re-leading as it is loose and as it is in a door being opened, closed and push it will deteriorate quickly

**Recommendation** – Remove, re-lead and re-fit

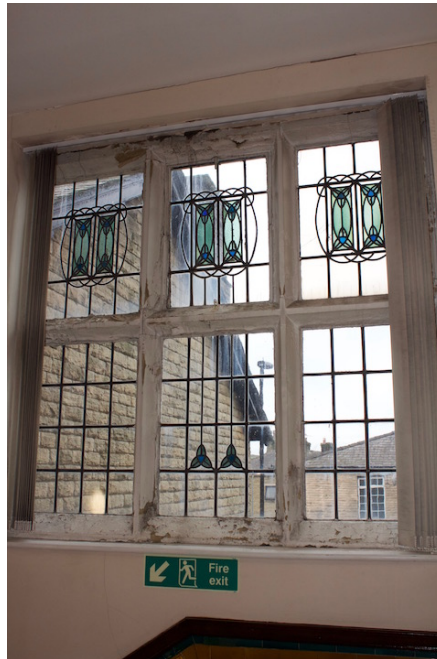
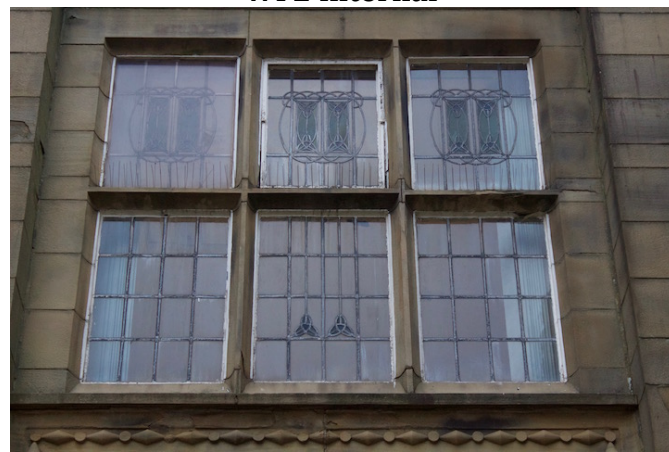
**WF2 internal**

**Condition** – Glass / lead is very poor

All panels have broken solders

Panel 3 is badly damaged and covered externally with perspex

**Recommendation** – Remove all panels, re-lead and re-fit

Refurbish hopper or manufacture new stainless steel

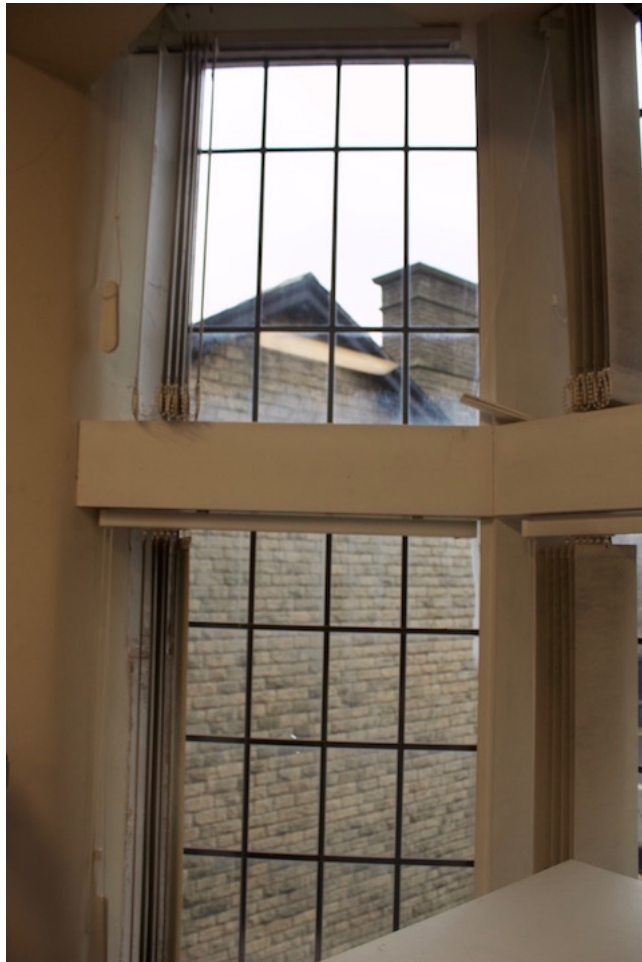
**WF2**

**Condition** – Bottom panel to WF2 has a small crack

**Recommendation** – Remove and replace with leaded lights (as they would have been originally)

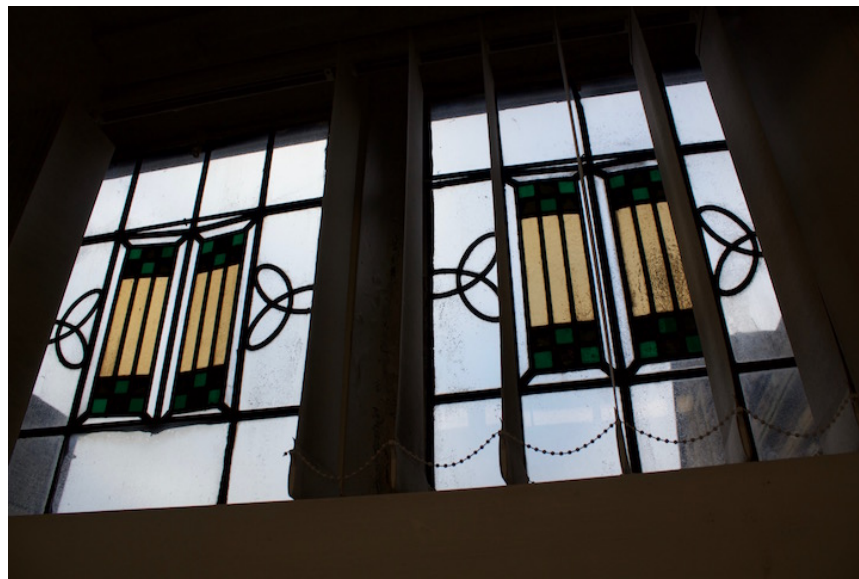
**WF3 top lights**

**Condition** – Leaded lights are in very poor condition

Bottom openers working, light 4 is missing stay

**WF3** – The leaded lights to this window need re-leading but as it is high and requires a fixed scaffold externally the work could be carried out with other work (ie. stone repairs)

**Recommendation** - Replace stick-on lead panels with leaded lights (as they would have been originally)

Remove leaded panels, re-lead and re-fit

Refurbish openers or manufacture new stainless steel

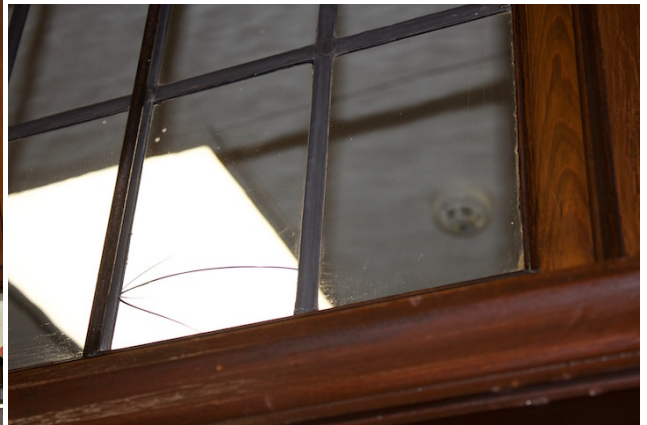
There are quite a few square-leaded internal windows in the main library rooms these are all in satisfactory condition. There is one damaged pane to one of the windows between the two rooms (this could be repaired in-situ although it is not in danger of falling out). The door to the staff room has had some previous in-situ repairs and the panel is slightly loose, this needs monitoring. The only panel that needs work is the door to the computer room mentioned earlier in this report

**Damaged pane to internal window**
