**Project Name:** Tack Lea - Rochdale and Bury old rd

**Project Date:** 18/03/2021

## Section Inspection - 18/03/2021 - MH1X

## Section Inspection - 18/03/2021 - UpstreamX

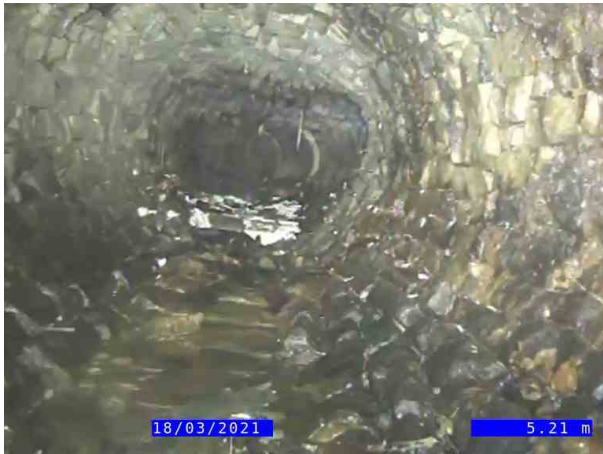
| Scale: | 1:85 | Position [m] | Code | Observation | MPEG | Photo | Grade |
|---|---|---|---|---|---|---|---|
| | | 5.21 | ID | Infiltration, dripping from 11 o'clock to 1 o'clock | 00:02:26 | Upstream<br>X_58999e<br>b5-f369-49 | |

UpstreamX\_58999eb5-f369-49fd-aa40-196d5b0d55b6\_20210325\_090653\_387.jpg, 00:02:26, 5.21 m  
Infiltration, dripping from 11 o'clock to 1 o'clock

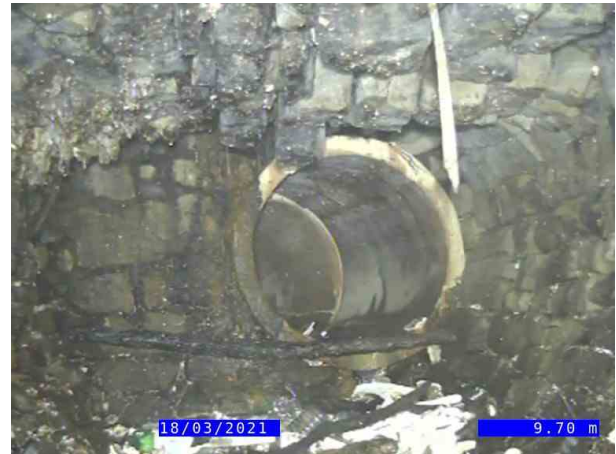
| Scale: | 1:85 | Position [m] | Code | Observation | MPEG | Photo | Grade |
|---|---|---|---|---|---|---|---|
| | | 9.70 | SA | Survey abandoned: Due to obstructions in pipe | 00:04:18 | Upstream<br>X_978c7c<br>51-c7b3-4 | |

UpstreamX\_978c7c51-c7b3-4809-a74b-be8b13f5dae1\_20210325\_090812\_218.jpg, 00:04:18, 9.70 m  
Survey abandoned, Due to obstructions in pipe
