R3271

Higher Moorgate Farm, Gristlehurst Lane, Birtle  
Heywood, OL10 4BJ

Proposed Conversion of the former "Chicken Shed"

# REPORT ON STRUCTURE

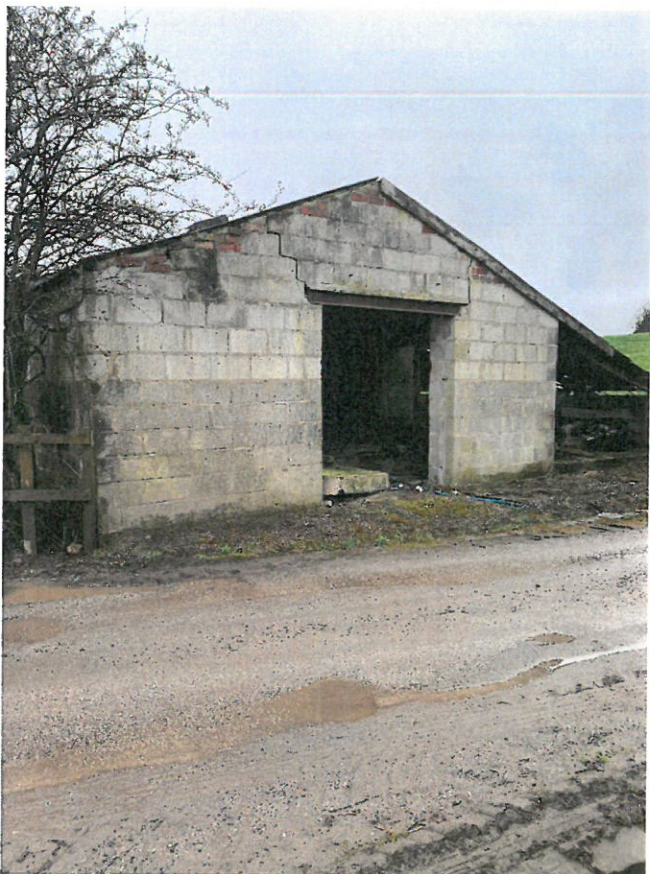
Photograph 2

When viewed from the farm drive, there is gable elevation with a central large door opening, photograph 2.

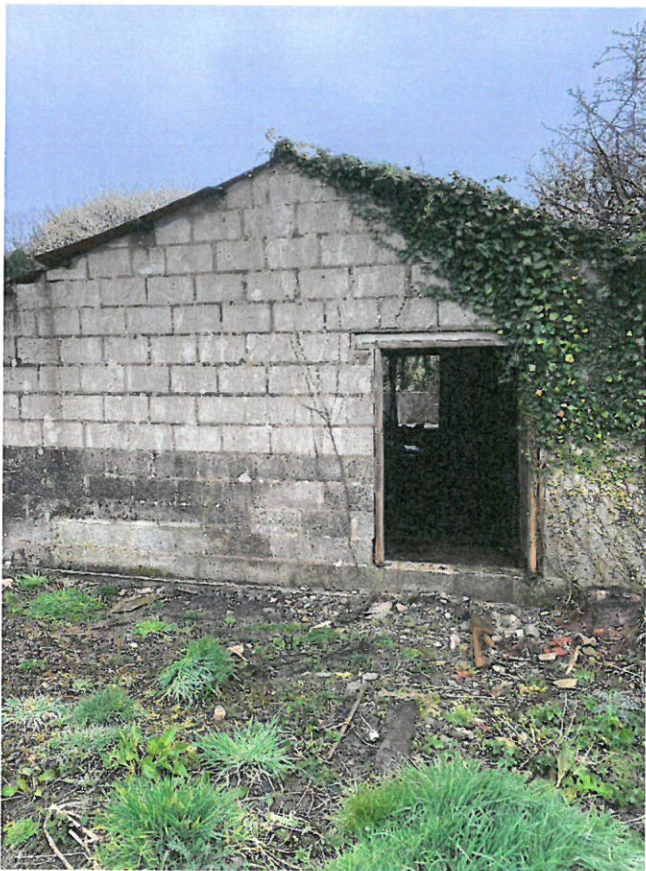
Photograph 3

**2.02** The opposite gable has a smaller door opening positioned closer to the front, photograph 3.

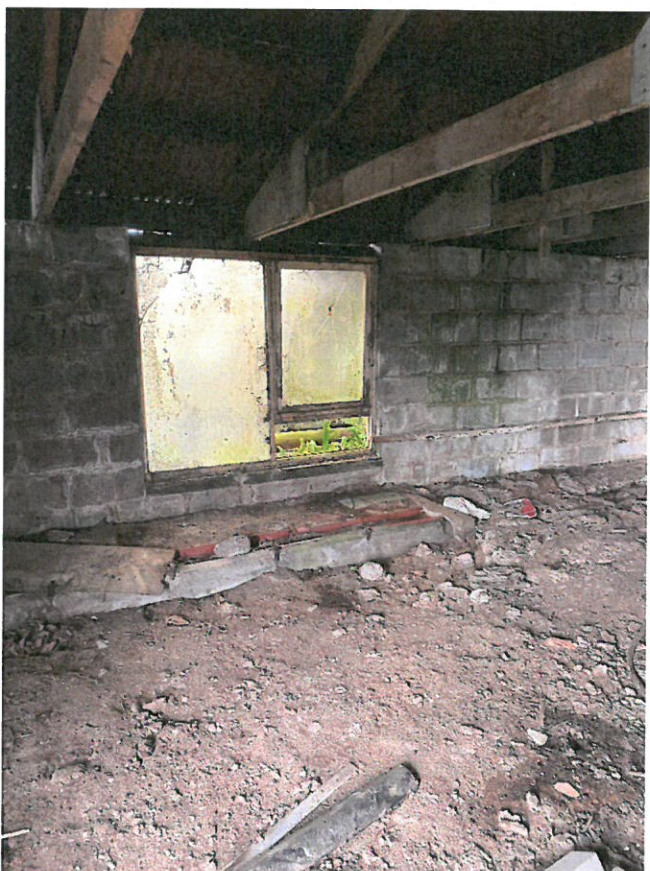
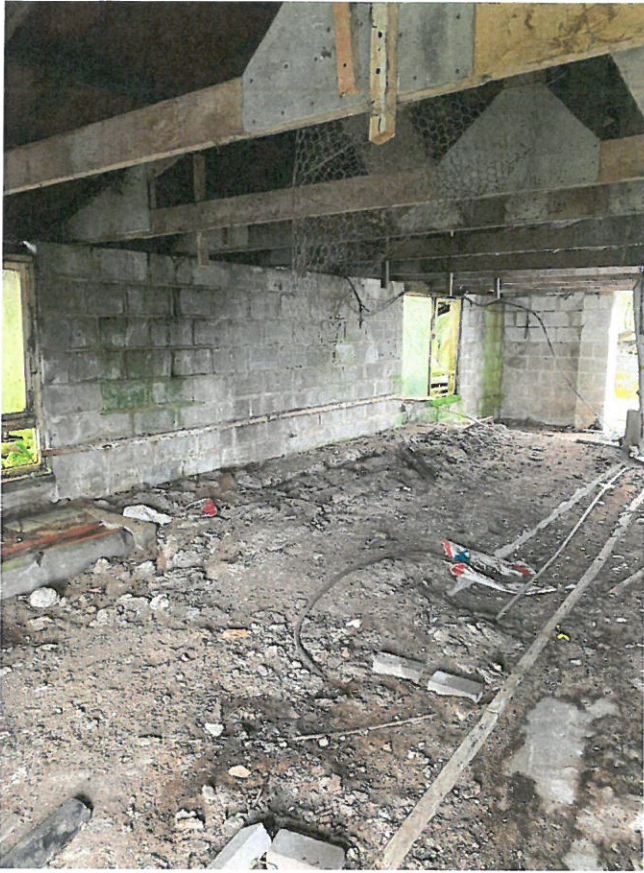
**2.04** The rear elevation is best viewed from within where there are two window openings, photographs 4 & 5.

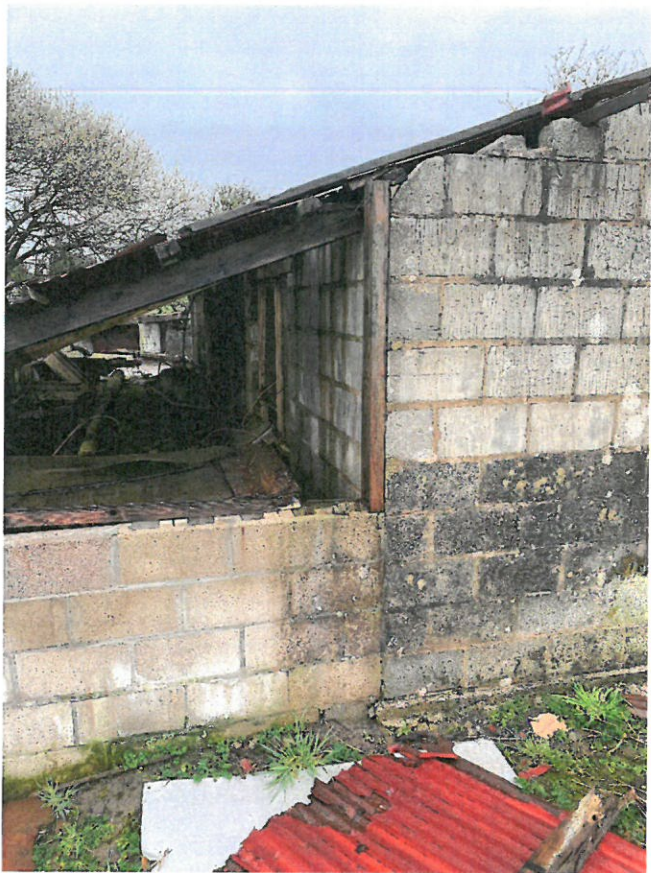
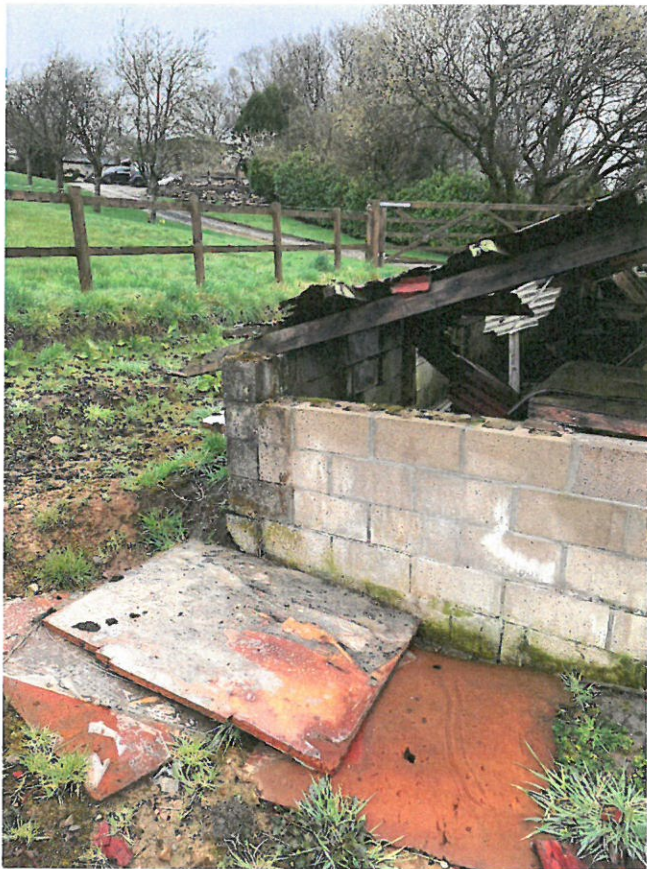
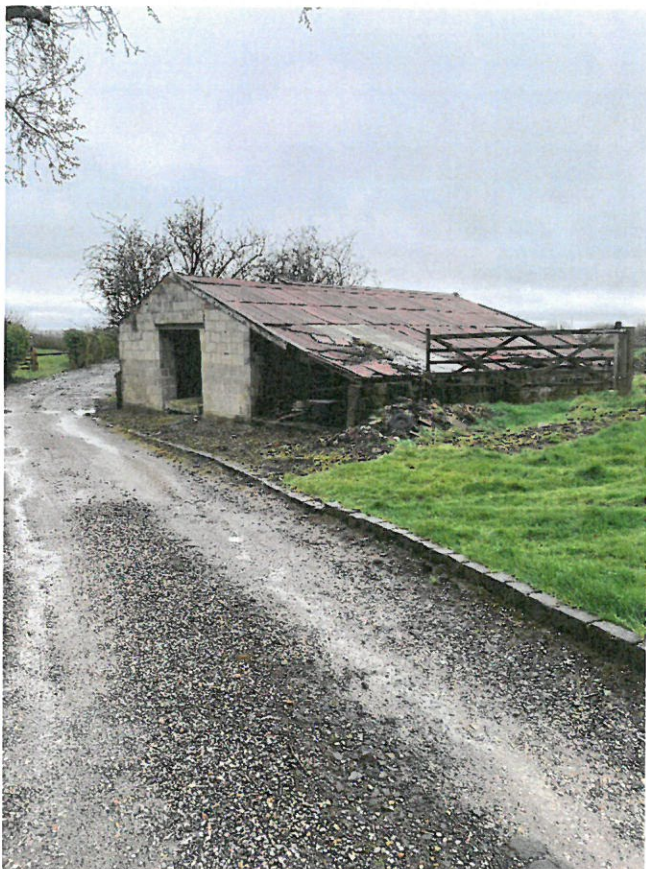
**2.05** The roof is duo pitched front to rear and has an asymmetric appearance due to the fact that the roof extends beyond the main rear elevation to a dado wall. The area beyond the dado acts as a covered external store. Photographs 6, 7 & 8.

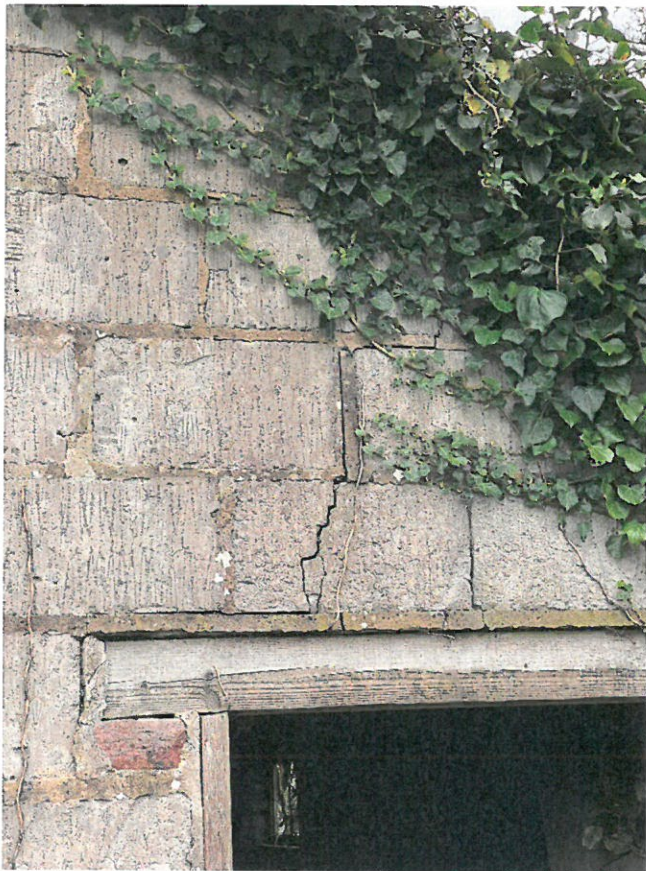
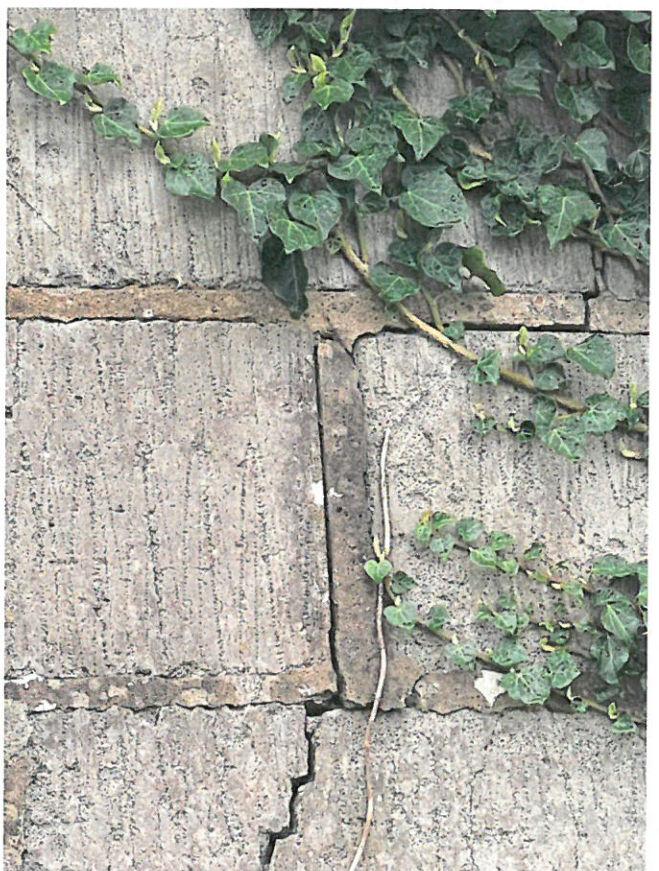
There is nominal cracking above the door on the right-hand side elevation, photographs 11 & 12. This will require only nominal repair.
