Validation Report  
Land off Don Street, Middleton

Reference: 14-554-R8-1  
Date: January 2024

# REMEDIATION AND ENABLING WORKS VALIDATION PHASE 2A AND 3

Land off Don Street  
Middleton  
Greater Manchester  
M24 2DB

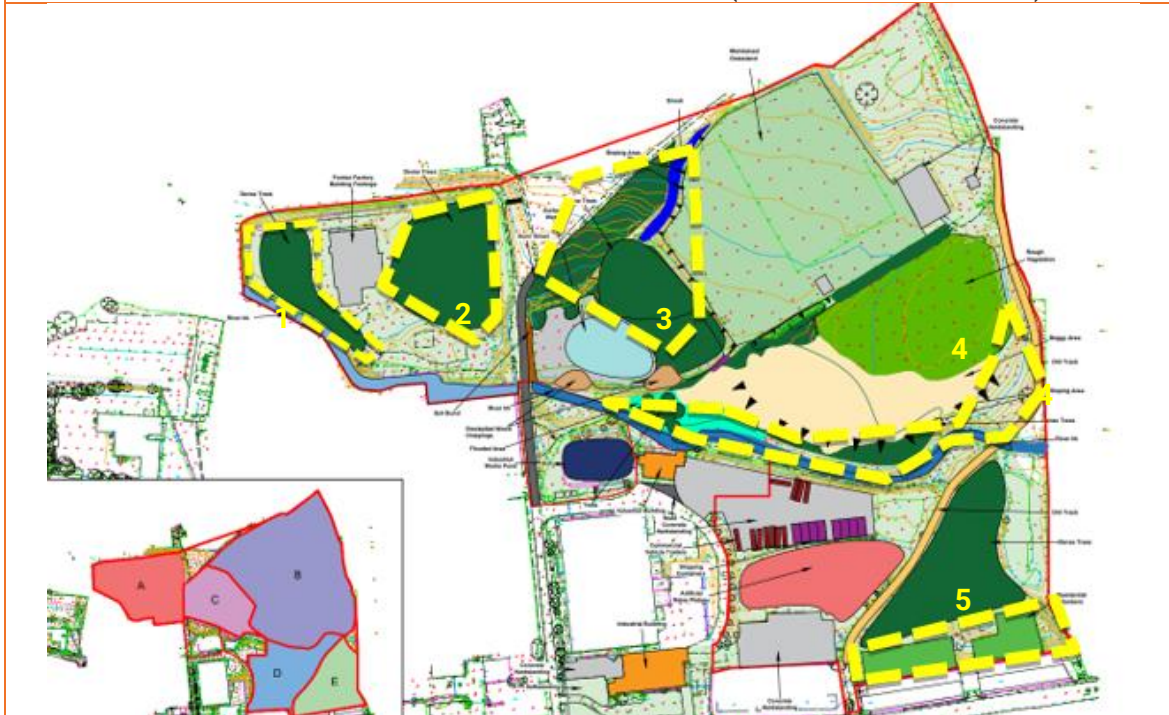
FIGURE 4.1 – AREAS REQUIRING FURTHER INVESTIGATION (YELLOW DASHED AREAS)

The further investigation did not identify any true peat deposits, only very soft to soft clays with a shear strength value (Cu) of less than 30 kN/m<sup>2</sup>, the material is not suitable for vibro stone columns and requires removal with granular replacement during remedial works in this area.

Granular replacement of soft organic clays in Area 3 (Phase 2A) was completed in January and February 2023.

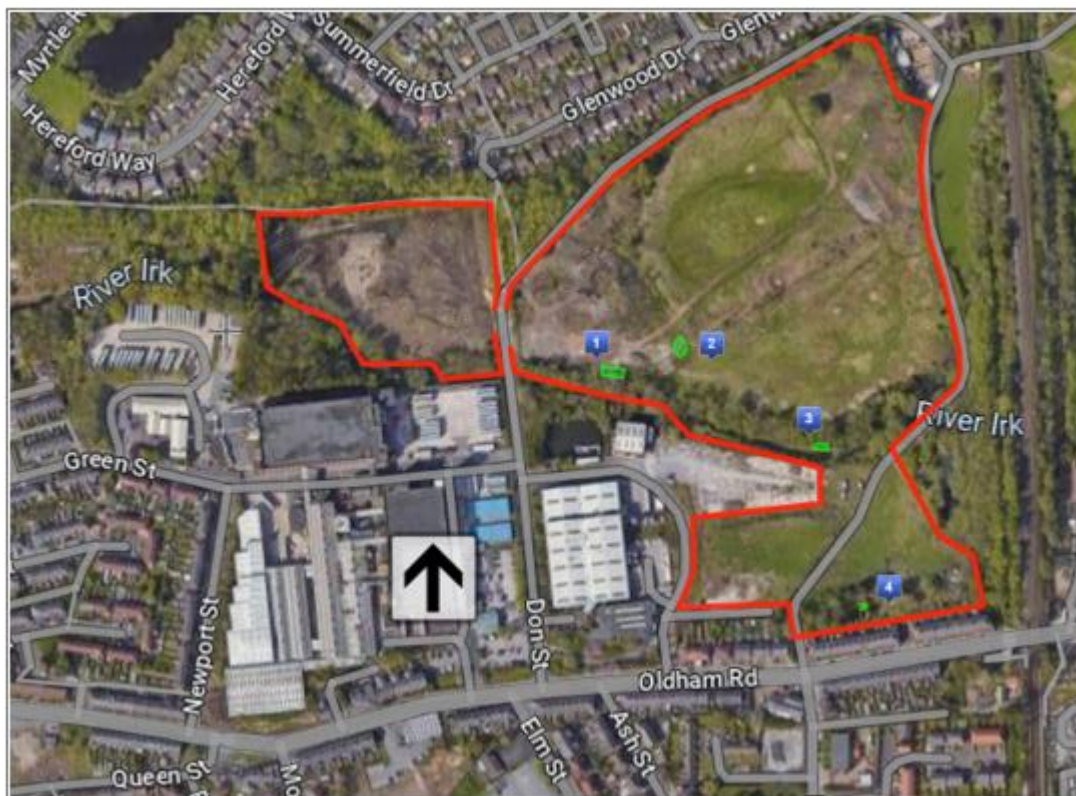
FIGURE 4.3 – JAPANESE KNOTWEED LOCATIONS

Japanese Knotweed impacted materials were excavated under the supervision of Knotweed Eradication in April and May 2023. Material excavated in April 2023 was placed in a temporary stockpile area on visqueen sheeting, tested by E3P, and subsequently removed from site. Impacted material excavated in May 2023 was placed directly into wagons and removed from site. A validation report was prepared by Knotweed Eradication (IWMP2255A, dated October 2023) that is available upon request to Kellen Homes or Urban Regen.

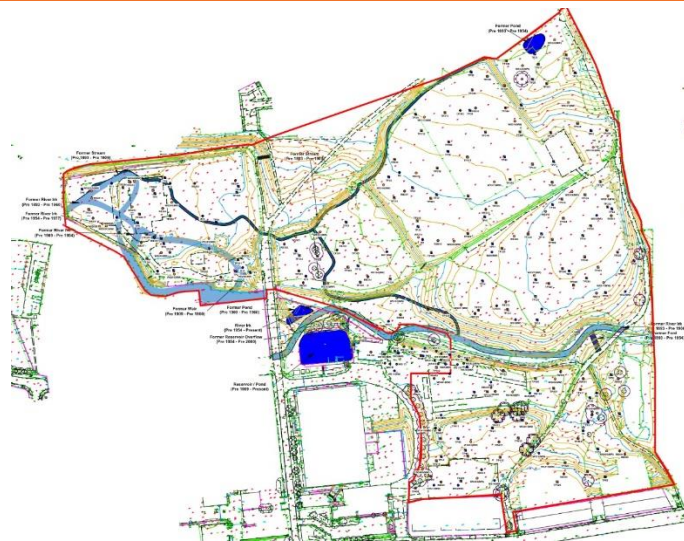
FIGURE 4.4 LOCATION OF IDENTIFIED INFILLED PONDS, STREAMS AND RIVERS

Within Phase 1 a former stream and historical River Irk layout is present through much of the south and west of the parcel. E3P maintained part time supervision during turnover in this parcel, no soft

alluvial deposits or geotechnically unsuitable material resembling historic river or stream deposits was noted, as such, it is assumed this was grubbed out prior to the construction of the former Rex Mill. No further works were required in this area.

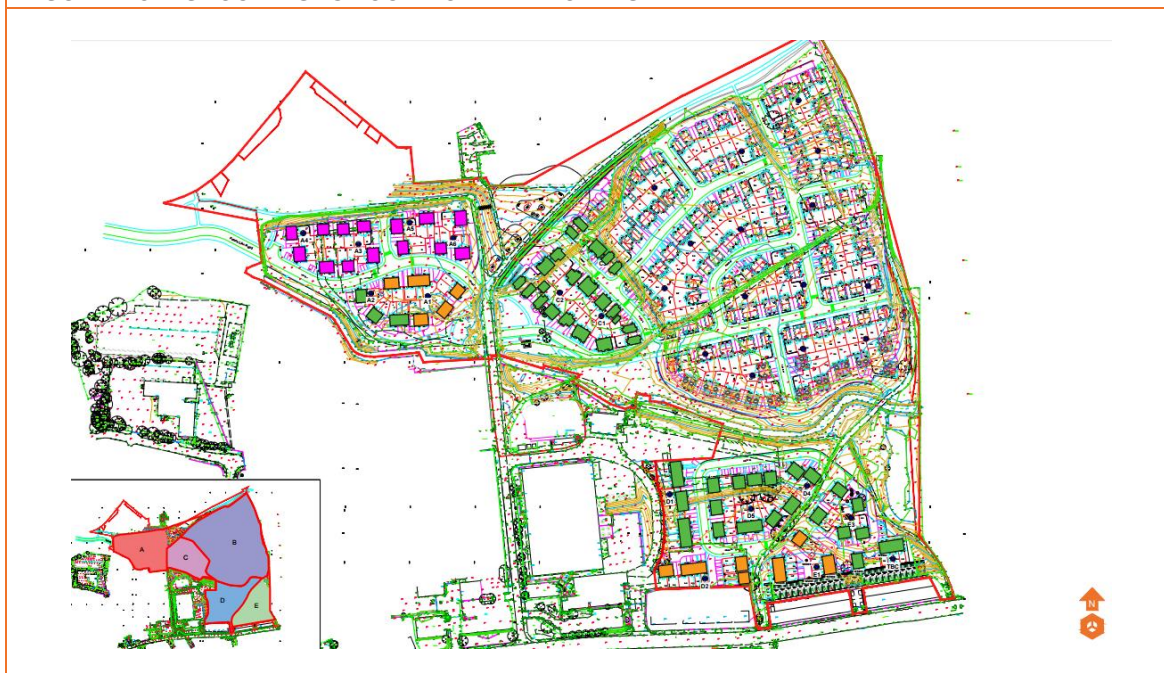
**FIGURE 4.5 – GROUND GAS LOCATION AND ZONING PLAN**

- ✳ In the vicinity of D2, carbon dioxide has been identified above the 5% v/v threshold, however the GSV is noted to be within a CS1 classification. The LQM Gas Composition Tool (Figure 3.1) suggests that the concentrations are indicative of ambient air and air/CO<sub>2</sub> mixing. Within the NHBC Hazardous Ground Gas Guidance, April 2023 (Figure 3.2) D2 gas concentrations fall within the ternary plot zone indicative of biological respiration or oxidation of organic material within the ground – in this case likely associated with the Made Ground / Coal Measures. Given the onsite source and high sensitivity end use, to be appropriately conservative, CS2/ Amber 1 gas protection measures should be implemented on plots within this area (plots 242-251).

✿ In the vicinity of E1, methane has been identified above the 5% v/v threshold, with GSV noted to exceed the CS1 threshold on one occasion. E1 gas concentrations fall within the ternary plot zone indicative of very low rate of gas generation from Made Ground – low risk of emissions from the ground. The results also plot within the residual landfill gas generation or gas migration from off site source. Given E1 is located circa 150m south of the landfill, with the River Irk in between, it is considered unlikely gas concentrations are related to landfill gas migration. However, given the location of E1 along the south of the site, an offsite source cannot be discounted. Methane values above Amber 2 thresholds have been recorded within 2 visits. However, given the lack of steady flow recorded across all monitoring visits, very low rate of gas generation and low risk of emissions from the ground, CS2/Amber 1 ground gas protection measures are deemed to be sufficient to plots within this area (Plots 287-295).

- ✿ In the vicinity of A3 and A5, carbon dioxide has been identified above the 5% v/v threshold and methane above the 2% v/v CS1 threshold. The GSV is noted to be within a CS1 classification in all locations. The LQM Gas Composition Tool (Figure 3.1) suggests that the concentrations are indicative of ambient air and air/CO2 mixing, with the exception of A3 that was indicative of geogenic gas, likely associated with the underlying coal seams. Within the NHBC Hazardous Ground Gas Guidance, April 2023 (Figure 3.2) A3 plots within the indicative of alluvium and hydrocarbon degradation which is likely associated with the historic use as a Mill and the underlying Coal Measures.

Additional ground gas monitoring/assessment within Phase 2B and 2C.

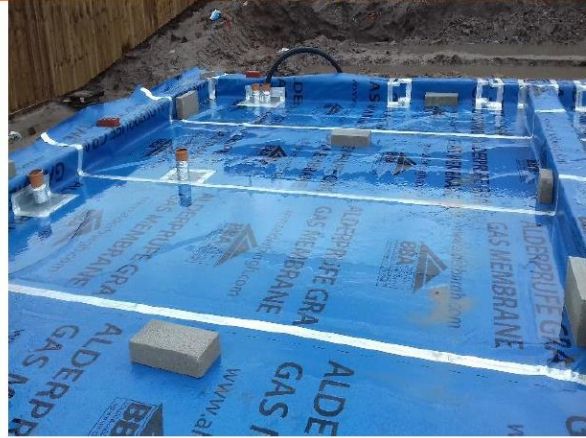
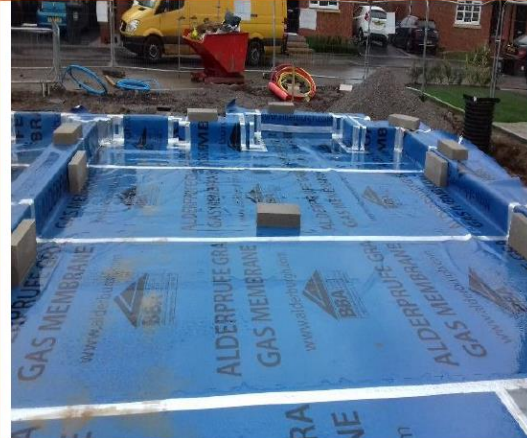
Plot – 236

General Condition of Membrane-Good Condition

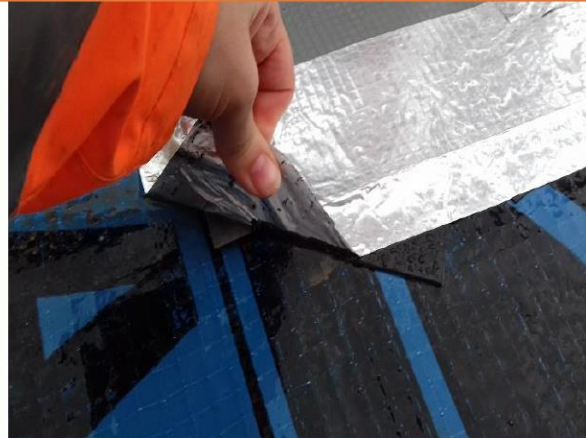
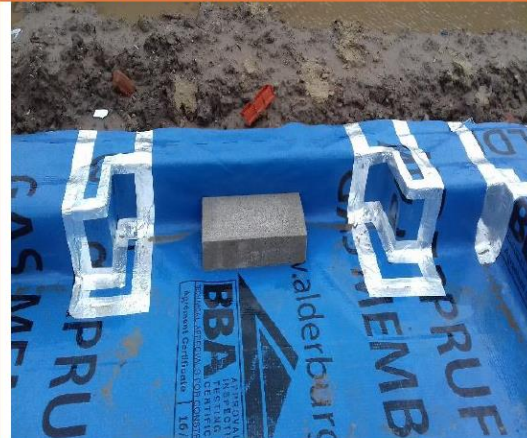
Verification of Joints and Seals-Good Condition

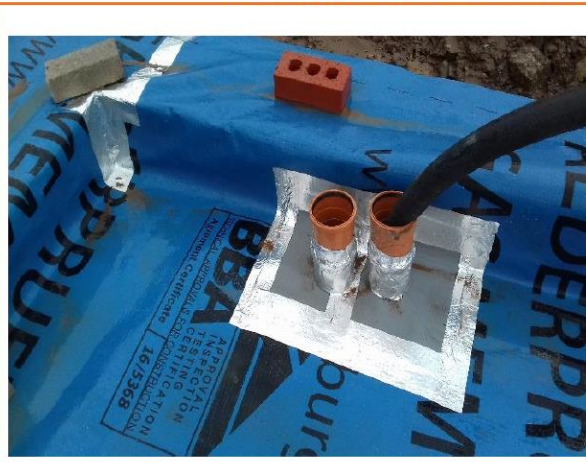
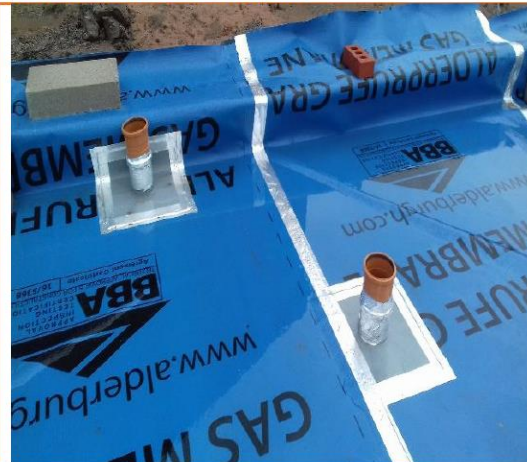
Verification of Service Penetrations-Good Condition
