### Demolition Survey

**Redcross Street,  
Rochdale, OL12 0NZ**

Redcross Street,  
Rochdale, OL12 0NZ  
**Survey Date:- 6<sup>th</sup> November 2023**

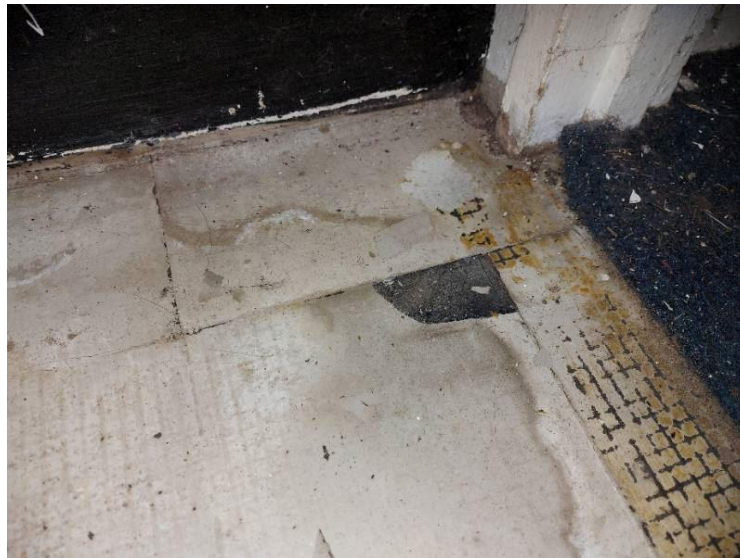
| <b>Room Ref:</b> | Corridor to stairs | | |

| <b>Form:</b> | Bonded Materials | <b>Sample No:</b> | As RBH/ASB-63647 |
| <b>Extent:</b> | 3 sqm | <b>Lab Analysis Result:</b> | Chrysotile |
| <b>Location:</b> | Black floor tiles | | |

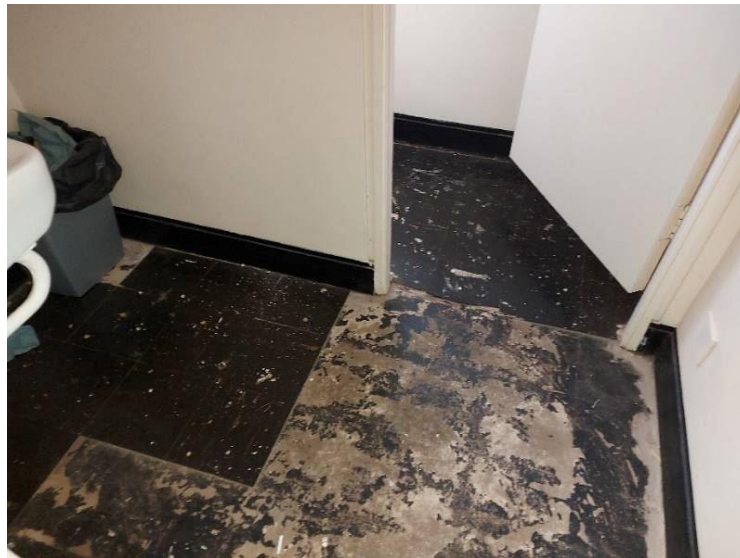
| <b>Location:</b> | Black floor tiles | | |

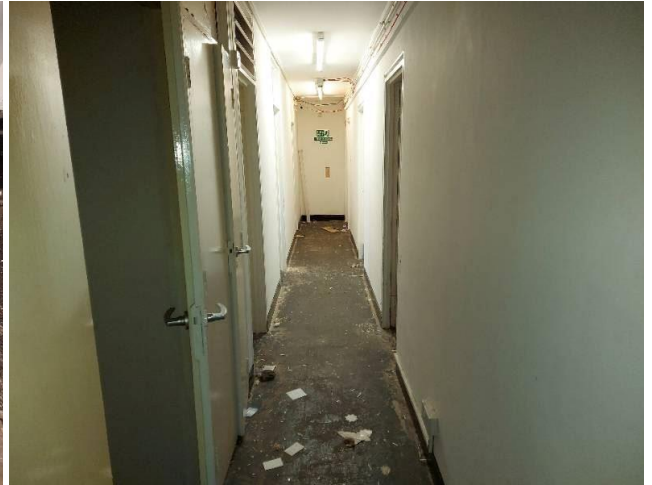
| <b>Location:</b> | Black floor tiles | | |

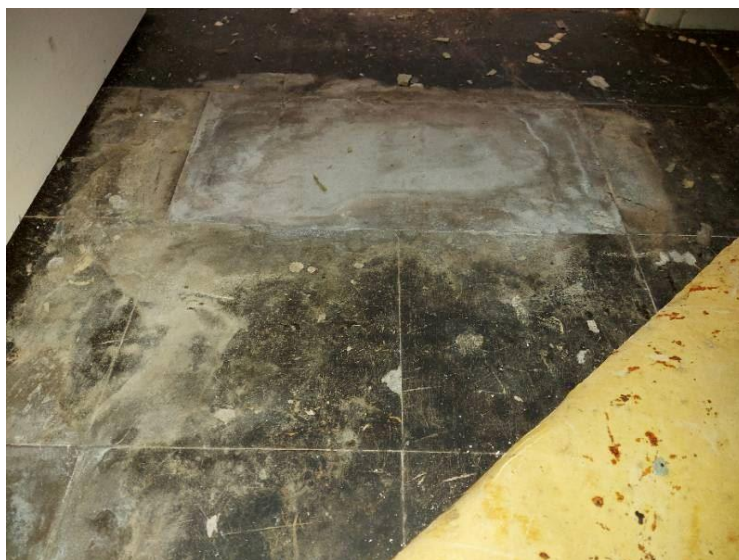
| <b>Location:</b> | Black floor tiles | | |

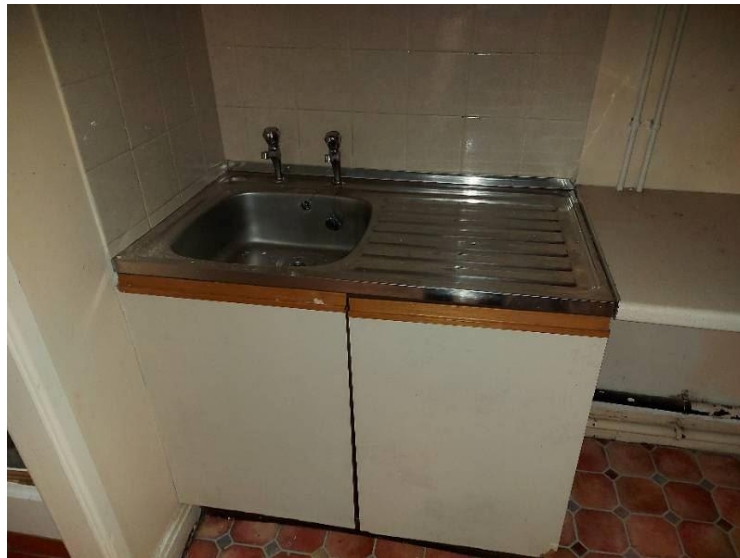
| <b>Location:</b> | Sink pad | | |

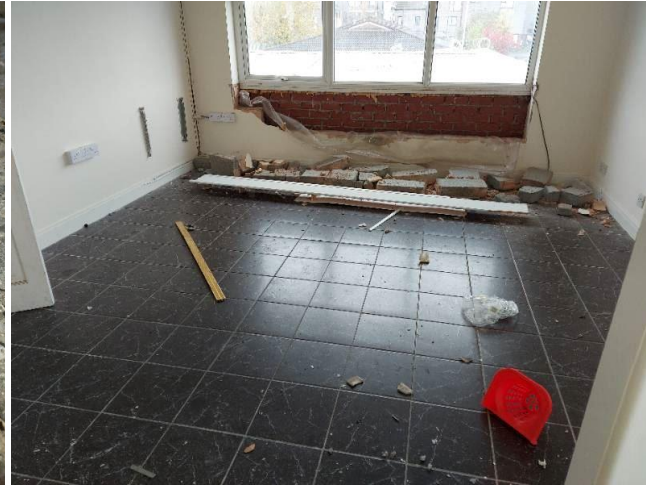
| <b>Location:</b> | Black floor tiles | | |

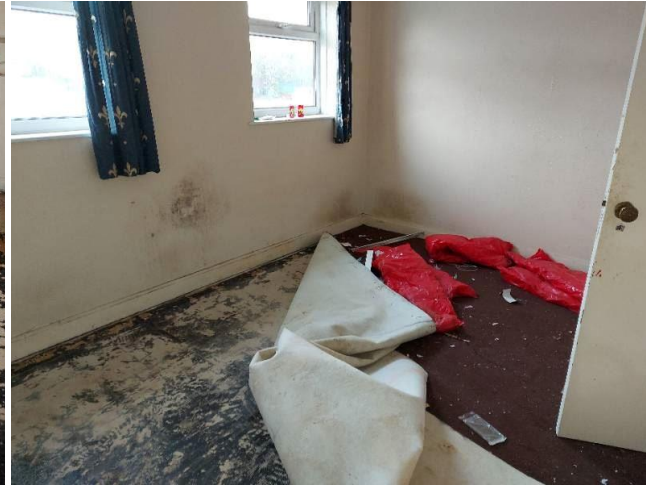
| <b>Location:</b> | Black floor tiles | | |

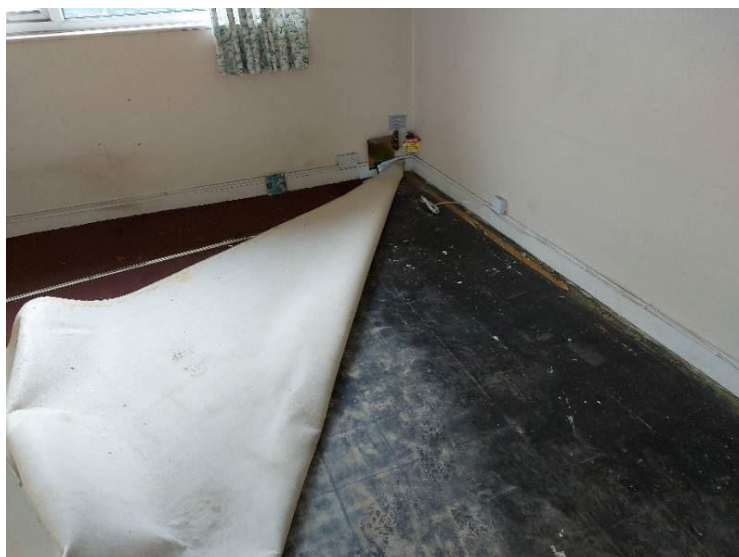
| <b>Location:</b> | Black floor tiles | | |

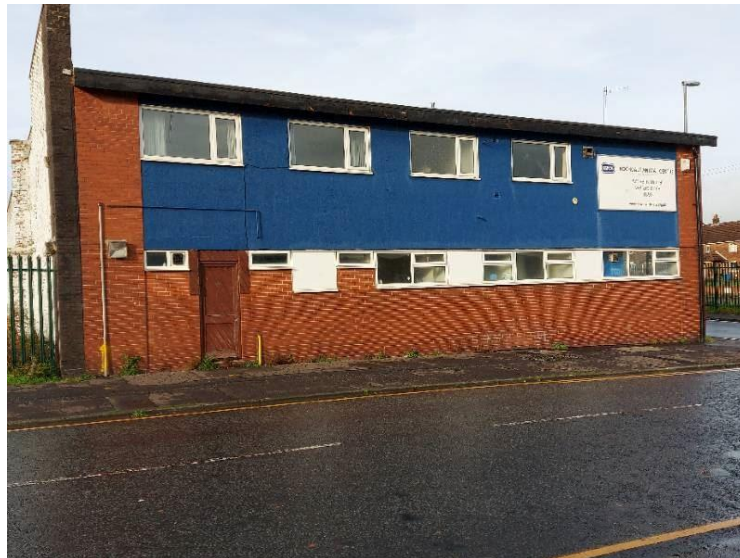
| <b>Location:</b> | DPC | | |

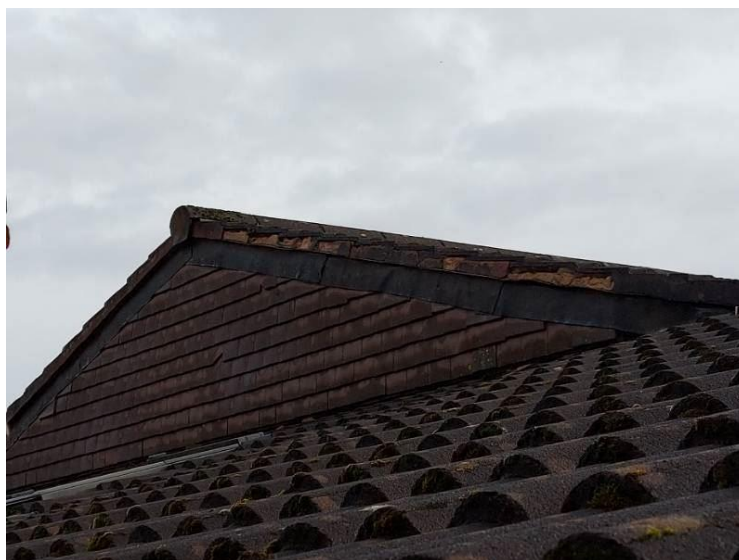
| <b>Location:</b> | Undercloak | | |

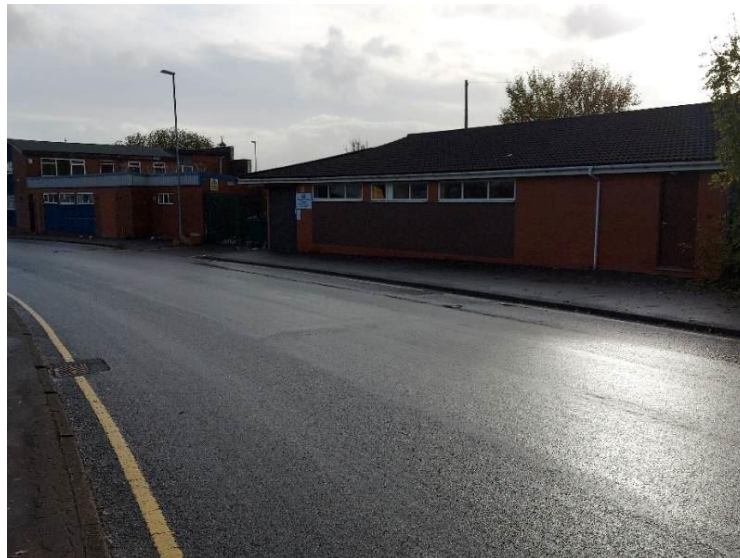
| <b>Location:</b> | DPC | | |
