## GAS MEMBRANE VALIDATION

**Site: Boothroyden Road, Middleton**

Project Number: 13-500

Plots Validated: 28 & 29

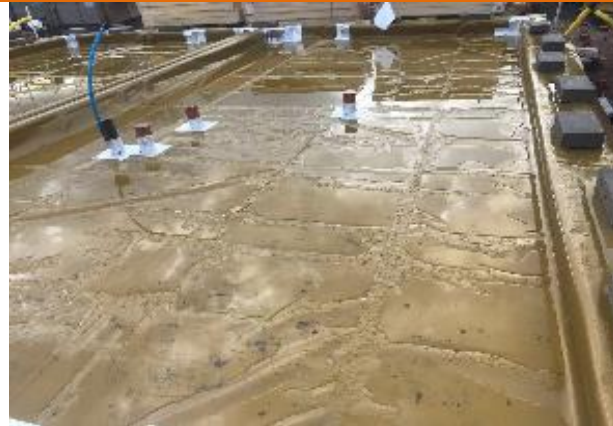
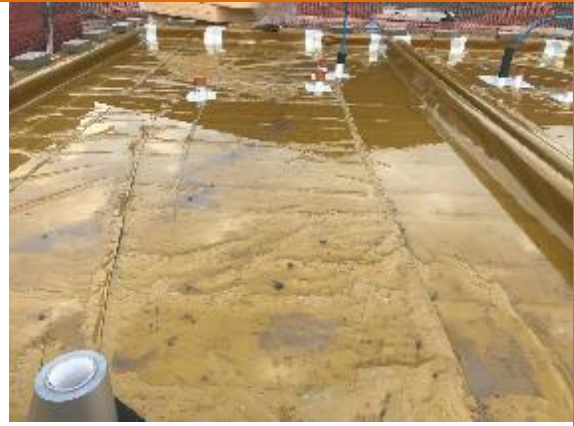
**Plot – 28**

**General Condition of Membrane-Good Condition**

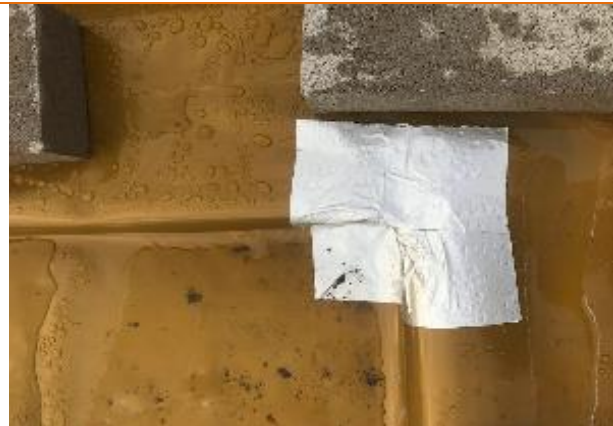
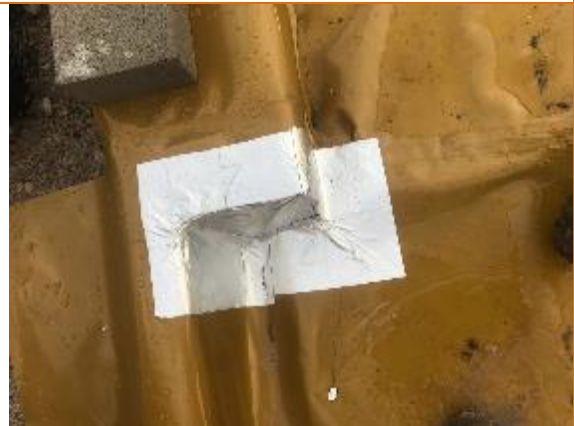
**Verification of Joints and Seals-Good Condition**

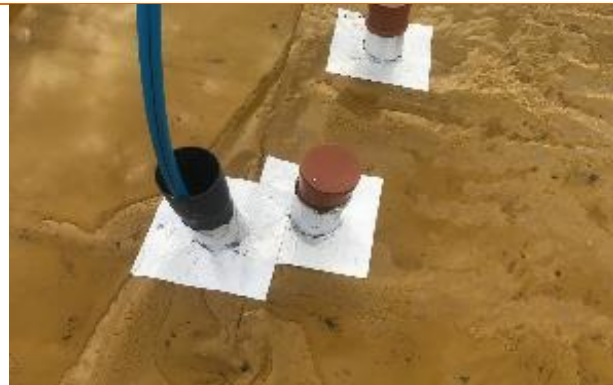
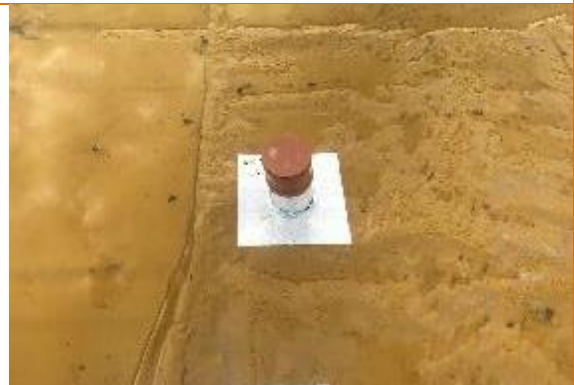
**Verification of Service Penetrations-Good Condition**

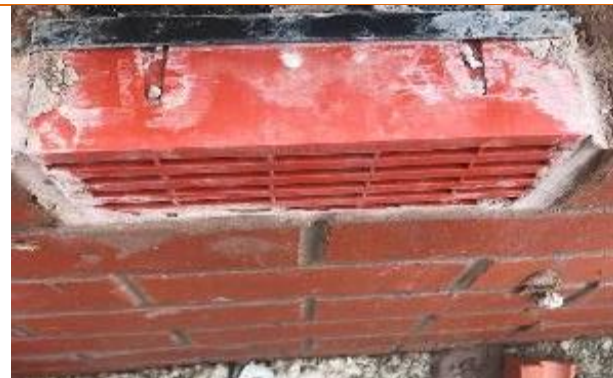
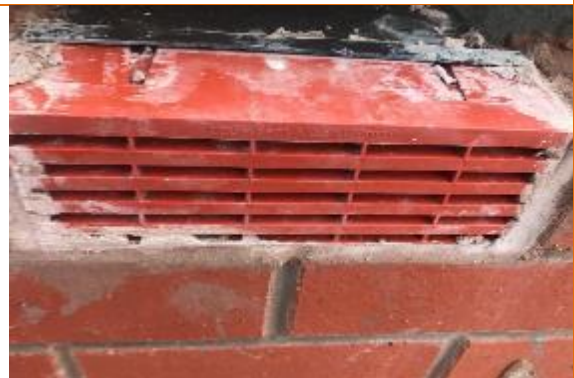
**Verification of Ventilation-Good Condition**

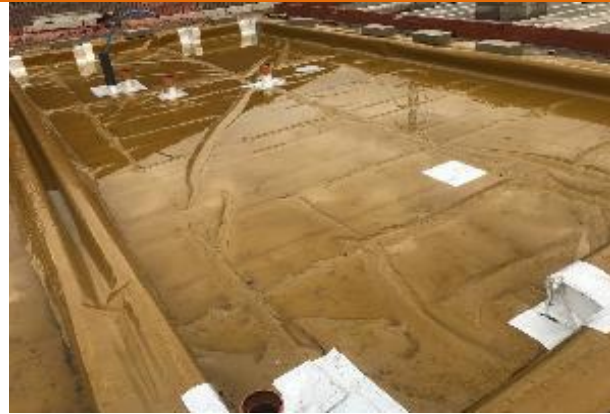
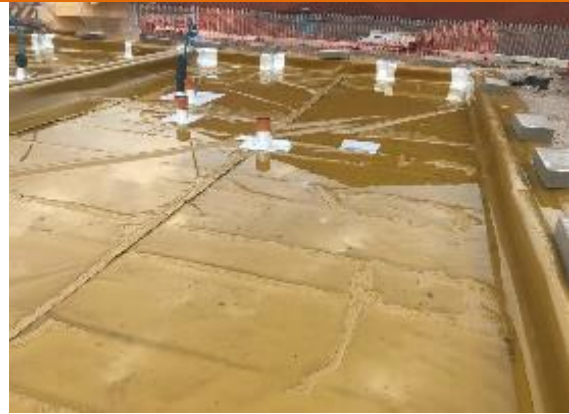
**Plot - 29**

**General Condition of Membrane-Good Condition**

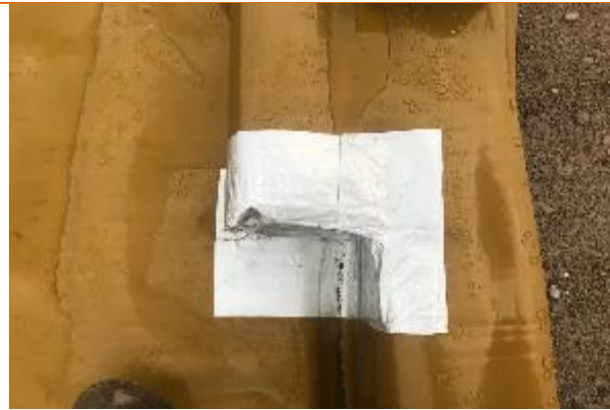
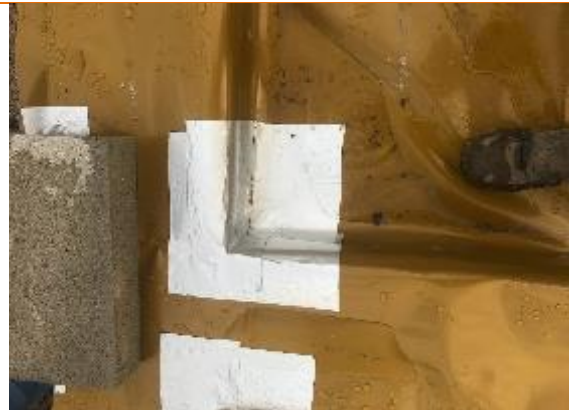
**Verification of Joints and Seals-Good Condition**

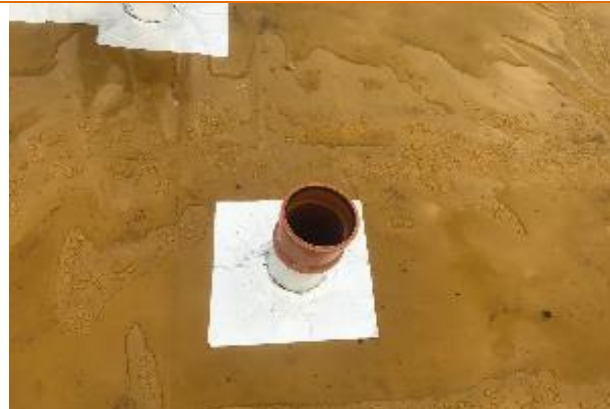
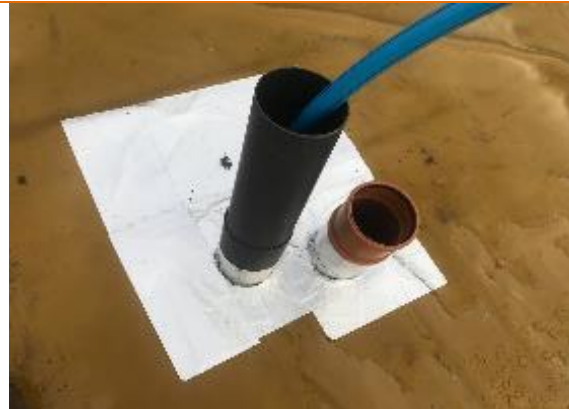
**Verification of Service Penetrations-Good Condition**

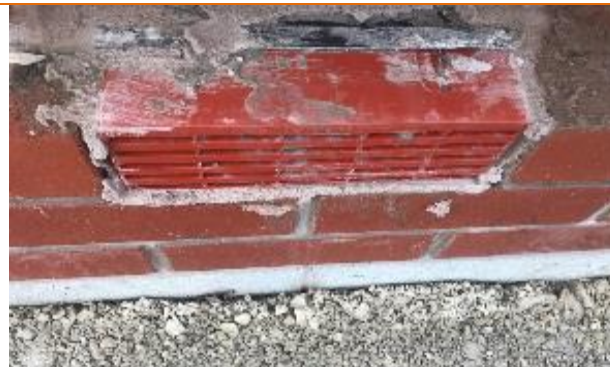
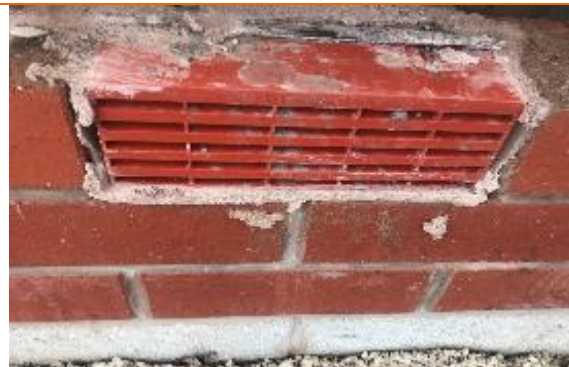
**Verification of Ventilation-Good Condition**
