# TREE SURVEY & REPORT

For Mr A Prince  
24 Reddyshore Brow,  
Littleborough  
Rochdale  
OL15 9PF

## TREE SURVEY / SCHEDULE AND REPORT

Location: 24 Reddyshore Brow, Littleborough, OL15 9PF

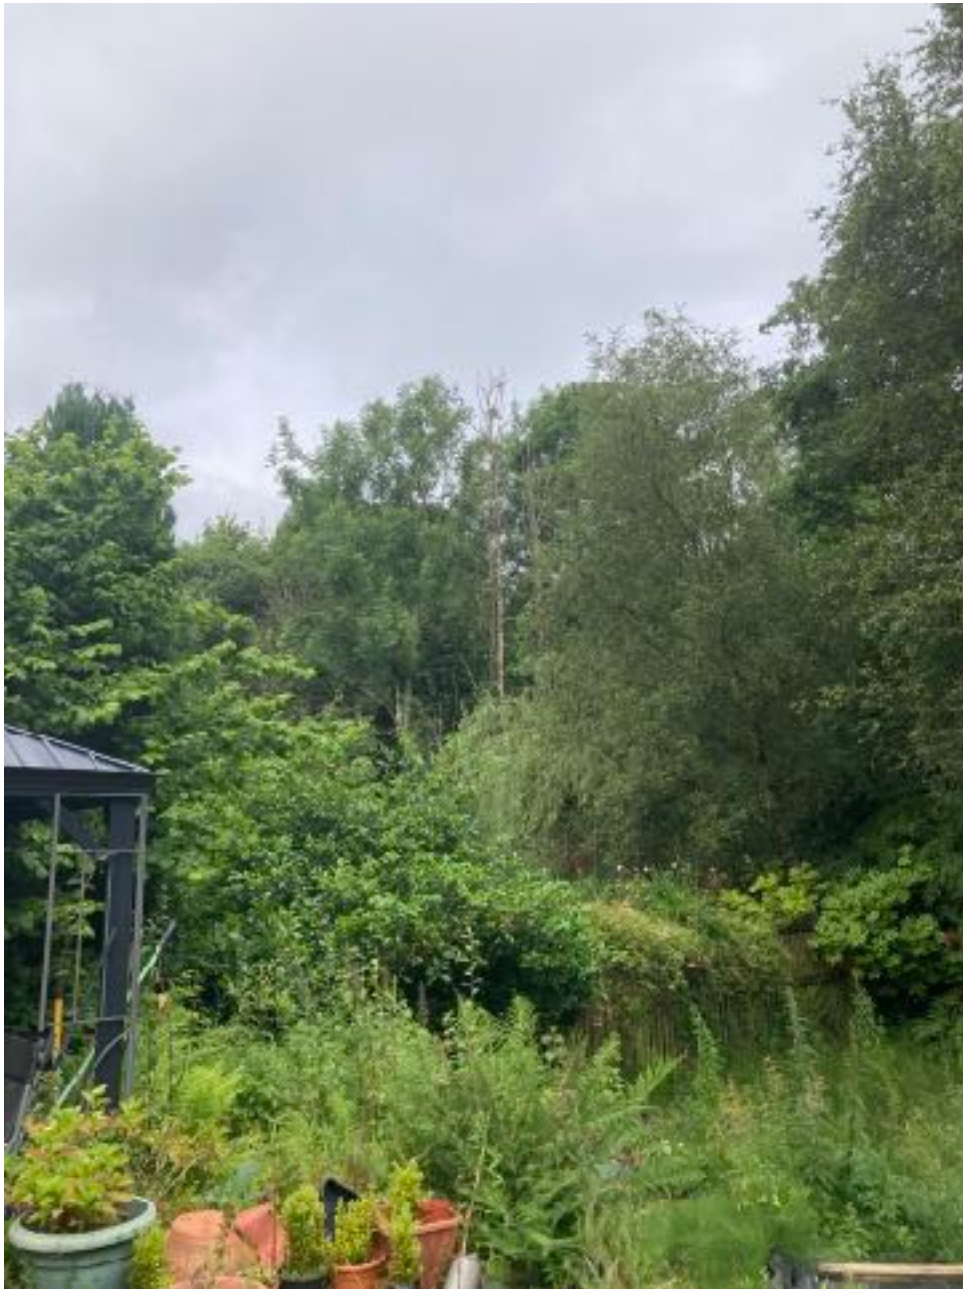
The disease *Hymenoscyphus fraxineus* (Chalara) Ash dieback is well established in the area and has had a detrimental effect on the wooded stand. Some trees have already failed and have fallen over the boundary to the public footpath, others have fallen within the stand where the residents are improving their grounds.

View from the rear of the property looking toward the stand of ash trees some of them showing the signs of Ash dieback.

It is important to make safe the Stand of trees; the residents aim is to remove the infected ash trees with dieback, approximately 37,

but to leave some pollarded dead wood for wildlife. Also to leave the whips and young ash trees which do not have dieback to hopefully survive the disease, these should be monitored.

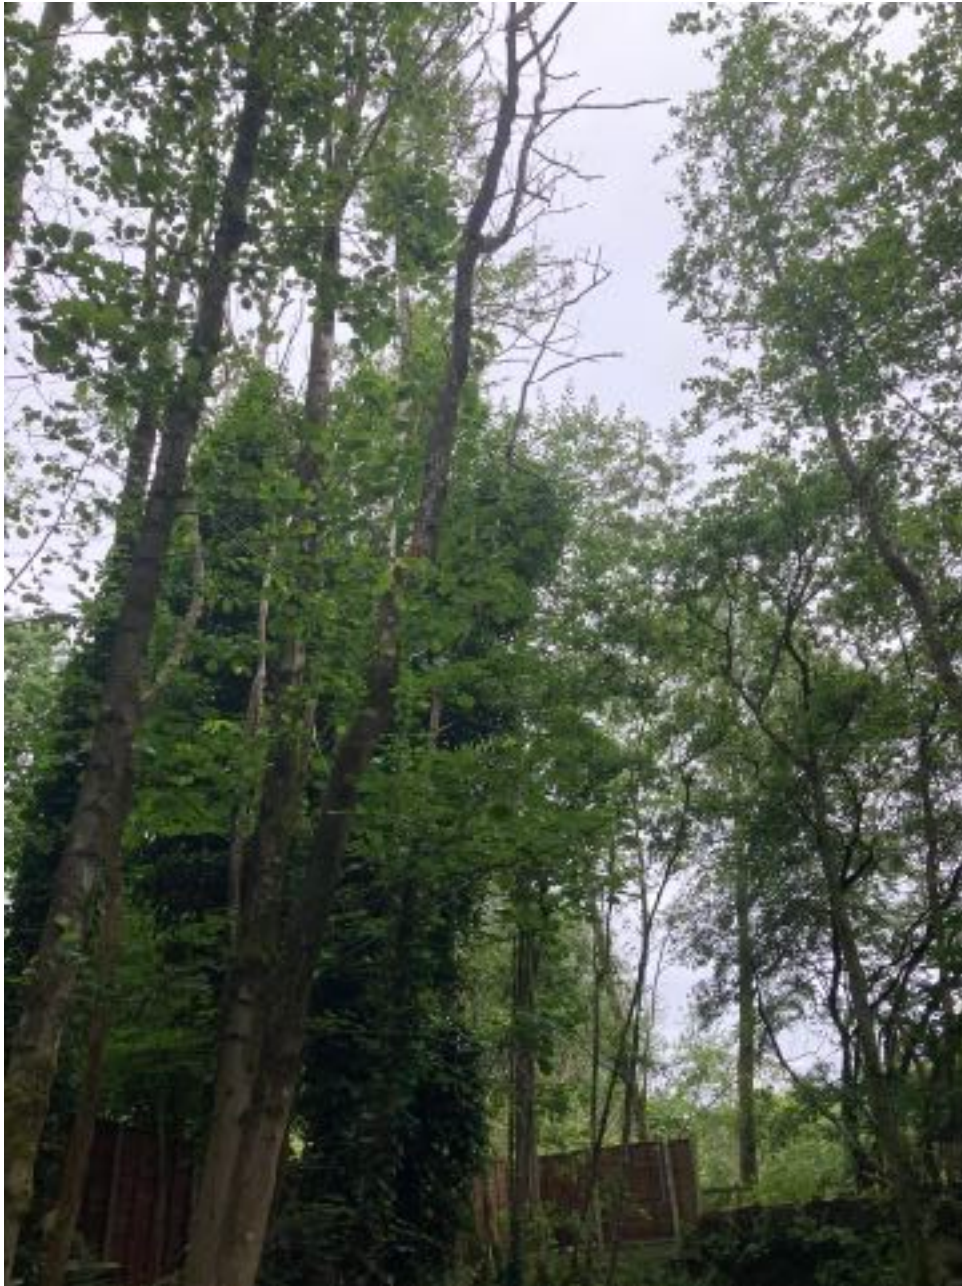
Looking toward the furthest point of the garden and stand of Ash on the left.

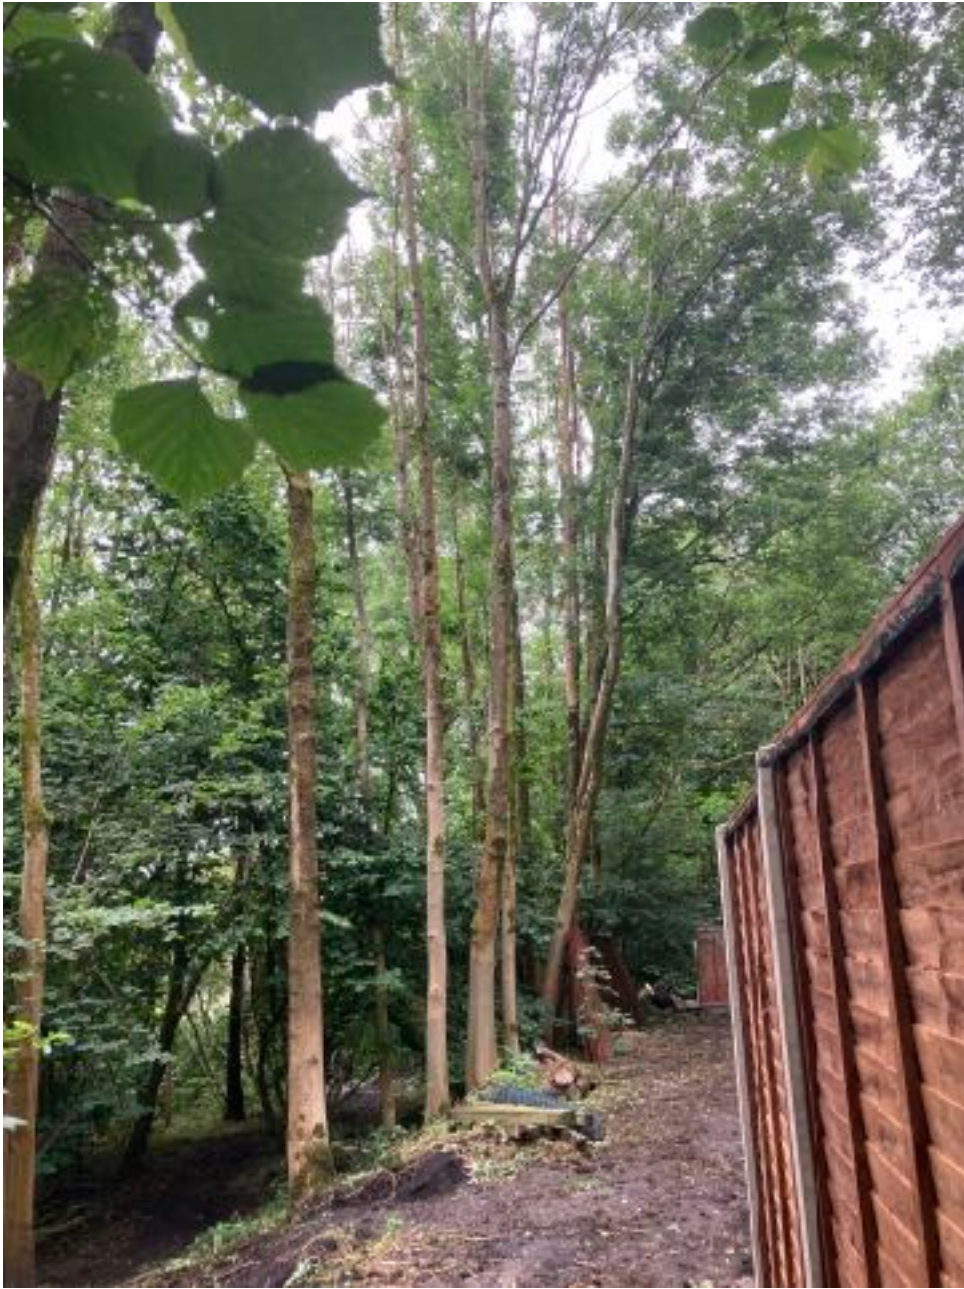
Behind the fence line is a public footpath, to the left the stand of ash trees.
