# TREE SURVEY & REPORT

21 Botesworth Green Milnrow  
OL16 3PJ

## TREE SURVEY / SCHEDULE AND REPORT

Order: Land off Charles Lane Milnrow, Sycamore  
T5 TPO 137

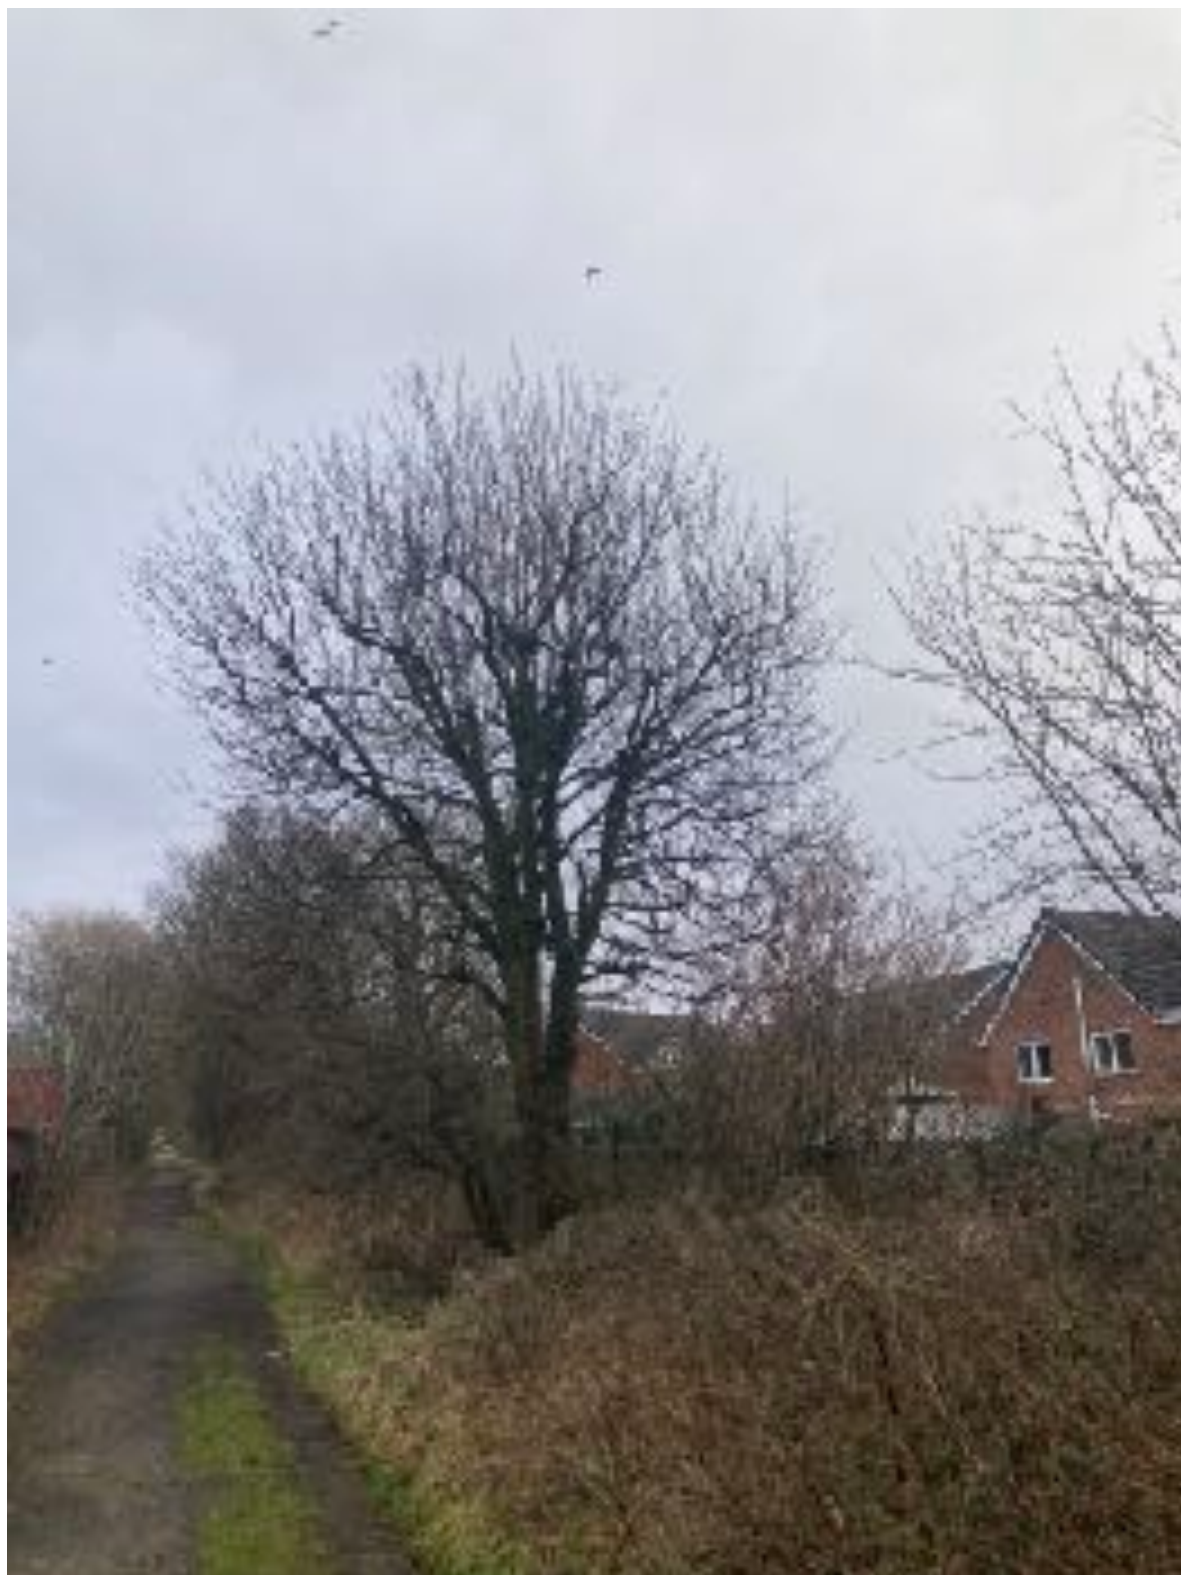
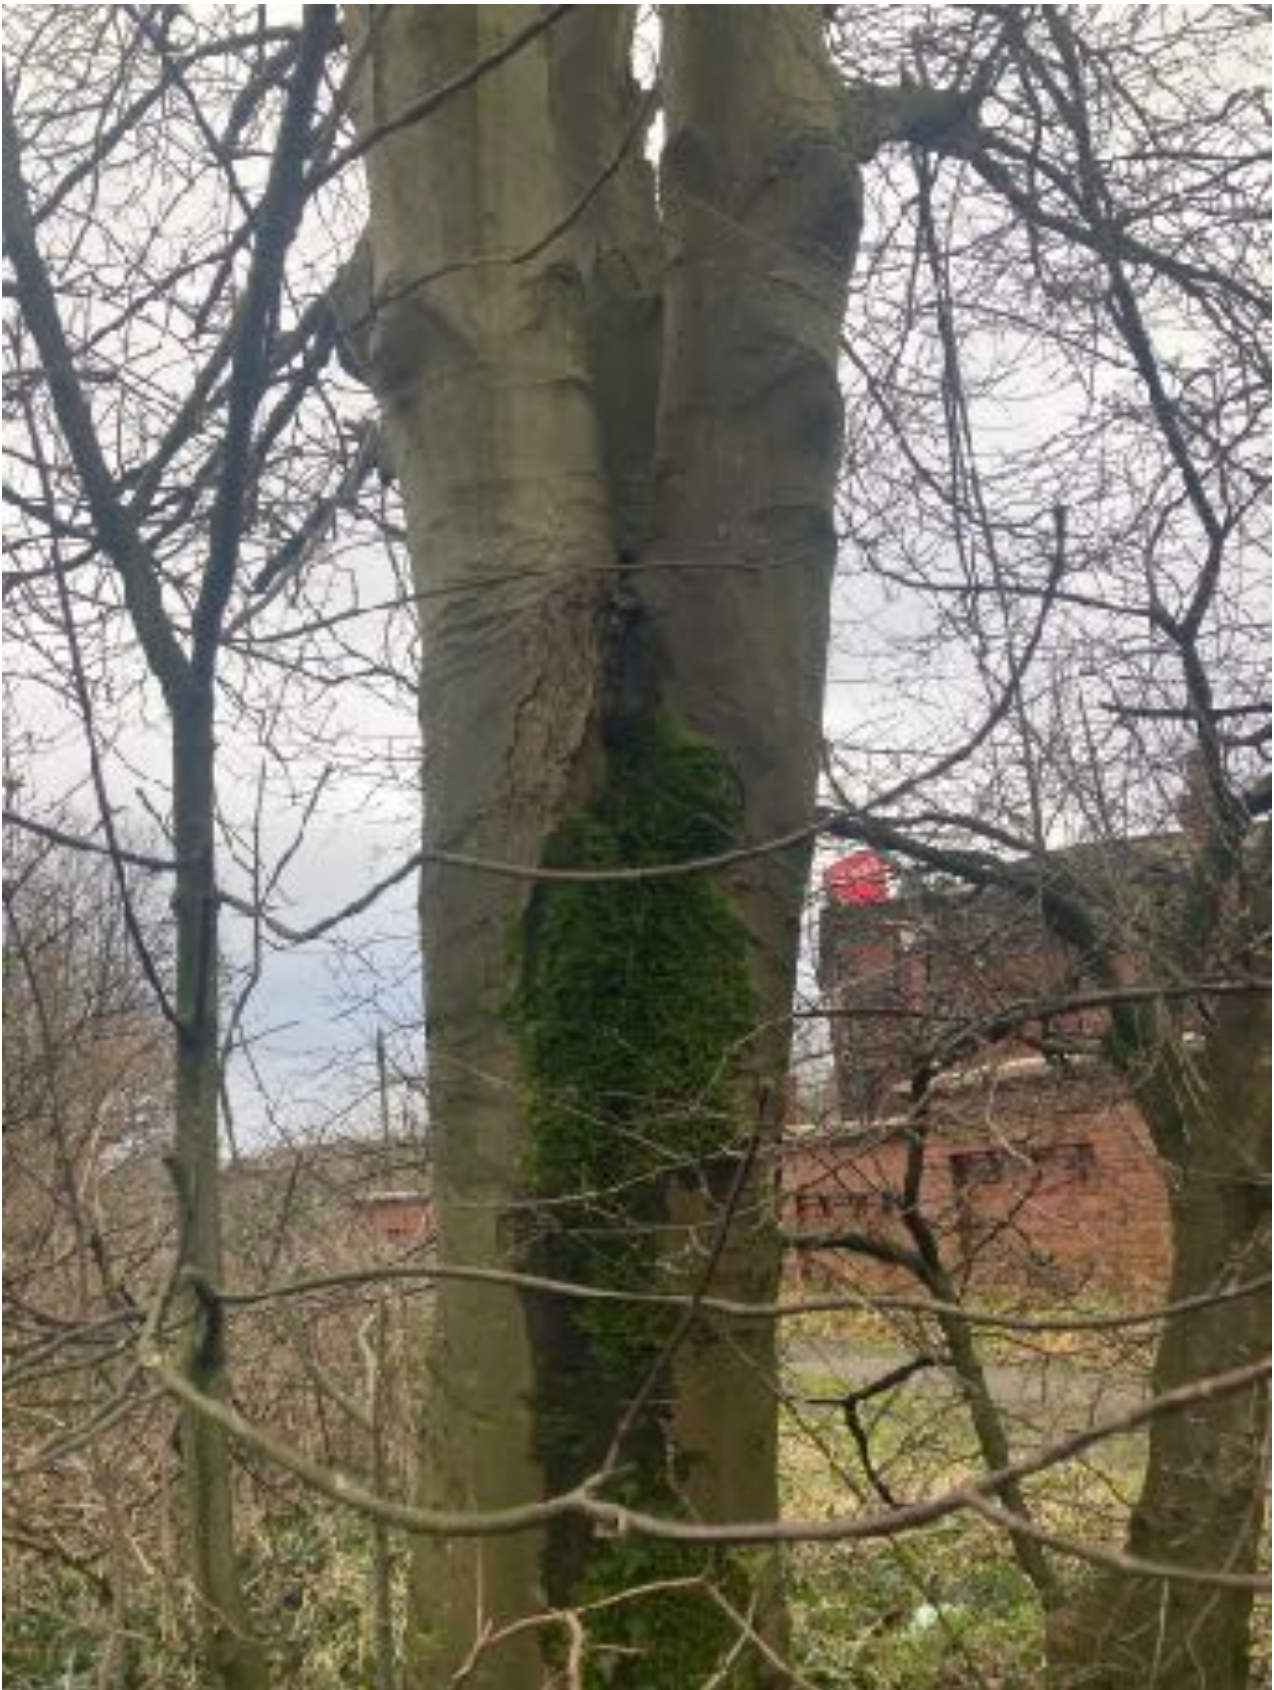
The tree is a mature 3 stemmed Sycamore in good health. However a significant fault on the main scaffold limb facing 21 Botesworth Green needs to be mentioned. The included bark union of the 3 main stems shows signs of weakness and risk of failure. Typically the debris and ingress of rainfall

to the included bark union can be seen by the damp and moss growth on the limb.

Remove the tree by section down, and replant with 2 x Heavy Standard native trees more suitable in height and shape. This option takes away the risk and the shading, plus eliminates the continuing application process for work and costs; also the work load on the Local authority.
