# **Rochdale Town Hall**

## **Historic Lighting Column Report**

Date Issued: 31.10.22

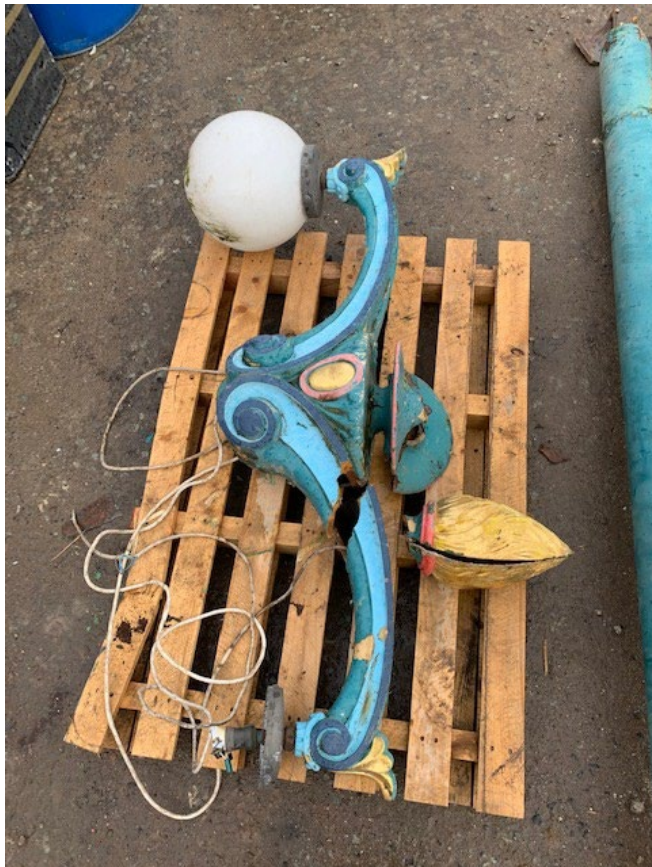
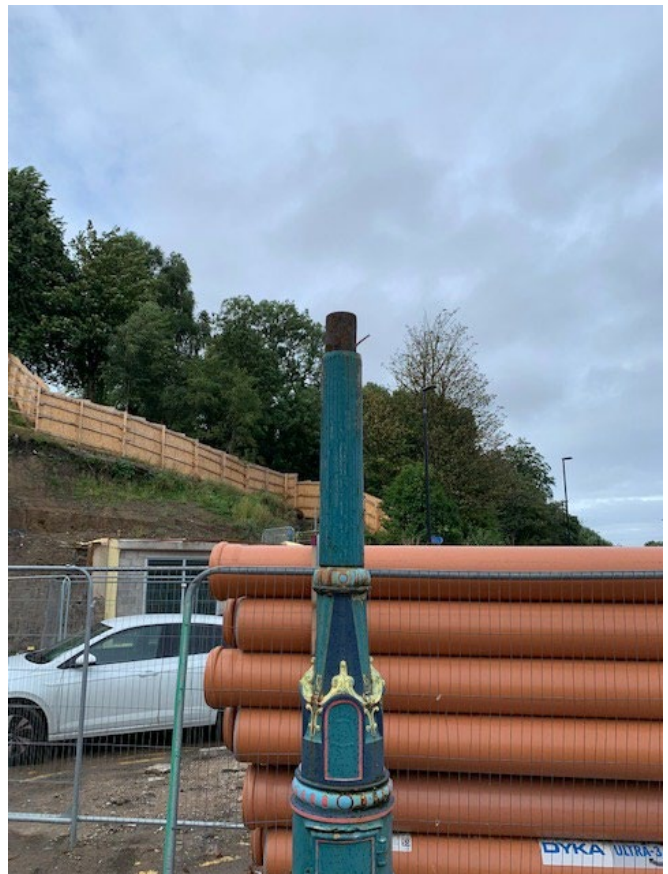
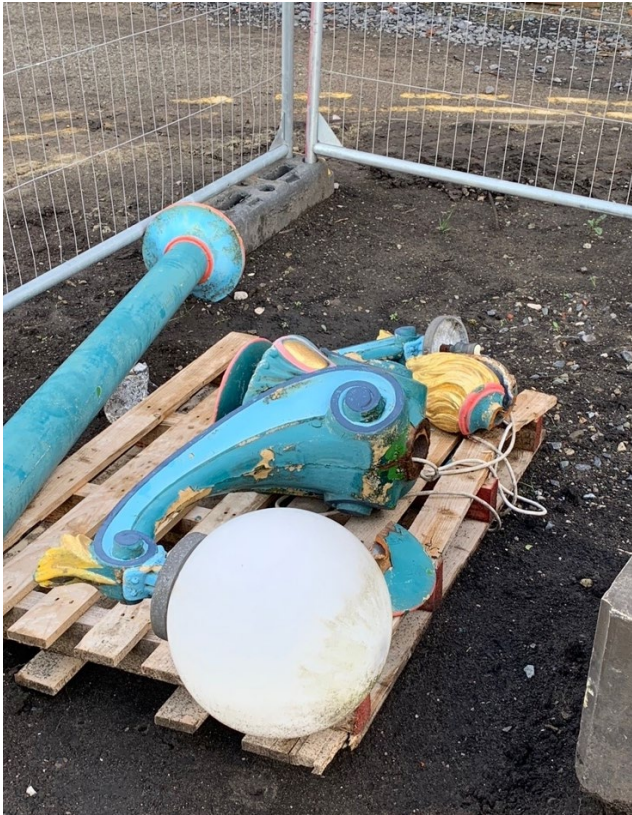
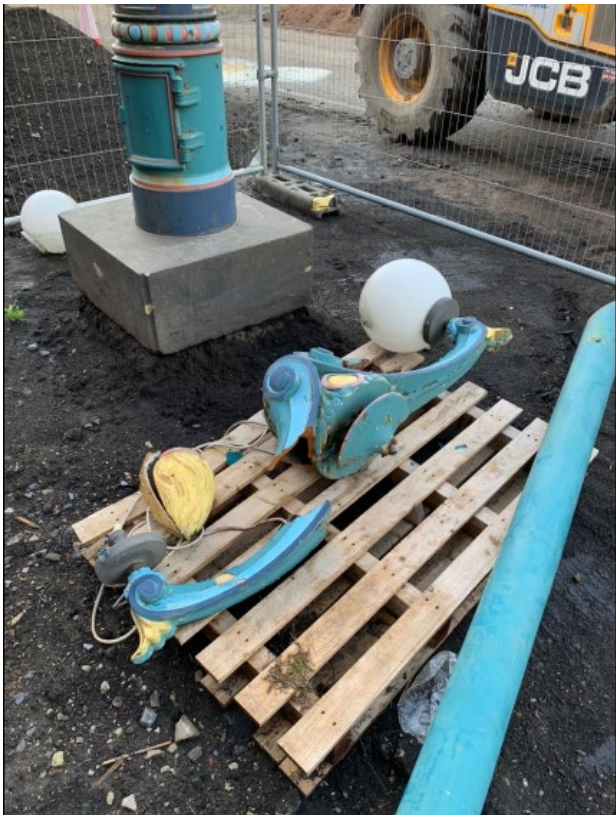
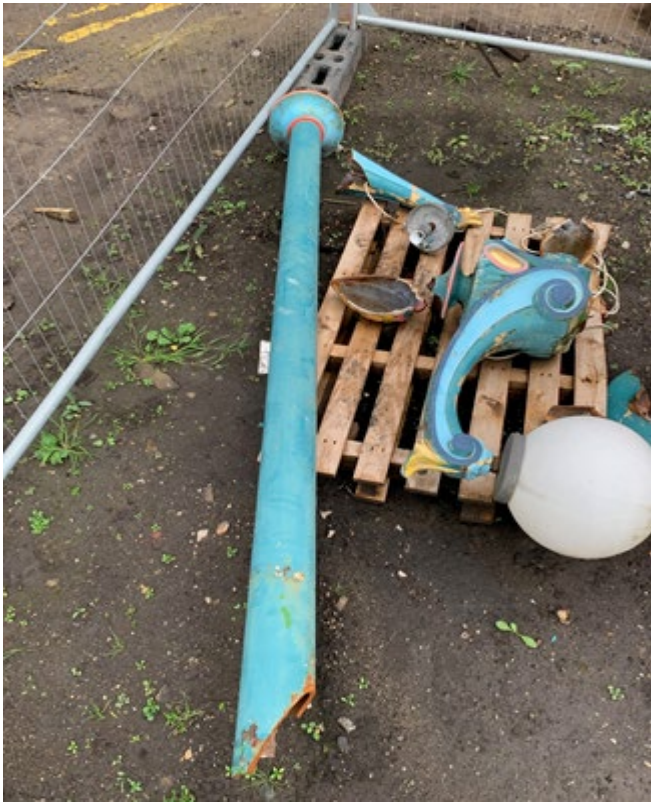
The methodology for lifting the lamppost was for the bottom concrete foundation to be excavated fully around the outside, and a webbed sling to be used to lift the lamppost. This sling was to be placed in the centre of the post (half the way up), and a 13-tonne excavator would be used to lift the lamppost out. The slinger/banks-person then instructed the machine operator to lift the lamppost approx. 4 inches from the ground to ensure the load was stable and ready for moving. After about 15 seconds the lamppost separated in the middle just below the sling position, the bottom section dropped the 4 inches back to the floor and the top section then fell towards the ground. This caused the top section to break into several pieces. (As per the pictures below).

Local historic lighting restoration company MetCraft attended site to review the broken lamppost and offer advice on the remaining ones. They said that they could undertake paint removal/repainting and lighting upgrades onsite but would need a watertight enclosure constructing, with full access around each lamppost to undertake the works. They also said it was not advisable to move them from their current position and wouldn't be able to offer any guarantees that the lampposts were structurally sound. Reviewing the broken one, and the existing ones, he commented on the visible cracks at high level, and the thickness of the cast iron to the lighting arm, which in places is “much thinner than would be expected”. They believed the lampposts were a “cheap modern recreation”, mainly due to the casting thickness and the fact that the two halves to the upper section had been cast separately and been stuck together using resin and a grub screw - and estimated that they were approx. 50 years old.

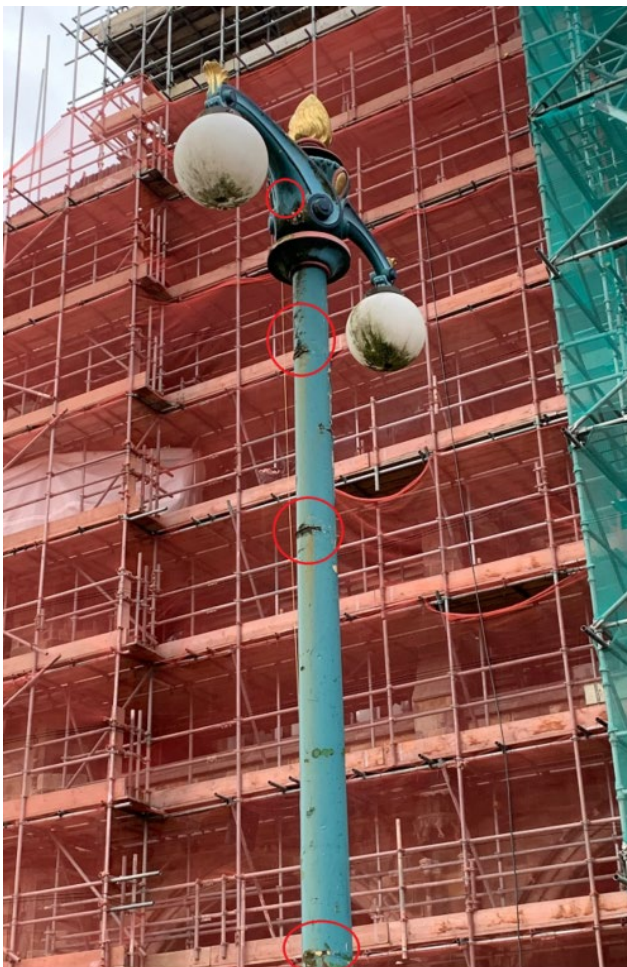
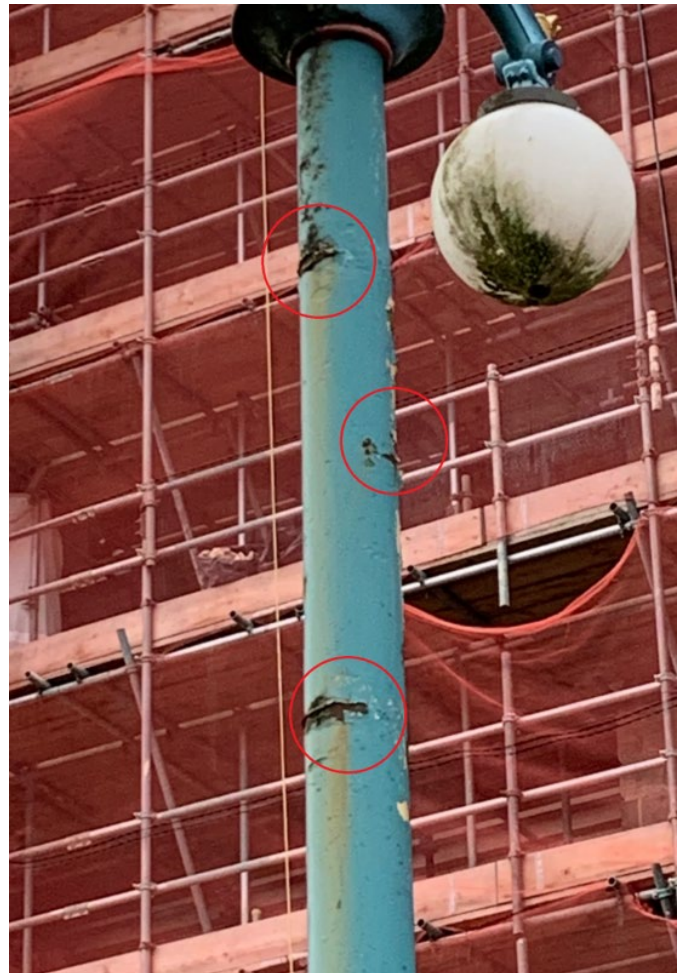
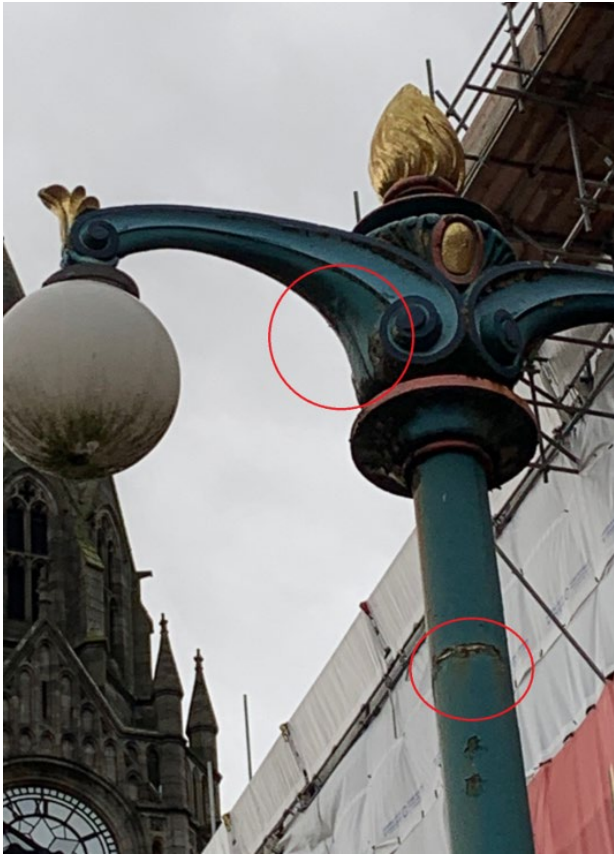
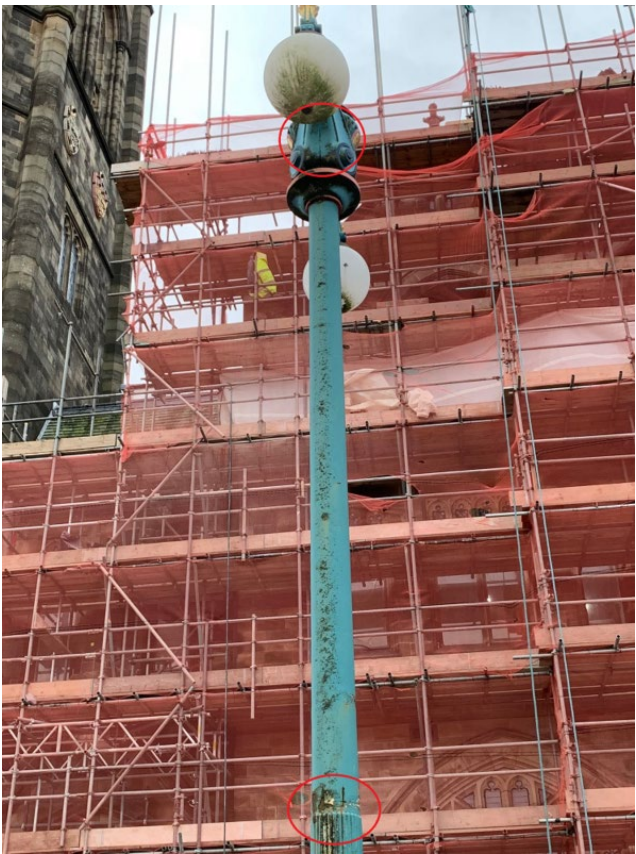
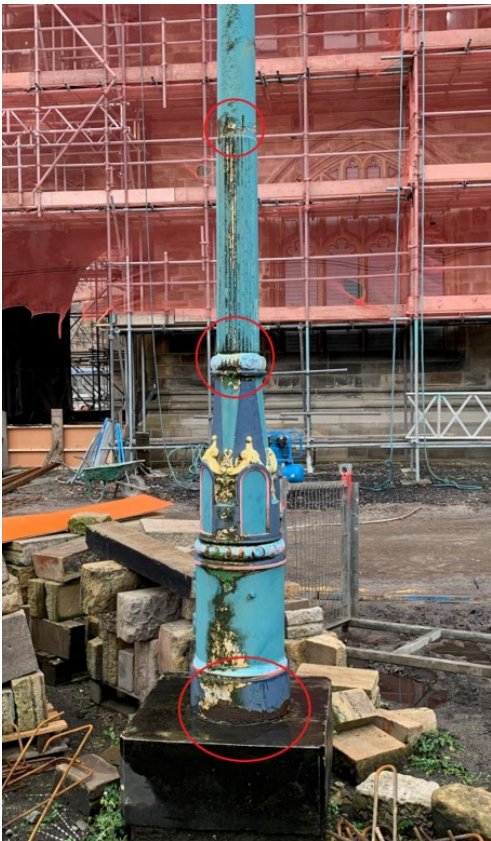
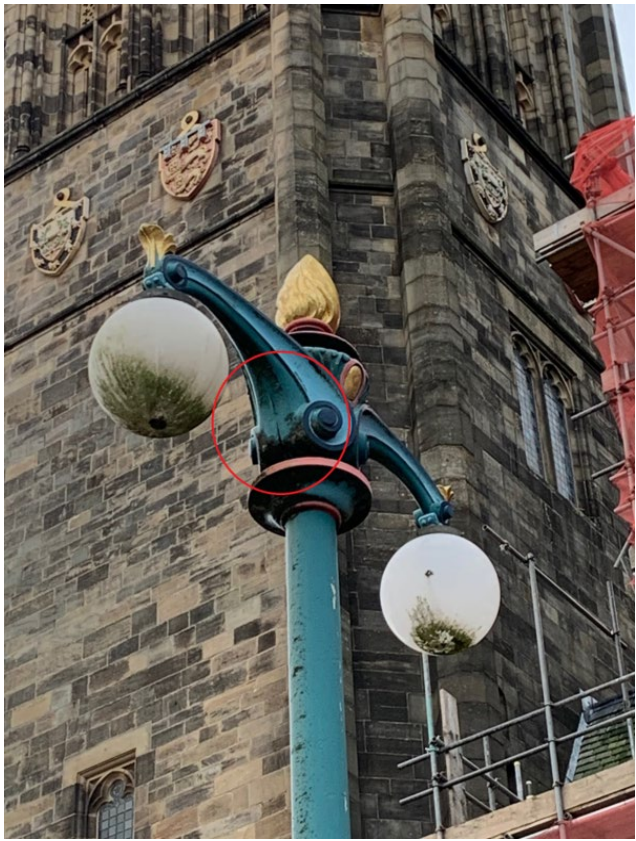
HHS and MetCraft have undertaken joint visual inspections from the ground and noted several defects, examples of which are highlighted in the images below.

One of the main issues with the remaining columns is the split to the light arm. The arm itself has a thin section of cast iron, which in MetCraft's opinion could fracture at any time. Hairline fractures to the column may also be hidden behind the several layers of paintwork.

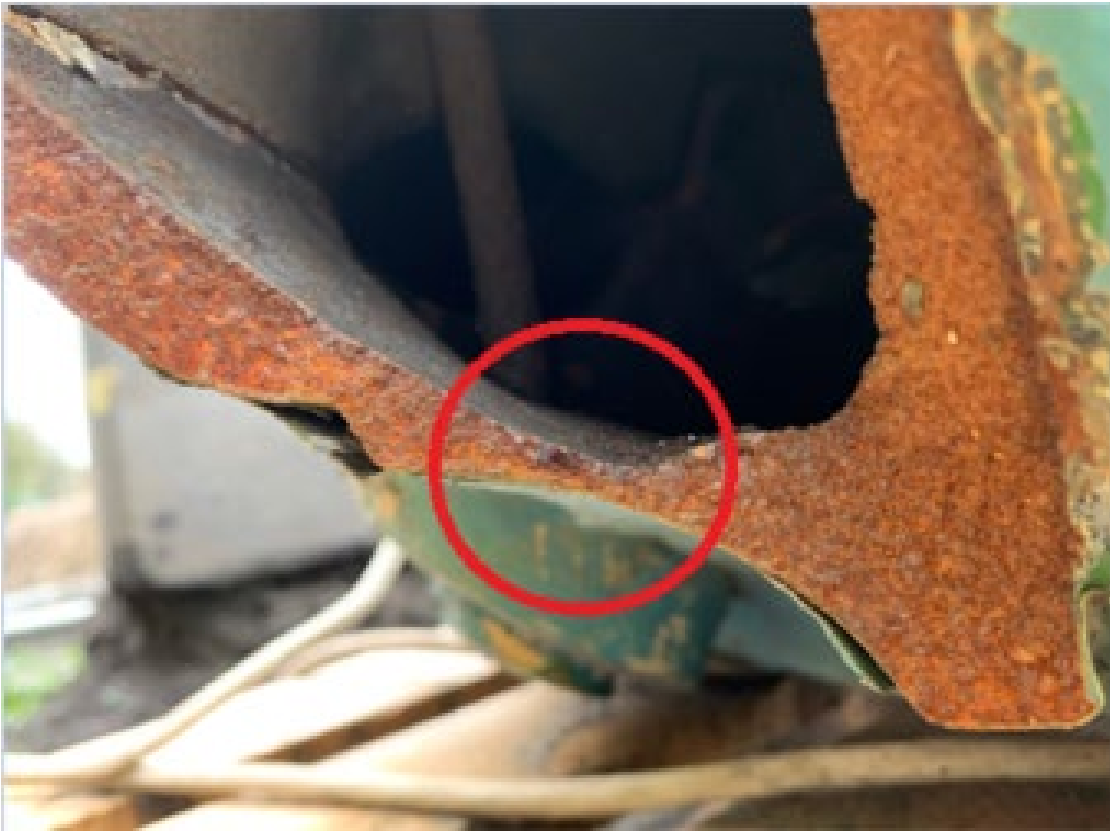
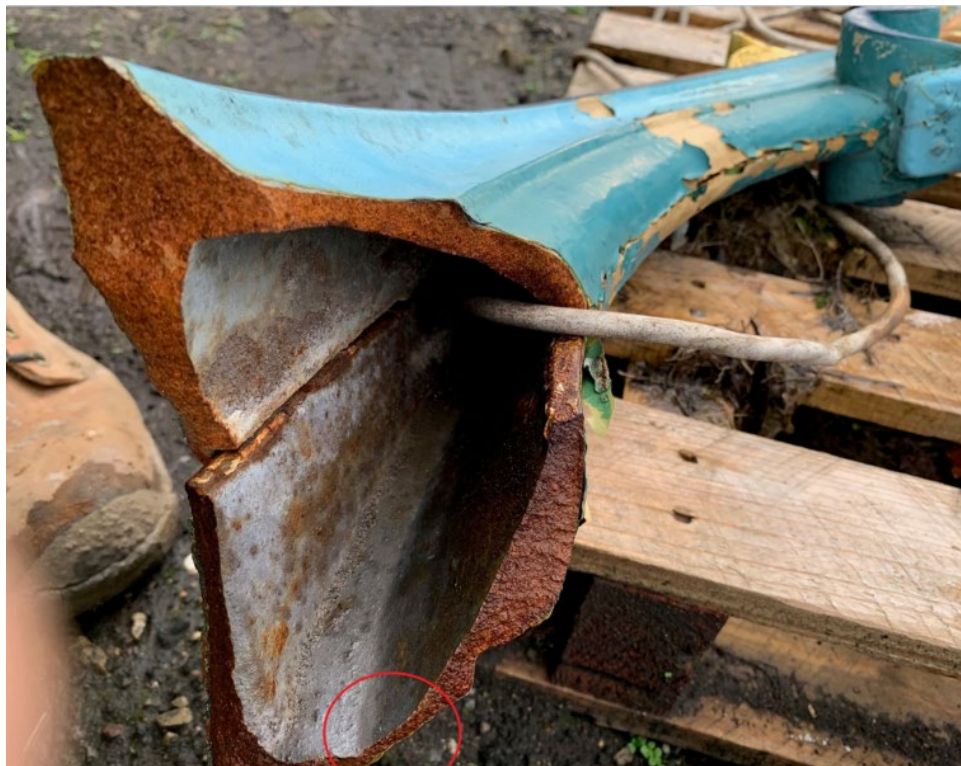
Thin section to Lighting Arm
