R3270

Higher Moorgate Farm, Gristlehurst Lane, Birtle  
Heywood, OL10 4BJ

Proposed conversion of Stable Block.

# REPORT ON STRUCTURE

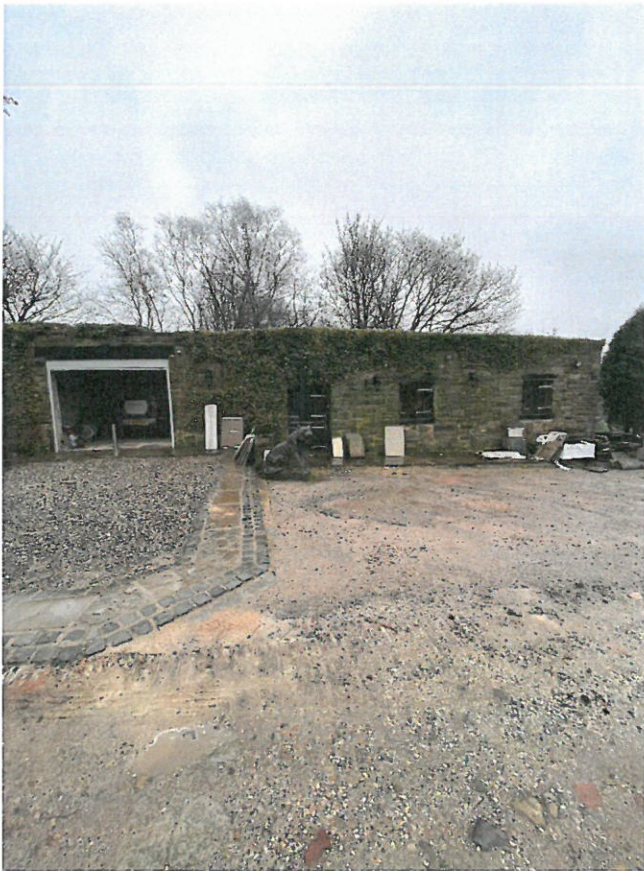
Photograph 1

- 2.01** The Stable Block is a single storey structure on a sloping site that falls from left to right. Photograph 1.
- 2.02** The front elevation is faced with random stone and comprises of a garage on the left with roller shutter door, this is followed by a stable door and two stable windows, each with timber shutters. Photographs 2, 3 & 4.
- 2.03** On the right-hand side there is a ramp leading to a timber shed, the ramp also leads to the main entrance into the stable block.

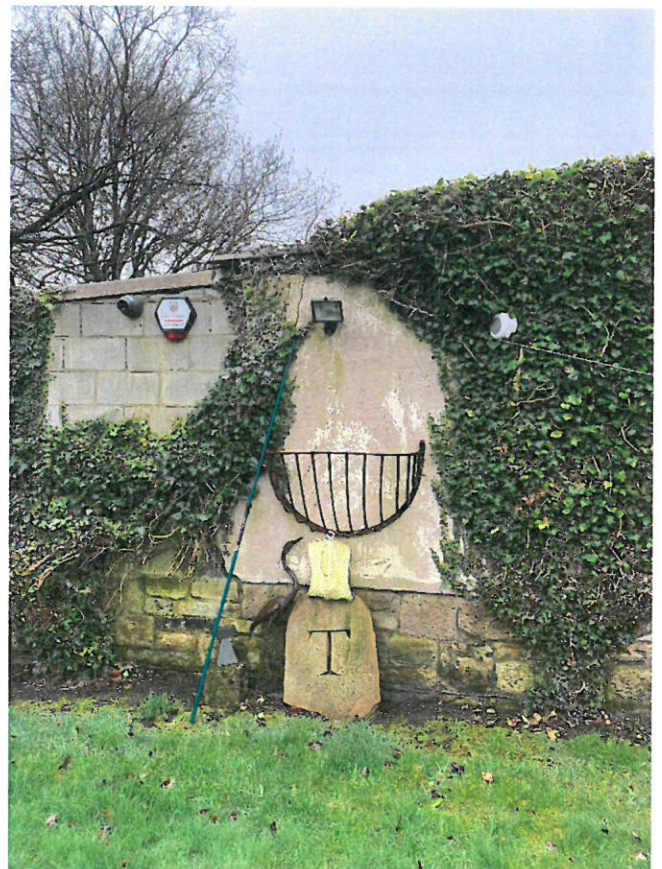
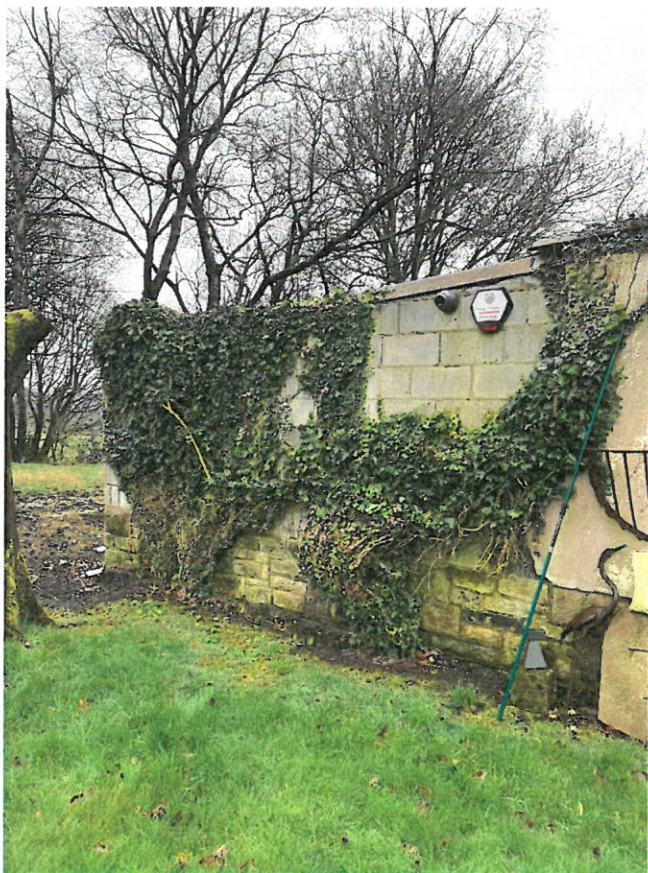
- 2.04** The left-hand side elevation is partially random stone and partially blockwork. At the time of our survey this was predominantly covered in ivy. Photographs 8 & 9.

There are clear areas of newer blockwork particularly towards the rear along with a rendered panel where there is a hay rack.

On the left-hand elevation, we obviously cannot see behind the ivy, and the reason for the external blockwork is unknown, but the elevation is also considered to be in a reasonable structural condition.

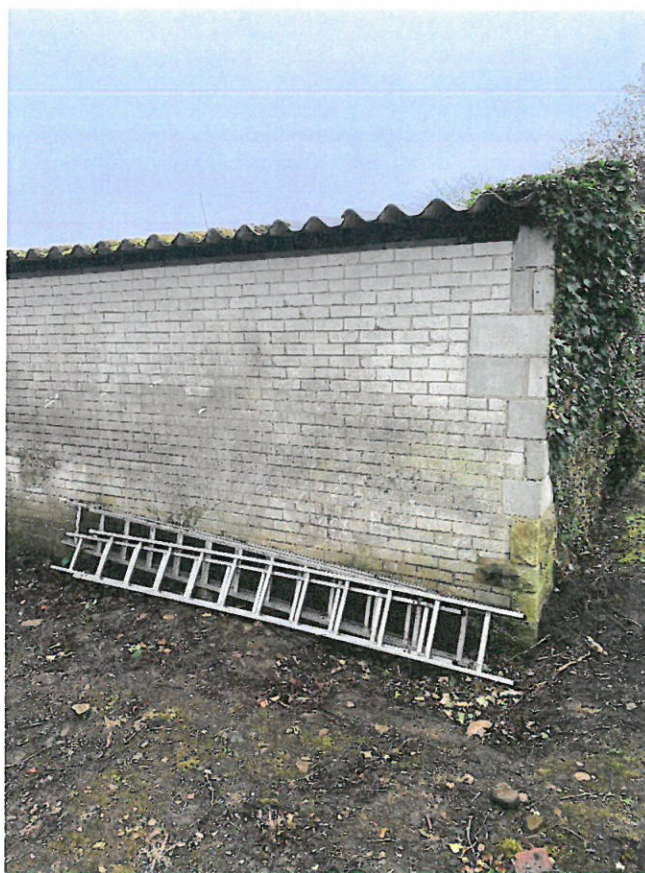
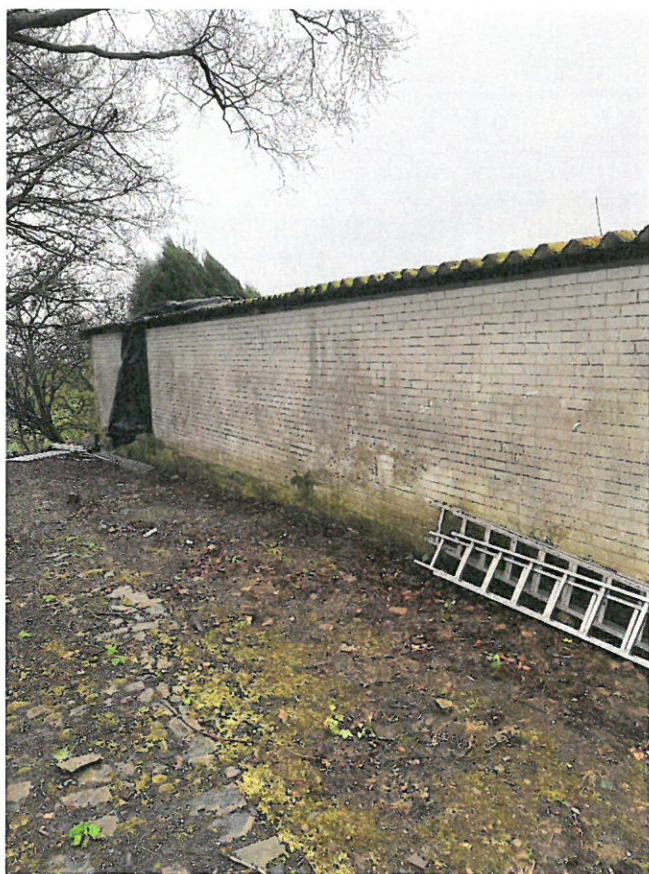
- 2.05** The rear elevation has been rebuilt in the past using a concrete common brick. Photographs 10 & 11.
- 2.06** The roof is mono pitched front to rear with the higher level at the front. The roof covering is of a "Big Six" asbestos cement sheet. There is a small parapet to the front. Photograph 12.

The rear elevation, faced with the concrete common brick, is in a good condition.

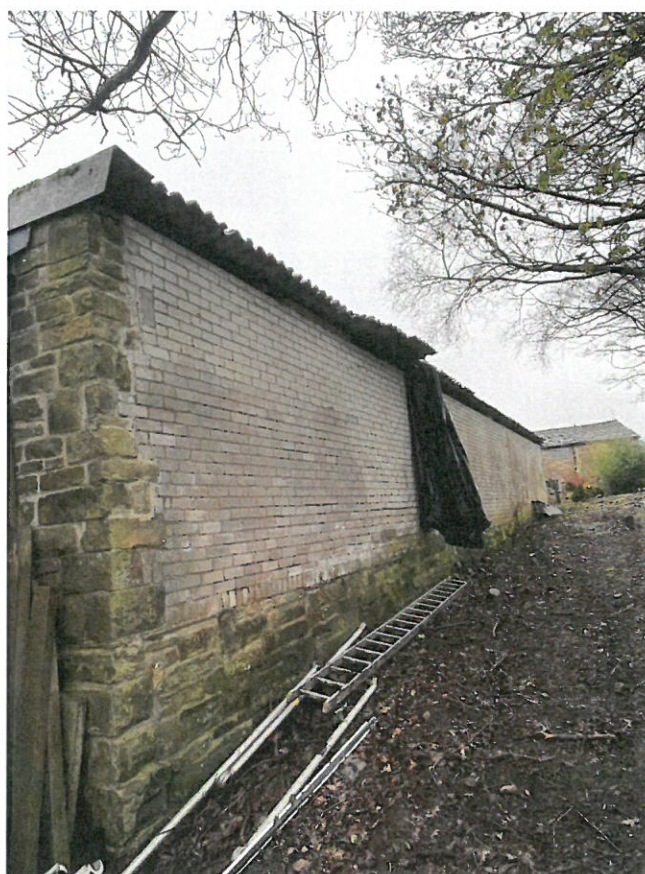
Photograph 12

The roof is mono pitched front to rear and is in a poor condition and will require total replacement.

The existing roof covering will require careful removal.

- 4.01** The external elevations of the property are considered to be in a structurally sound condition and are perfectly capable of being structurally re-used as part of a domestic dwelling.
- 4.02** The roof covering, and the roof structure will require total replacement.
- 4.03** The internal floor slab, which is independent of the structure will need to be replaced or ideally overlaid.

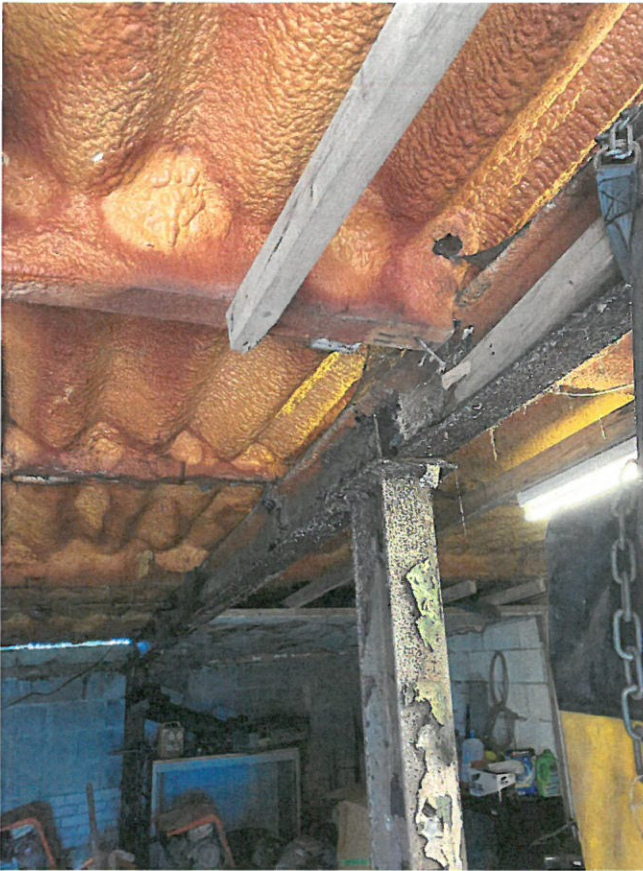
Photograph 13

- 2.08** The roof is supported by steel beams with steel angles acting as purlins. There is a propped steel member running front to rear on the right of the garage area. Photograph 13.

The steel members internally are not part of the overall structure and can be removed.

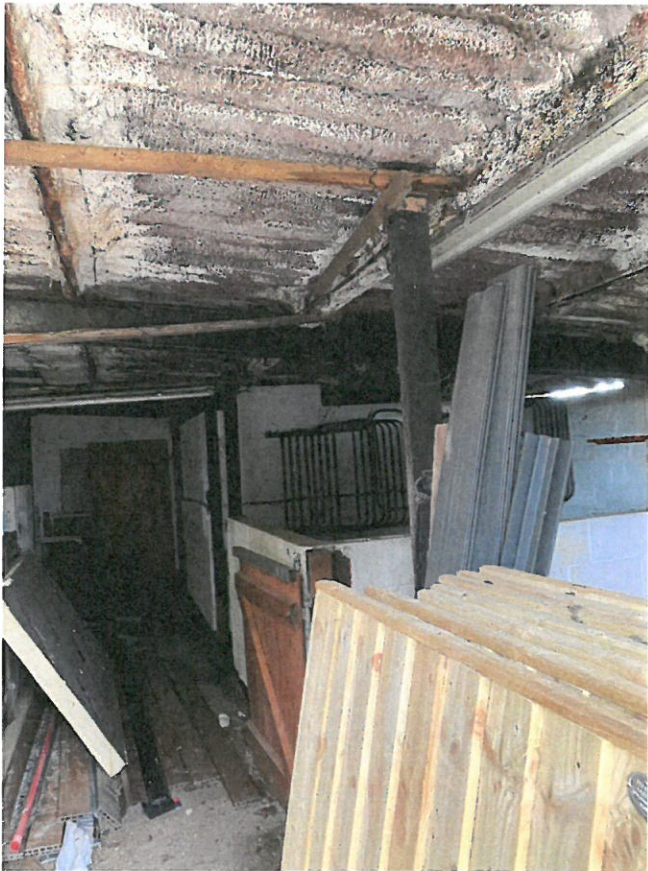
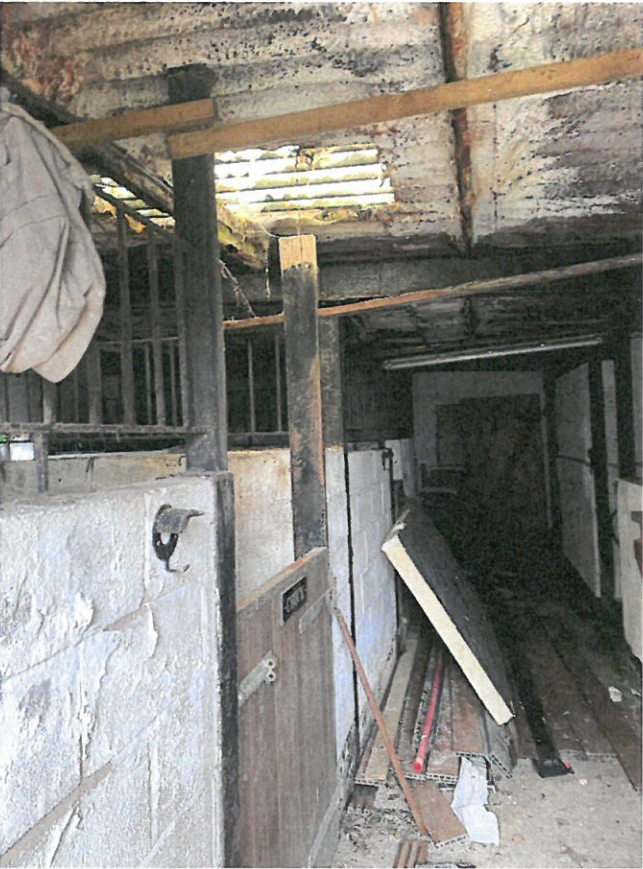
- 2.09** To the right of the garage party wall there is an open plan stable block. There are six stables. The roof to this part of the structure is similar to the garage roof with the internal steel supports on two lines. Photographs 14 & 15.

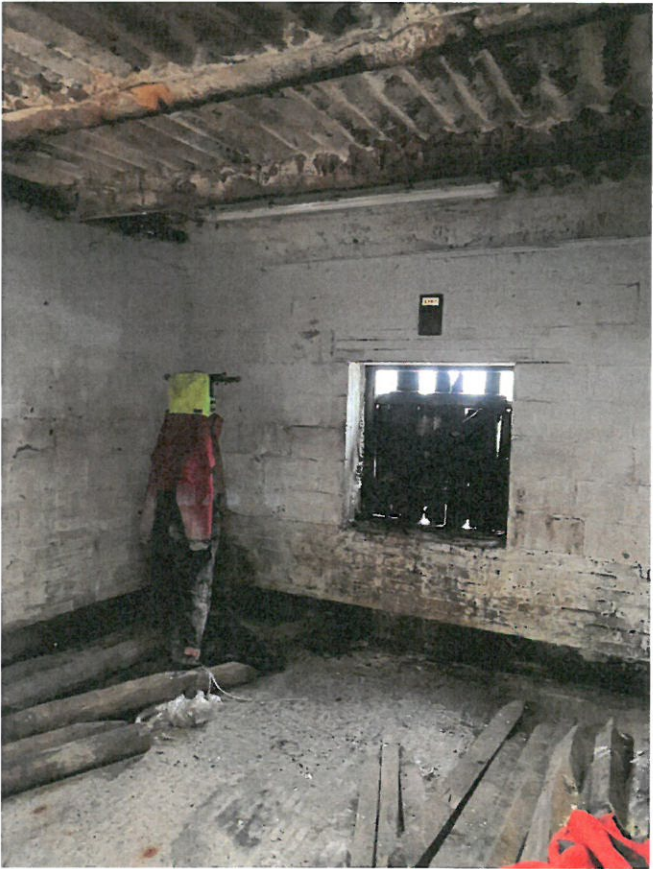
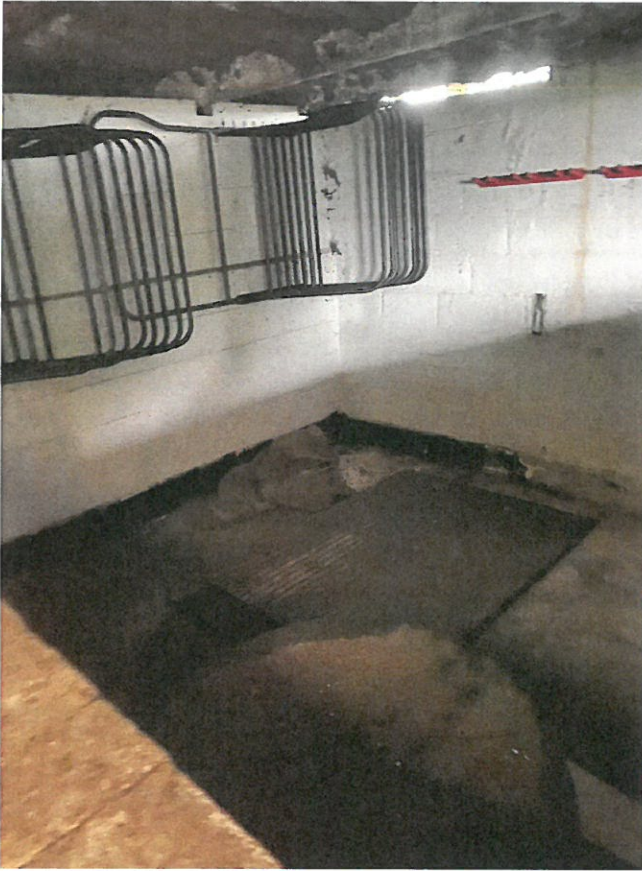
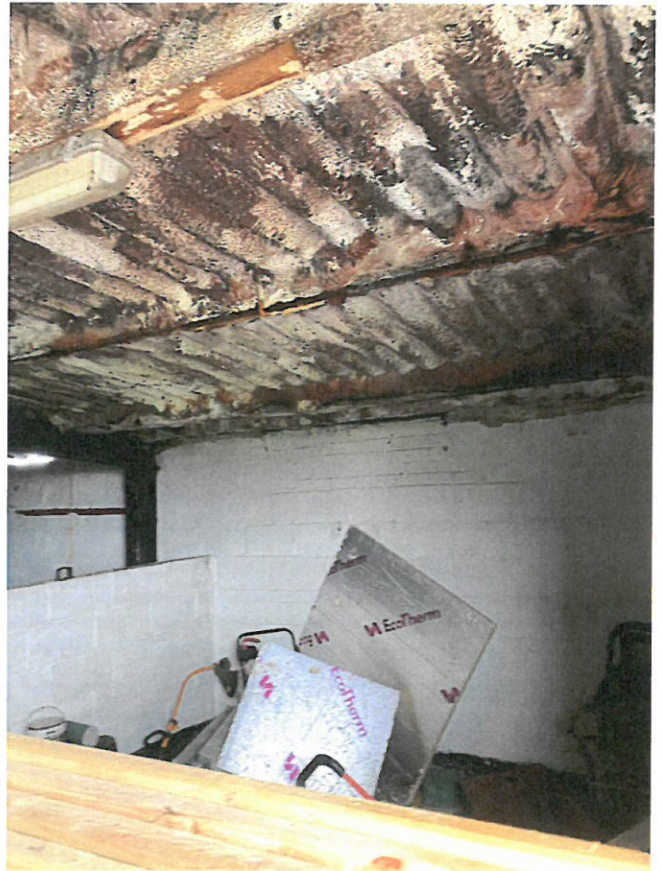
The external walls are of random stone on three elevation and on the rear elevation there is a concrete common brick used as a facing. All the walls are backed up internally with concrete block. Photographs 16, 17 & 18 are typical. These walls are structurally adequate.

The walls are generally true to plumb and do not show any signs of any significant movement. There is a slight bulge in the front elevation to the right of the first stable door, but this is considered to be well within acceptable tolerances. No remedial action is deemed necessary.
