# Preliminary Roost Assessment

132 Drake Street

Rochdale

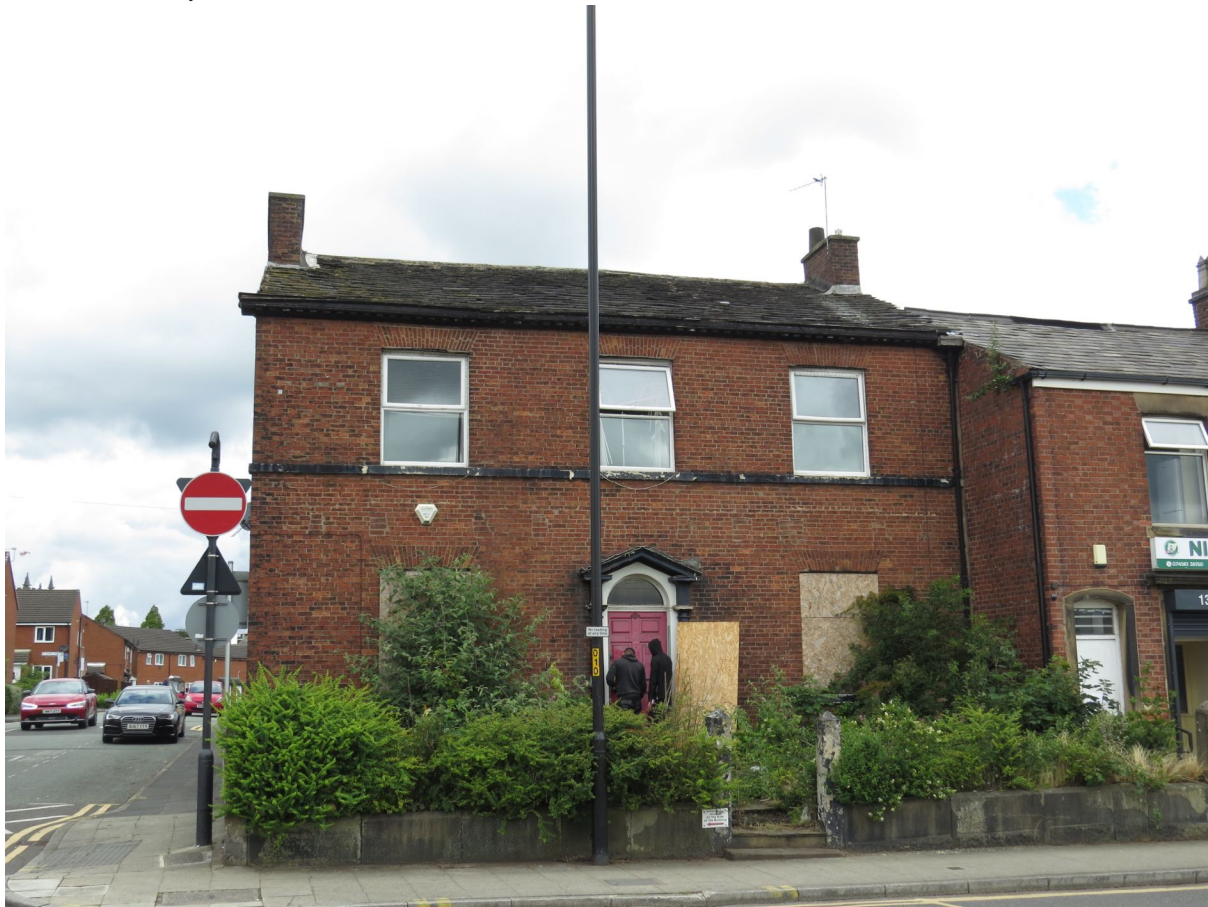
3.1a – The front of the house.

The building is in poor condition. There are gaps between natural stone tiles, timbers at the eaves are in poor condition, windows could give access to the inside of the building. Fascia boards and hidden gutters are perished, with gaps between timbers and brickwork. Walls are in good condition, with no missing mortar or cracks.

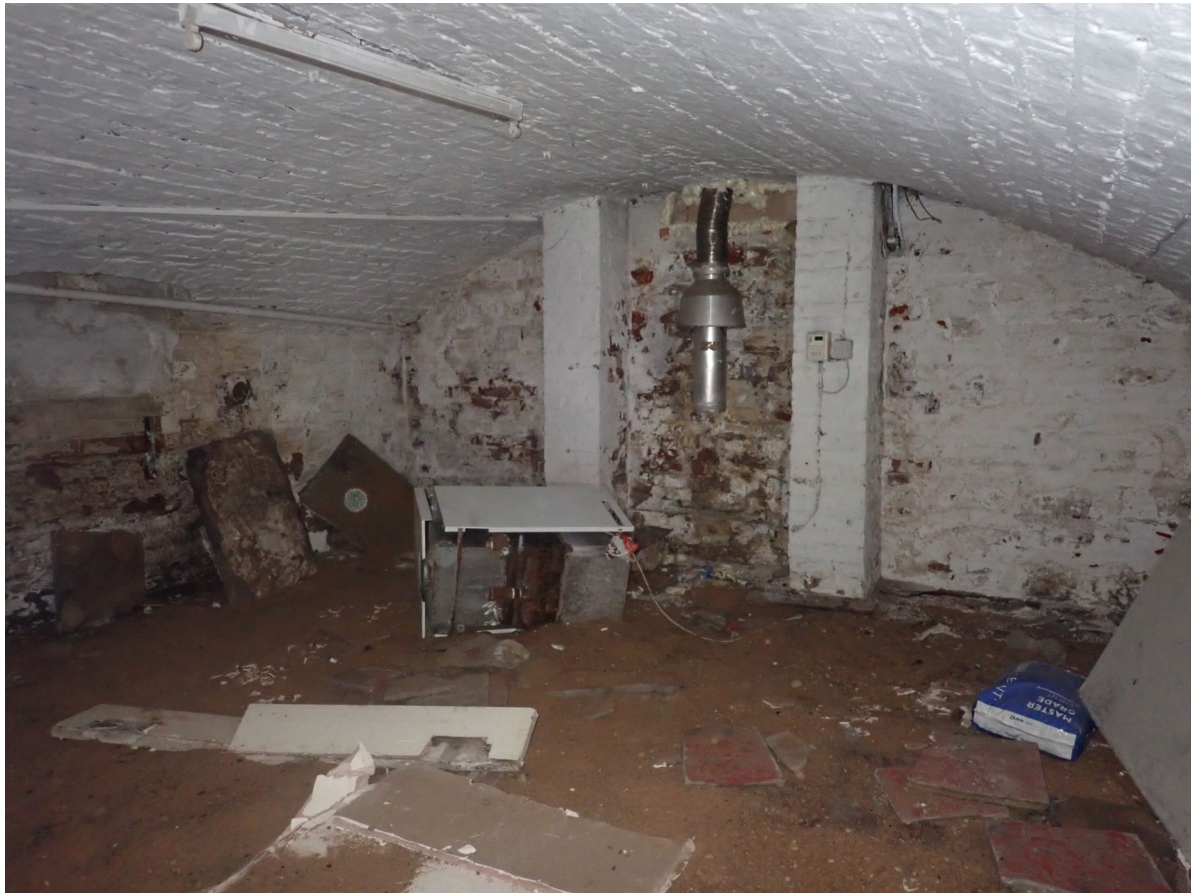
3.2a – The cellar.

The wall plate, gable end, and party walls were inspected in detail using an endoscope; these areas are generally filled with dusty cobwebs. There are minor gaps at the gable end, however no indications of use by bats were found. The building has a large cellar. The cellar has no direct access from the outside, and is dusty and cobwebbed.

Cellars are dusty and cobwebbed with no sign of disturbance, no direct entrance from the outside, and no indications of use by bats.

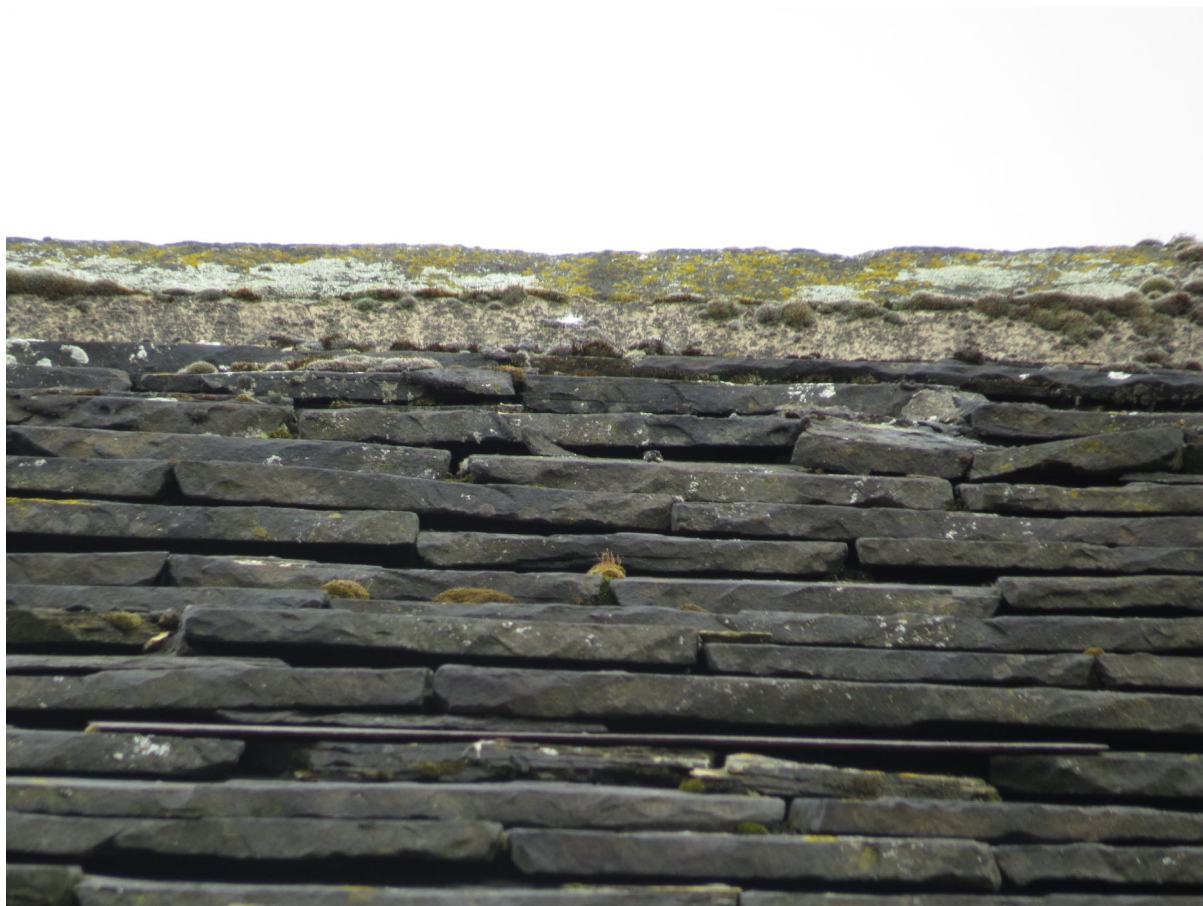
3 – Stone roof and ridge tiles are in good condition.

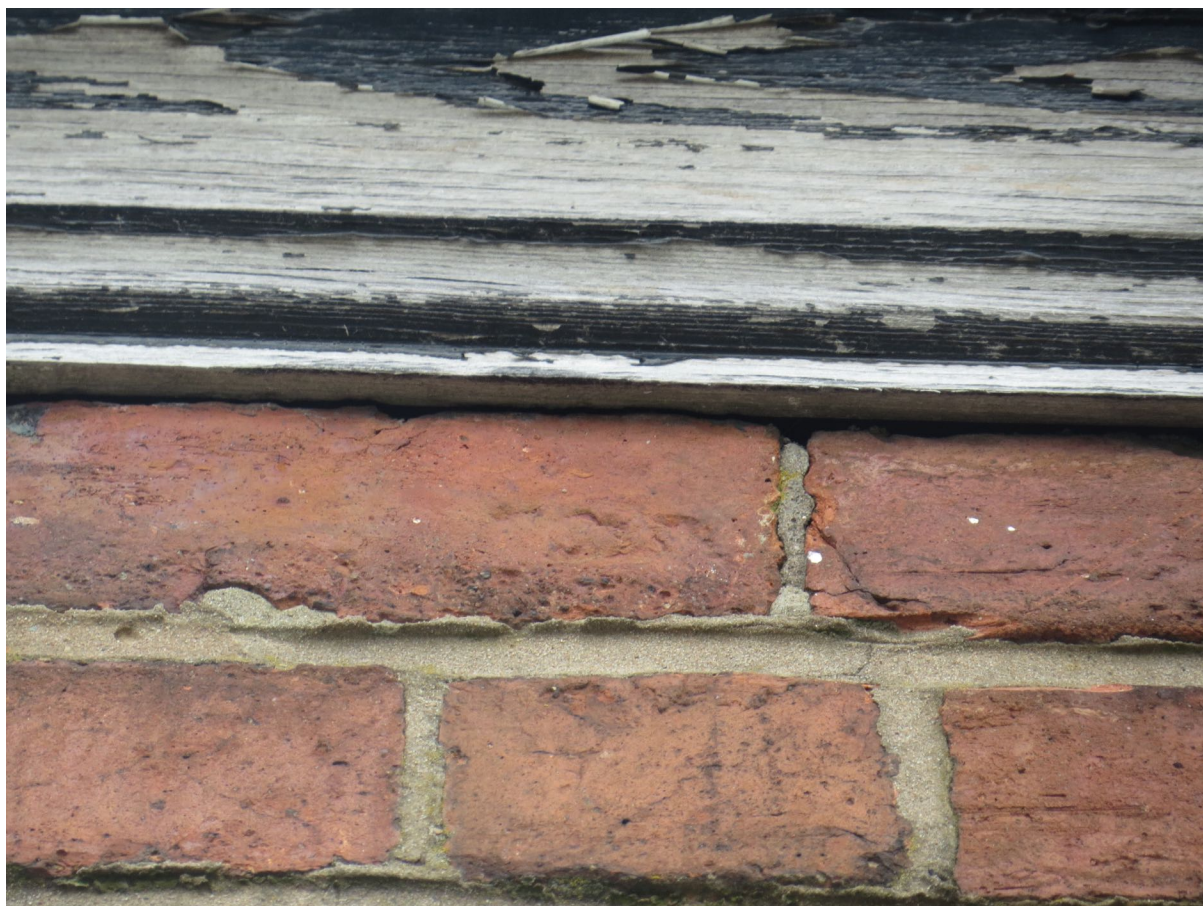
4 – Timber fascia boards at the eaves are fixed tightly against brickwork, but perished.

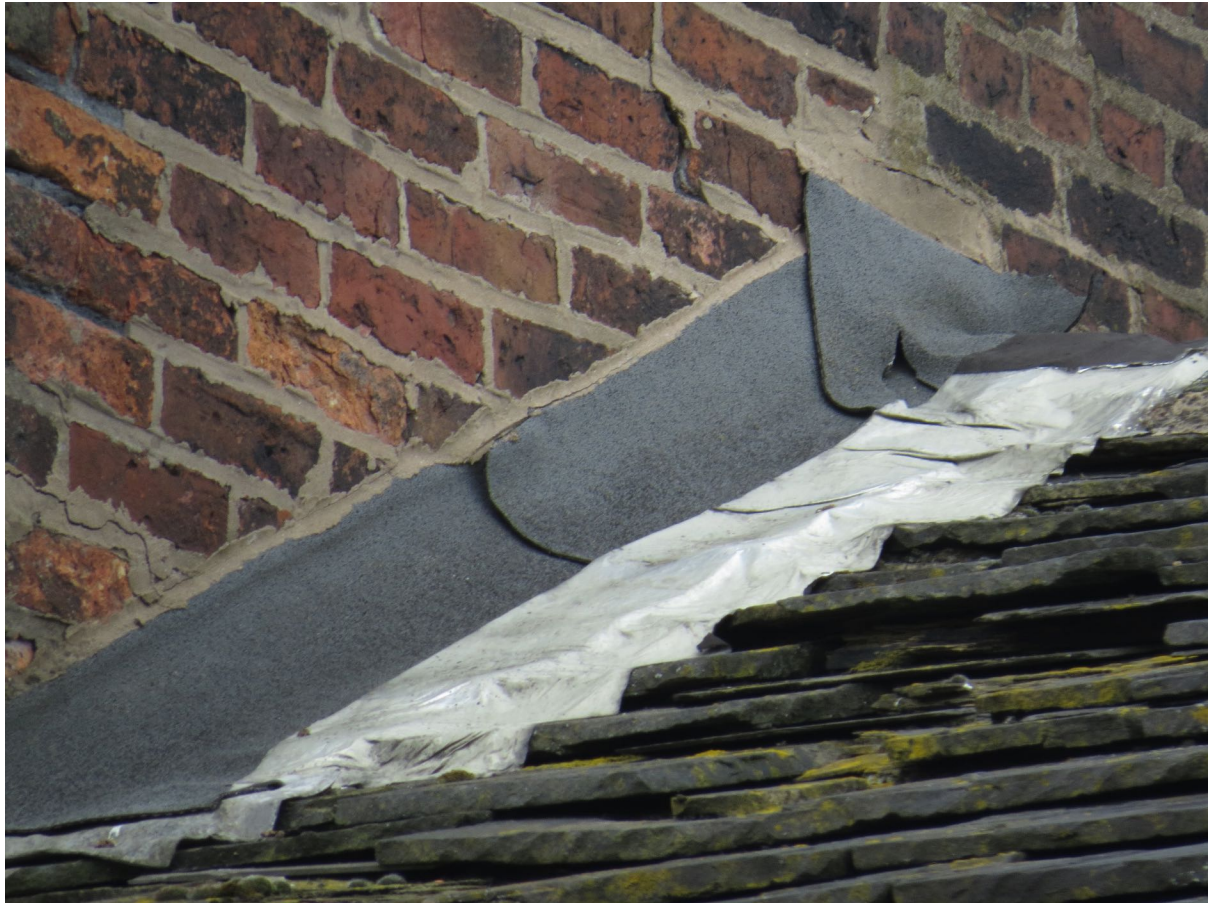
Roof pitches face northwest and southeast; the gable end faces southwest. Lead flashing has been removed and replaced with bitumen flash banding. Timber hidden gutters are fitted at the front of the building, timber fascia boards are fitted at the eaves and gable end.

5 – Lead flashing has been replaced with bitumen.

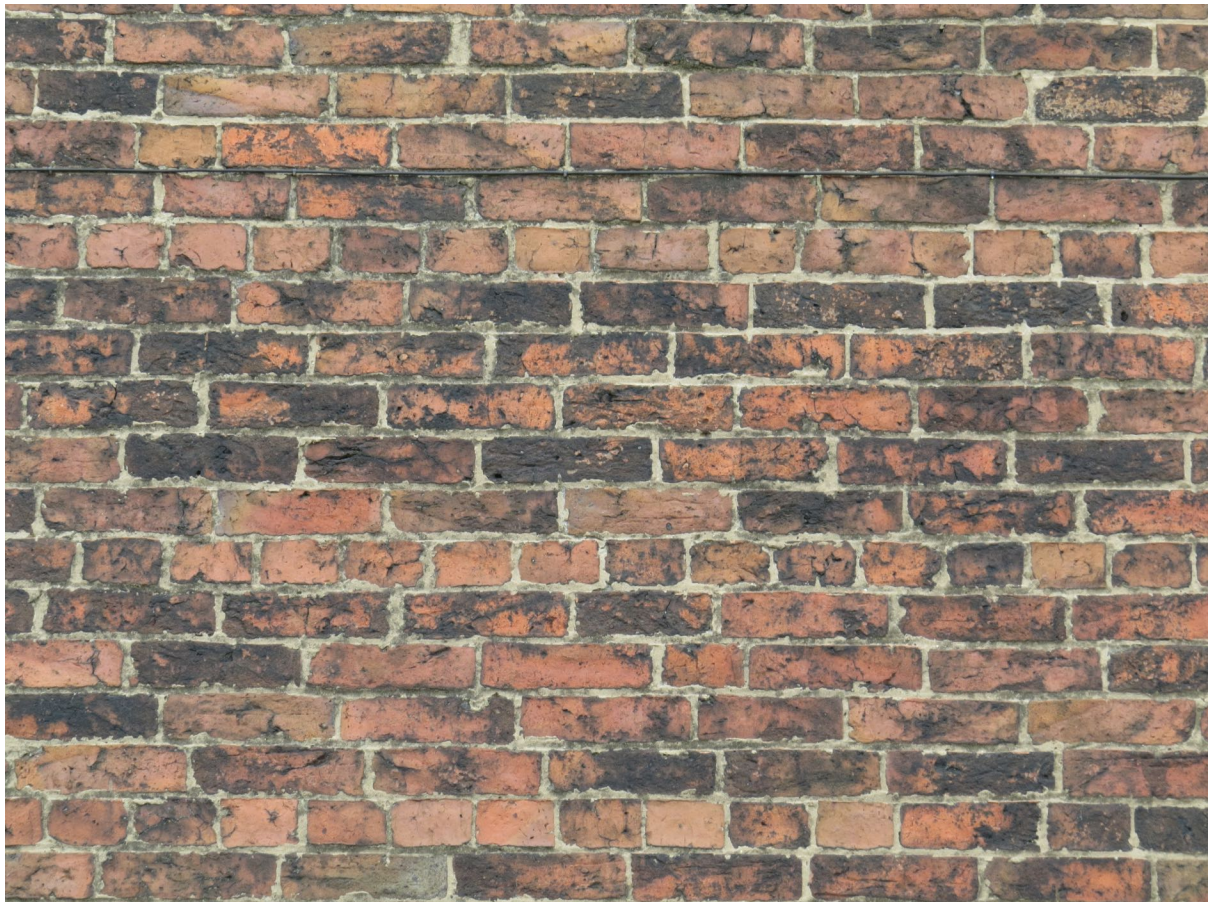
Walls are solid brick with no insulating cavity. Walls are in good condition, with no cracks, or missing mortar which could be used by crevice dwelling bats.

6 – Brickwork and mortar are in good condition with no suitable gaps.

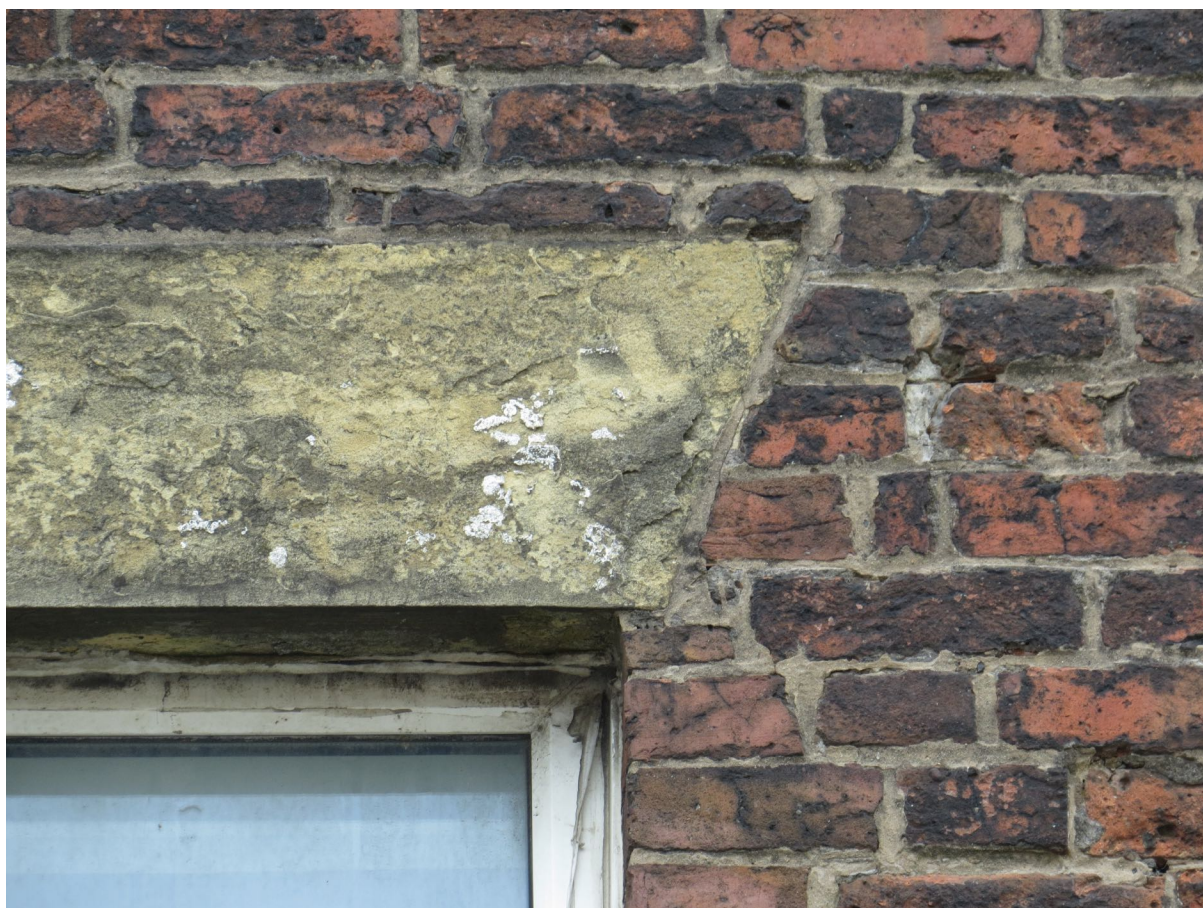
Window and door frames are fixed into the brickwork, gaps are filled with sealant, and offer no suitable roosting opportunities. There are a number of open or broken windows which could allow bats into the building, however, no indications of use were found.

7 – Window and door frames are sealed into brickwork with no suitable gaps.

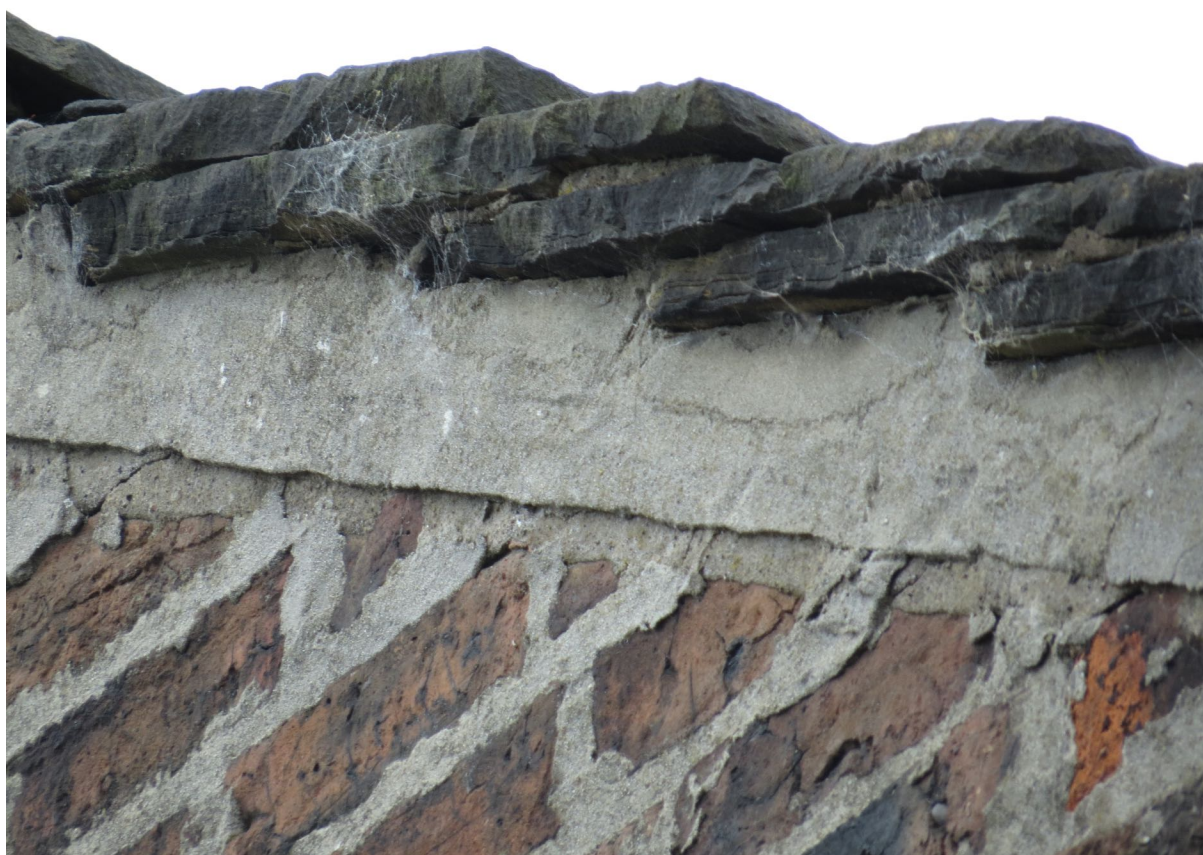
8 – End tiles at the verges are sealed with cement.

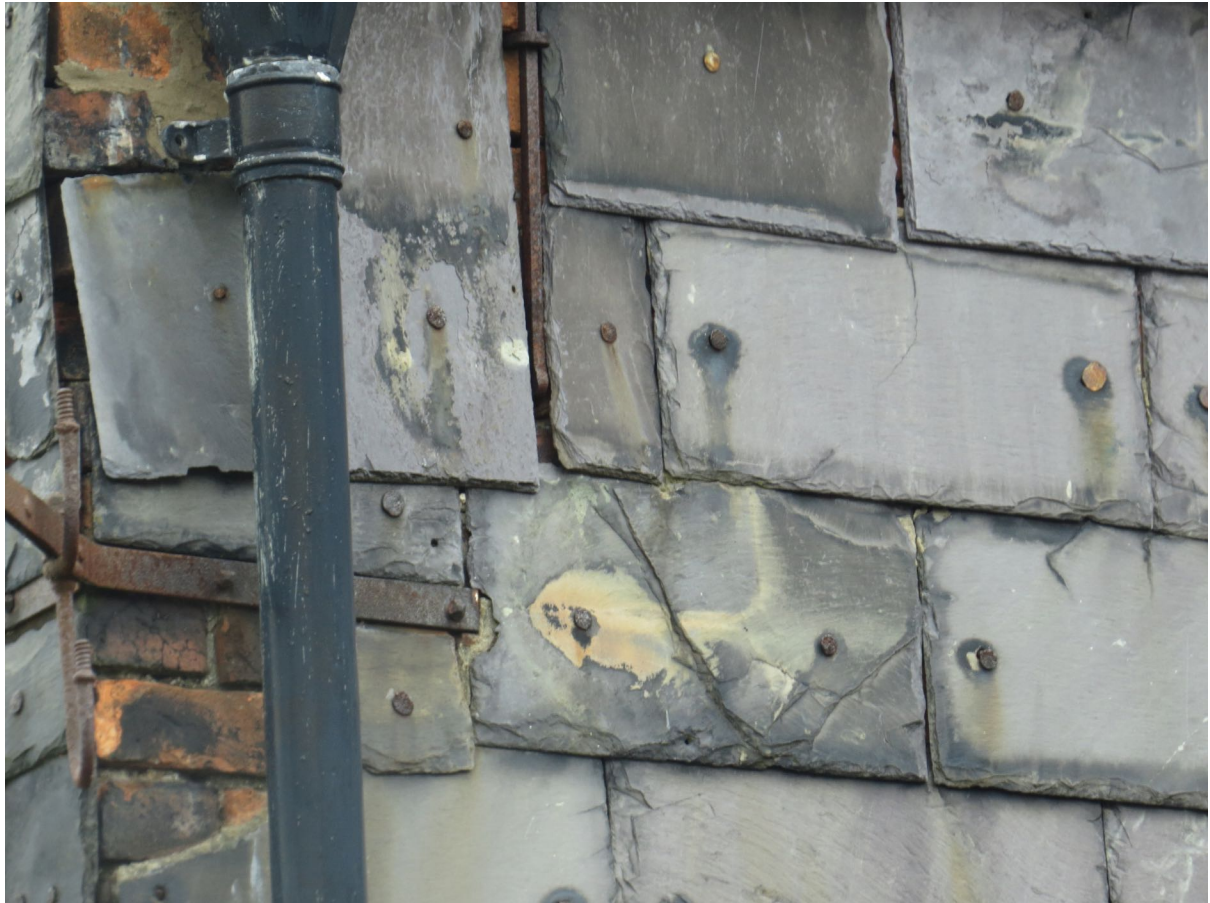
9 – Gaps in hanging tiles were checked from a ladder using an endoscope.

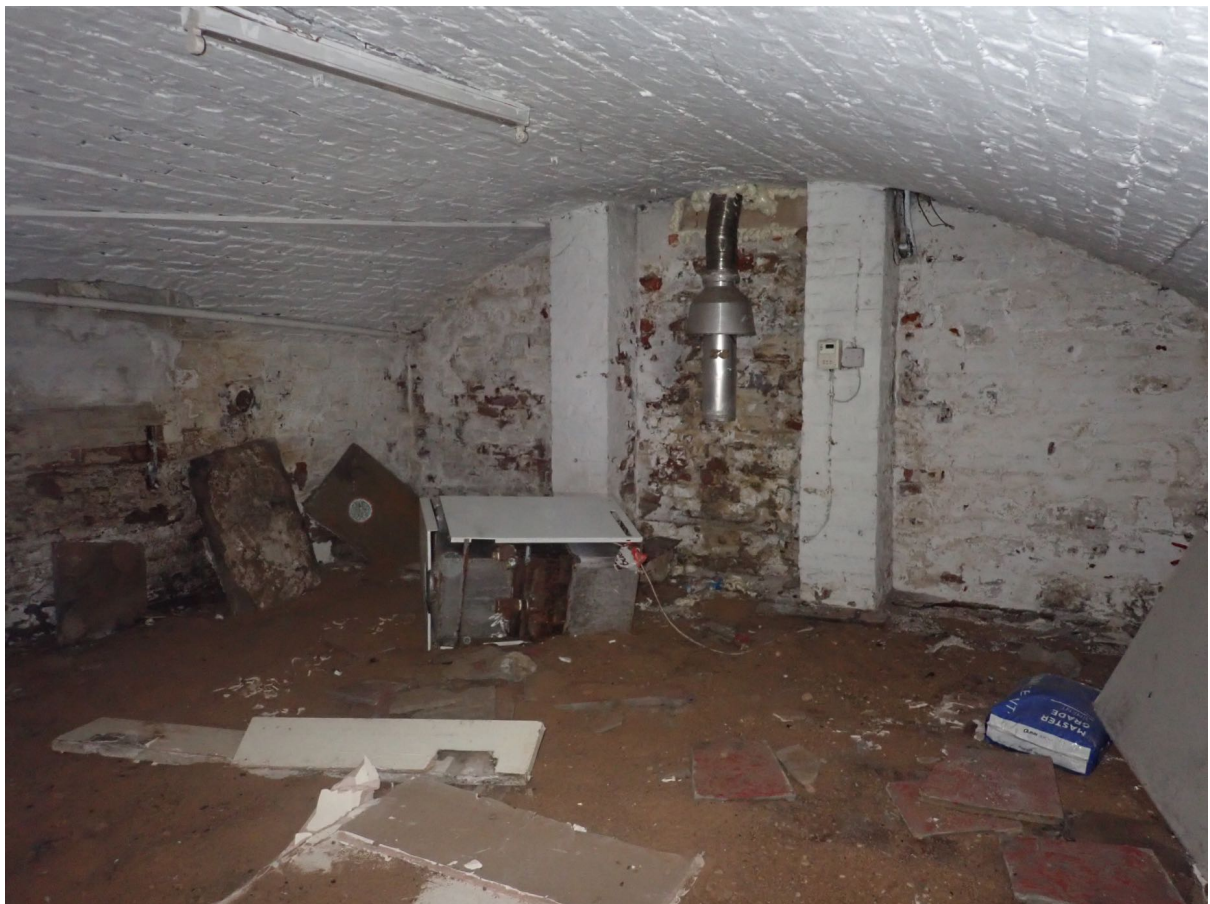
10 – Cellars have no direct access points from the outside.
