**STRUCTURAL INSPECTION**

836-838 Manchester Road  
Castleton  
Rochdale  
OL11 2SP

Mr. Steve Buckley  
C/o. Michael Booth  
Architectural Services

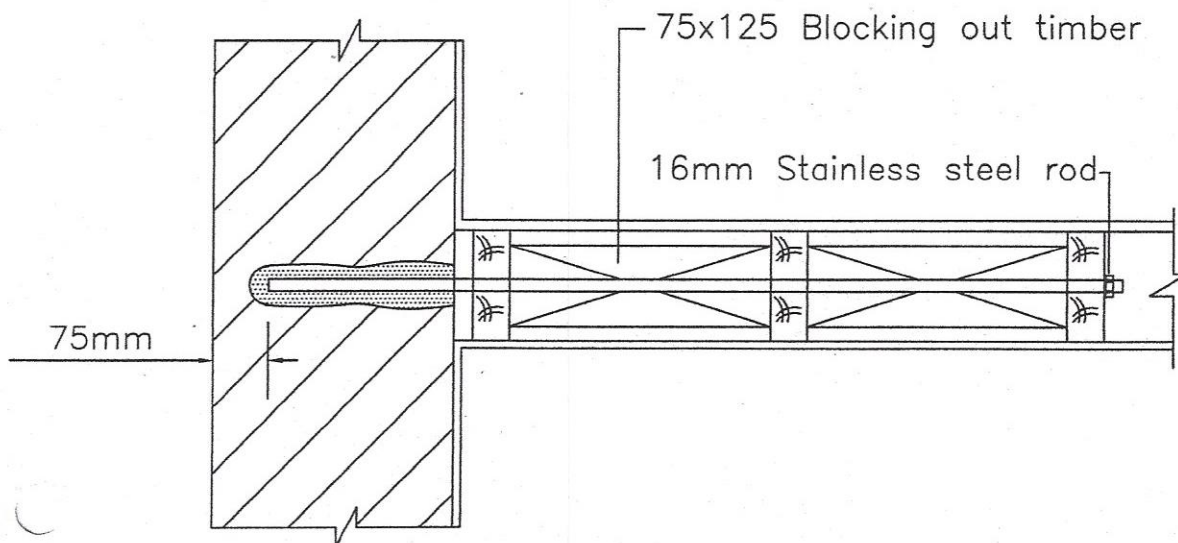
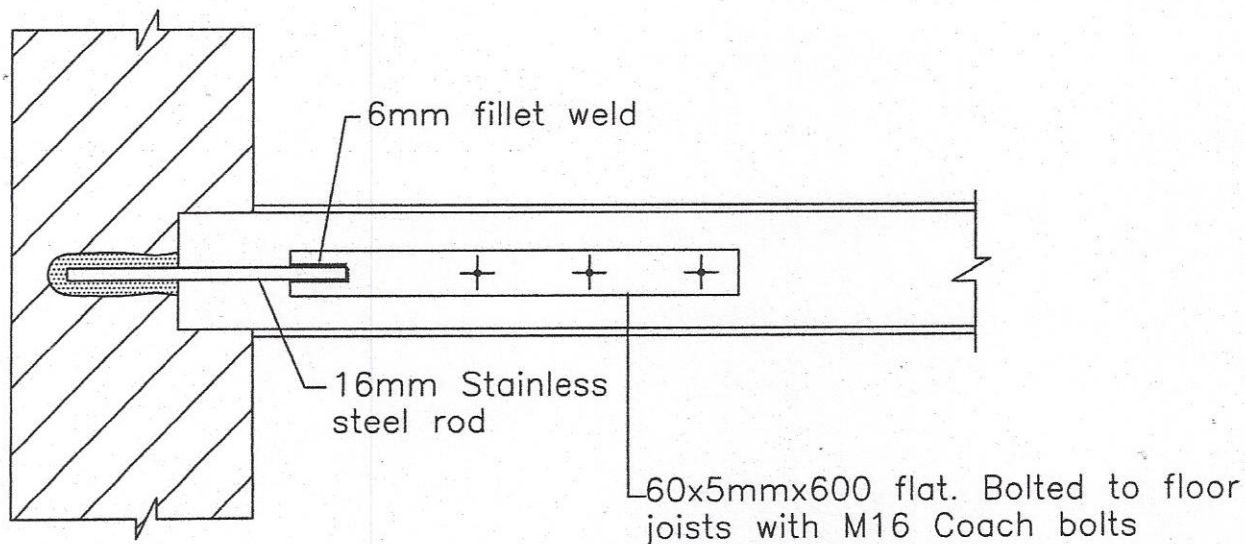
## STABILISATION OF EXTERNAL WALL

Whilst the lower part of the front wall appears to have been buttressed the upper part of the end property displays structural movement in the form of cracks and also lateral movement.

In view of the aggregation of defects to the outer part of the front wall it would be advisable to make provision for rebuilding the outer leaf.

Provision should also be made for tying the front wall back to the first-floor joists in a similar manner to that shown on the attached sketch.

Similar ties should be used to tie the rear wall back to the first-floor and also the upper ground floor joists.

In view of this the gable should be strapped back to the upper ground and first-floor joists in a similar manner to that recommended for the front and rear walls.

- 6.4**      Strap the gable wall and also the rear wall at both the higher ground floor level and the first-floor level with patent straps in a similar manner to that shown on the attached sketch. The straps should be inserted at approximately 1.2m centres and should be installed by a specialist familiar with resin bonding techniques.
