**Lower Starring farm cottage**

## **Structural Engineers Report**

FS 4850 pkd/pkd

**Sir Frederick Snow & Partners**

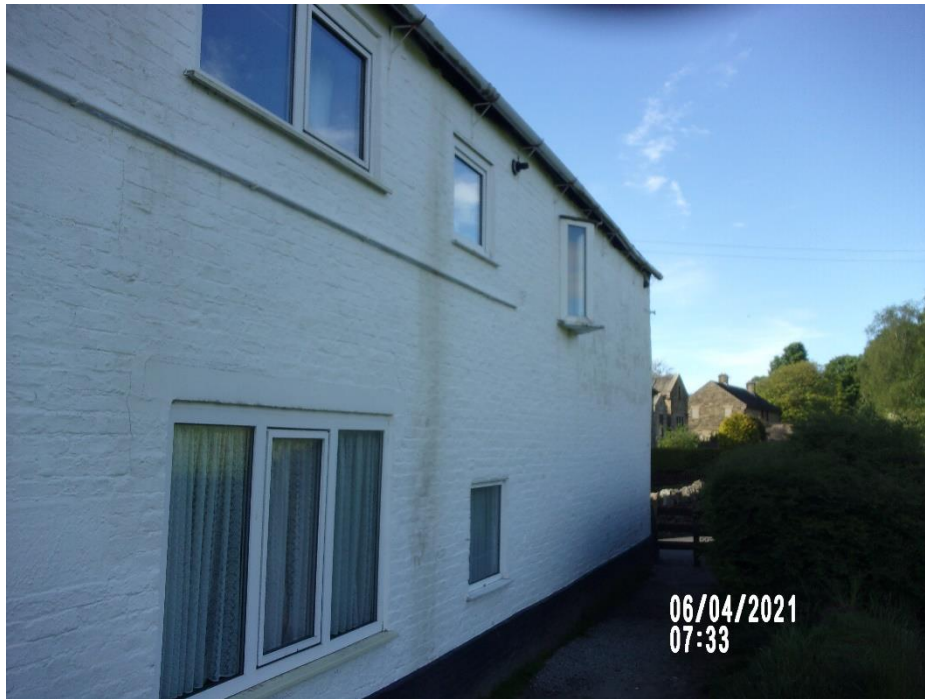
The present building configuration consists of a solid mortared brick white washed perimeter wall some 400mm thick approximately 20m x 7m in plan. There was no evidence of a damp proof course. All walls appeared reasonably plumb with no significant signs of distress for a building of this age.

Generally the windows had stone lintels.

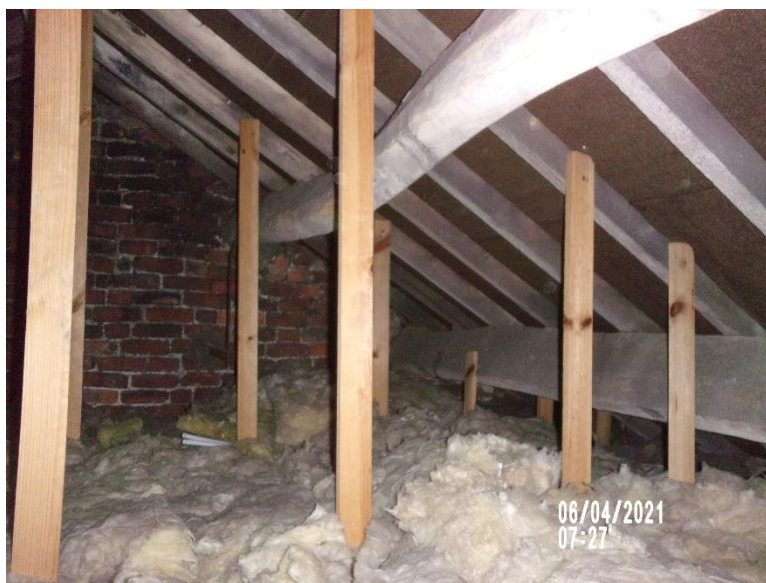
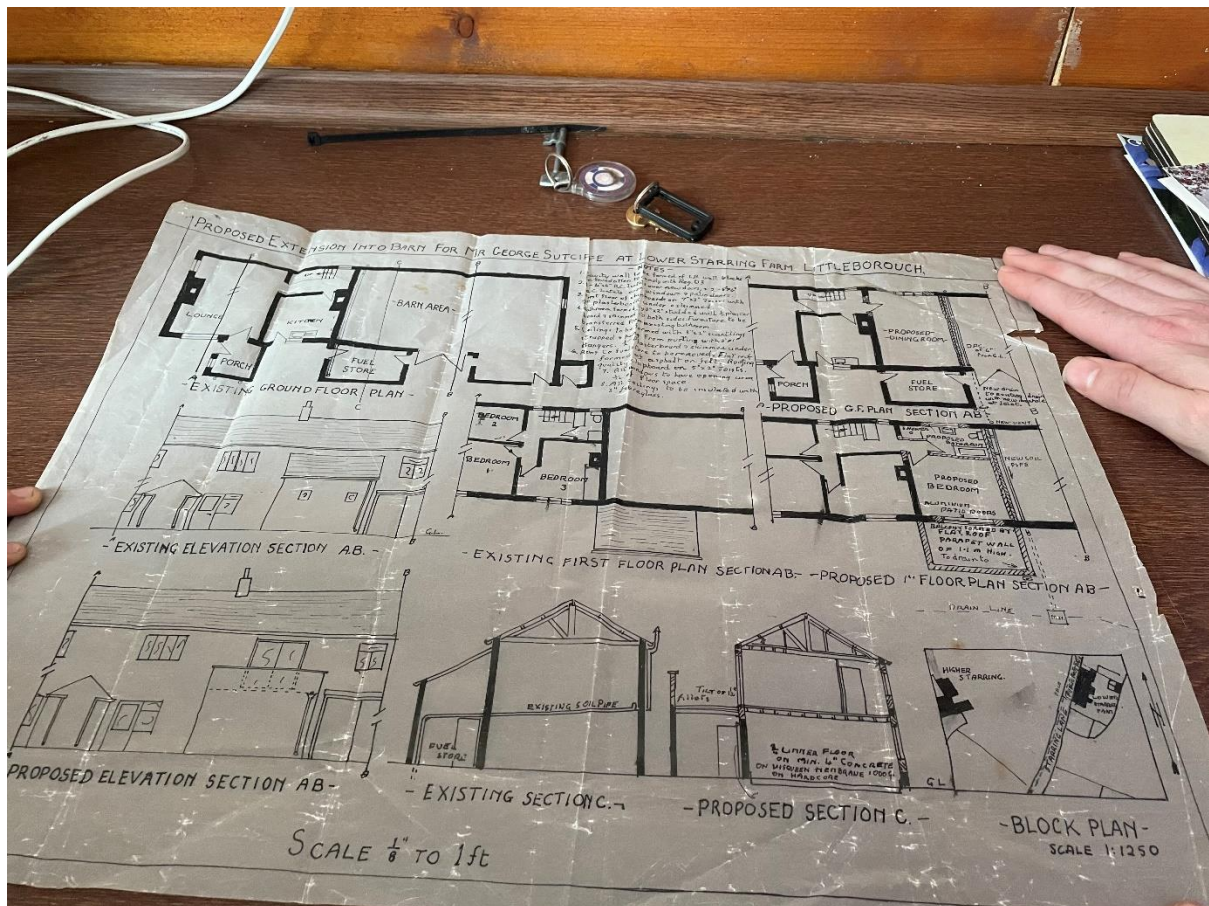
The roof is flagged and under felted sitting on machine cut joists that have obviously been reroofed with in the last fifty years or so. These in turn sit on rafters spanning some 4m onto king post truss frames or cross walls. The roof generally is in good repair and the timbers appear in reasonable condition.

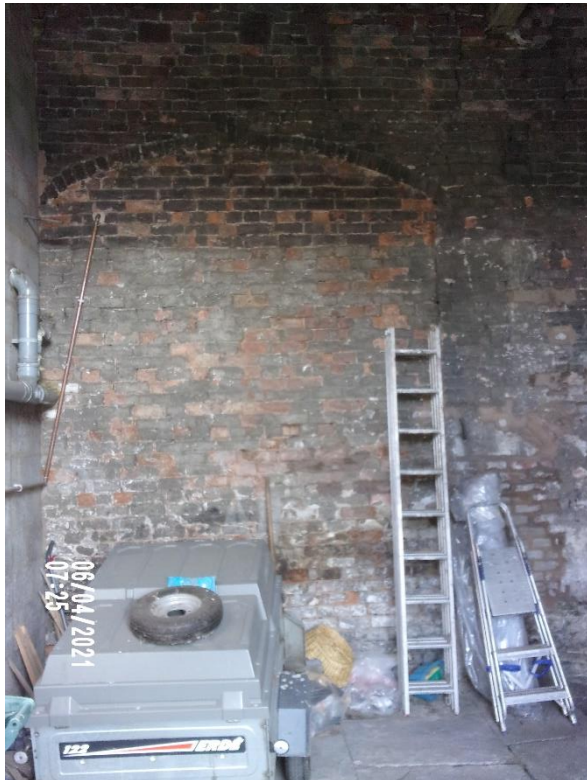
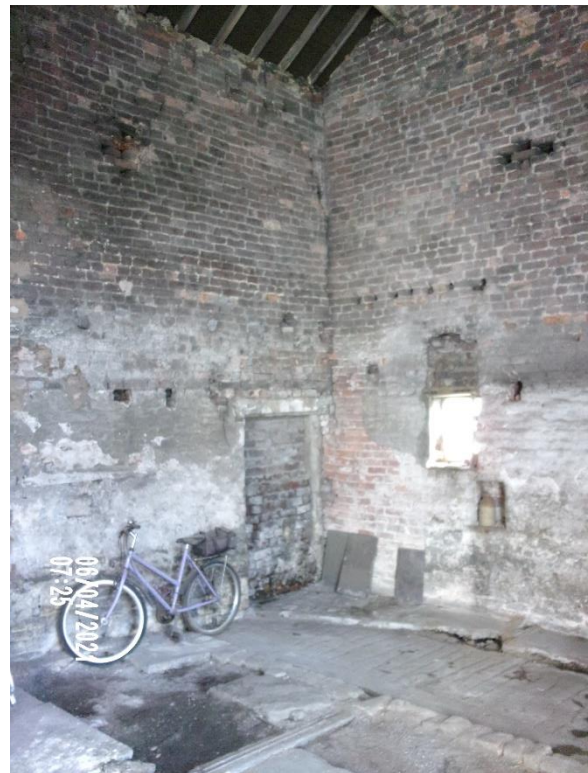
The remaining Barn does show signs of distress with a vertical crack evident internally on the brickwork in the northern corner of the barn.

The brick shows the configuration of infilled openings and disused joist holes has altered over the years as the use of the building has changed. The floor also shows a mixture of flags, cobbles, screed and earth reflecting varied uses.

The crack in the corner should ideally be tied/stitched back as while there is no immediate danger of collapse long term movement may cause further distress and movement in this gable corner. The cost of such works should be under £2000. In the short term tell tales could be applied to see if further movement occurs.
