# Heywood Stores Manchester Road

Arboricultural Impact Assessment  
October 2022

#### **Heywood Stores, Heywood**

Report reference: AR-6197-01  
June 2022

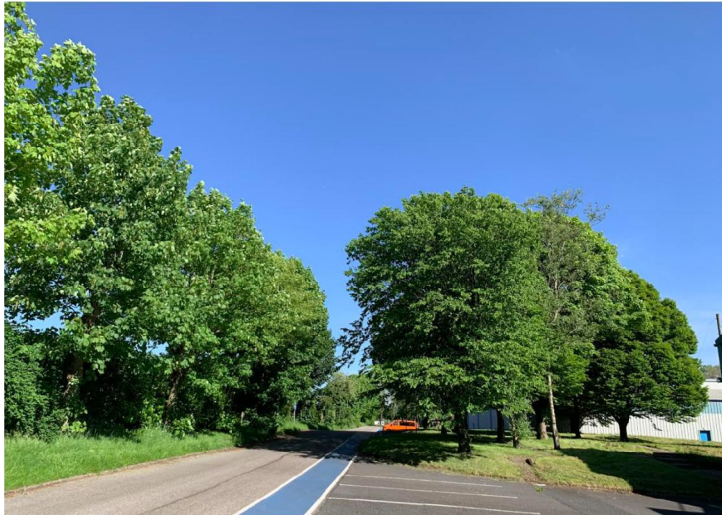
**Figure 1: Looking SE along the towards Manchester Road.**

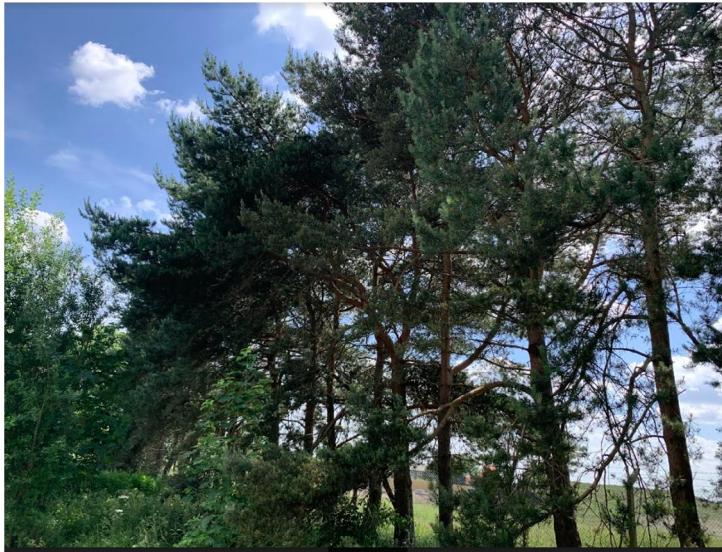
**Figure 2: Trees along the W boundary in G210.**

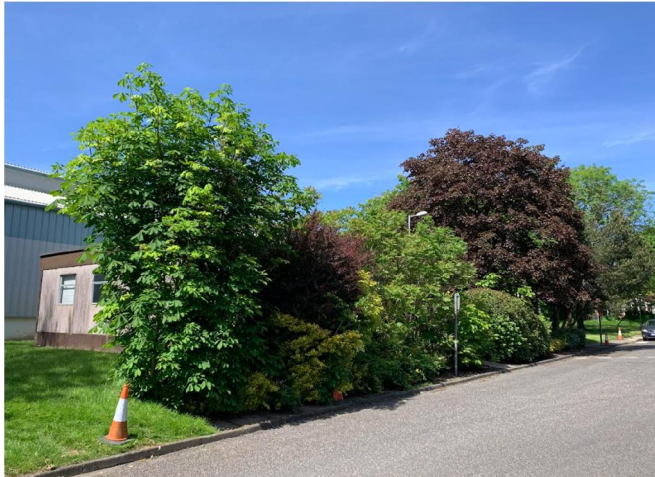
**Figure 3: T's 40-47 located in the SE of the site.**

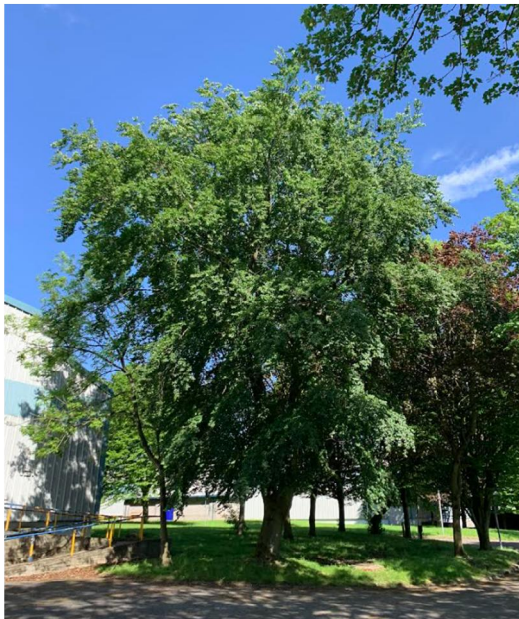
**Figure 4; T122 located in the S of the site.**
